Franzoni E and Pizzigatti C (2024), Onsite and  
laboratory assessment of repair mortars for  
reinforced concrete floor slabs in heritage  
buildings.

# Onsite and laboratory assessment of repair mortars for reinforced concrete floor slabs in heritage buildings

In the present paper, the use of different mortars for the repair of a reinforced concrete floor slab built in the 1930s was investigated, in terms of effectiveness and compatibility. The floor slab under testing is composed by a ribbed reinforced slab and hollow bricks, and it covered on the lower side by a layer of hollow brick and plaster, which was removed to investigate the state of the reinforced concrete beams, in view of the assessment of their load bearing capacity. Then, three concrete beams were reprofiled using three different commercial products, which were applied with procedures currently used in real practice, to highlight the performance of these solutions in real conditions. After some onsite inspection and testing, the three reinforced concrete beams were entirely cut and transported to the laboratory, where different characterization tests were carried out.

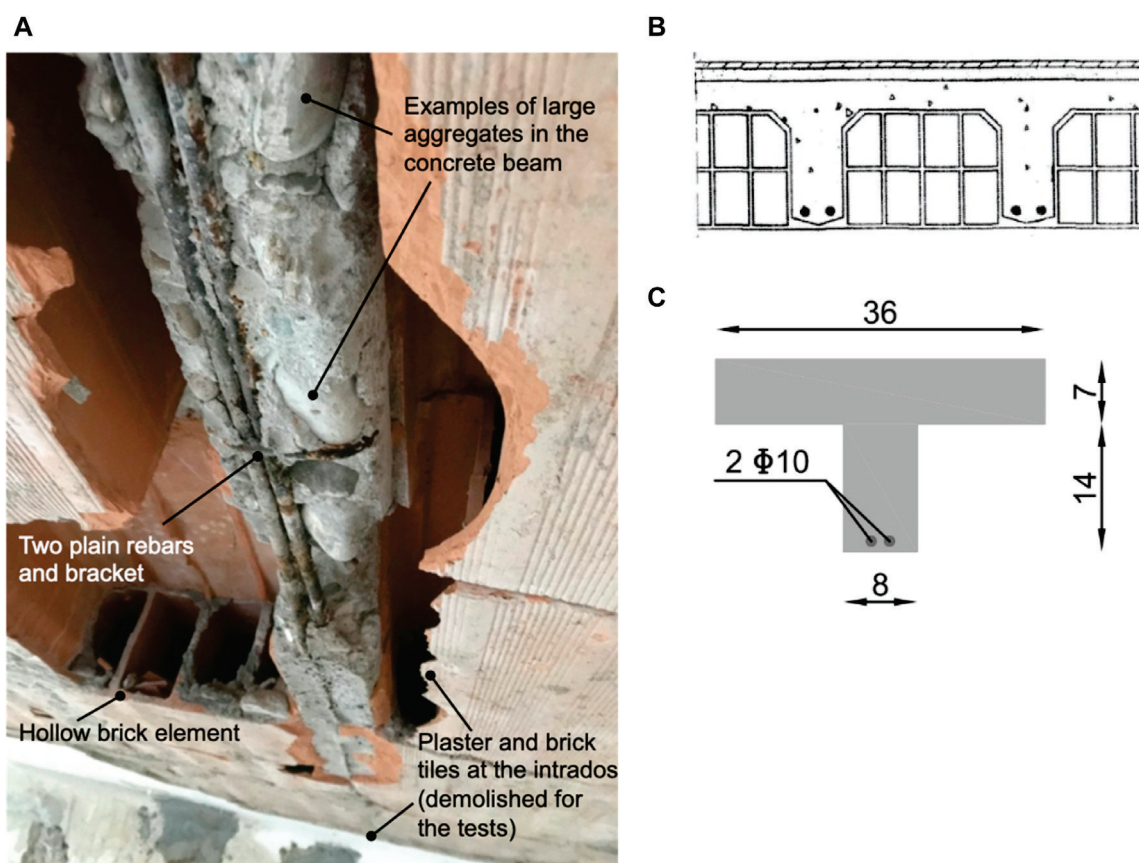
FIGURE 2

(A) Detail of a beam after the demolition of the layers underneath: it is possible to see the large size of the gravel and the irregular position of the longitudinal steel bars; (B) sketch of the reinforced concrete and hollow tiles mixed floor; (C) size of the reinforced concrete beams (sizes in cm, diameter of the rebars in mm).

raised ground floor (Figure 1B) and is constituted by a ribbed reinforced concrete slab and hollow bricks (Figure 2A). The painted plaster at the intrados appeared in good state of conservation, but prevented the examination of the slab materials, hence the

layers of thin hollow brick and plaster were demolished and four reinforced concrete ribs (beams) were entirely exposed (Figure 2A). These beams were characterized by exceptionally large aggregates (size up to 8 cm, Figure 2A), totally unfitting to the cross section of the beam, which is 8 cm large. In fact, visible gaps and voids were observed in the beams, confirming that casting the fresh concrete into the formworks was difficult. Likely, at the age of construction the provincial workers were not familiar with concrete yet. At the bottom of each beam, two plain rebars having diameter 10 mm were present (Figures 2B, C). These rebars were placed in a very inaccurate way, i.e., not symmetrically and directly on the formworks, resulting in an almost nonexistent concrete cover. Rust was observed over the rebars' surface.

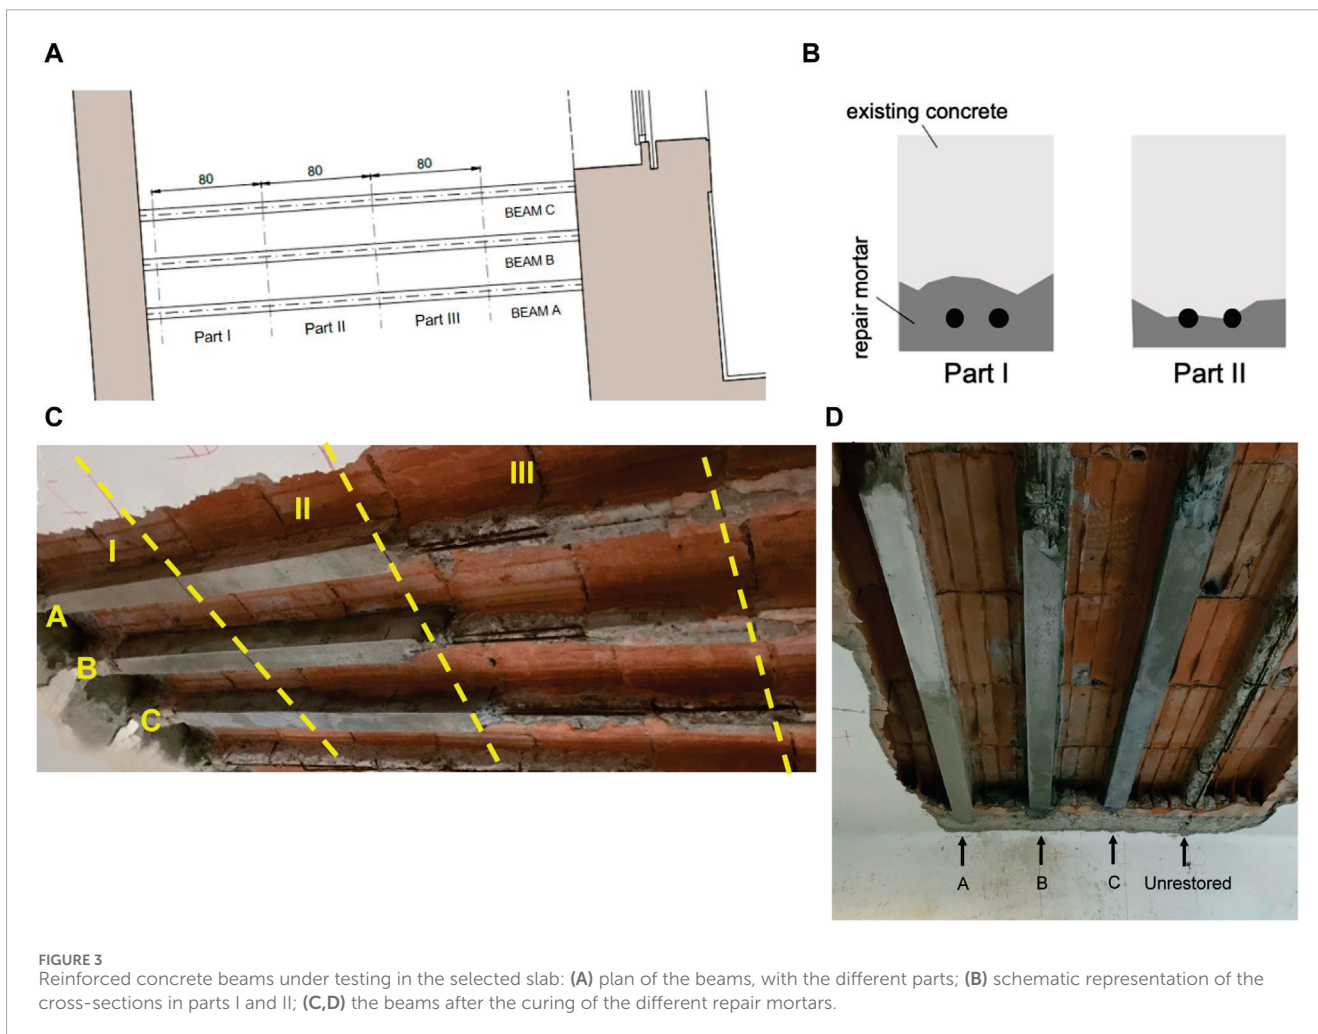
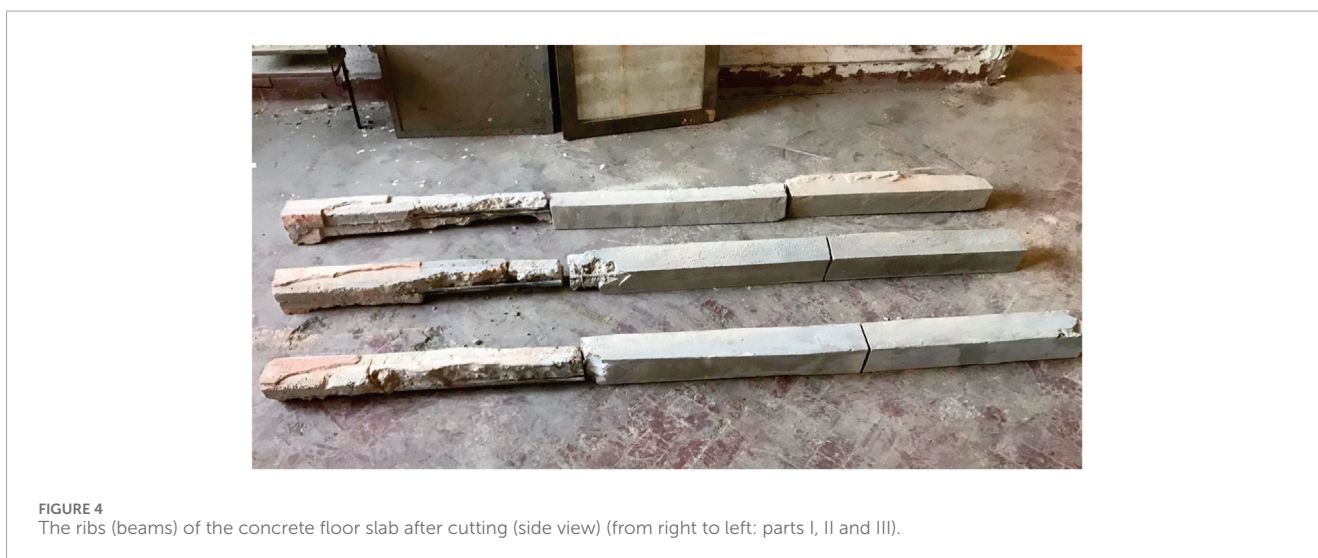
- In Part I, concrete was removed all around the reinforcing bars, and rust was manually cleaned by steel brush (Figure 3B). Then, the original profile of the beam was recreated by applying a repair mortar.
- In Part II, concrete was removed only in the cover part, i.e., below the steel rebars, and rust was manually cleaned by steel brush only from the exposed surface of the bars (Figure 3B). This condition was investigated to mimic what could happen in practice, if a less radical demolition is carried out. Then, the original profile of the beam was recreated by applying a repair mortar.
- Part III was left without any mortar application, for reference.

The repair materials were repeatedly wetted for the first day after the application, then they were let cure at room condition up to 28 days (Figures 3C, D). After curing, the bar corrosion potential was measured onsite (Section 2.2). Then, the vertical portions of the three T-shaped concrete beams were cut by an angle grinder (Figure 4) and transported to the laboratory for further testing. The remaining floor slab was sustained by a purposely designed steel profiles structure.

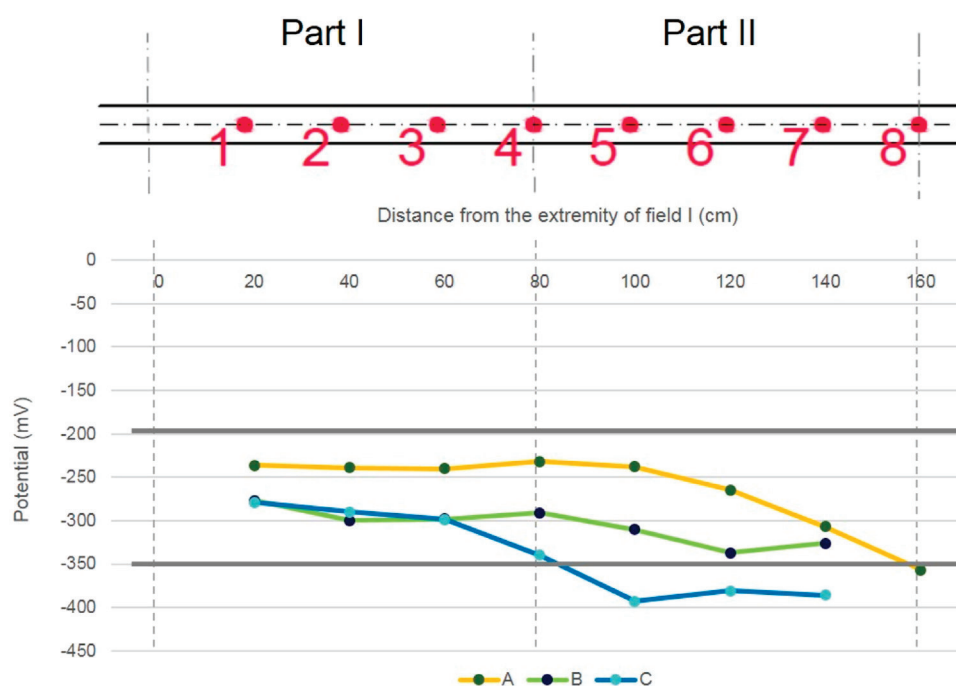
FIGURE 6  
Potential measurement along the repaired parts of the beams (parts I and II), together with the location of the measurement points (bottom view).

The corrosion potential values measured along the beams are reported in Figure 6. It was not possible to find reliable values for the untreated original concrete, as the values resulted very scattered, likely due to the uneven surface of the material and the presence of void and large aggregates adjoining the steel reinforcements. According to UNI 10174, potential values > −200 mV indicate that corrosion is probably absent (probability >90%), whereas potential values < −350 mV indicate that corrosion is probably ongoing (probability >90%). None of the repair mortars could restore a potential > −200 mV, so according to the mentioned standard the corrosion process was not totally stopped in any case by the mortars' application. However, the potential values significantly improved passing from part II to part I, confirming the importance of cleaning the whole steel surface. Indeed, an only partial removal of the rust (part II) strongly jeopardizes the treatment's success, notwithstanding their alleged inhibition effect. The fact that the potential, even in the parts where the repair mortar was applied all around the reinforcement, was not restored to values > −200 mV may be ascribed to an incomplete removal of the rust by manual cleaning and/or to the fact that the material surrounding the rebars was mortar rather than concrete, hence the reference values reported in the standard might be not entirely fitting and specific values should be fixed. Moreover, it is known that potential measurements taken from the concrete surface are influenced not only by the corrosion state of the rebars (active or passive) but also by the concrete cover and resistivity, which varies at least with temperature, moisture, carbonation, thus the reference values of potential should not be used as absolute criteria to determine the condition of steel in concrete (Elsener et al., 2003). However, the comparison of the potential values across different beam sections offers valuable insights into corrosion susceptibility and, although the results could change over time, the measurement performed at 28-day seems adequate for an initial assessment.

In terms of comparison among the different repair solutions in Part I of the beams, the measured potential values seem quite comparable, but beam A exhibited a slightly higher potential, likely due to the corrosion inhibitor, although this effect might be ascribed also to some heterogeneity in the beams' cleaning.

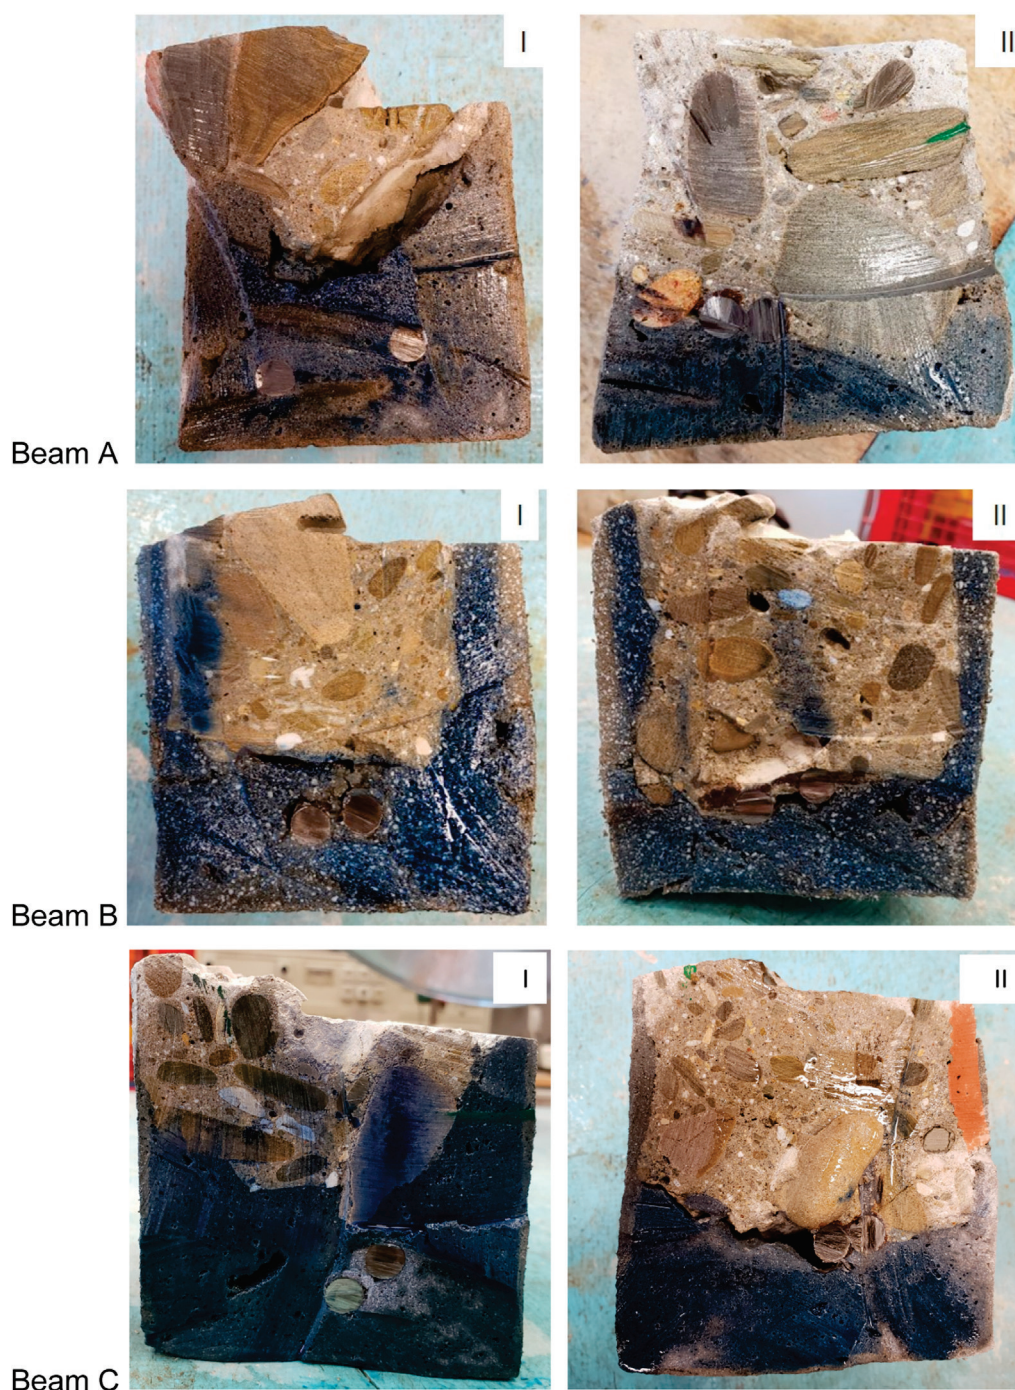
FIGURE 7

Colorimetric tests performed by thymolphthalein on the cross sections of beams (A–C) (some circular blue traces on the concrete are due to the powder of repair mortars spread by the angle grinder during the cut).

The colorimetric test by thymolphthalein (Figure 7) highlighted that the original concrete was entirely carbonated, while all the repair mortars were highly alkaline, as expected. The pH values measured in the positions of Figure 5 are reported in Table 1. The two set of measurements taken after 24 and 48 h in water (see Section 2.2.1) were basically identical, hence the pH values reported in Table 1 are their average. The original concrete exhibited an average pH equal to 9.5, while the new mortars resulted quite similar each other and with an average pH of 12.4. It is difficult to say if some re-alkalization of the original concrete occurred as a consequence of the application of the new products, because the pH of concrete close to the interface (sampling position 2 in Figure 5) was in some cases

unaltered and in some cases slightly higher, so drawing conclusive remarks was not possible. However, even when improved, the pH or the original concrete adjacent to the repair mortars only reached values equal to 10.6, 11.8, and 10.1 (in parts I of beams A, B and C, respectively), so not enough for protection conditions.

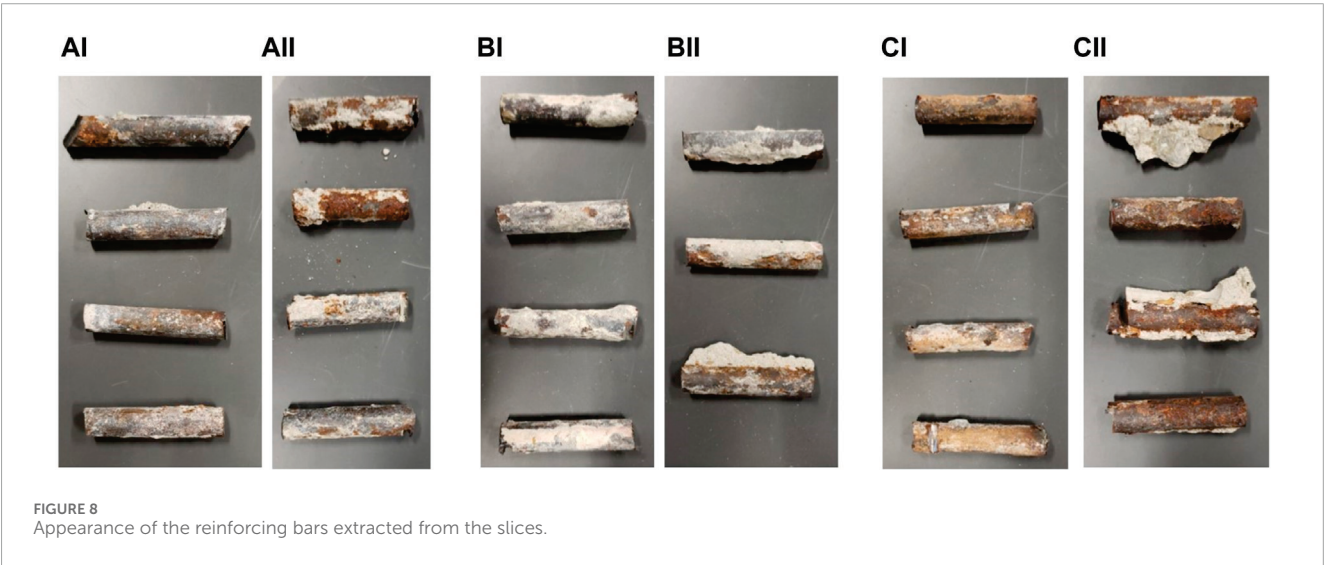
The appearance of the reinforcing bars extracted from the slices of the beams is shown in Figure 8. Although the photos provide no insight into the corrosion depth, they show at a glance how rust is present almost everywhere, despite the cleaning of the rebars before the application of the repair products, thus steel brushing was not effective enough in removing the corrosion products. This observation is consistent with the data of the corrosion potential described above. The shiny patina in A I is due to the corrosion inhibitor, while the white layer covering the reinforcement in B I is due to the passivating paste. In C I, the light brown color of the steel is likely due to some mixing between the rust powder and the repair mortar.

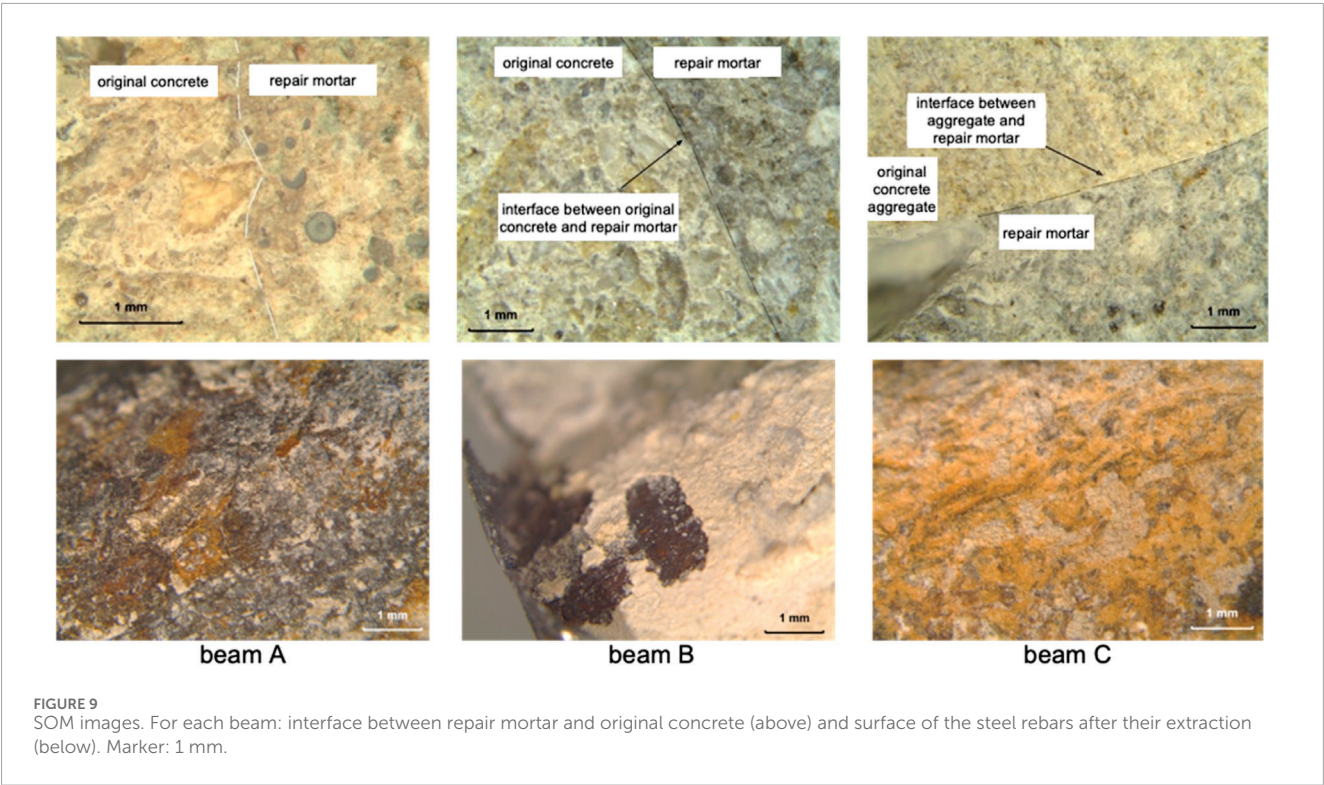
Based on microscopic observation of the interface between concrete and repair mortars, all the new products seem able to provide a good adhesion to concrete (Figure 9, above) and steel (Figure 9, below). However, from a macroscopic point of view, several gaps are visible between the new and the original materials (Figure 10). The insufficient filling ability of the repair mortars seems due to their low flowability, necessary for ceiling application but counterproductive for the filling ability. An alternative application technology should be developed, involving the casting of the mortar (Ana Bras et al., 2013). Figure 10 shows that the original concrete exhibits very coarse aggregates, large voids and an asymmetric arrangement of the steel rebars, as observed onsite.

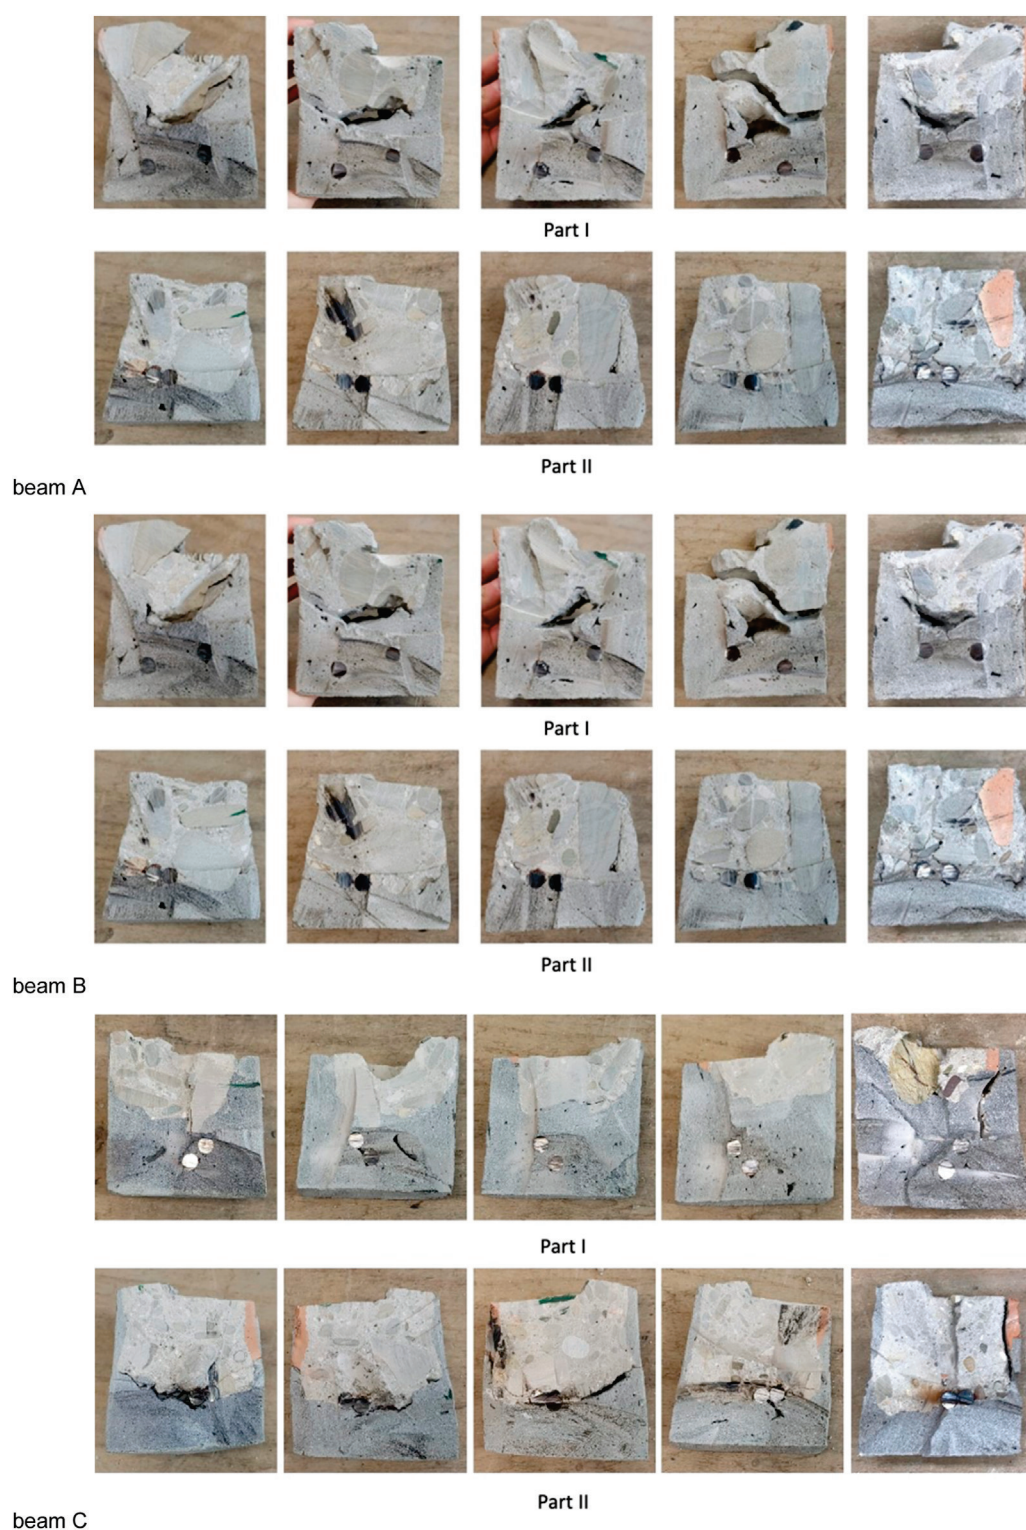
FIGURE 10  
Appearance of the cross section of the slices.

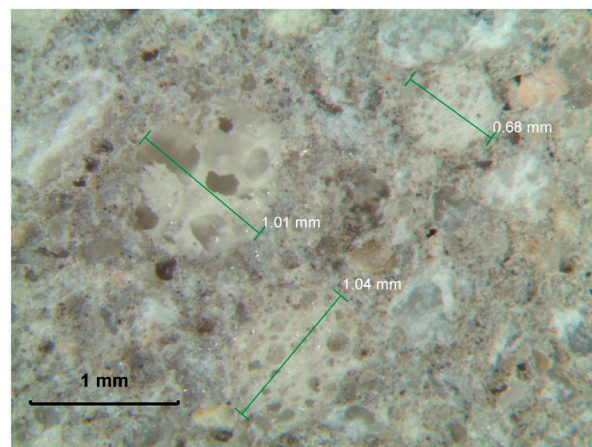
Concerning microstructural compatibility, the results are reported in Table 2. The original concrete exhibits a bulk density equal to  $2.3 \text{ kg/dm}^3$ , which is in line with the typical values for this kind of material, while all the three repair mortars exhibit a much lower bulk density (in the range  $1.8\text{--}1.9 \text{ kg/dm}^3$ ). The use of lightweight materials is generally considered a positive feature in structural strengthening of existing buildings. The bulk densities of the repair mortars are different from the values reported in their technical datasheets, due to the presence of air entrapped during the hand mixing (Figure 12) and/or to the fact that the water was added to the dry mixes onsite just to reach a suitable workability, as in real practice, without considering the amount reported in the datasheets. Consequently, the mortars exhibit a higher open porosity and water absorption than concrete. However, mortar B, despite having a bulk density equal to mortars A and C, exhibits a much lower open porosity and water absorption. Considering that the real density of the mortars is the same, the low open porosity of mortar B suggests the presence in the mix of some lightweight aggregates having close porosity. This was confirmed through optical microscopy, as small spheres having a foam appearance were observed (Figure 11).

FIGURE 11  
SOM image of mortar (B): small spheres having a foamy appearance, with closed porosity.

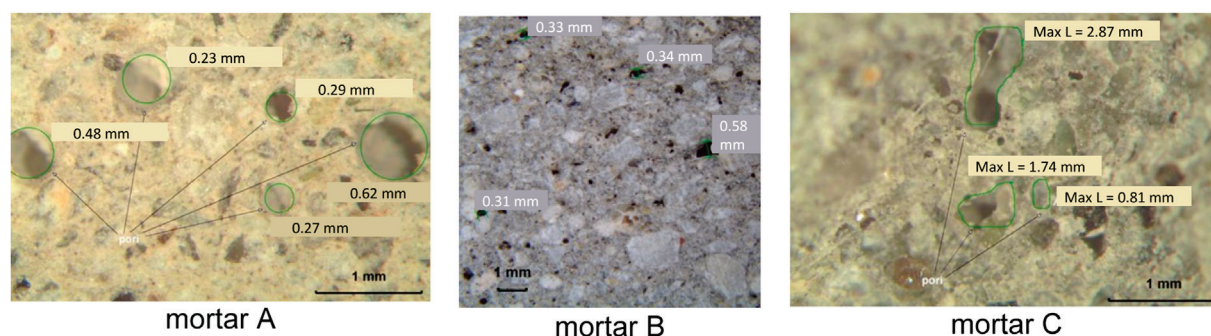
FIGURE 13  
Air voids in mortars (A–C), observed by SOM.
