Damage and collapses in industrial precast buildings after the 2012 Emilia earthquake

DAMAGE AND COLLAPSES IN INDUSTRIAL PRECAST BUILDINGS AFTER THE 2012 EMILIA EARTHQUAKE

SUMMARY – The present paper presents a complete and commented collection of cases of damage and collapse in reinforced concrete (RC) precast industrial buildings, observed by the authors during a series of field surveys after the 2012 Emilia earthquake in Northern Italy. They were selected among a total of about 2000 industrial RC precast buildings, whose structural characteristics and damage have been collected in a large database by the authors.

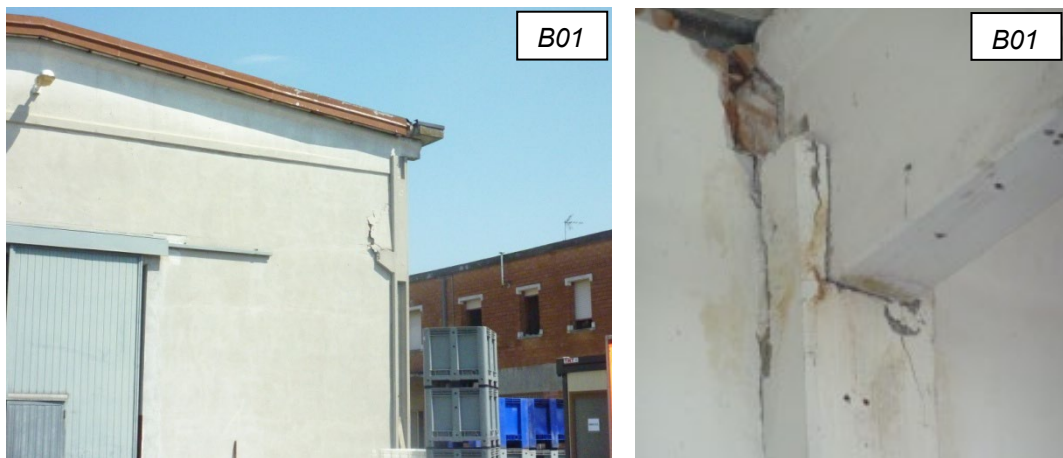
Figure 10. (a) Precast RC building with regular masonry cladding walls, only slightly damaged by the earthquake; (b) Damage to the column fork, due to the transverse rotation of the double slope roof beam during the ground motion.

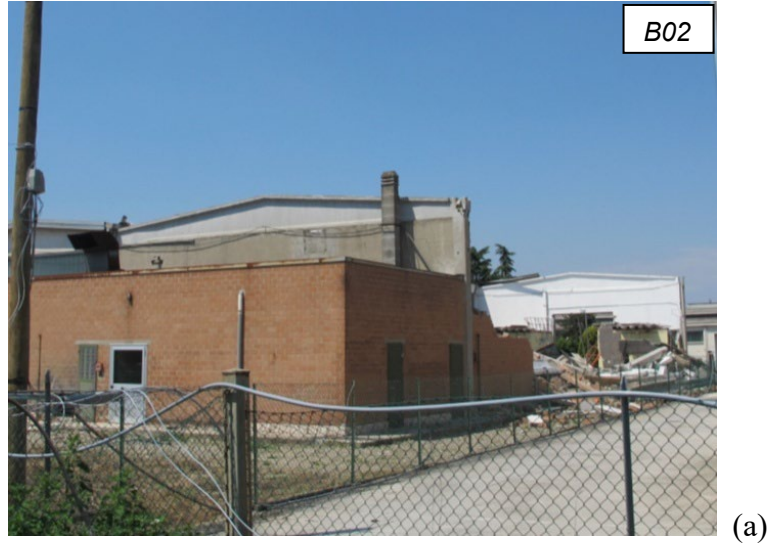
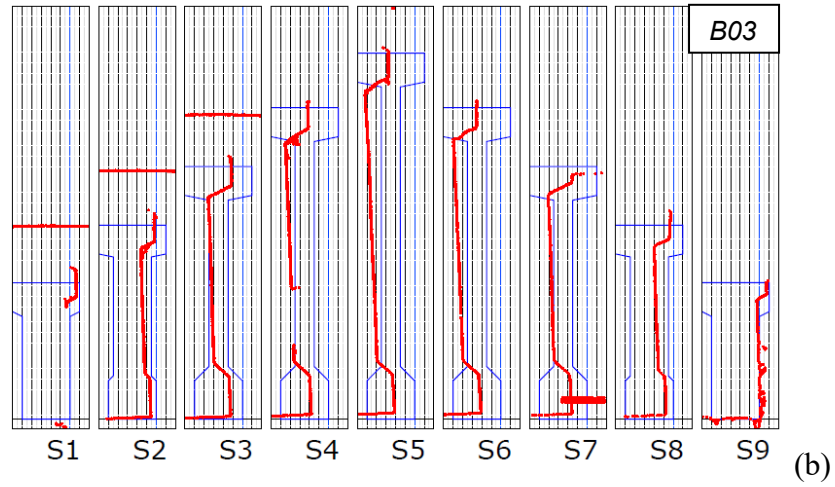
Figure 11: (a) A collapsed building with deformable roof, the only remaining elements are the two short facade masonry walls; (b) permanent rotation after the earthquake of different cross sections of a double-slope beam. S1 and S9 are the support sections and S5 at mid-span. Blue and red lines indicate the theoretical and the actual position, respectively.

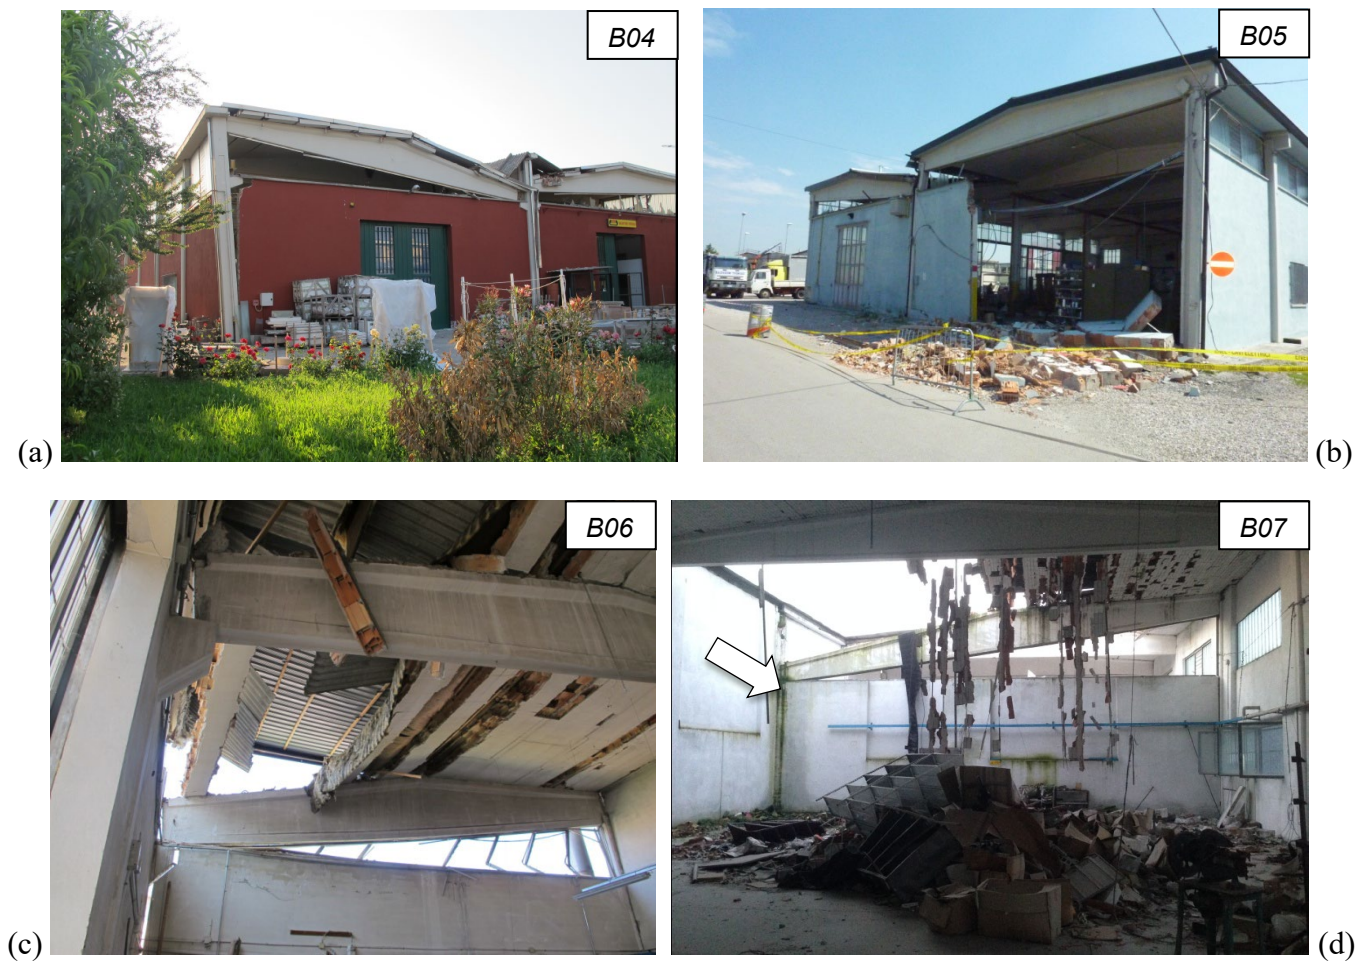
4 Industrial buildings with curtain masonry walls and strip-windows just under precast double-slope
5 beams were often severely damaged and often collapsed (Figure 12). This was probably the most frequent
6 cause of failure in some industrial areas (e.g., San Felice sul Panaro and Mirandola).

11 In the building in Figure 12b, it is interesting to note that, in the bay on the left side, the presence of
12 an irregular wall caused the unseating of the double-slope beam, whereas, in the bay on the right side, the
13 masonry wall, only partially restrained by the RC structure, collapsed and, consequently, no unseating of
14 the roof beam occurred. Typically, this kind of failure involved only the two external portal frames (Figure
15 12a, b), and in a few cases also the subsequent ones (Figure 12c). In the building of Figure 12d, the presence
16 of a rigid partition masonry wall inside the building caused the same kind of collapse. Because of the action
17 in the infill wall, the horizontal force in the short columns of the terminal frames was so high that, when
18 the loss-of-support failure did not take place, flexural plastic hinge failures were observed (Figure 14b-c)
19 in the columns. In some cases, the significant reduction of the shear-span of columns, due to the interaction

Figure 12: (a, b, c) Collapses due to the presence of strip windows on the top of masonry walls (the building in picture (a) is the same shown in Figure 7b before the collapse); (d) collapse due to the presence of an internal masonry wall (indicated by an arrow).

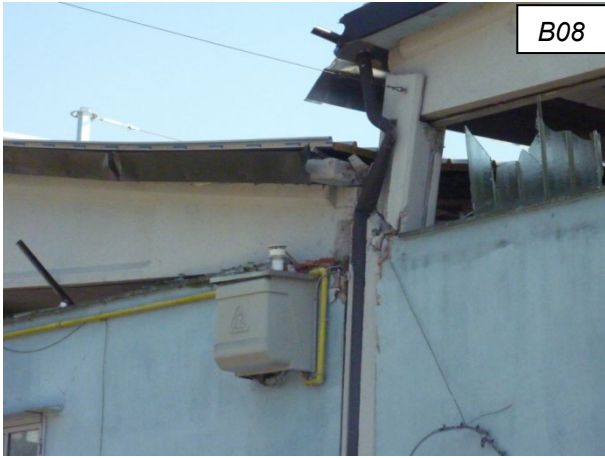
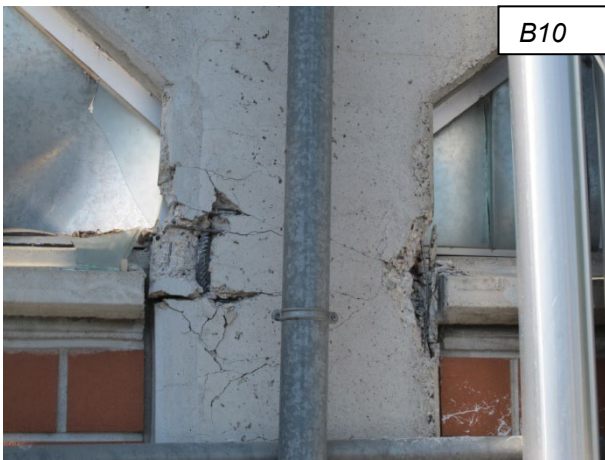
20 with infills, produced a modification of the failure mode from flexural to shear-type, as illustrated in Figure
21 14a which shows a flexural-shear failure.

Figure 14. Flexural-shear (a) and flexural (b, c) damage of the facade columns due to the interaction with irregular masonry walls.

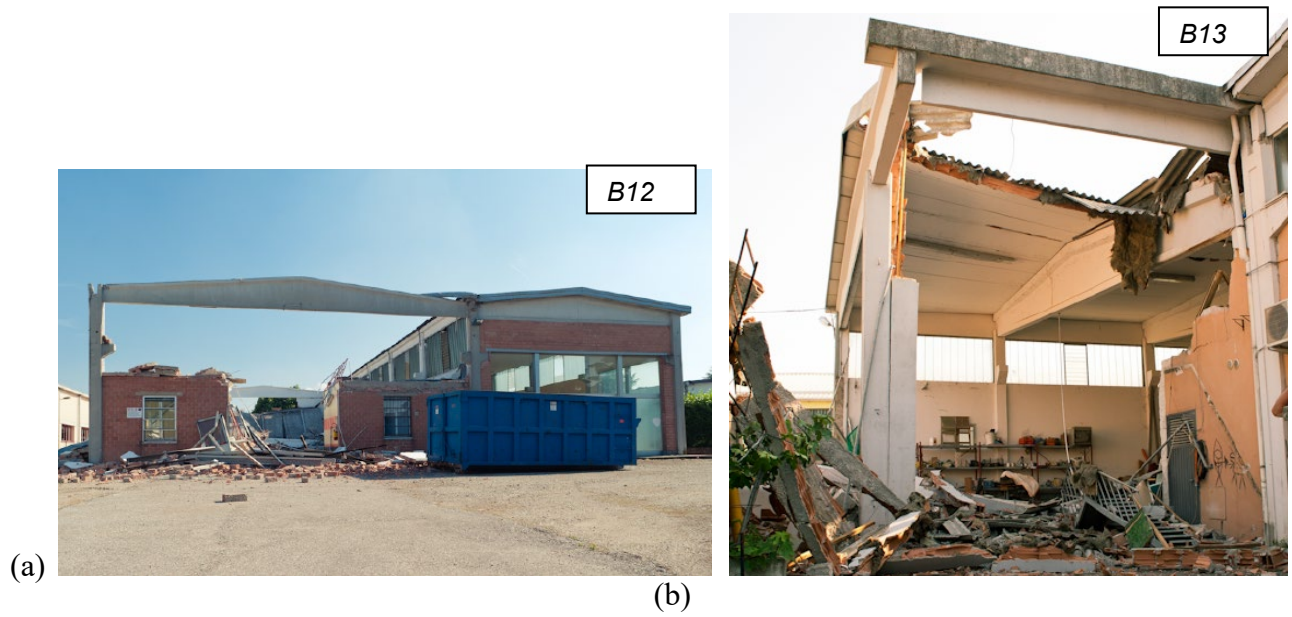
7 Plan-irregularity was another important cause of roof collapses. For instance, in the building of Figure
8 16a, the presence of a smaller (and then stiffer) precast building on the right side caused the transmission
9 of high horizontal forces at the support levels of intermediate columns. Friction resistance at the beam-
10 column support was then overcome and all the intermediate beams fell down from their supports. The
11 prefabricated building in Figure 16b suffered the collapse of the roof of a bay external to the two main
12 spans of the building, being much more flexible and undergoing large and differential displacements at the
13 level of column tops.

Figure 16: Collapses due to plan-irregularities in two industrial buildings.

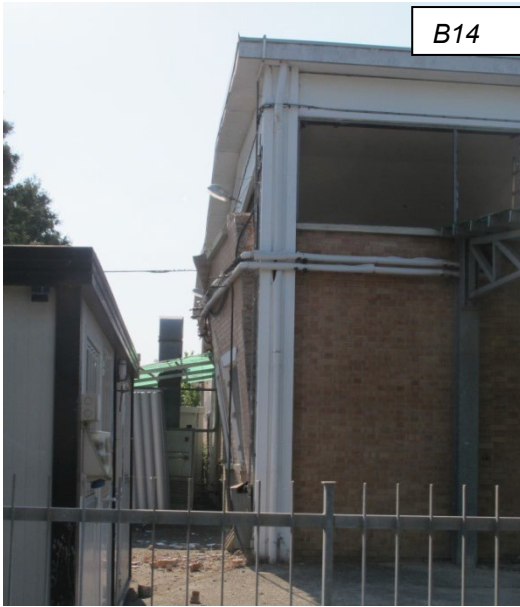
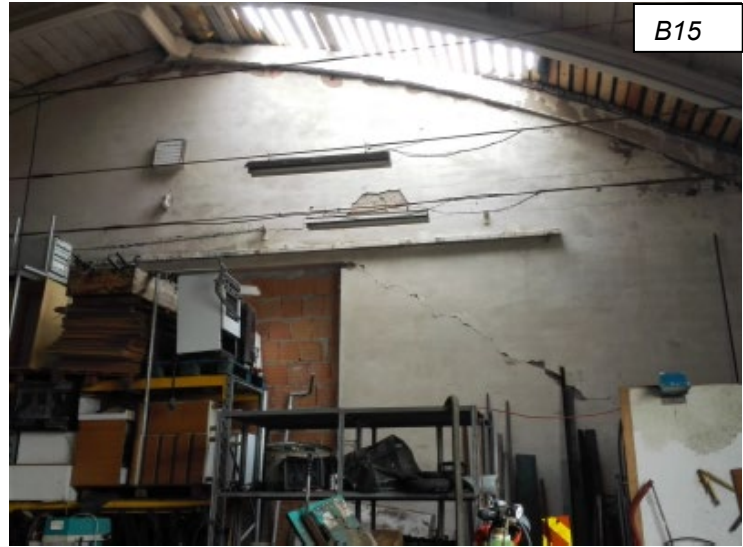
14 In some cases, masonry walls, not connected to the top beam because of the presence of strip windows,
15 either collapsed or were severely damaged (Figure 17a). Moreover, Figure 17b shows a partial collapse of
16 a roof made of clay hollow block panels supported over curved precast RC beams. This structural typology,
17 used frequently in the late sixties for buildings hosting manufactories, has masonry walls of different height
18 along both the long and short sides carrying the horizontal seismic forces. These very flexible, and
19 lightweight, roofs were usually able to deform during the ground motions without significant damage. Only
20 in a few cases, as in the building of Figure 17b, the relative displacement between the last two curved RC
21 beams of the roof at the building extremities, caused damage and sometimes collapse of portions of the clay
22 hollow block panels of the roof. In fact, the displacement of the façade RC beam is clearly limited by the

Figure 17. (a) Out-of-plane collapse of a cladding masonry wall non properly connected to the top beam due to the presence of a strip windows; (b) partial roof collapse in a curved roof due to the interaction with the masonry façade panels.

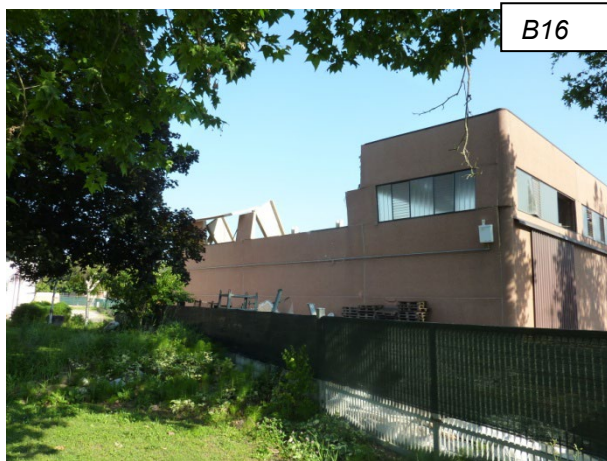
This section presents a commented collection of failure cases observed on Type-2 buildings. The failure mechanisms in more recent precast industrial buildings with flat roofs are various and more complex with respect to those described in the previous section. Even some recent structures (built in the last 10 years) suffered extensive damage or even full collapses (Figure 18).

Figure 18. Complete collapse of a recently built precast structure.

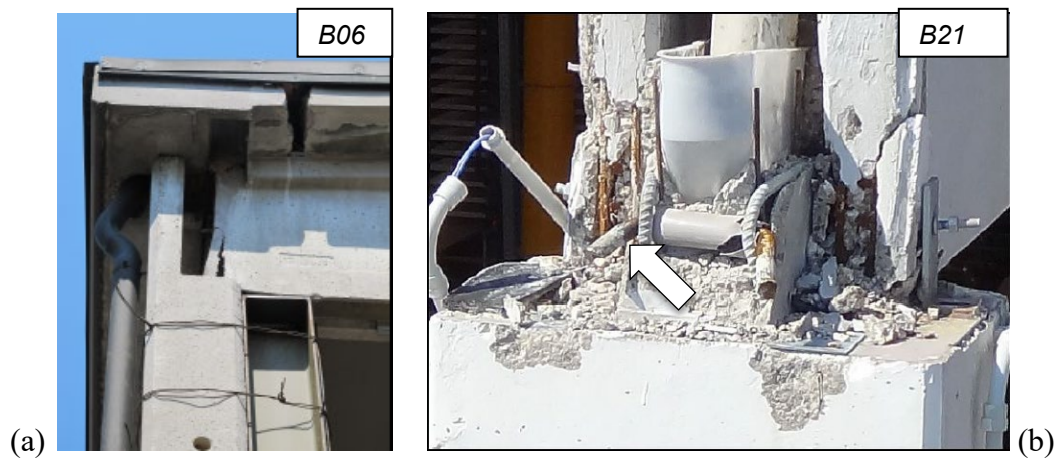
In some cases, despite of their presence, steel dowels to connect beams and columns were inadequate to bear the forces to be transferred. In Figure 20a, the steel reinforcement in the rear portion of the beam was not sufficient to resist the force produced by the steel dowel in the beam-column connection. Figure

Figure 20. (a) Damage at the extremity of a precast beam where no steel rebars were present in the beam to carry the force transferred by the steel dowel in the beam - column connection; (b) the steel dowel completely bent because unable to carry the horizontal force at the beam – column connection.

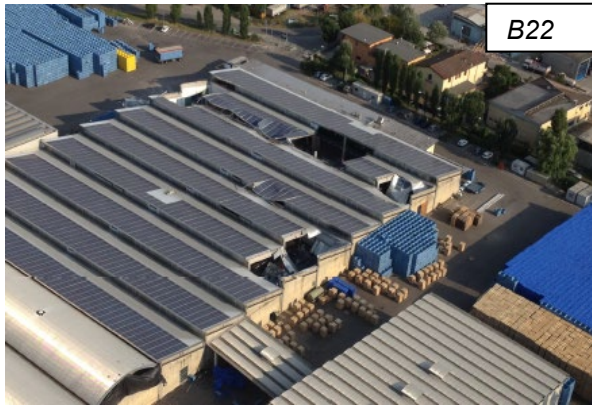
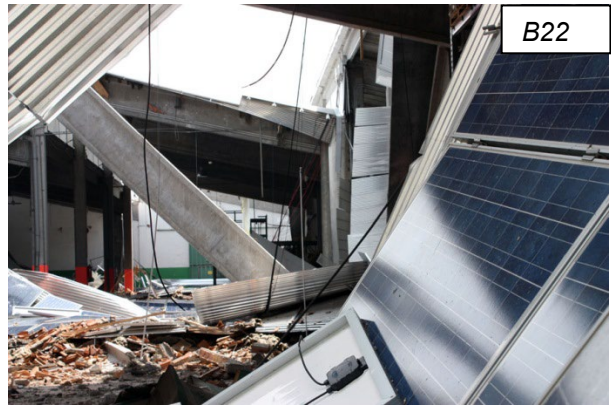
Figure 21: Collapses in a recent fruit warehouse with inclined precast beams to realize a shed structure.

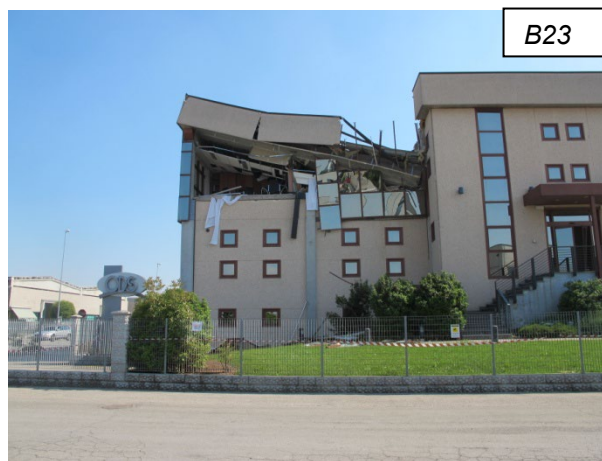
In the case of the precast multi-storey commercial building of Figure 22, the loss of support of precast roof elements was also due to plan-irregularity. The larger lateral stiffness of the right portion of the building caused the transfer of large horizontal forces at the level of the roof-beam supports, with forces exceeding friction resistance.

Figure 22. Failure due to the loss of support of roof elements related to plan-irregularity a commercial prefabricated building.

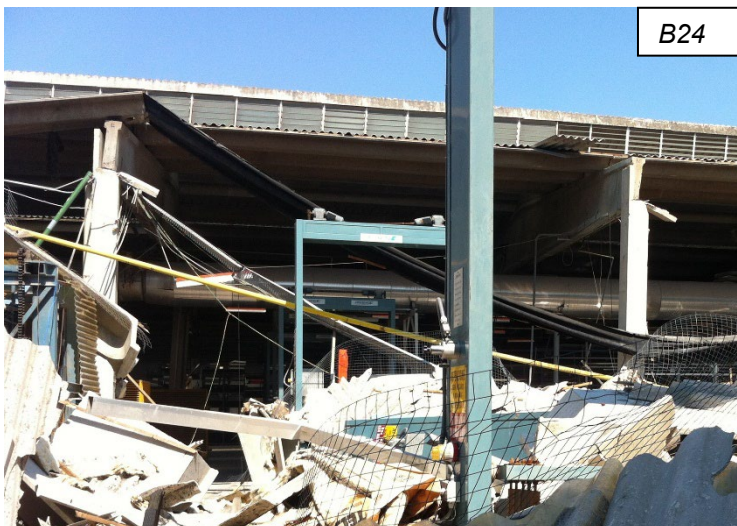
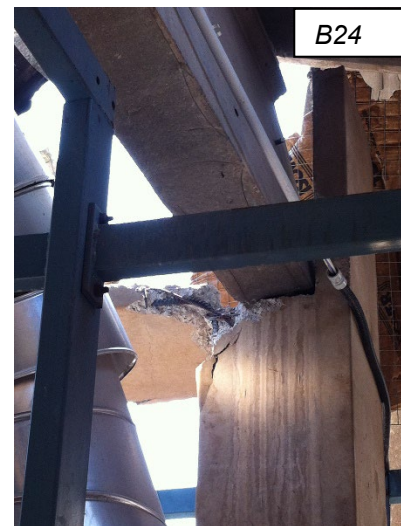
Some roof collapses were caused by the lateral rotation of beams supporting roof elements. These rotations were due to the eccentricity of the upper mass of the roof with respect to the beam supports. In the building of Figure 23a-b, most of the roof collapsed due to the rotation of the beam that followed the rupture of upper forks of columns, whose steel reinforcement was clearly insufficient. In other cases, the upper fork was even absent (see Figure 24a). In the collapsed structure of Figure 24b, the lateral rotation of the beams during the earthquake is highlighted by the shear cracking of the lower portion of the beam.

Figure 23. Complete collapse of an industrial building due to lateral overturning of beams.

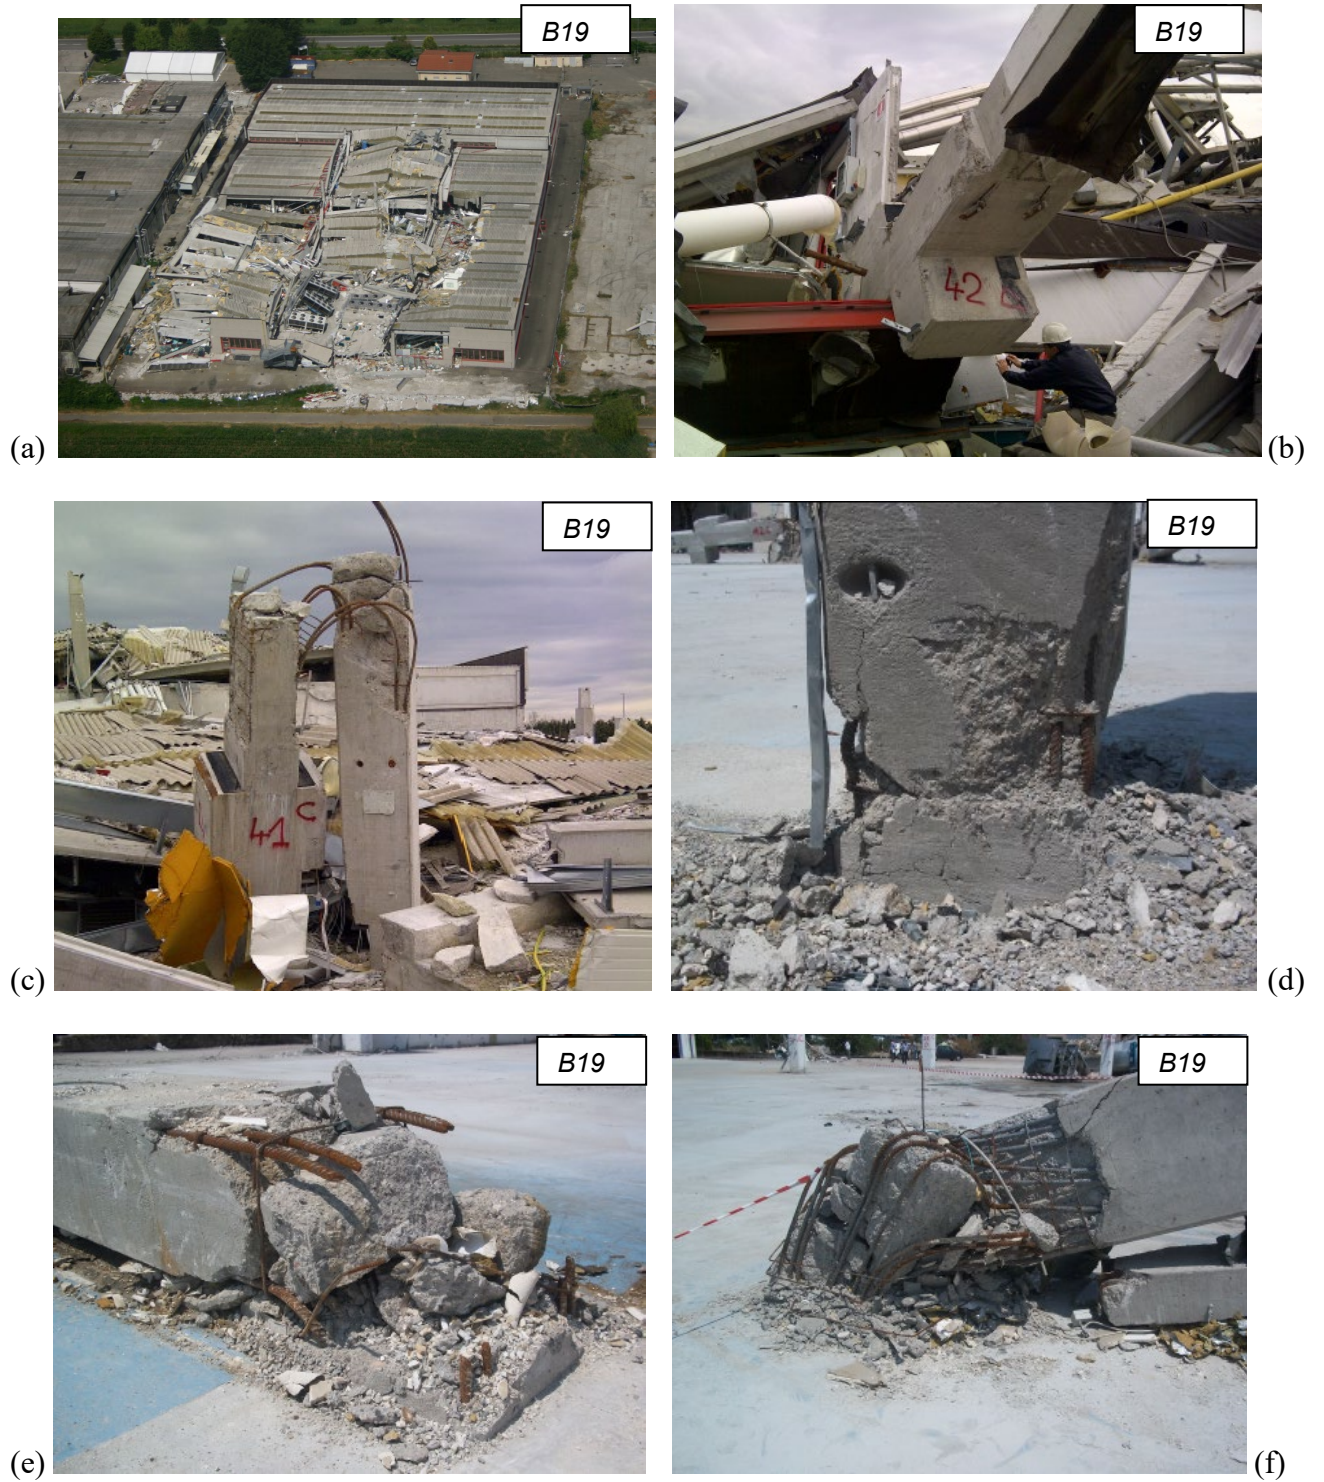
Figure 26. A collapsed building in Cavezzo (MO): (a) Aerial view, (b) column rotation due to the formation of a flexural plastic hinge, (c) rupture of a column in an intermediate position due to the presence of a TT precast slab, (d) plastic hinge with bar instability, (e) flexural failure with bar necking, (f) shear failure of a highly reinforced column in flexure.

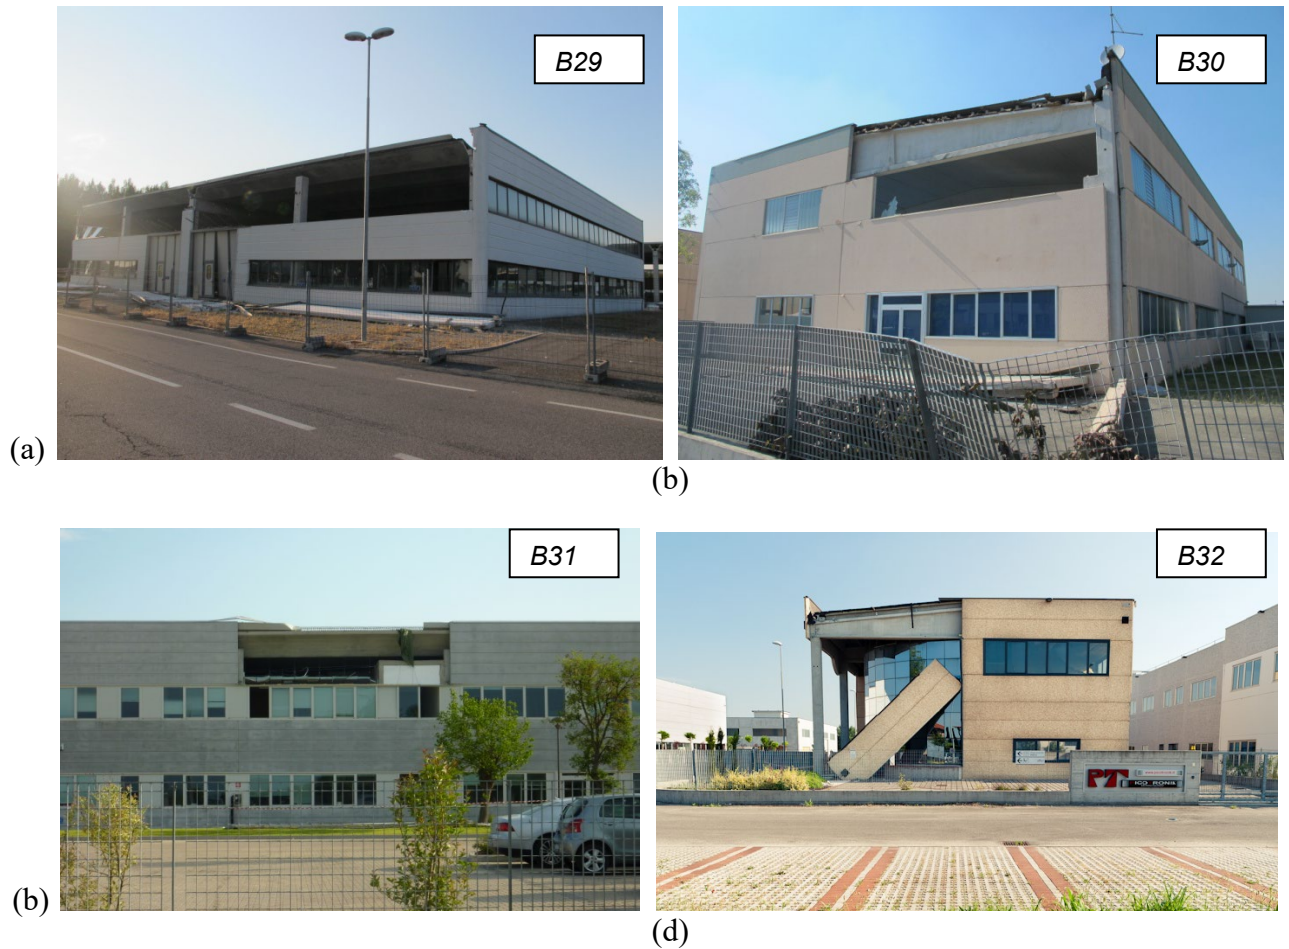
Figure 28. (a – d) Collapse of horizontal precast cladding panels.

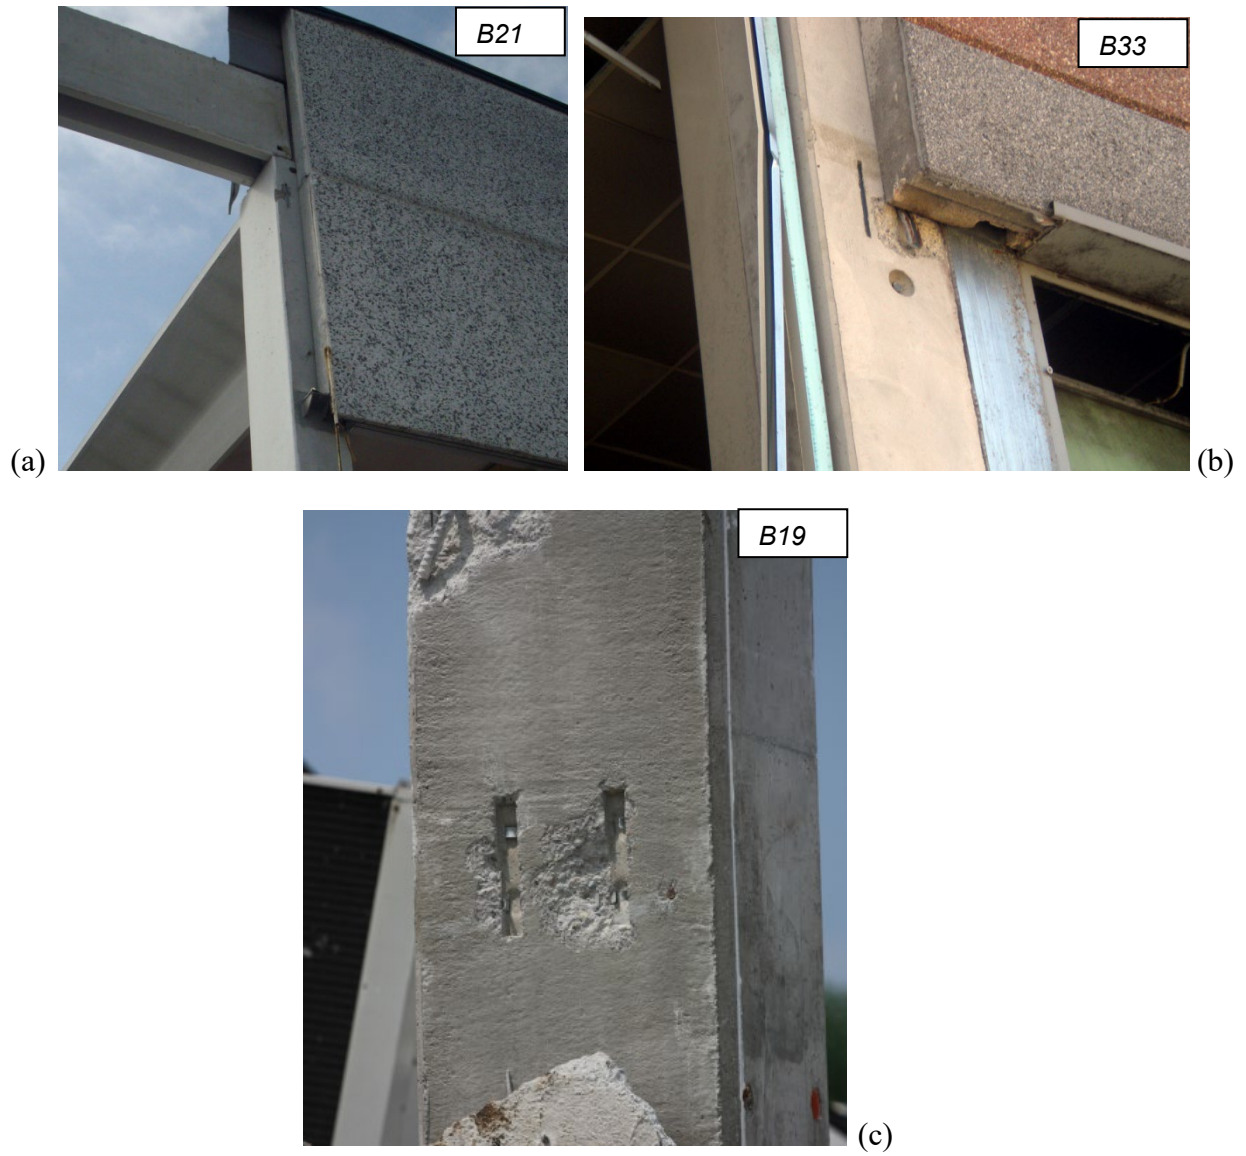
Figure 29. Damage of fastening devices for panel- column connections when their deformation capacity was exceeded.

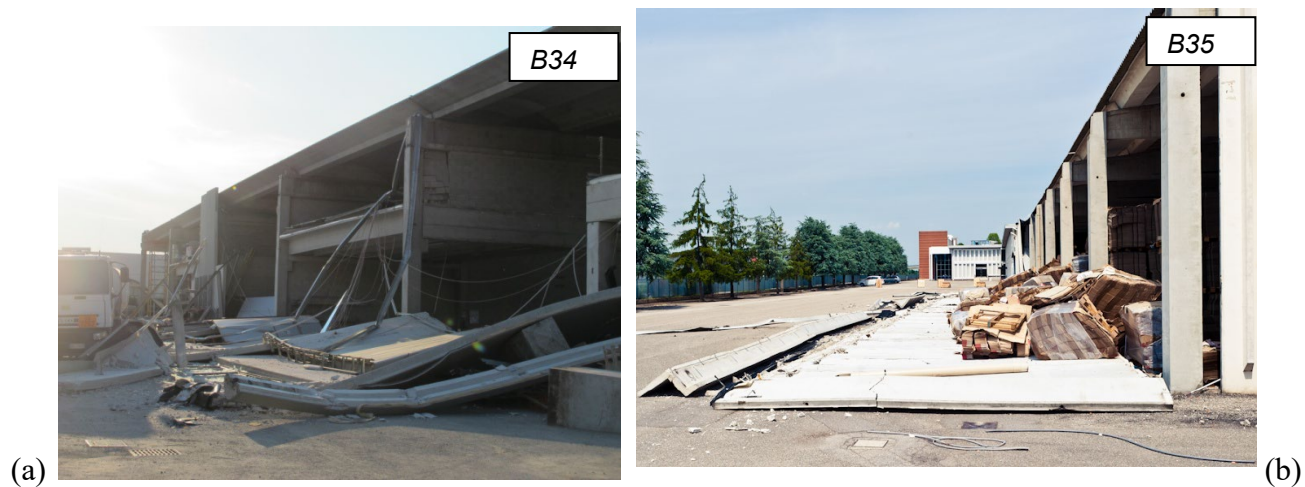
The behaviour of vertical cladding walls was better, in general. When clamped at the base on RC foundation beams and/or on concrete pavements, they also provided a significant additional stiffness and strength to the external columns of the building (Figure 25). Some collapses of vertical panels were observed, when they were not properly restrained on the foundations or when they had an internal sandwich lightweight structure (Figure 30a). In some cases, the failure of vertical panels was due to the overturning of industrial stocks contained in warehouse areas (Figure 30b).

Figure 30. Collapse of precast cladding panels non properly restrained at the base.

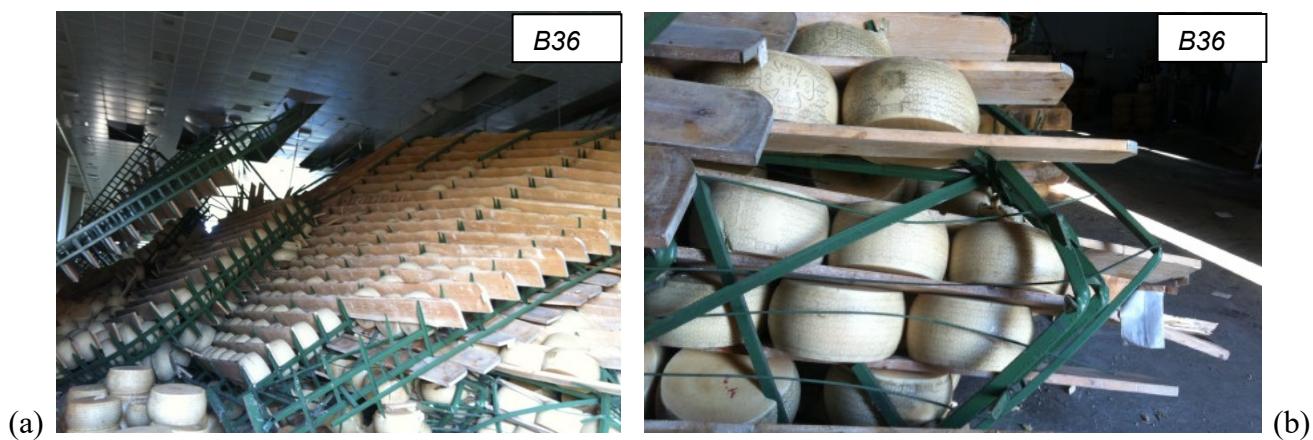
Figure 31. (a) Collapse of a cheese warehouse in the province of Mantova, (b) detail of the light steel structure made of cold-formed steel profiles not designed to bear horizontal loads.

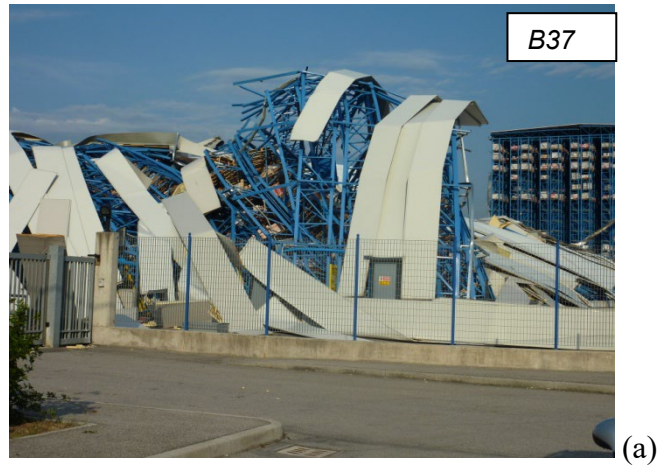
Figure 32. (a) Collapse of an automated warehouse containing ceramic tiles; (b, c) an automatic warehouse with permanent deformations after the earthquake, and detail of plastic buckling in a column after dismounting.

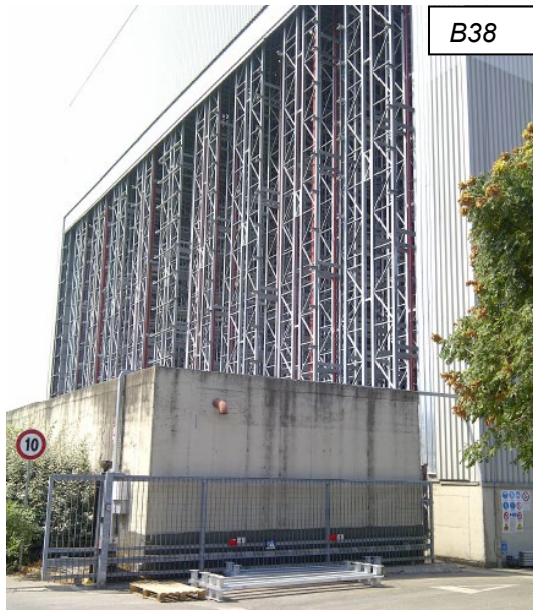
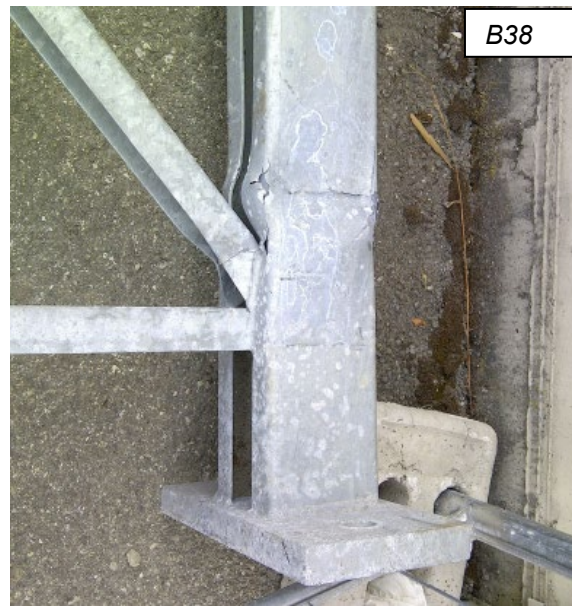
Economic losses were very high also when automatic warehouses were only damaged by the earthquake, as in the case depicted in Figure 32b, c. In this case, the very high normal stresses in the cold-formed profiles constituting the shelf columns caused local instability and permanent deformation in the profiles (Figure 32c). The permanent displacement on the top of the shelves after the earthquake was about 20 cm. The repair and strengthening intervention of the steel structure was still possible, but it required almost one year.
