Damage and collapses in industrial precast buildings after the 2012 Emilia earthquake

Savoia, M., Buratti, N., Vincenzi, L. (2017). Damage and collapses in industrial precast buildings after the 2012 Emilia earthquake. *ENGINEERING STRUCTURES*, 137, 162-180 [10.1016/j.engstruct.2017.01.059].

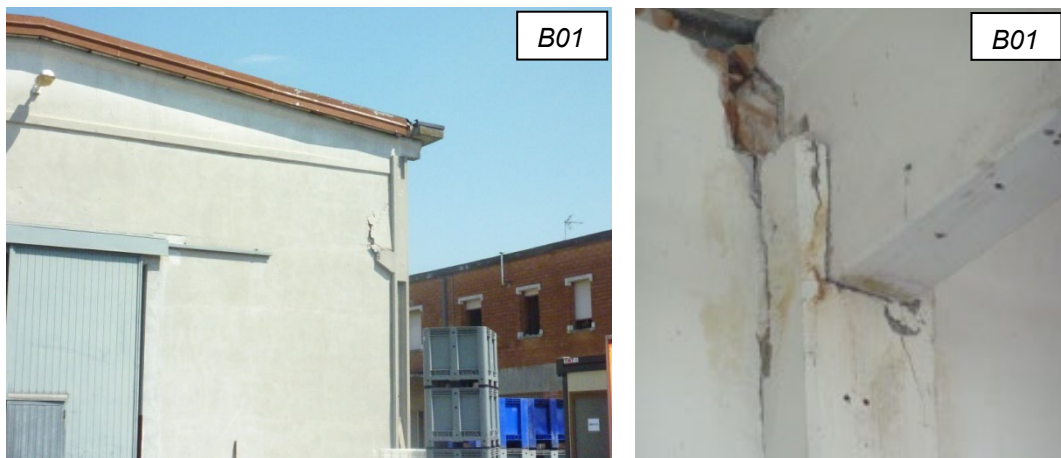
Figure 10. (a) Precast RC building with regular masonry cladding walls, only slightly damaged by the earthquake; (b) Damage to the column fork, due to the transverse rotation of the double slope roof beam during the ground motion.

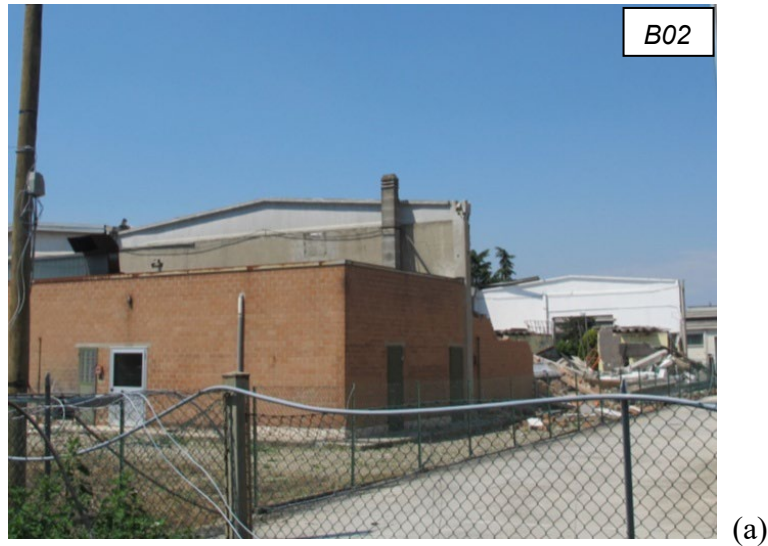
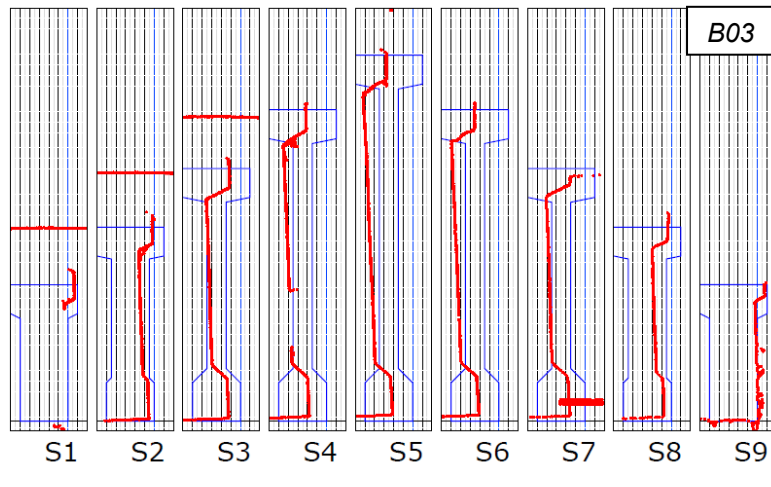
Figure 11: (a) A collapsed building with deformable roof, the only remaining elements are the two short facade masonry walls; (b) permanent rotation after the earthquake of different cross sections of a double-slope beam. S1 and S9 are the support sections and S5 at mid-span. Blue and red lines indicate the theoretical and the actual position, respectively.

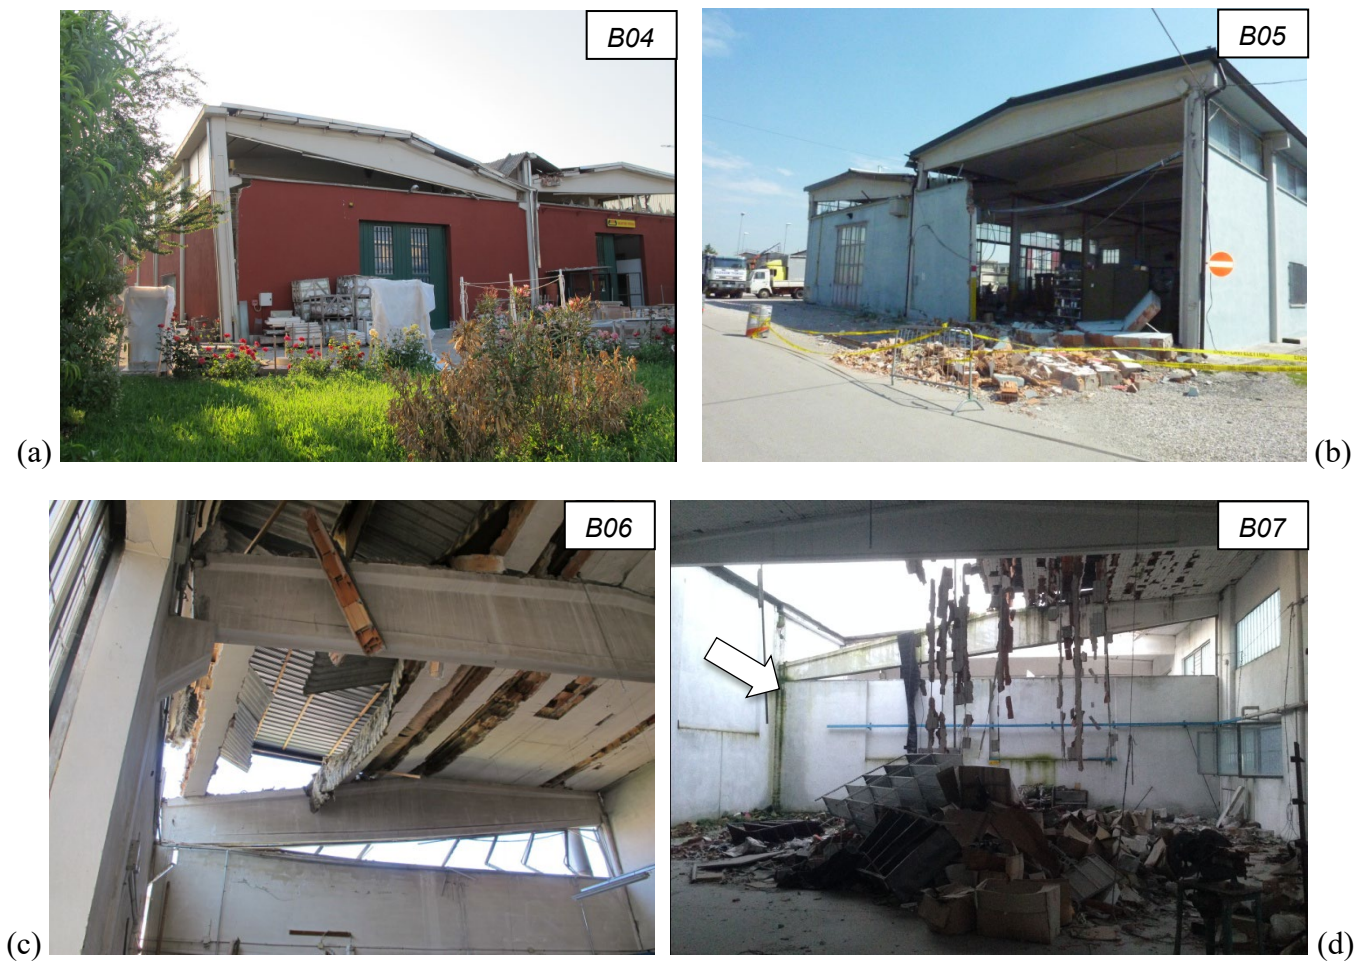
4 Industrial buildings with curtain masonry walls and strip-windows just under precast double-slope
5 beams were often severely damaged and often collapsed (Figure 12). This was probably the most frequent
6 cause of failure in some industrial areas (e.g., San Felice sul Panaro and Mirandola).

11 In the building in Figure 12b, it is interesting to note that, in the bay on the left side, the presence of
12 an irregular wall caused the unseating of the double-slope beam, whereas, in the bay on the right side, the
13 masonry wall, only partially restrained by the RC structure, collapsed and, consequently, no unseating of
14 the roof beam occurred. Typically, this kind of failure involved only the two external portal frames (Figure
15 12a, b), and in a few cases also the subsequent ones (Figure 12c). In the building of Figure 12d, the presence
16 of a rigid partition masonry wall inside the building caused the same kind of collapse. Because of the action
17 in the infill wall, the horizontal force in the short columns of the terminal frames was so high that, when
18 the loss-of-support failure did not take place, flexural plastic hinge failures were observed (Figure 14b-c)
19 in the columns. In some cases, the significant reduction of the shear-span of columns, due to the interaction

Figure 12: (a, b, c) Collapses due to the presence of strip windows on the top of masonry walls (the building in picture (a) is the same shown in Figure 7b before the collapse); (d) collapse due to the presence of an internal masonry wall (indicated by an arrow).

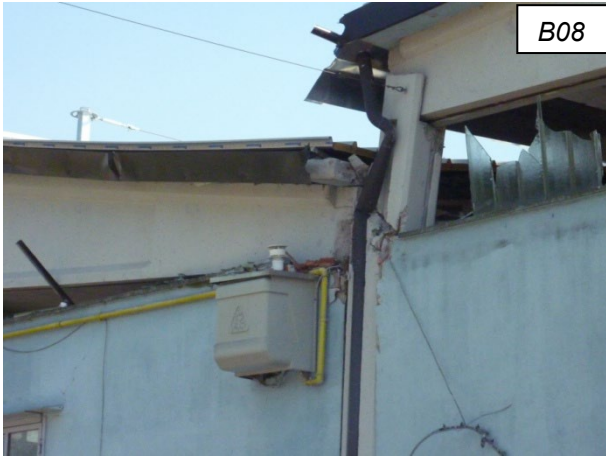
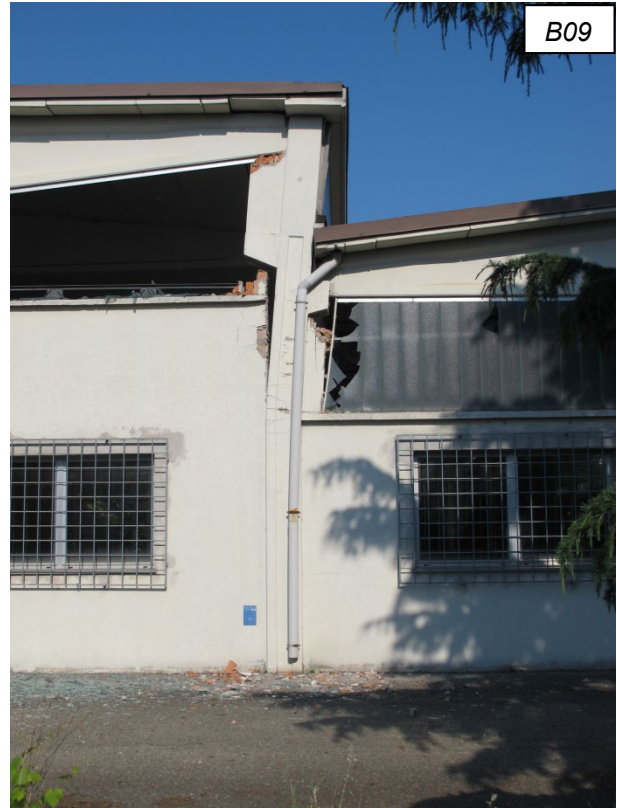
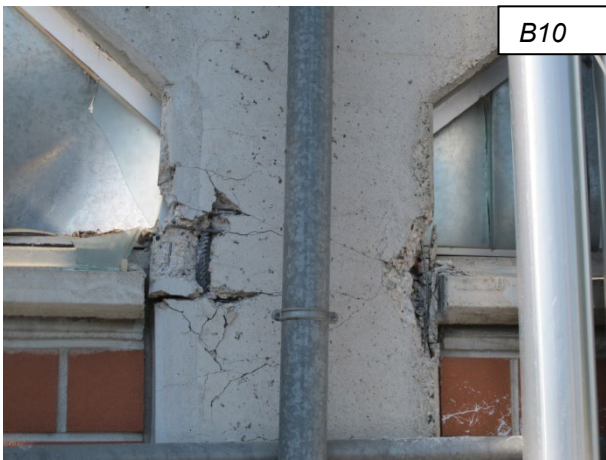
20 with infills, produced a modification of the failure mode from flexural to shear-type, as illustrated in Figure
21 14a which shows a flexural-shear failure.

Figure 14. Flexural-shear (a) and flexural (b, c) damage of the facade columns due to the interaction with irregular masonry walls.

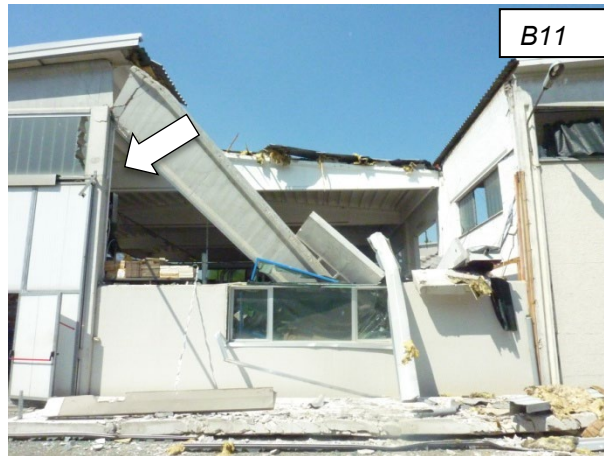
22 The interaction of the portal frame elements with additional façade RC elements often caused severe
23 damage or even collapses. Figure 15 shows a collapse mainly caused by the presence of an additional RC
24 facade column, aimed at supporting a metallic gate, and connected at the mid-span of the precast beam of
25 the portal frame. Of course, the double slope beam was originally designed neglecting the presence of the

1 additional facade column, i.e., a simply supported condition. Being instead in a statically redundant
2 condition (three–point support), the double – slope beam suffered sudden variations of the vertical reactions
3 on the two lateral supports on the main external columns during the earthquake. The condition of
4 overcoming of friction resistance was then attained during the ground–motion and the support was lost on
5 the right column. Of course, with half beam behaving as a cantilever, failure occurred because of
6 insufficient top steel-reinforcement.

Figure 15. Collapse of the beam of the facade frame due to the interaction with the non structural columns indicated with an arrow.

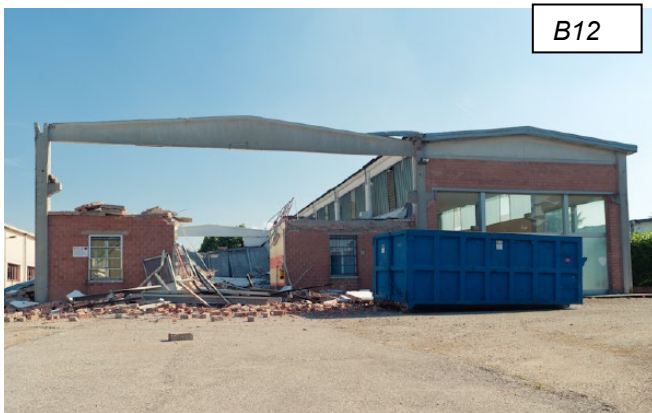
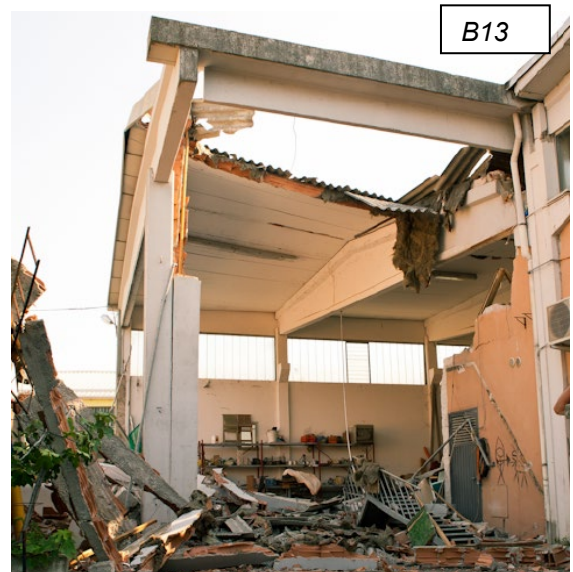
7 Plan-irregularity was another important cause of roof collapses. For instance, in the building of Figure
8 16a, the presence of a smaller (and then stiffer) precast building on the right side caused the transmission
9 of high horizontal forces at the support levels of intermediate columns. Friction resistance at the beam-
10 column support was then overcome and all the intermediate beams fell down from their supports. The
11 prefabricated building in Figure 16b suffered the collapse of the roof of a bay external to the two main
12 spans of the building, being much more flexible and undergoing large and differential displacements at the
13 level of column tops.

Figure 16: Collapses due to plan-irregularities in two industrial buildings.

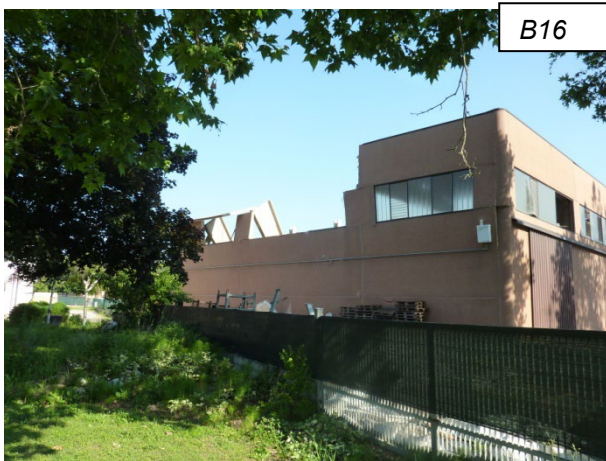
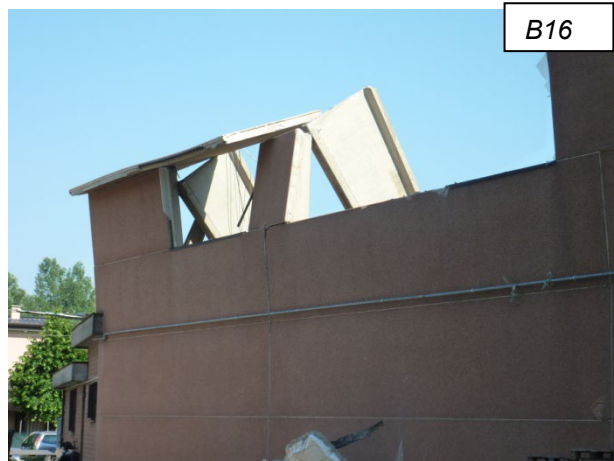
This section presents a commented collection of failure cases observed on Type-2 buildings. The failure mechanisms in more recent precast industrial buildings with flat roofs are various and more complex with respect to those described in the previous section. Even some recent structures (built in the last 10 years) suffered extensive damage or even full collapses (Figure 18).

Figure 18. Complete collapse of a recently built precast structure.

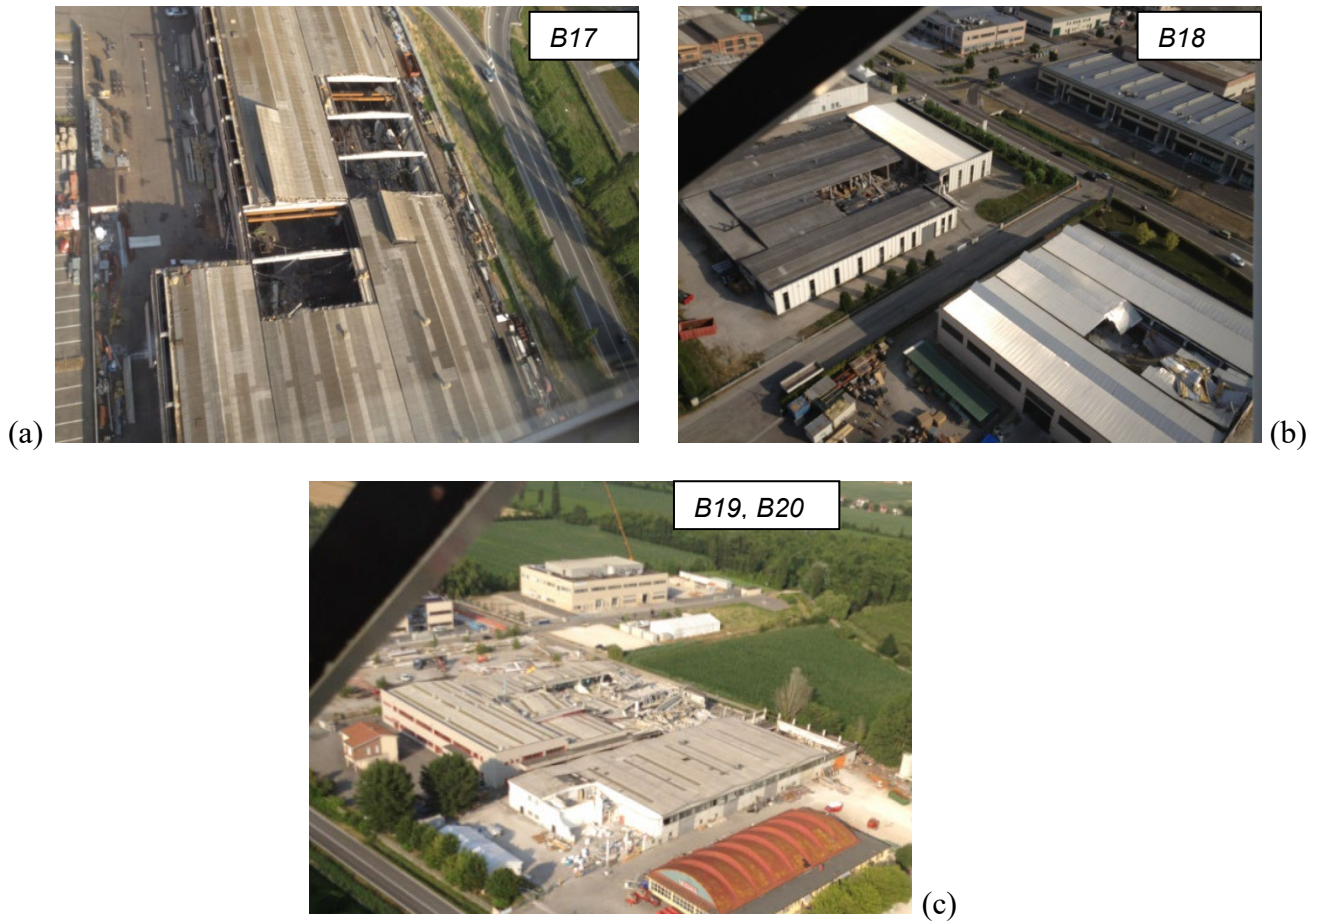
Figure 19. Failures of roof elements, often located in irregular portion of buildings.

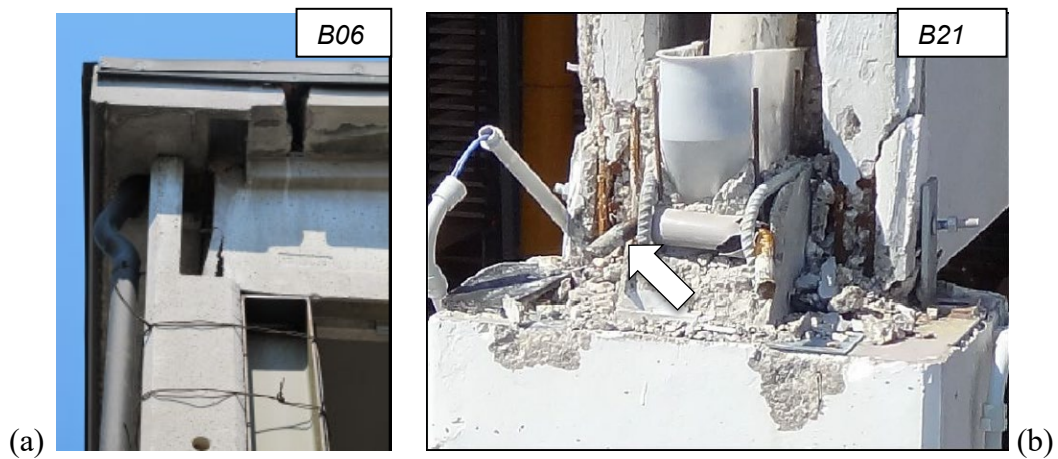
In some cases, despite of their presence, steel dowels to connect beams and columns were inadequate to bear the forces to be transferred. In Figure 20a, the steel reinforcement in the rear portion of the beam was not sufficient to resist the force produced by the steel dowel in the beam-column connection. Figure

Figure 20. (a) Damage at the extremity of a precast beam where no steel rebars were present in the beam to carry the force transferred by the steel dowel in the beam - column connection; (b) the steel dowel completely bent because unable to carry the horizontal force at the beam – column connection.

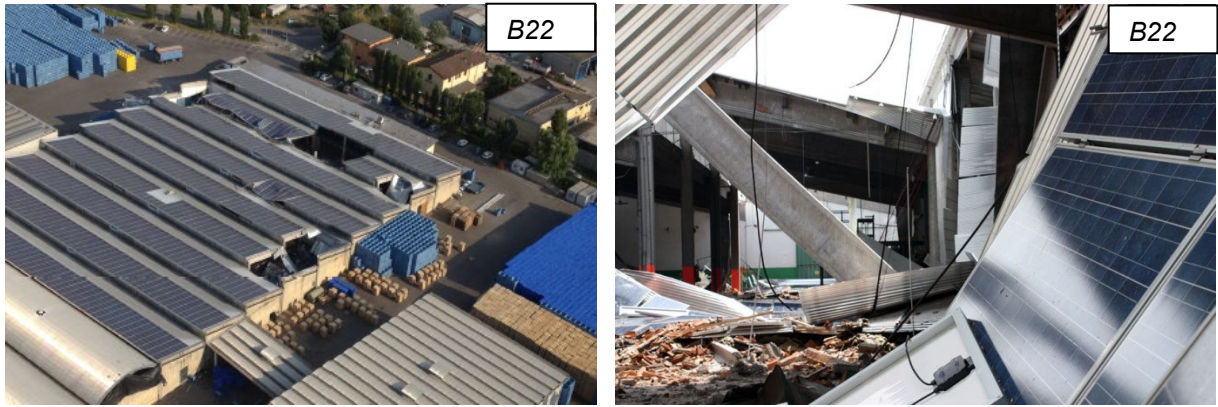
Figure 21: Collapses in a recent fruit warehouse with inclined precast beams to realize a shed structure.

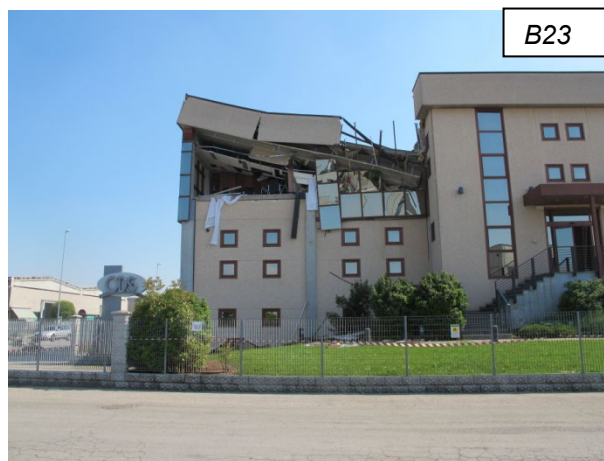
11 In the case of the precast multi-storey commercial building of Figure 22, the loss of support of precast
12 roof elements was also due to plan-irregularity. The larger lateral stiffness of the right portion of the
13 building caused the transfer of large horizontal forces at the level of the roof-beam supports, with forces
14 exceeding friction resistance.

Figure 22. Failure due to the loss of support of roof elements related to plan-irregularity a commercial prefabricated building.

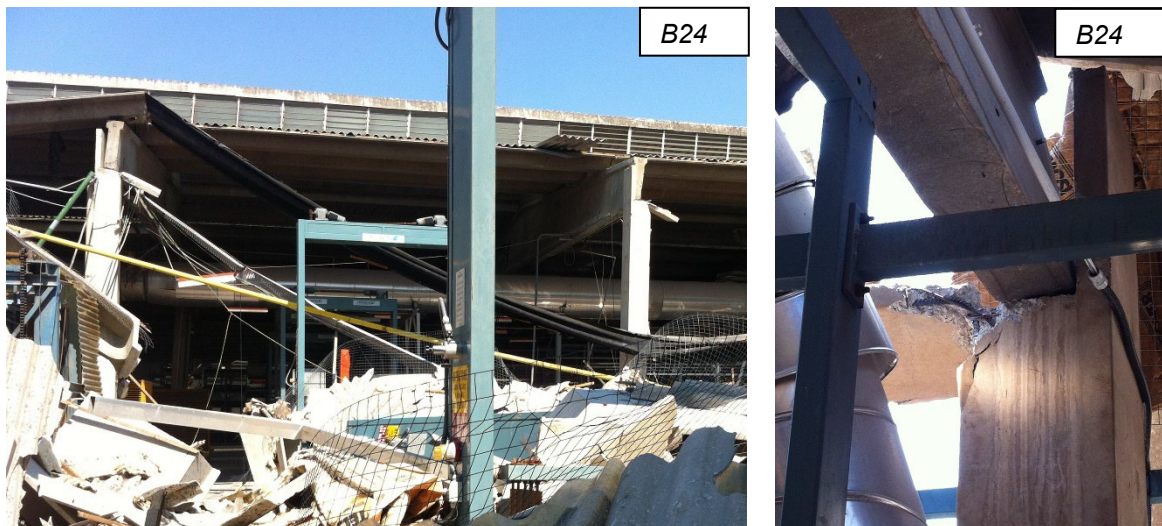
15 Some roof collapses were caused by the lateral rotation of beams supporting roof elements. These
16 rotations were due to the eccentricity of the upper mass of the roof with respect to the beam supports. In
17 the building of Figure 23a-b, most of the roof collapsed due to the rotation of the beam that followed the
18 rupture of upper forks of columns, whose steel reinforcement was clearly insufficient. In other cases, the
19 upper fork was even absent (see Figure 24a). In the collapsed structure of Figure 24b, the lateral rotation
20 of the beams during the earthquake is highlighted by the shear cracking of the lower portion of the beam.

Figure 23. Complete collapse of an industrial building due to lateral overturning of beams.

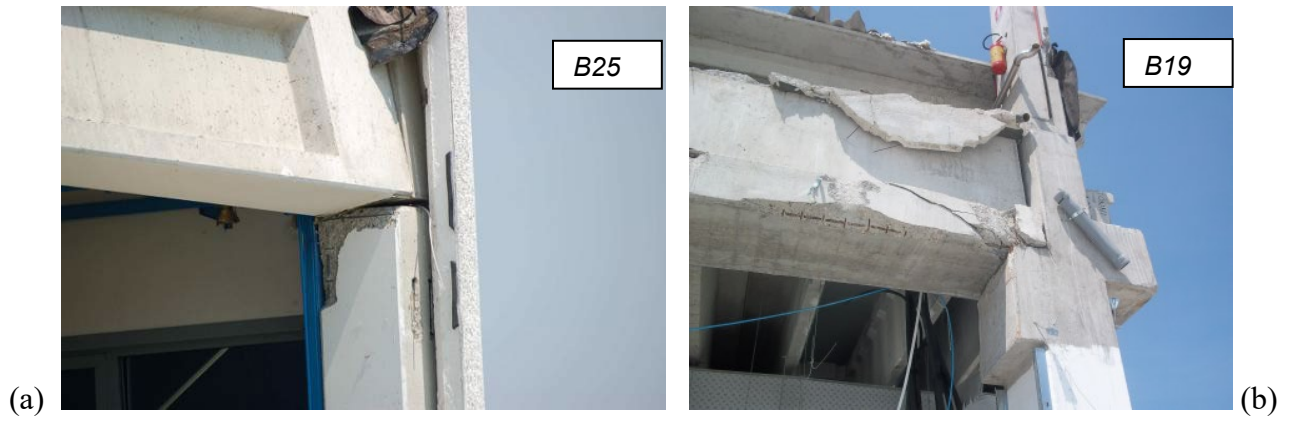
Figure 24. (a, b) Permanent lateral beam rotations in two partially collapsed buildings.

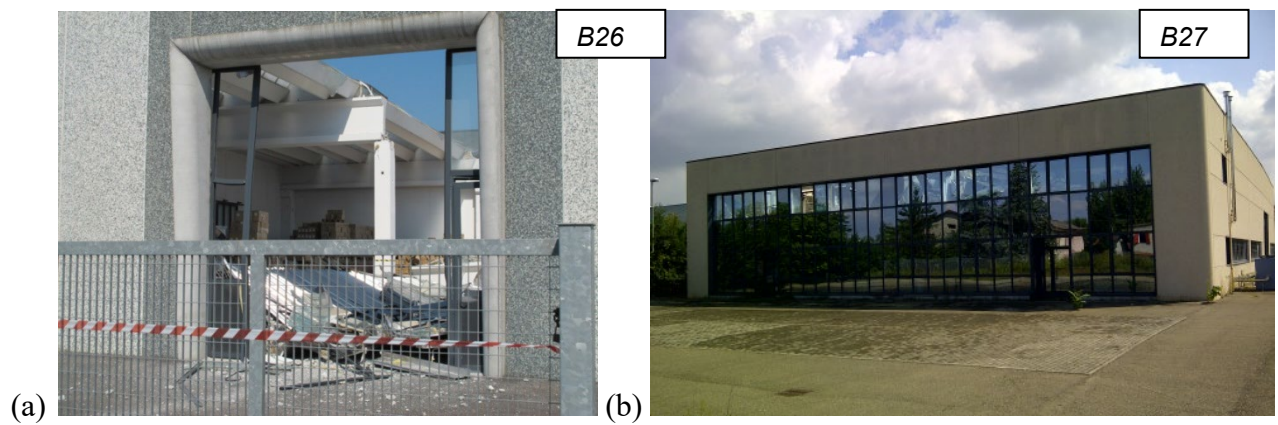
1 The building in Figure 25a is particularly representative of this type of failure. Significant damage
2 was registered in internal columns after the May 20th earthquake, and the building fully collapsed during
3 the May 29th earthquake. This structure was particularly vulnerable to horizontal seismic actions, as many
4 other similar recent precast construction designed without specific seismic provisions, the only actions
5 considered being gravity and wind loads. In design of these structures, the wind lateral forces were mostly
6 assigned to external columns, being the roof fully deformable due to the presence of large roof-flight strips
7 between the slab precast elements. According to the design criteria adopted, internal columns had resisting
8 bending moments smaller than external columns, being the moment in the first ones only that corresponding
9 to the eccentricity of the vertical action due to differences in spans or to variable loading combinations.

1 internal collapses with no evident damage from outside (Figure 25b). Axial load increases in columns,
2 caused by inertia forces produced by vertical accelerations might have contributed to these failures in near-
3 source areas.

Figure 25. Complete collapse of two industrial buildings due to the failure of the internal columns.

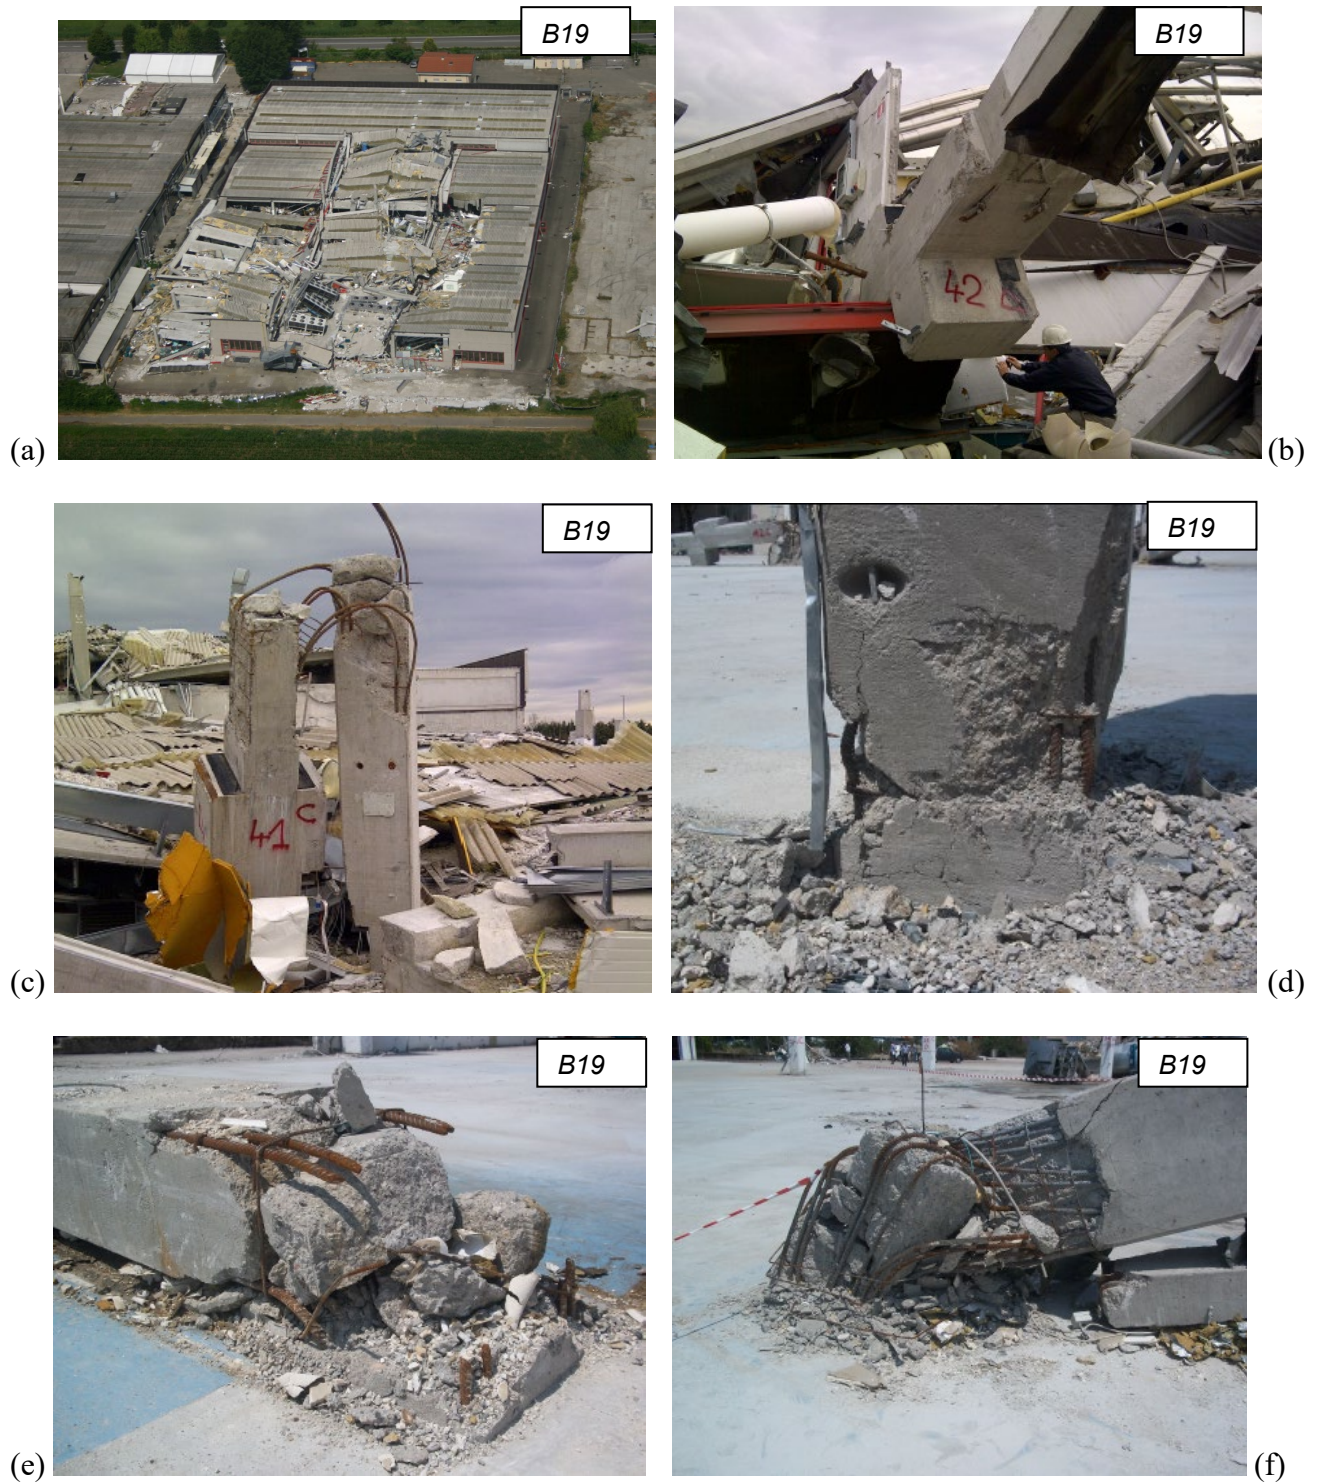
4 A very catastrophic collapse with four casualties occurred in a 9-years old precast building in Medolla
5 (Figure 26). In this case, several negative circumstances occurred: *i*) the building was highly irregular, with
6 two floors in the (collapsed) central part; *ii*) a heavy 15 cm thick concrete slab was cast on the top of the
7 roof, where heavy air conditioning units were located (Figure 26 a); *iii*) the two-level portion of the building
8 (alongside the road, top of the figure), where offices were located, had a very stiff RC staircase and many
9 partition walls; *iv*) there was a large separation RC wall between the offices and production sections of the
10 building. These factors contributed in making the building very irregular in plan, shifting the centroid of
11 stiffness towards the office area. During the ground motions, large rotations occurred, with very large
12 displacements especially on the side farthest from the road (bottom in the picture), whereas the office

13 portion did not suffer any damage. Numerical simulations indicate that the onset of a progressive collapse
14 is probably due to the loss of support of the upper beams on the central two-level portion of the building
15 [43]. During the collapse, some columns failed with formation of plastic hinges at the base section (Figure
16 26 b, d, e), whereas others failed at the level of the intermediate slab (Figure 26 c), about 1.80 m above the
17 corbels constituting the support of precast beams. Several columns suffered buckling of longitudinal bars
18 (Figure 26d) with significant residual rotations. Secondary columns failed with longitudinal bar necking
19 (Figure 26e). One column in the central portion of the building exhibited a shear – flexure failure (Figure
20 26f). This failure mechanism, apparently singular in such long columns, is a consequence of their peculiar
21 design against wind actions. These columns, sustaining the two-level portion of the building, were exposed

Figure 26. A collapsed building in Cavezzo (MO): (a) Aerial view, (b) column rotation due to the formation of a flexural plastic hinge, (c) rupture of a column in an intermediate position due to the presence of a TT precast slab, (d) plastic hinge with bar instability, (e) flexural failure with bar necking, (f) shear failure of a highly reinforced column in flexure.

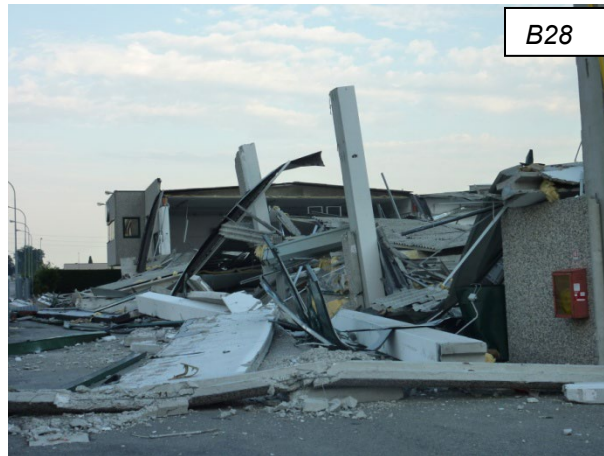
5 Some collapses of industrial buildings were due to base rotations of the columns. Even if a clear
6 identification of the causes would require more information than what available to the authors, the collapse
7 documented in Figure 27 can be, with a high degree of confidence, considered a consequence of the rotation
8 of foundations. A complete absence of any cracking along the columns and the almost equal rotation of a
9 series of columns on one side of the building, in an area where the retention action of the concrete pavement
10 was absent, indicate a rigid rotation of the columns as the most plausible cause of collapse. This conclusion
11 is supported by the large use, after the '90s, of pocket foundations realized with pocket precast elements
12 simply supported over larger cast-in-situ foundations, without any connections between the two (precast
13 and cast-in-situ) elements. In fact, in design, the verification against overturning of these foundations was

14 performed considering wind as the only horizontal actions. Moreover, external columns usually did not
15 exhibit any inelastic behaviour (no cracks were observed in the columns of the building in Figure 27),
16 because their cross-sections were, in general, oversized in order to reduce the drift under wind actions (see
17 the previous section).

Figure 27. Complete collapses of an industrial building in S. Agostino, with large base rotations of the columns probably due to rotation of foundations.

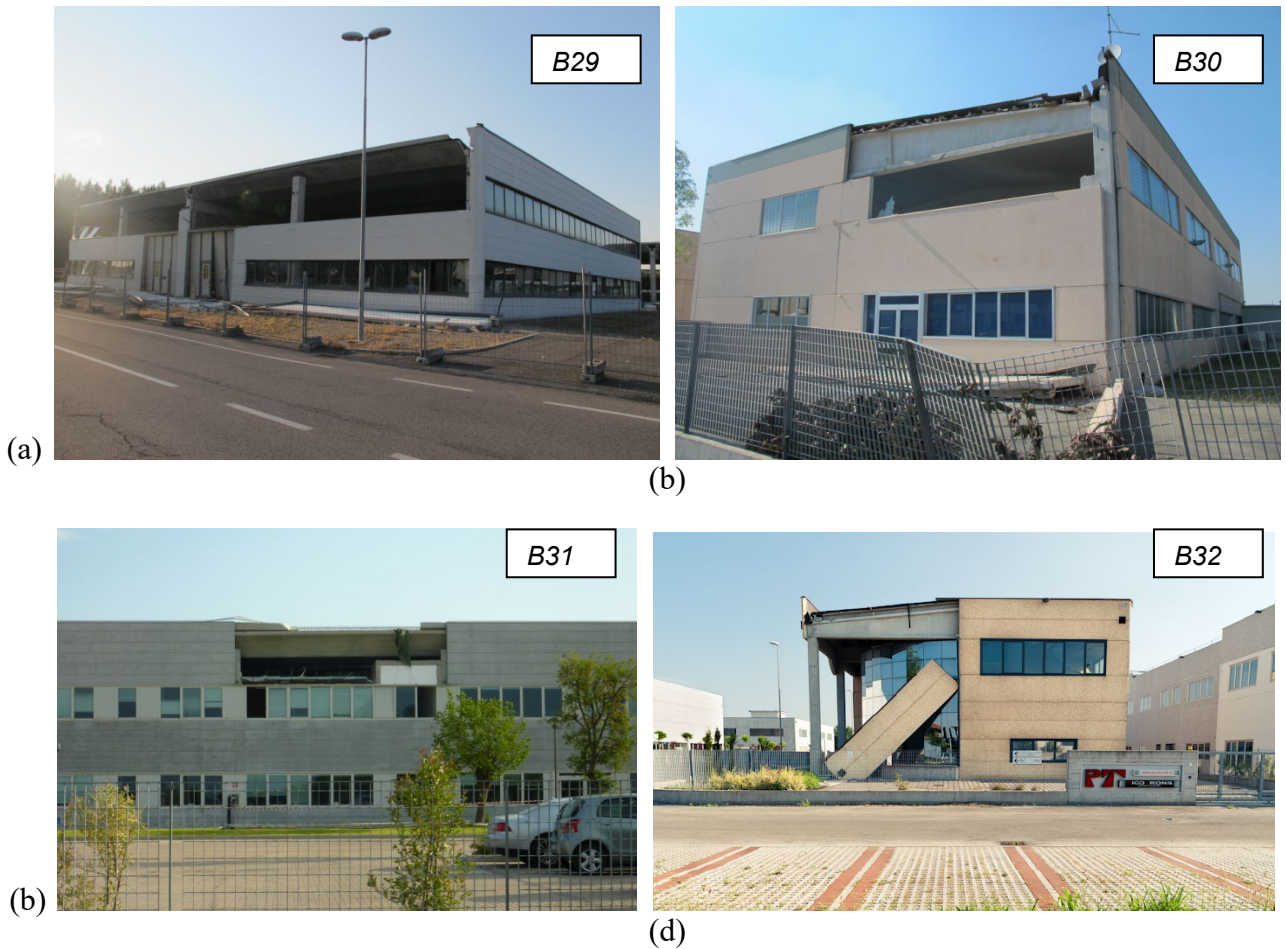
Figure 28. (a – d) Collapse of horizontal precast cladding panels.

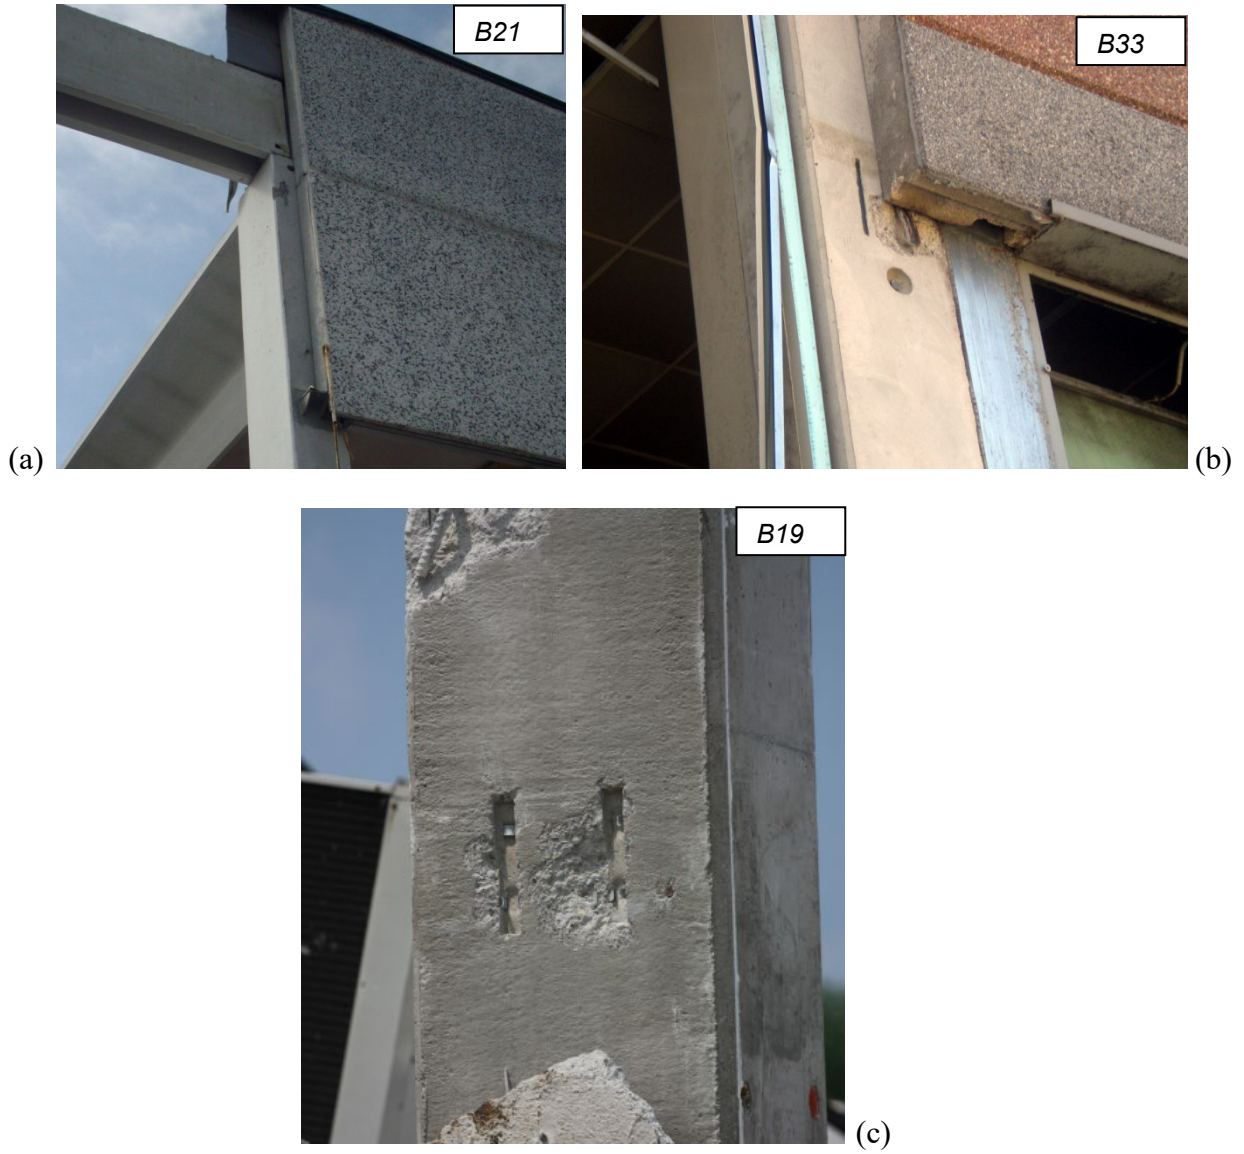
10 up to 30-35 mm. Furthermore, being the connectors for this type of panel at a distance of 1.2 m from the
11 lower support, they must allow a relative displacement of about 10-15 mm. Since connectors were not
12 designed to allow displacements, they were subjected to high forces that broke the steel profiles embedded
13 in the concrete cover the columns, thus causing the failure of the cladding panels (Figure 29).

Figure 29. Damage of fastening devices for panel- column connections when their deformation capacity was exceeded.

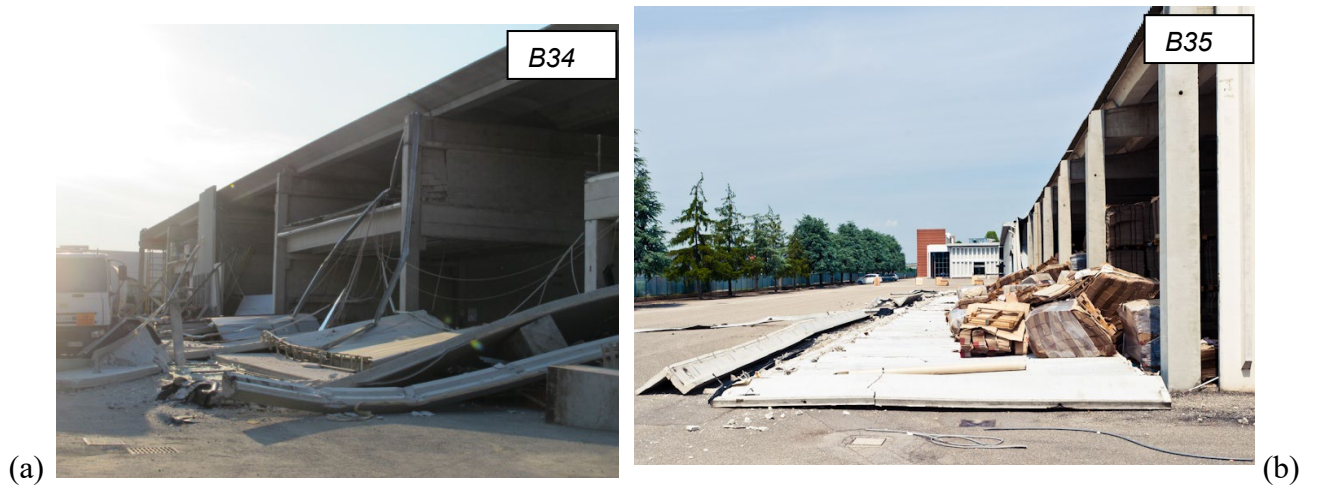
14 The behaviour of vertical cladding walls was better, in general. When clamped at the base on RC
15 foundation beams and/or on concrete pavements, they also provided a significant additional stiffness and
16 strength to the external columns of the building (Figure 25). Some collapses of vertical panels were
17 observed, when they were not properly restrained on the foundations or when they had an internal sandwich
18 lightweight structure (Figure 30a). In some cases, the failure of vertical panels was due to the overturning
19 of industrial stocks contained in warehouse areas (Figure 30b).

Figure 30. Collapse of precast cladding panels non properly restrained at the base.

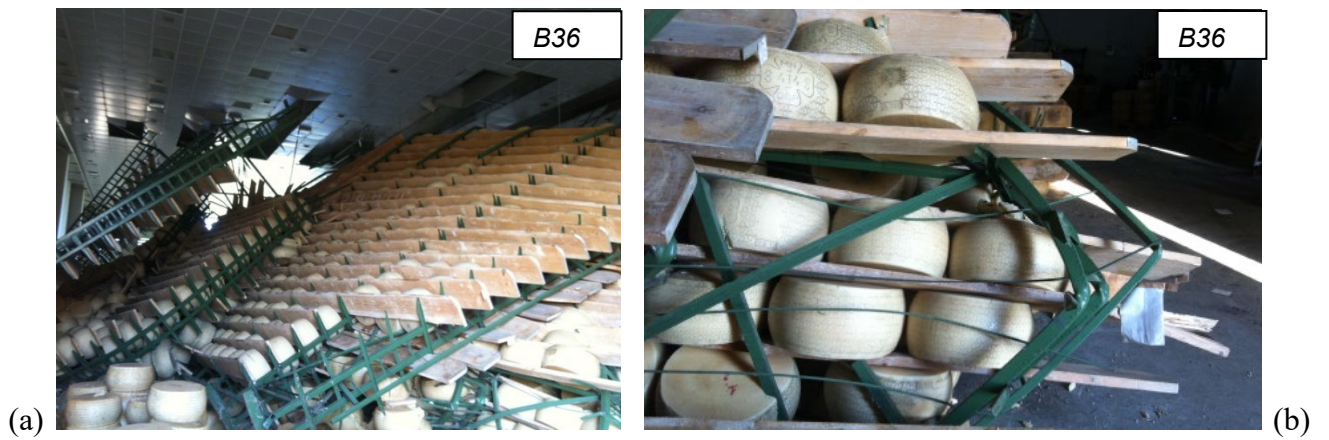
Figure 31. (a) Collapse of a cheese warehouse in the province of Mantova, (b) detail of the light steel structure made of cold-formed steel profiles not designed to bear horizontal loads.

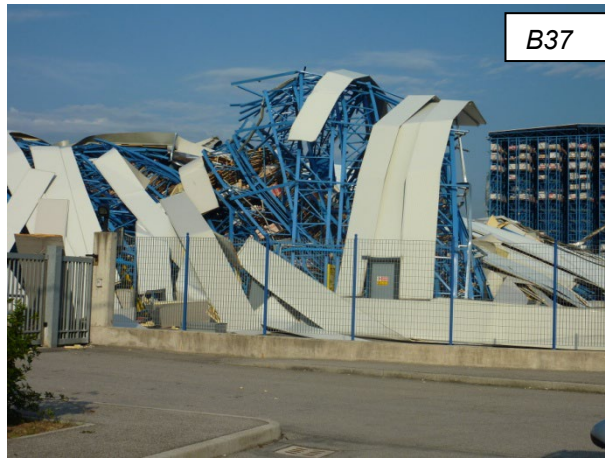
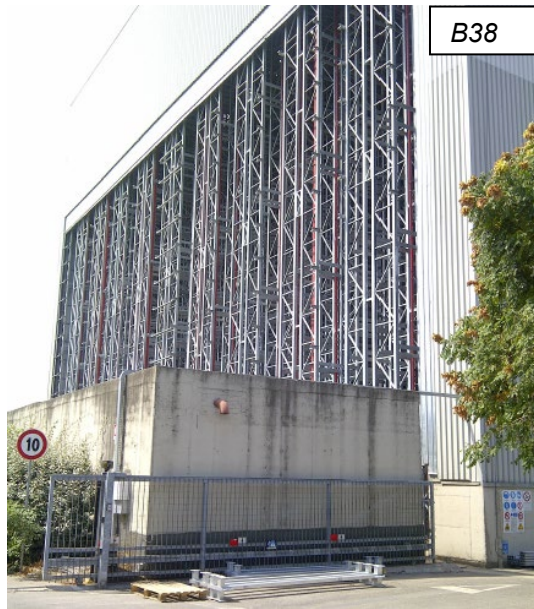
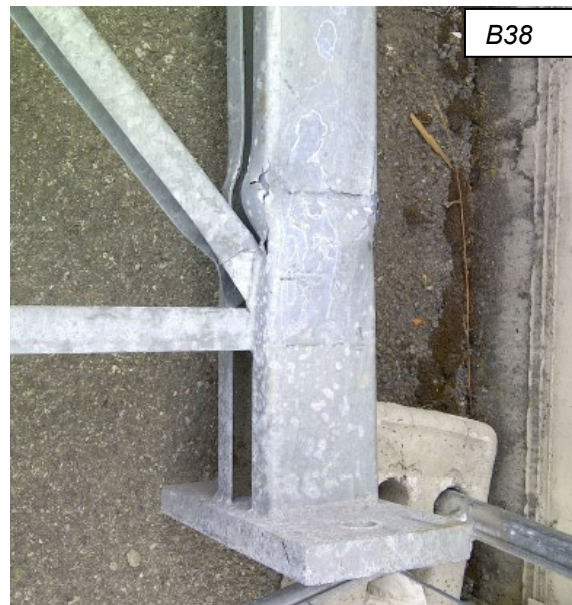
10 Economic losses were very high also when automatic warehouses were only damaged by the
11 earthquake, as in the case depicted in Figure 32b, c. In this case, the very high normal stresses in the cold-
12 formed profiles constituting the shelf columns caused local instability and permanent deformation in the
13 profiles (Figure 32c). The permanent displacement on the top of the shelves after the earthquake was about
14 20 cm. The repair and strengthening intervention of the steel structure was still possible, but it required
15 almost one year.

Figure 32. (a) Collapse of an automated warehouse containing ceramic tiles; (b, c) an automatic warehouse with permanent deformations after the earthquake, and detail of plastic buckling in a column after dismounting.
