Collapse and damage to vernacular buildings induced by 2012 Emilia earthquakes

Bovo, M., Barbaresi, A., Torreggiani, D., Tassinari, P. (2020). Collapse and damage to vernacular buildings induced by 2012 Emilia earthquakes. BULLETIN OF EARTHQUAKE ENGINEERING, 18(3), 1049-1080 [10.1007/s10518-019-00737-7].

# **Collapse and damage to vernacular buildings induced by 2012 Emilia earthquakes**

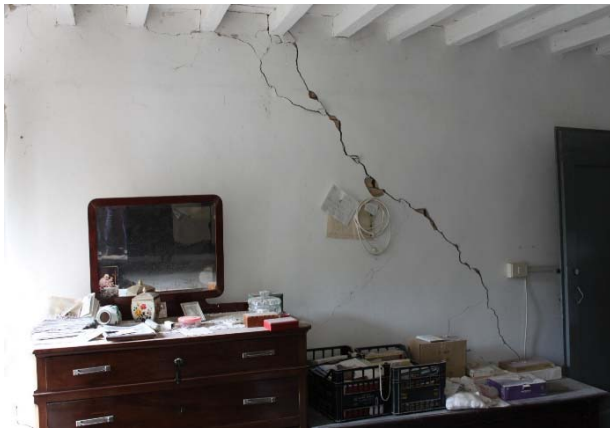
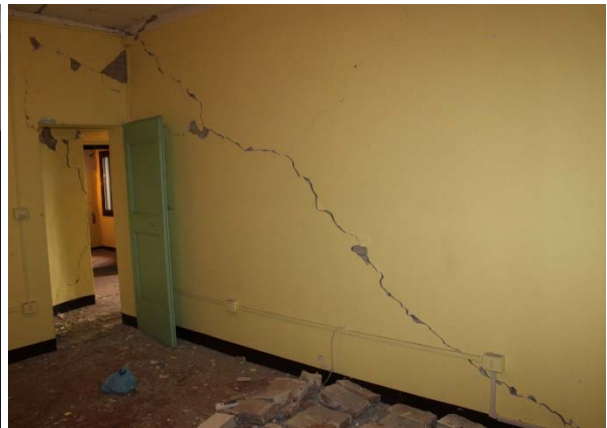
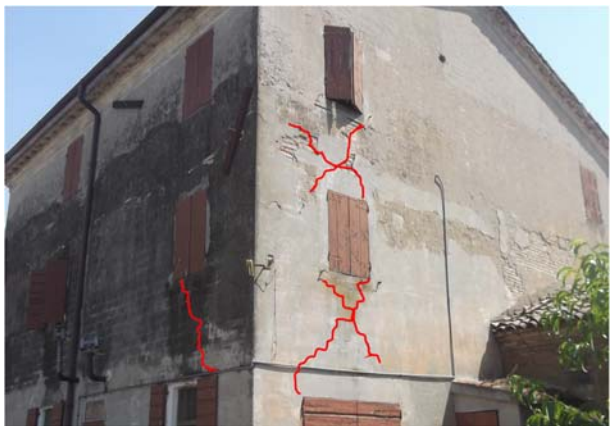
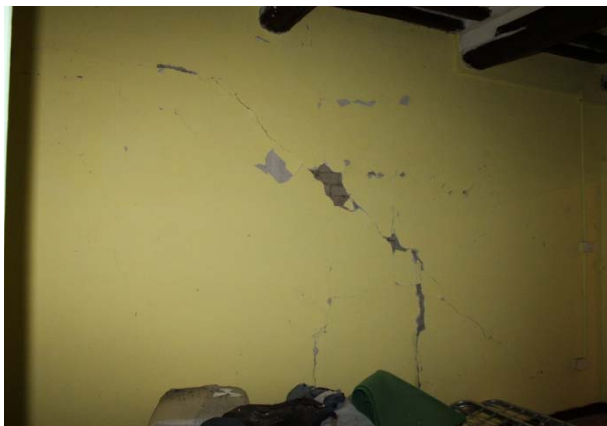
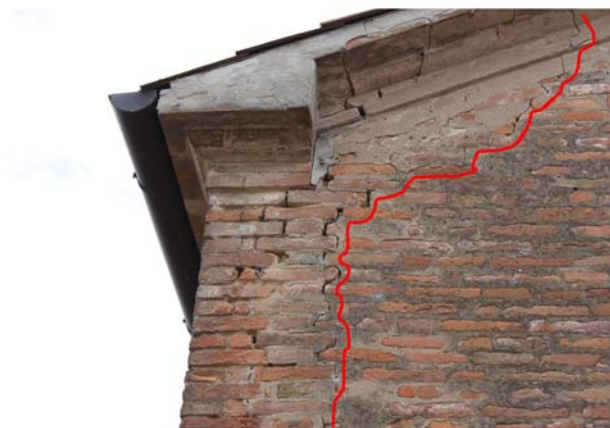
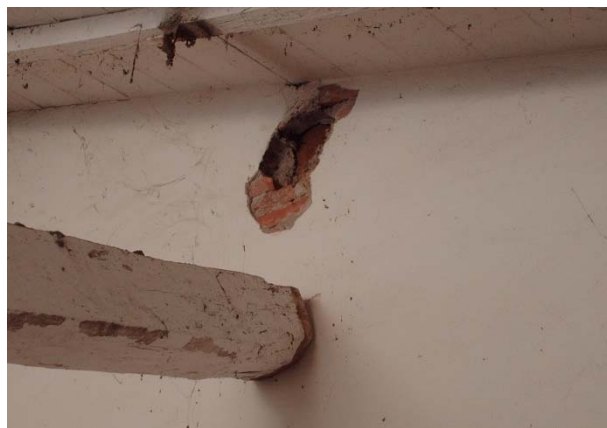
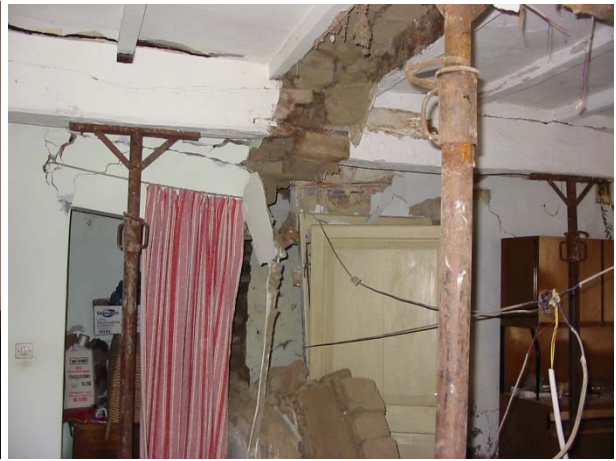
The damage observed for buildings in category A1 (isolated dwellings) are typically mode II mechanisms (i.e. mechanism in the wall plane [38]) to bearing and partition walls, as depicted in Figure 9a-b. Due to limited length and height compared to thickness, the mode I failure wall mechanisms (i.e. out-of-plane overturning, horizontal and vertical out-of-plane flexure) were not observed, even if the connections between orthogonal walls are in general very poor, as showed by the cracks in Figure 9c. Most of the damage must be attributed to the poor material properties of the masonry [15], realized in many cases with irregular texture and poor strength mortar [13]. Moreover, the floor-wall connection is rather lacking since in many cases, it was observed the sliding of beams from the masonry walls (see Figure 7b), or even the failure, due to loss of support, as documented in Figure 9d. In few cases, also failure of lintels (see Figure 9e) or masonry arches (Figure 9f) have been observed, typically involving permanent settlements to the horizontal structures of the floors.

Figure 9. Main damage to building category A1. Example of in-plane damage induced by seismic force on (a) partition walls (bldgs. #2 and #3) and (b) bearing walls (bldgs. #6 and #3); (c) Cracking of corner between two orthogonal masonry walls (bldg. #1); (d) Loss of support of a wood beams from the masonry walls (bldg. #2); (e) View of a lintel failed and (f) arch collapse (bldg. #20).

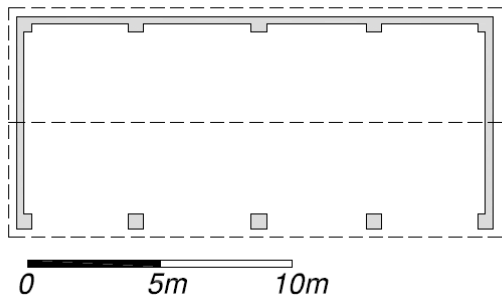
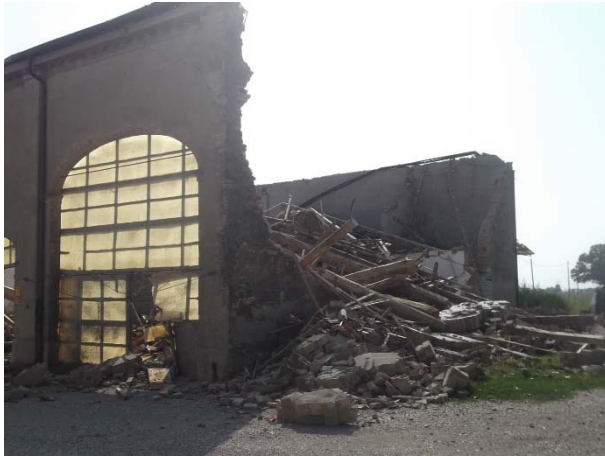
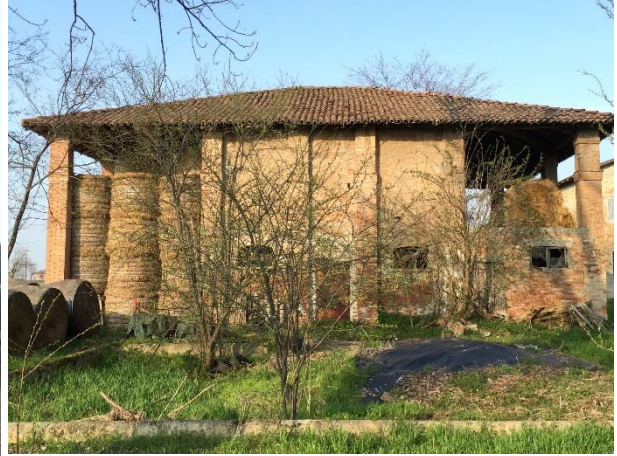
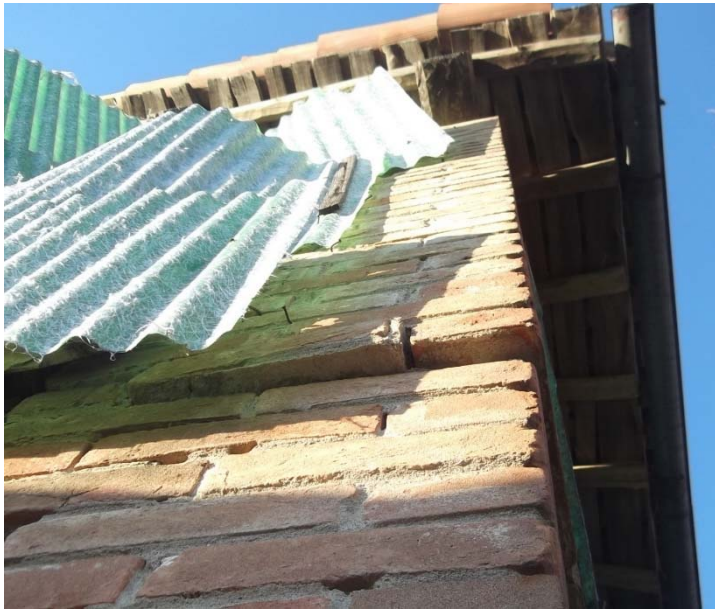
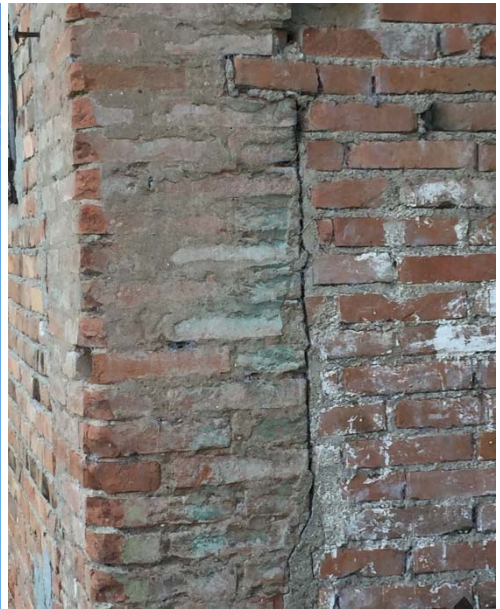
The “casella” building, shown in Figure 12d, was modified from its original configuration over the years: the transverse (i.e. the shorter) façades were infilled by brickwork walls poorly connected to original corner columns, and an intermediate stiff floor was added. In this building, conversely to the “barchessa” response, the contemporary presence of strong asymmetry (for the presence of perimeter walls just on three out of four façades) and stiff intermediate floor probably magnified the torsion effects. In fact, Figure 12e shows the most important seismic-induced damage to the columns caused by the asymmetric behaviour of the building. Maybe due to torsion effects, the corner columns were literally cut at the level of the intermediate floor, and the residual settlements (of 2-3cm) highlighted in Figure 12e support this hypothesis. Furthermore, the lack of corner column-infill walls connections produced the detachment of the

walls during the seismic events (see Figure 12f). The structure was demolished few months after the earthquake since was judged not reparable. The different dynamic response between the two buildings and the main reasons of their severe damage could have been completely different, but the consequences were catastrophic in both the buildings. In the hope of the authors, the indications emerging from this lesson learned would be of help to define the most suitable strengthening interventions for still standing buildings of the same category, which represent an important cultural heritage of that region.

Figure 12. Main damage to buildings of category A3. (a) Plan view, (b) lateral view and (c) collapse scenario of a “barchessa” building (bldg. #22); (d) Lateral view of a “casella” (bldg. #11) with details of severe damage to (e) masonry columns due to excessive shear force imposed by torsion and (f) infill walls for detachment from the bearing columns.

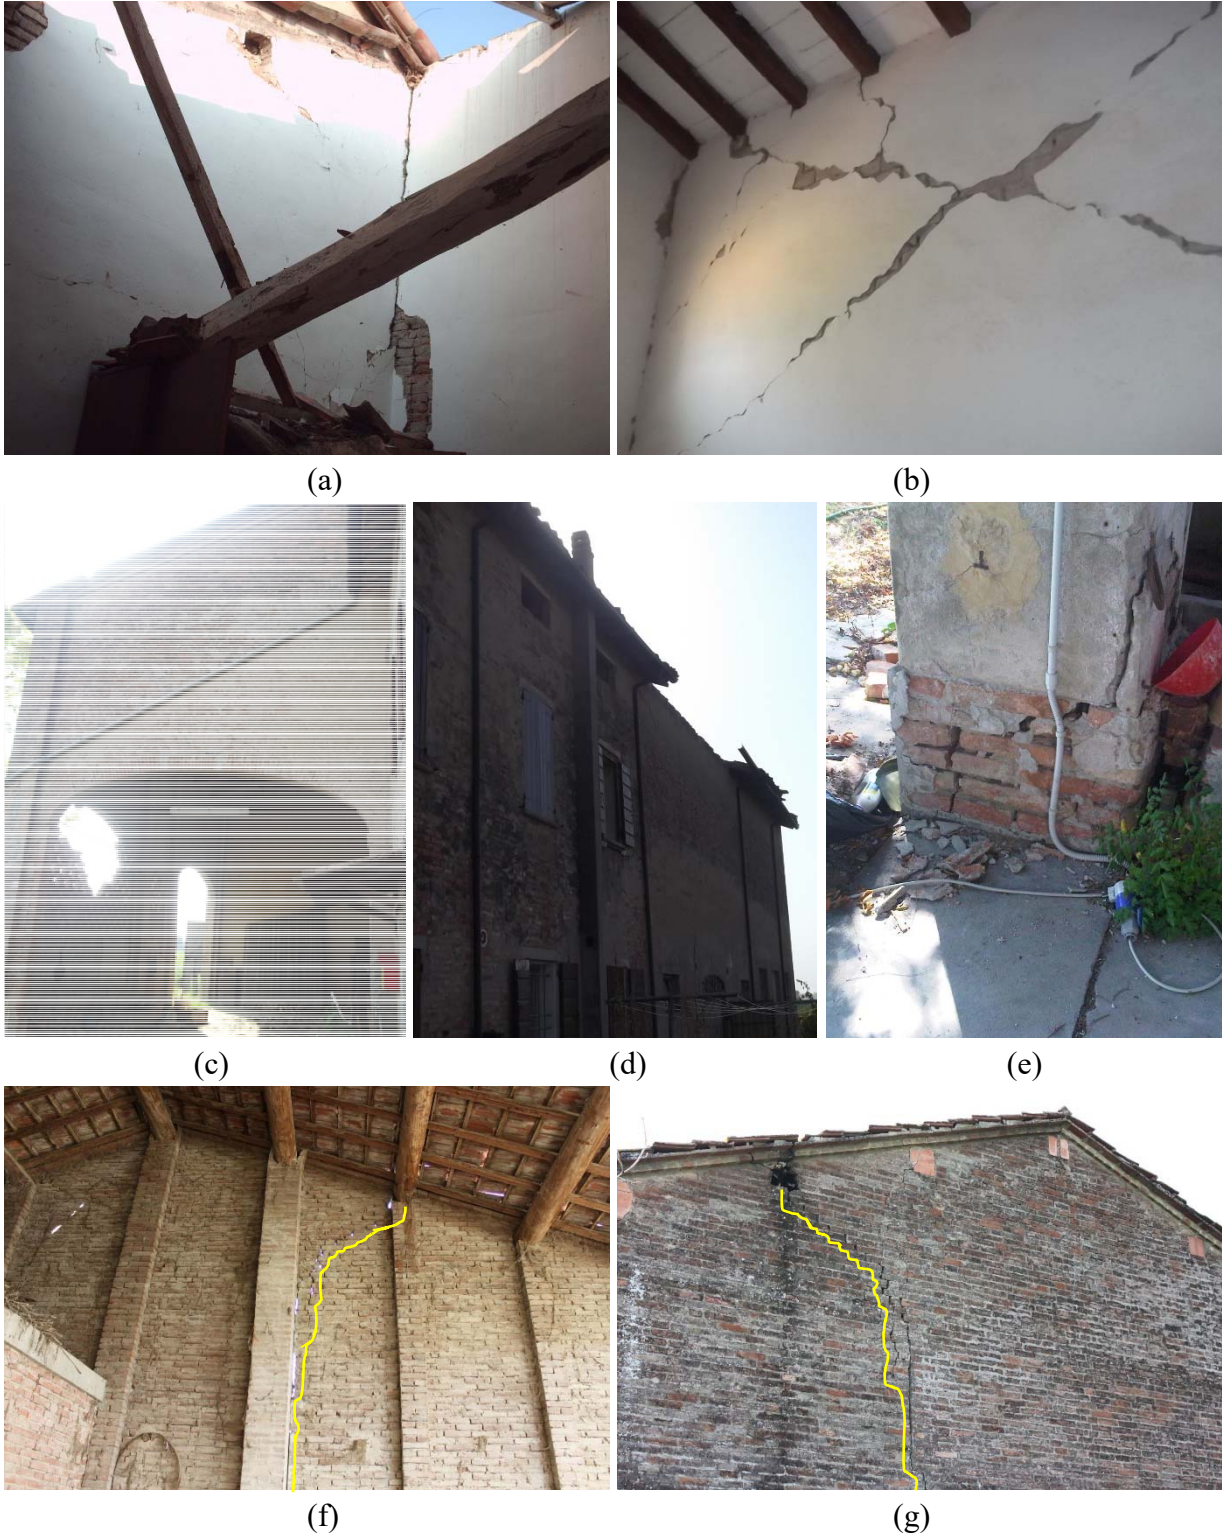
With reference to composed buildings (labelled as category B in this paper), it is worth to note that damage mechanisms observed during on-field inspections are very similar to those observed in isolated buildings, and the collapses can probably be ascribed to analogous causes. Moreover, few additional damage sources, to be attributed to the interaction between adjacent bodies, must be considered. In fact, due to the different use, the interacting bodies have often different storey level, inner height and wall slenderness, especially for building in category B1-2, mainly damaged by the 2012 earthquakes. As a result, in several situations, sliding and fall of roof beams (see Figure 16a), corner opening between non-properly connected orthogonal walls (see Figure 16b) were observed. Despite their slenderness (if measured on the hayloft side), sometimes the intermediate transverse walls reported X-shape cracks or bricks sliding typical of shear damage mechanism and did not collapse in local way because of the restraint guaranteed by intermediate storey on the other (i.e. home) side.

Among the observed seismic damage, it is worth to note those to non-structural elements. The failure or fall of these elements, even if non-responsible of building collapse, can represent a serious risk for people inside or nearby the building. In Figure 16c and d two typical examples are shown. The first is related to the failure of non-structural ornamental elements, like the “gelosie” (Figure 16c), holed infill walls typical of Northern Italy. The second refers to perimeter masonry cornice (Figure 16d), typically built with good external texture masonry, internally infilled by waste material with poor mechanical strength. Lastly, as mentioned above, in rural buildings it is not unusual to find porticos and wooden sheds commonly supported by thin masonry pillars. After the seismic events, some columns displayed cracking and damage at the base due to the large curvature prescribed in proximity of their connection to foundation elements. A typical crack pattern of the base portion is showed in Figure 16e. It is evident that the column base-section results partially no-longer working since it is detached by foundation plinth.

Figure 16. Detail of damage to category B buildings and non-structural elements. (a) Fall of timber roof beams from the intermediate wall in the composed bldg. # 8. (b) Shear cracks on a wall (bldg. #8). (c) Failure of “gelosie”, typical holed infill walls (bldg. #5). (d) Fall of a portion of the perimeter masonry cornice (bldg. #5). (e) Cracking at the base of a masonry column portico (bldg. #7); (f) Internal and (g) external view of the detachment of the infill panels from the bearing columns due to a poor connection (bldg. #12).
