The problem of conservation of XX Century architectural heritage: the fibreglass dome of the Woodpecker dance club in Milano Marittima (Italy)

Cesare Pizzigatti¹, Elisa Franzoni^{1*}

Abstract

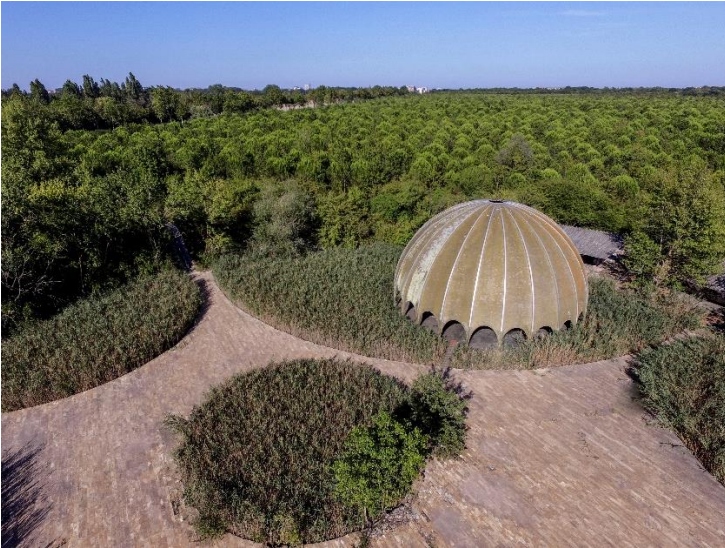
Fig. 3 Current state of the Woodpecker dance club, invaded by vegetation (the photo was taken through the drone described in § 3.1).

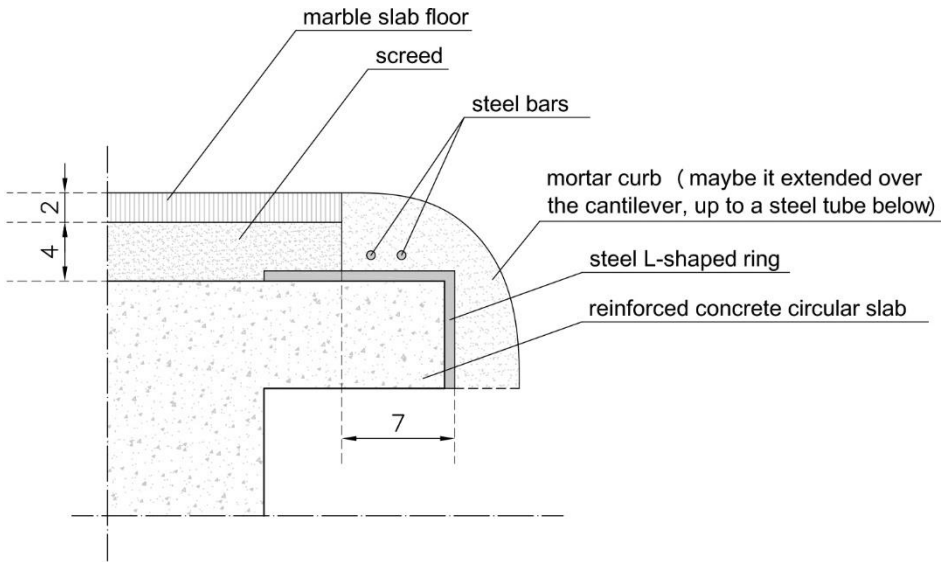
- the basement is a circular reinforced concrete slab, with a cantilever edge covered by a steel ring having a L-shaped cross section. This element, now completely rusted, was originally hidden under a mortar layer (Fig. 6), now mostly detached;

Fig. 6 Edge of the basement: the cross section in correspondence of an opening of the dome, as inferred by the investigation on site (sizes in cm).

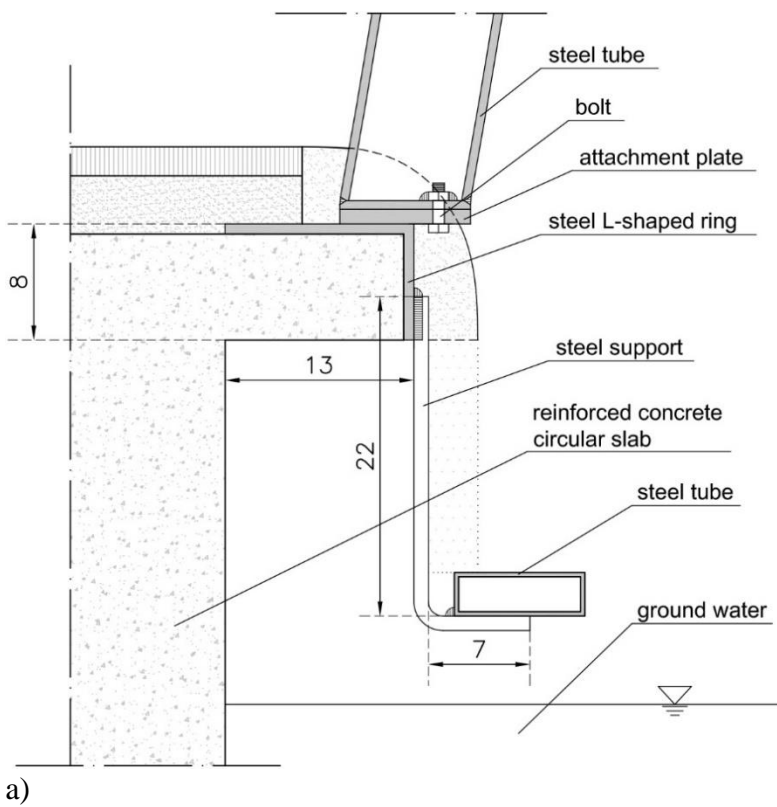
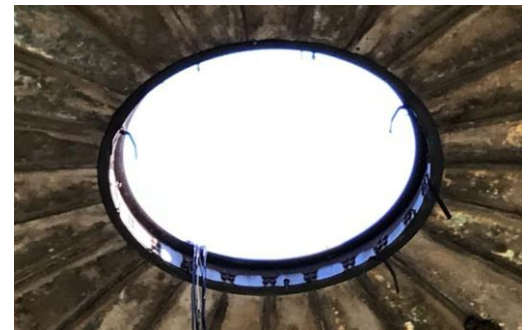
Fig. 7 Attachment of the steel framework to the concrete base (*a*, *c*) and to the steel ring on the top (*b*). The detail of the cross section in correspondence of a tubular steel arch in *a*) (sizes in cm) was inferred by the investigation on site. The role of the hollow rectangular steel tube below is not clear: it was likely designed to support the mortar curb, which probably extended below the cantilever originally.

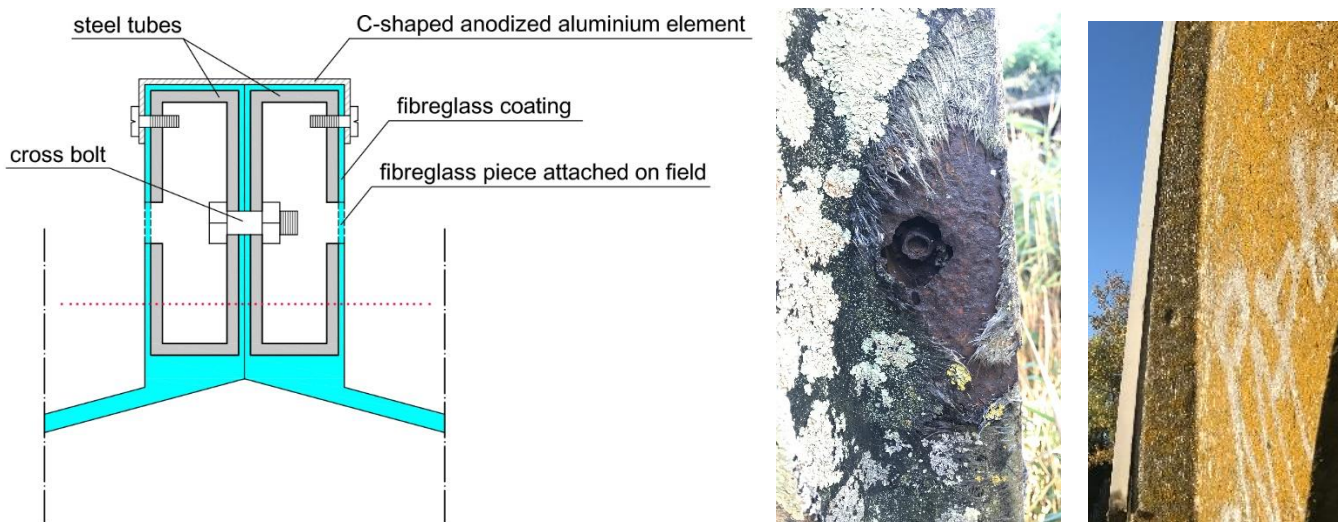
- Each couple of flanked tubular steel arches was cross bolted, the bolts being hidden inside the tubes. As the joining of the arches was made on site, bolts, whose diameter seems approximately 10-15 mm (it was not possible to determine the exact value, for the reasons explained above), were supposedly inserted by drilling through the fibreglass coating and the steel elements, finally the holes were covered with fibreglass patches. This assembling system can now be observed in few points, where the deterioration of fibreglass makes the holes visible. The distance between adjacent bolts can be deduced from local dips or swellings in the fibreglass along the ribs (Fig. 9) and resulted equal to about 1 m.

Fig. 9 Join of flanked tubes: the cross section (*left*) and some photos (*centre* and *right*). The dotted red line indicates where the vaults could be cut for the repair intervention, as explained in Section 5. The bad conservation state of fibreglass, which is lacking in some points and is affected by dips or swellings in other points, allowed this joining system to be identified. On the right, it is also possible to observe the C-shaped anodized aluminium element still in place in the upper part of the dome.

- construction of a temporary supporting structure inside the dome;
- dismantling of the vaults. Operationally, a cut will be made in the position indicated by the dotted red line in Fig. 9, left. In this way, the internal surface of the vaults will be totally conserved and will likely be not affected by the dismantling operations. Conversely, the metallic tubes will be entirely removed and replaced (see below);

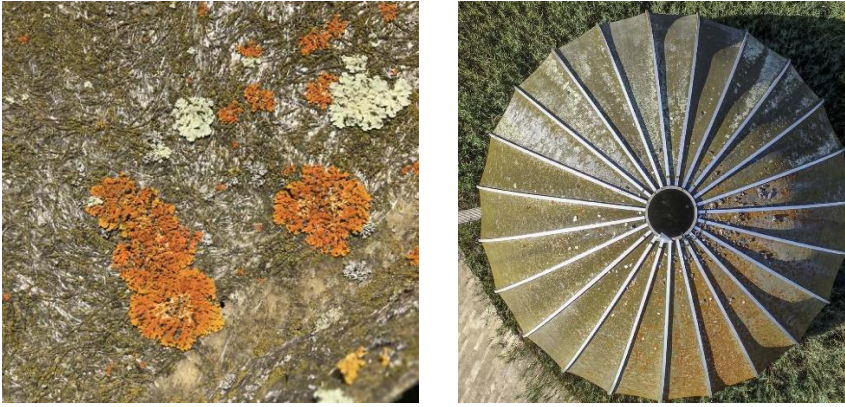
Fig. 10 Lichens on the external surface of the dome. On the left: emerging mat and differences between lichens. On the right: north-oriented zenith view of the dome, where lichens of different colours depending on the orientation can be seen (the photo was taken through the drone described in § 3.1).

- repair of the external fiberglass surface, according to the following steps: cleaning, by removal of lichens and deteriorated fibreglass parts; application of a new layer of unsaturated polyester resin (and additional layers of fibre mat, if necessary) up to obtaining a smooth surface and a uniform thickness;

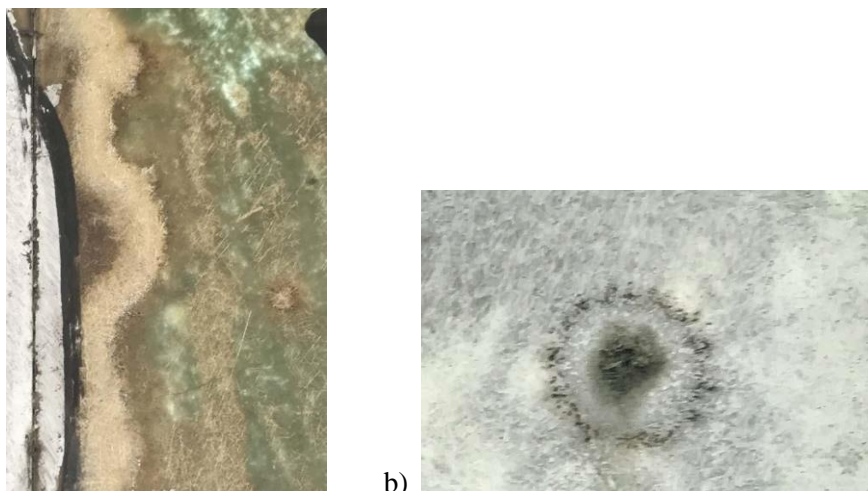
- In some areas of the dome intrados, fibres emerge, having the appearance of a scratched surface or of crust on the fibreglass, depending on the level of deterioration (Fig. 12a). Several local bulges can be observed too, similar to small craters surrounded by radial hair cracks. In some of these bulges the inner layers are exposed to the environment (Fig. 12b).

Fig. 12 a) Fibers emerging from fibreglass inside the dome; b) local bulge on the internal surface of the dome.

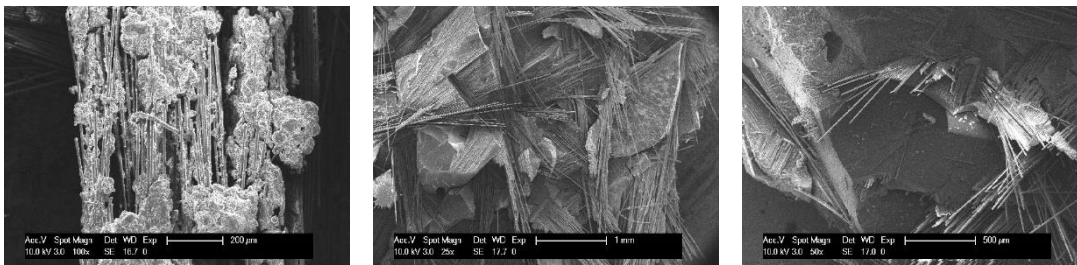
SEM images showed that the resin wrapping the fibres is not present anymore in many zones (Fig. 18, left). This erosion was mainly ascribed to the ageing of the polymer, likely due to hydrolysis, which consists in polymer bonds breaking due to prolonged exposure to water [57, 59, 66]. In the Woodpecker dome, this kind of degradation was exacerbated by the environmental conditions (see Section 4.2), involving a very high relative humidity all over the year, also combined with high precipitation during winter and high temperature during the summer season, which favoured hydrolysis. The direct and unsheltered exposure to solar radiation (and hence UV) and the presence of surrounding vegetation (providing O₂) likely boosted the ageing of the resin. Once the resin layer started to deteriorate, the occurrence of freeze-thaw cycles and the presence of lichens keeping the surface moist for long time seem to have intensified the deterioration processes [57, 60, 68-71]. The arrangement of fibres, which is visible due to the lack of the matrix, confirmed that they are in the form of mat, as per preliminary hypothesis (Fig. 18, centre). The SEM image of the surface of a deteriorated fibreglass sample (Fig. 18, right) highlights the presence of a series of layers of matrix and mat, confirming that the vaults were manufactured by a hand layup process (see Section 4.1). Observing the fibres by SEM, no hair cracks were found (Fig. 19, left), despite the aggressiveness of environment where the dome is located, probably also thanks to the presence of the original protective coating (sizing) over the glass fibres [26-27, 55-56, 59]. The EDS analysis performed on a portion of the fibre surface not covered by the resin anymore (Fig. 19, centre) allowed to detect the presence of calcium (Ca) and the absence of sodium (Na) and potassium (K) (Fig. 19, right). Based on this, the mat was probably constituted by E-glass fibres [55-56], the most widespread type of fibres used in the production of fibreglass elements when the Woodpecker was built. Indeed, their low cost combined with good physical-chemical properties made these fibres attractive for several applications [26-27, 55-56, 59].

Fig. 18 Fibreglass samples. On the left: SEM image of sample S4, affected by deterioration (marker = 200 µm). At the centre: SEM image of sample S5, affected by deterioration (marker = 1 mm). On the right: SEM image of sample S4 (marker = 500 µm).

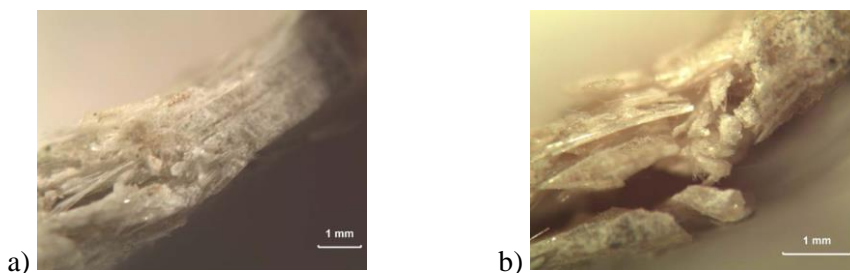
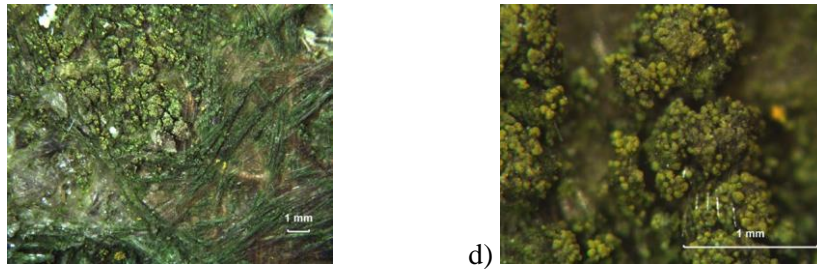
In Figs. 20a-b some significant SOM images of cross sections of a fibreglass sample are reported. A marked delamination, i.e., the separation of resin and mat layers, can be observed. This type of deterioration is detrimental, as it hinders a correct stress transmission within the composite material and compromises its mechanical performance. This loss of adhesion between the matrix and the reinforcement may be due to the breaking of strong bonds formed during reticulation process between the polymer matrix and the fibres sizing [26, 55, 59]. This deterioration can be accelerated by the presence of moisture at the interface, and by microbial decomposition of the sizing chemicals [55-56, 59, 66, 69, 72], although in this study no specific investigation on the nature of the adhesion mechanism (chemical or physical) and sizing was conducted.

In Figs. 20c-d, SOM images of the external surface of the fibreglass of the dome are reported. The fibre mat, which emerged due to the resin decay, became an optimum rough base for the growth of

various species of lichens, which actually cover most of the surface. These lichens probably caused an additional loss of resin, due to their metabolic processes. This biodeterioration includes a series of chemical and physical-mechanical actions onto the polymeric substrate, such as the leaching of some chemical compounds (fragments of polymeric chains, as well as additives) used as nutrients, the secretion of aggressive substances (e.g., acids and enzymes), the penetration and growth by hyphae, and the blistering due to gas evolution [57, 72-78].

Fig. 20 SOM images of: a-b) cross sections of fiberglass sample S7, affected by delamination (marker = 1 mm); c) external surface of the fiberglass sample S4, with lichens growing on the mat (marker = 1 mm); and d) a detail of the lichens in c) (marker = 1 mm).
