Construction and Building Materials

An integrated approach to the monitoring of rising damp in historic brick masonry

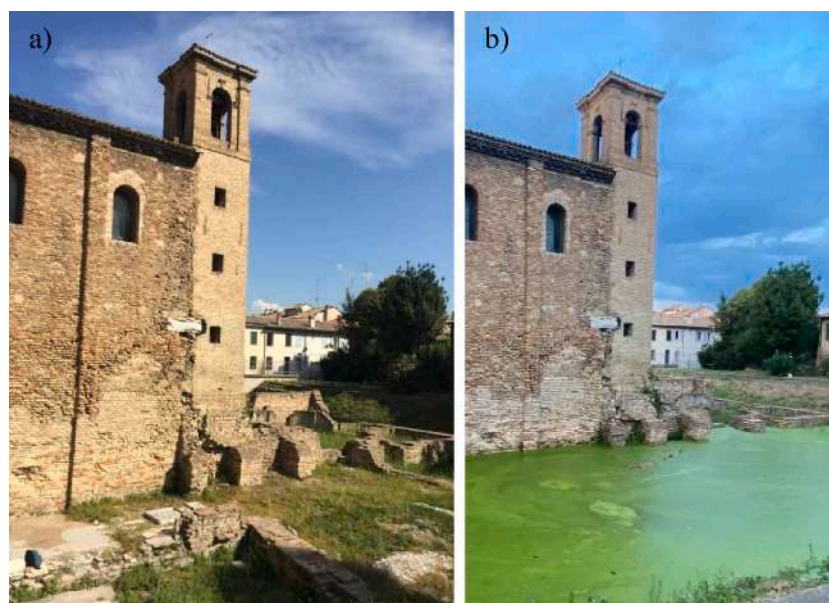
Fig. 1. a) the church of santa croce in September 2020 (south wall with bell tower), with the surrounding archaeologic area; b) the same zone during the flooding due to the pumping system failure in August 2021.

The onsite inspections started in September 2020 and are presently running. From August 2021 to November 2021, the church was submerged (Fig. 1), due to a pumping system failure, which allowed the investigation of the church also in the worst scenario.

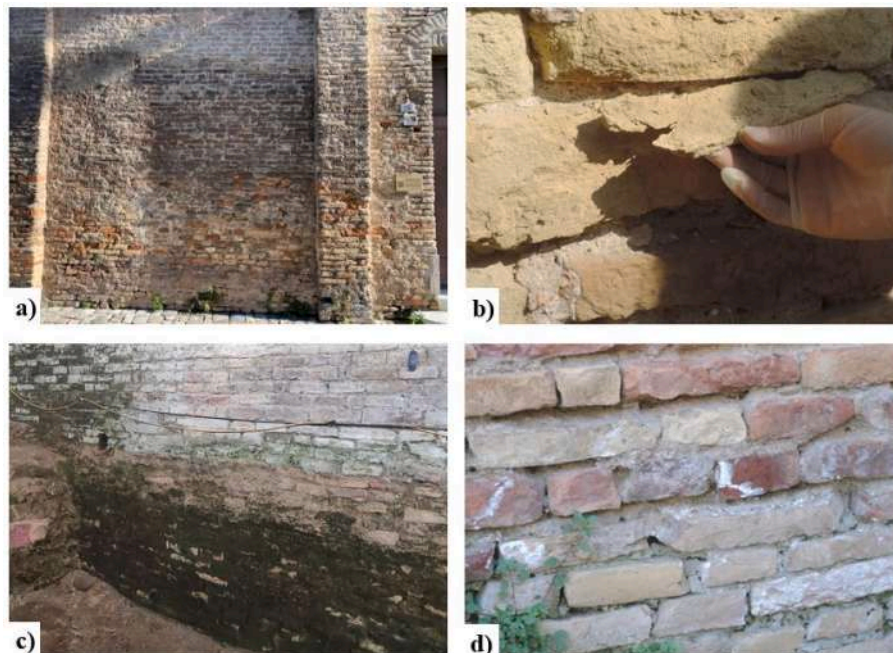
By visual observation, the church is strongly affected by rising damp, and various deterioration patterns are present in building materials. The external surface of the masonry is affected by colour change (Fig. 4a), bricks flaking and crumbling, possibly due to freeze–thaw and/or salt crystallization cycles (Fig. 4b), mortar joints' deterioration, efflorescence, and occasional plant growth (Fig. 4d). The interior is mostly affected by intense biological growth in the lowest part (Fig. 4c). The internal floor is constituted by soil and is also affected by deposits of pigeons' guano.

Fig. 4. Examples of materials' deterioration patterns in the church: a) darkening due to rising damp in the main façade (west); b) flaking and scaling of bricks (south façade, exterior); c) biological patina (north wall, interior); d) salt efflorescence and deterioration of mortar joints (north wall, exterior).

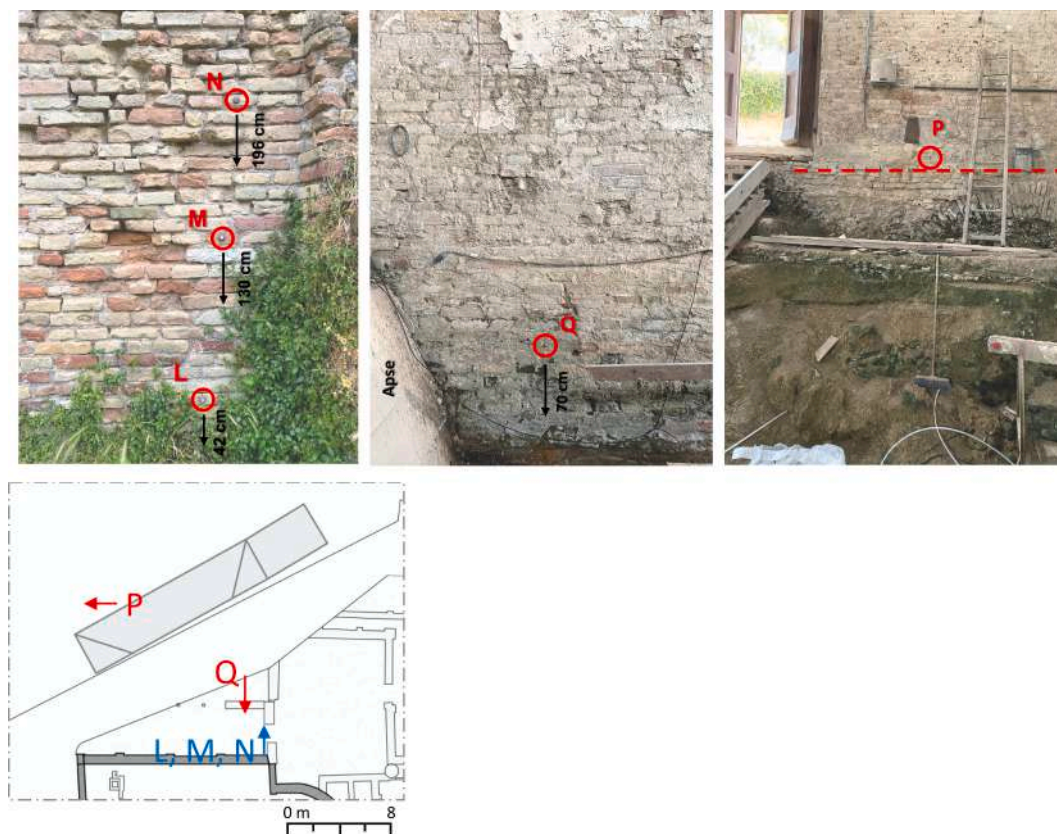
Fig. 5. Above, from left to right: permanent sampling points L–M–N (south wall, exterior), Q (south wall, interior), P (west wall, interior; the dotted line indicates the road level). Below: location of the sampling holes in the church plan.

- in September 2020, after the hot and dry summer season, moisture was present in the south wall in intermediate amounts (saturation degree 32 % in L and 58 % in Q), mostly in the first ~ 1 m above the floor. The fact that moisture amount decreases with height is typical of masonry affected by rising damp. Moisture was slightly higher on the internal side compared to the external one, likely due to the fact that no ventilation is present inside the church hence the water evaporation is hindered there (par. 4.3), while the lower relative humidity and the natural airflow on the external surfaces favour the moisture loss. Also in the west wall, moisture was intermediate (saturation degree 43 % in P), which means that the water capillary rise reaches and passes the road level

- in April 2021, after the cold and humid season, moisture in the south wall was considerably more abundant and reached a higher level, being close to saturation in L, intermediate in M, and absent 2 m above the floor, which seems to suggest an equilibrium line around 160–180 cm. On the internal side, the moisture amount was slightly lower, which suggests that rain may have contributed to the wetting of the wall on the external surface. Also in the west wall, moisture was higher compared to the previous date

- at the end of February – beginning of March 2022, i.e., about 3 months after the removal of the flooding water in the area, the situation was completely different. Moisture was present in much higher amounts (e.g., SD equal to 93 % in L, 92 % in Q, and 80 % in M) and up to an impressive height (>2 m). In fact, the saturation degree found in N (height 2 m) was equal to 46 %. The fact that 3 months after the removal of water the wall was still very wet must not surprise, as bricks and mortars are much faster in absorbing water than in drying [45], the latter being strongly influenced also by the climatic condition (see 4.3). The west wall exhibited a moisture amount comparable to the previous year, hence it was probably less affected by the flooding. In fact, the wall below point P is underground on one side (below the street) and covered with soil on the other side (Fig. 5-right), hence the evaporation in this part of the wall is always inhibited, and moreover the bricks were not directly in contact with water during flooding

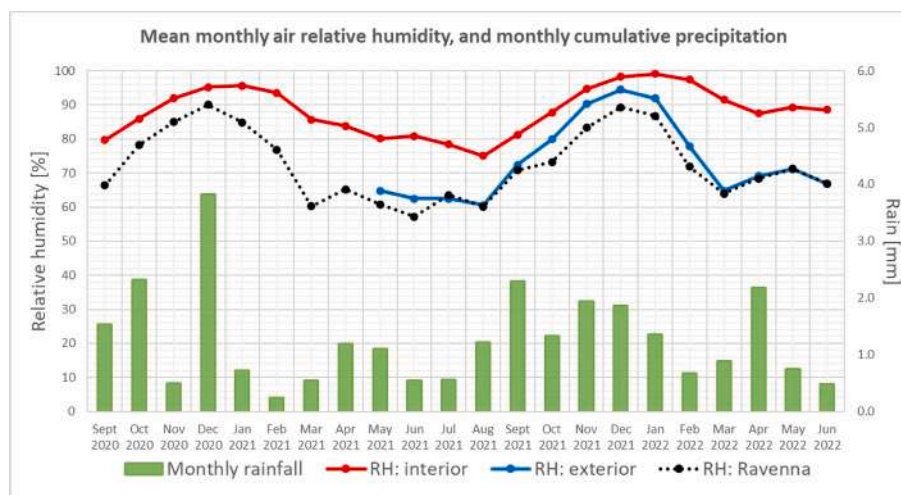
Fig. 8. Mean monthly values of air relative humidity inside and outside the church, and rainfall.

and autumn. Even if some differences were found in the temperature inside and outside, they seem too limited to account for such a huge difference in relative humidity. On the whole, the mean monthly relative humidity inside the church is basically higher than 80% all along the year, which can be ascribed to the absence of ventilation in the building (windows permanently closed), aimed at preventing the ingress of birds and the subsequent damage, and certainly reduced the evaporation rate of the walls through the internal surface, as confirmed also by thermal imaging [50]. Considering that the total absorption rate of water from the ground and the total evaporation rate of water through the masonry's surfaces come into balance and a steady state is established [4], it is clear that the evaporative conditions on both sides of the walls play a key role in determining the height of rising damp. On the other hand, the constantly humid air inside the church prevented the occurrence of cycles of crystallization-dissolution of salts [51], and in fact the physical-mechanical damage owing to this deterioration mechanism is present mostly in the external masonry surfaces.

Considering the rainfall values in Fig. 8 and the data in Table 4, there seems to be no particular correlation between monthly cumulative rain and moisture amount in the walls, probably because the level of the

underground water table is kept constant by the pumping system and is independent from the rainfall. Of course, some water absorption of wind-driven rain by the walls cannot be excluded, but it is likely a transient effect. This suggests that other factors play a major role in the phenomenon of rising damp, namely the rate of moisture evaporation and the level of the water table. To take into account all the factors influencing the capillary water rise in the walls of the church, a modelling will be carried out in future steps, exploiting both the data collected in this study (moisture in the walls at different dates, T-RH monitoring, masonry materials' characteristics) and others that are presently under collection (monitoring of the water table, wind, further measurement of moisture in the walls).
