Article

The San Carlo Colossus: An Insight into the Mild Galvanic Coupling between Wrought Iron and Copper

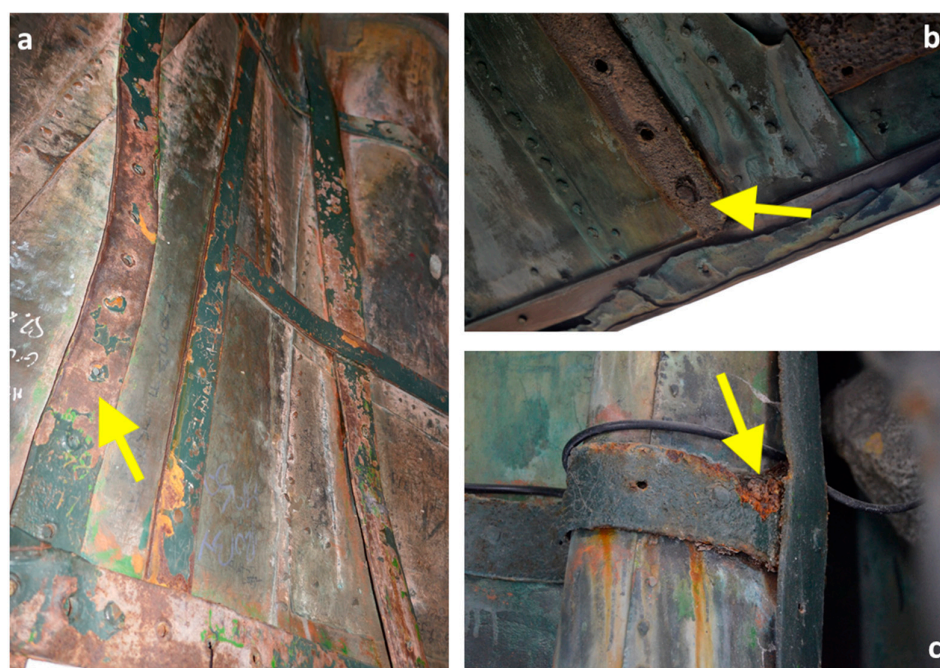
It has been reported that in a previous restoration, a protective coating was applied [1–3]. However, this coating is nowadays heavily deteriorated with large portions of the iron surfaces directly exposed to the atmosphere. The *San Carlone* statue, therefore, should be prone to galvanic corrosion. However, upon visual inspection of the monument, most iron elements of the Colossus appeared in quite good conservation condition despite the general degradation of the protective coating (Figure 2a) with scarce evidence of galvanic corrosion. In contrast, active corrosion of the iron elements was observed regardless of their direct contact with the copper sheets. In some cases, the same iron bars presented some portions in good conservation conditions and other nearby portions with active corrosion (Figure 2b,c).

Figure 2. Examples of degradation patterns on iron elements. (a) Iron bars in good conservation conditions despite the degradation of the protective coating; (b,c) small areas characterised by severe corrosion surrounded by almost intact zones.

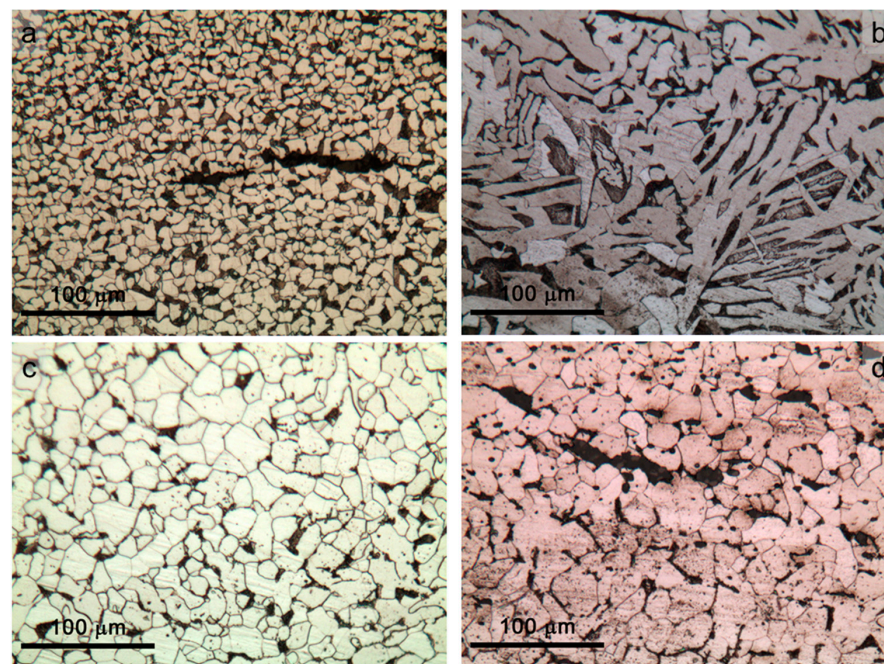
Figure 5. Microstructure observed by optical microscopy in the cross-sections of the iron samples from the *San Carlone* and on the reference sample of puddled iron after etching with Nital2. Outermost areas of the samples: (a) Sample 44—slightly corroded sample in contact with copper; (b) Sample 46—slightly corroded sample not in contact with copper; (c) Sample 87—heavily corroded sample in contact with copper; and (d) Sample A—reference sample of puddled iron.

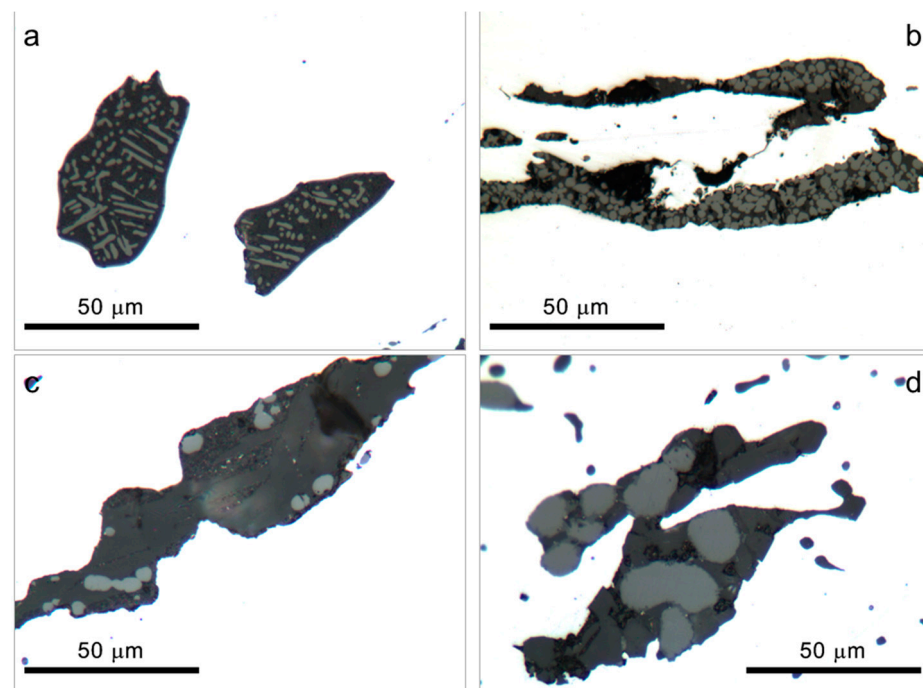
Figure 6. Inclusions observed by optical microscopy on nonetched cross-sections of the *San Carlone* iron samples and the reference sample of puddled iron. (a) Sample 44—slightly corroded sample in contact with copper; (b) Sample 46—slightly corroded sample not in contact with copper; (c) Sample 87—heavily corroded sample in contact with copper; and (d) Sample A—reference sample of puddled iron.

The observed good corrosion behaviour of iron elements may be possibly associated with the presence of slag inclusions. As discussed by Chang et al. [47], in the case of historic copper, the dimensions and nobility of inclusions may influence the composition of corrosion products and therefore the protection they provide to the underlying alloy.

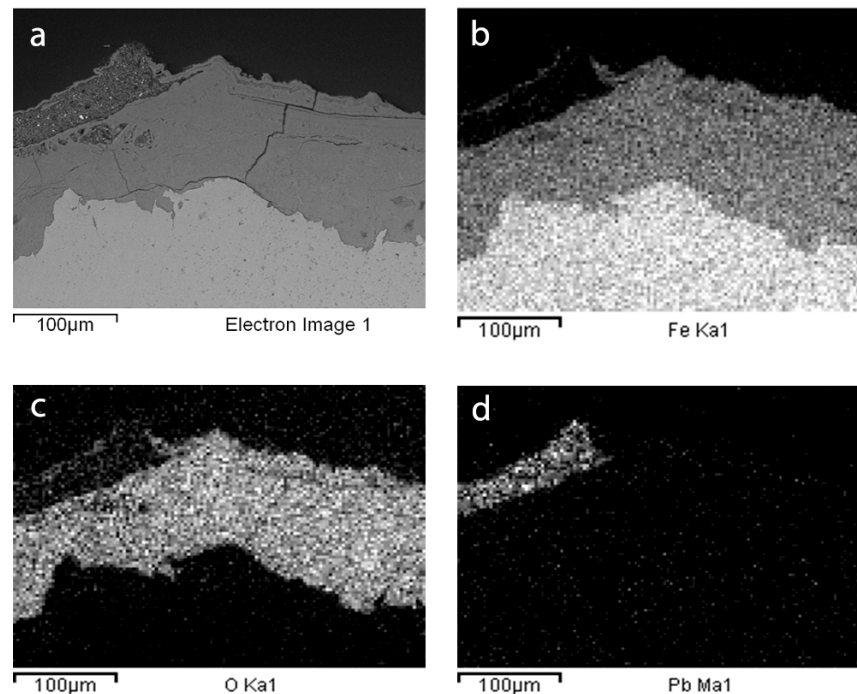
Figure 8. EDX maps of Sample 87 (a) Electron Image, (b) Iron Ka1, (c) Oxygen Ka1, and (d) Lead Ma1.

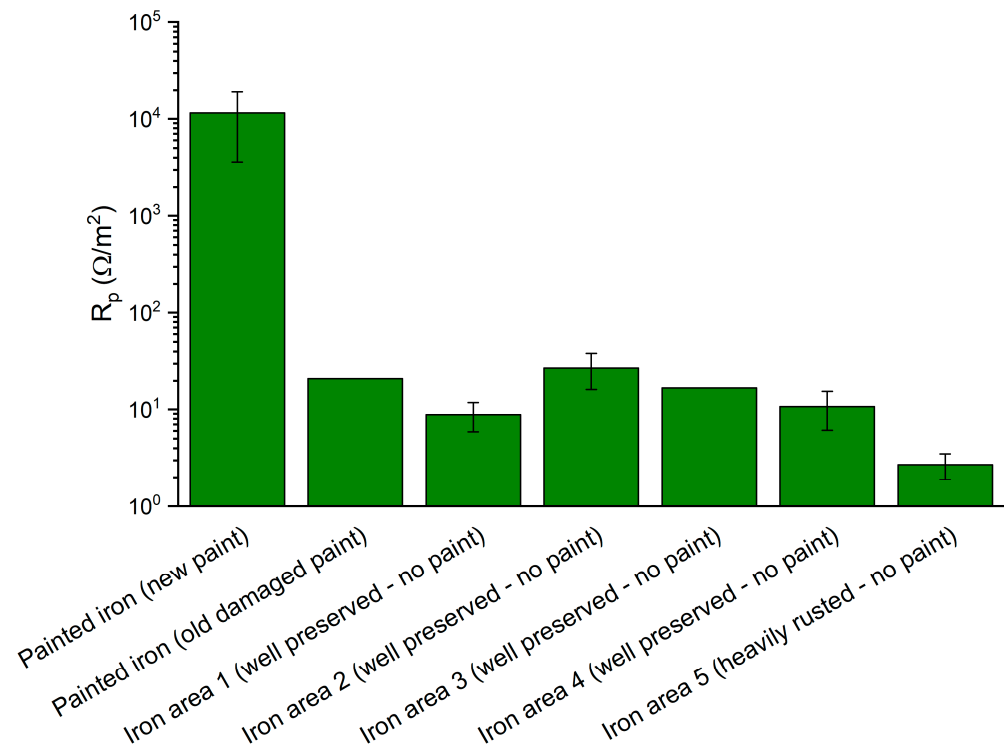
The R_p measurements, performed in situ, of different iron elements of the *San Carlone*, characterised by different conservation conditions are displayed in Figure 13. Only a few areas were characterised by the presence of a protective coating (“painted iron-new paint”), while most areas were characterised by a fairly good conservation condition despite the lack of paint (“well preserved”). These “well preserved” areas showed R_p measurements similar to the ones obtained from the fragments analysed in the laboratory, suggesting a relatively low corrosion rate. Rusted areas (“heavily rusted”) were those showing the lowest polarisation resistance.

Figure 13. In situ polarization resistance measurements on iron elements of the *San Carlone* of Arona.
