Decay Assessment of Stone-Built Cultural Heritage: The Case Study of the Cosenza Cathedral Façade (South Calabria, Italy)

Abstract: This study aims to assess the different decay phenomena affecting the Cosenza Cathedral façade (Calabria, South Italy) through the evaluation of the relative damage indices. For this goal, a multidisciplinary approach was applied exploiting both nondestructive and microdestructive techniques. Such a combination enabled proposing an intervention priority scale that can be helpful to institutions when planning a prompt restoration intervention. The results suggest the efficiency of this approach to obtain a multidisciplinary diagnostic and conservation system for the management and valorization of the Cultural Heritage also in terms of monitoring, maintenance, and selection of the most suitable restoration procedures over time.

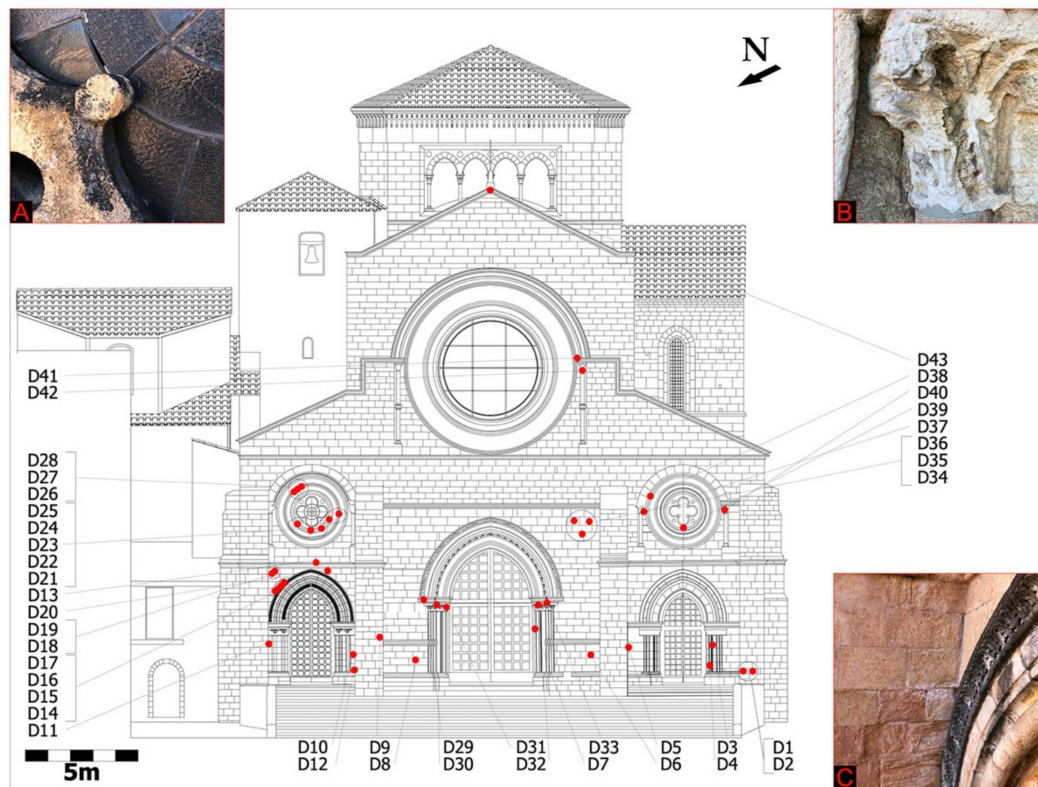
Figure 1. Samples taken from the façade. The images show some deteriorated areas in detail and relevant samples: (A) D21–D22; (B) D32–D33; and (C) D14–D15–D16–D17.

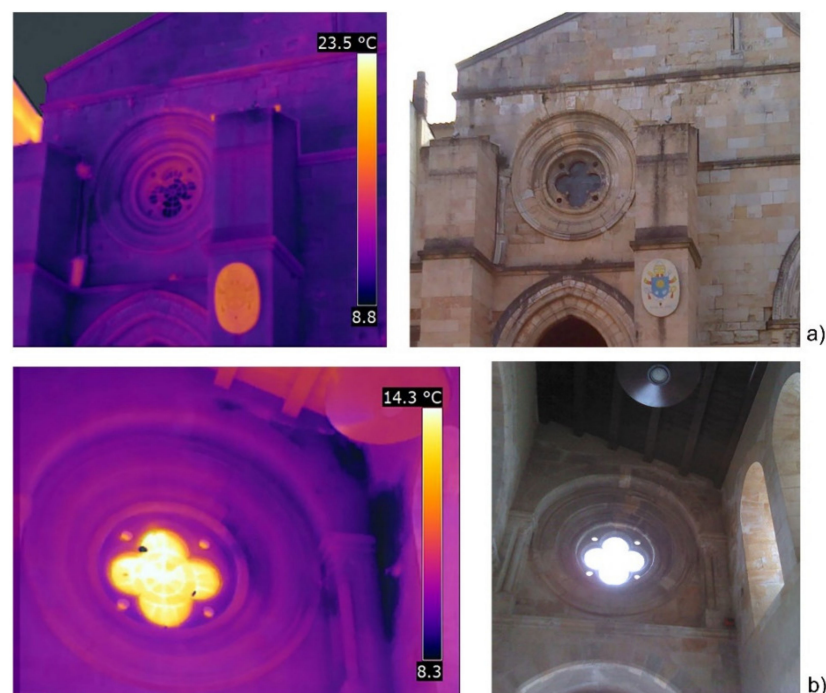
In the upper part, thermal anomalies compromising the structural proprieties and aesthetic values of the wall structures of the façade were detected. As clearly revealed in Figure 3, indeed, at the height of the lateral rose window, a wide water infiltration affects a large part of the façade.

Figure 3. Thermograms acquired on the external side (a) and on the corresponding internal side (b) and comparison with the photographic images of the same areas investigated. The colder areas (blue tones) locate the infiltration at the height of the side rose. A temperature of 12.7 °C and 64% relative humidity values measured during the 23 February 2021 in situ morning session were used to postprocess the thermograms here reported. This portion of the facade of the cathedral is related to an infiltration of rainwater from the external side of the masonry or from the roof and extends up to the frames of the rose window.

Correspondingly, on the internal side, the IRT inspection documented the higher intensity signal due to a presence of rainwater in the same portion of the wall structure. The diagnostic evidence confirmed that the rainwater infiltration through damage to the roofing system is one of the causes of the major deterioration in this wall portion.

The water migration into the porosity of the stone blocks due to evaporative phenomena led to the formation of salts efflorescence on the external side and, consequently, induced an important superficial decohesion, also identifiable in IRT images as colder surfaces.

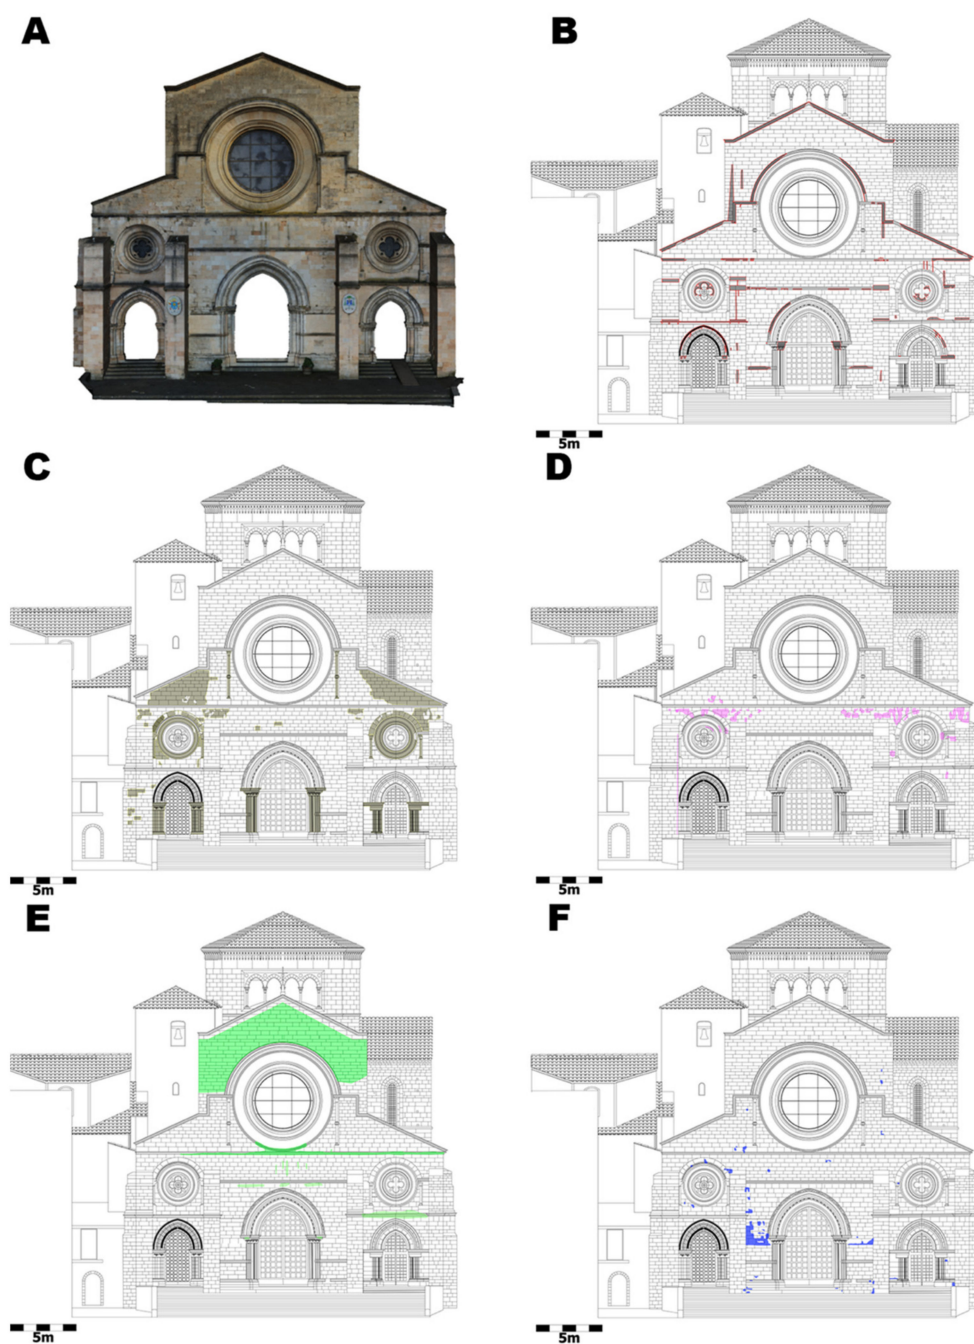
Black Crusts	Erosion/Disaggregation	Efflorescences	Biological Patina/Superficial Deposits	Loss of Material
Area (cm ²)	198,328.5	481,235.3	51,506.3	471,502.5	31,402.5
Area (%)	5.75	13.95	1.49	2.29	0.91

**Figure 5.** (A) 3D model of the façade; (B) Black crust; (C) Erosion/Disaggregation; (D) Efflorescences; (E) Biological patina/Superficial deposits; (F) Loss of material.

As highlighted during in situ decay observations, the left side of the façade was mostly affected by both efflorescences and erosion phenomena; therefore, damage indices were determined also on the two portions of the façade (left and right). The damage indices of the two portions were respectively: $DI_{lin} = 1.06$ and $DI_{prog} = 2.06$ for the left side, $DI_{lin} = 0.67$ and $DI_{prog} = 1.27$ for the right side. They suggest the necessity to intervene urgently in this area with a restoration plan.

Following a priority scale provided by damage categories assigned to different weathering forms, it would be recommendable to intervene firstly on areas affected by efflorescences, paying attention to the area above the left portal of the façade; while erosion covers about 14% of the façade, efflorescences may exacerbate the strong erosion already present and the combined effect of those may compromise the conservation of the whole structure. Although the area above the right portal of the façade has efflorescences, they are less intense; the uneven progression between these parts could be due to a heavy water infiltration on the left part, as highlighted by IRT, which favored its evolution over time. Finally, a cleaning intervention is required on areas affected by black crusts and biological patina.

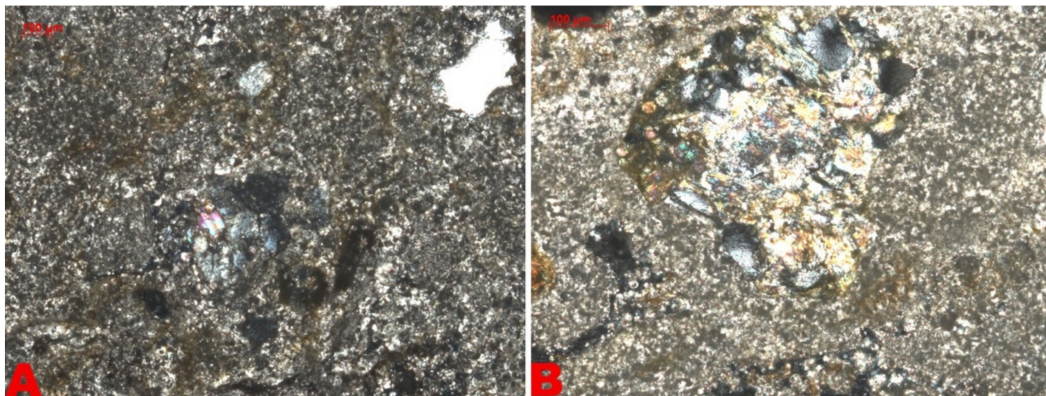
Petrographic observations suggest how all samples show similar features; in particular, they can be classified as biosparites/biopelsparites (Folk classification [23]) or wackestone (Dunham classification [24]). The most abundant accessory clasts were mostly siliciclastics, as quartz, plagioclase, micas (biotite, muscovite), and polycrystalline quartz. Fragments of granitoid rocks were found in D13 and D21 thin sections (Figure 6).

Figure 6. Fragments of granitoid in D13 (A) and D21 (B) samples (crossed polarized light view, CPL).

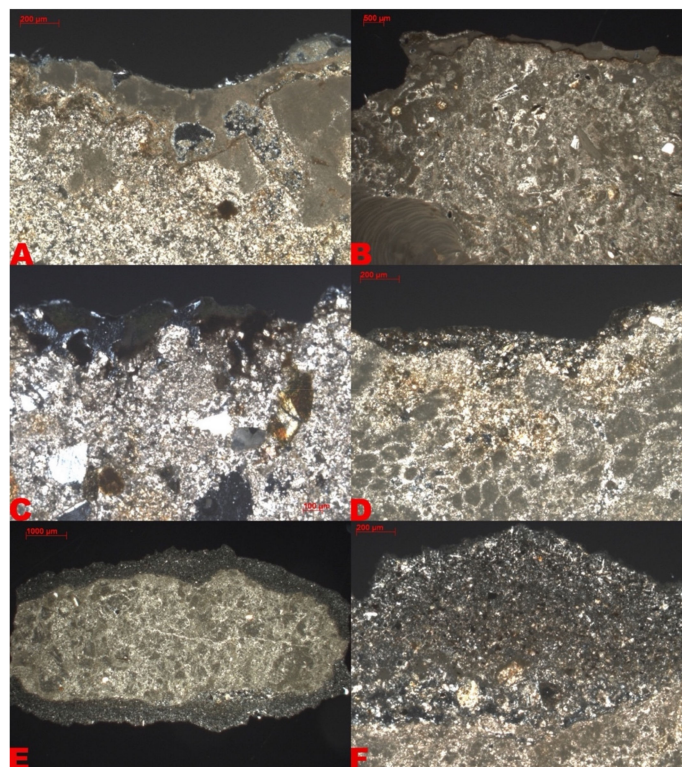
A superficial layer with variable thickness, made of microcrystalline gypsum, was observed on D13, D23, D31, D37, and D43 specimens. The level was related to the degradation forms (black crusts) identified under macroscopic observation. Traces of *scialbatura* (i.e. a sort of thin finishing lime layer) were found in D28 and D38 thin sections (Figure 7A,B).

Figure 7. (A,B) *Scialbatura* traces in D28 and D38 thin sections; (C) Siliciclastic accessory clasts mainly encountered; (D) Superficial layer overlying the substrate in D31 sample; (E,F) D37 sample and detail of the overlying black crust with visible acicular crystals of gypsum, Fe-oxides, and carbonaceous particles.

The superficial layer was discontinuous in most of the samples, with an average thickness ranging from 120 μm to 265 μm . It showed an irregular lower profile, while the upper one varied from irregular to lobate (Figure 7C,D). D37 was the only sample in which the superficial layer showed different characteristics. It appeared to continue in

the whole sample, with a thickness ranging from 350 to 900 μm . The crust was adherent to the substrate, except in some parts where it was fractured. The superficial layer was constituted mainly of microcrystalline gypsum; in addition, it was possible to observe also acicular gypsum crystals, Fe-oxides, and carbonaceous particles (Figure 7E,F).
