The problem of conservation of XX century architectural heritage: The fibreglass dome of the Woodpecker dance club in Milano Marittima (Italy)

Pizzigatti C., Franzoni E. (2021). The problem of conservation of XX century architectural heritage: The fibreglass dome of the Woodpecker dance club in Milano Marittima (Italy). JOURNAL OF BUILDING ENGINEERING, 42, 1-16 [10.1016/j.job.2021.102476].

# **The problem of conservation of XX Century architectural heritage: the fibreglass dome of the Woodpecker dance club in Milano Marittima (Italy)**

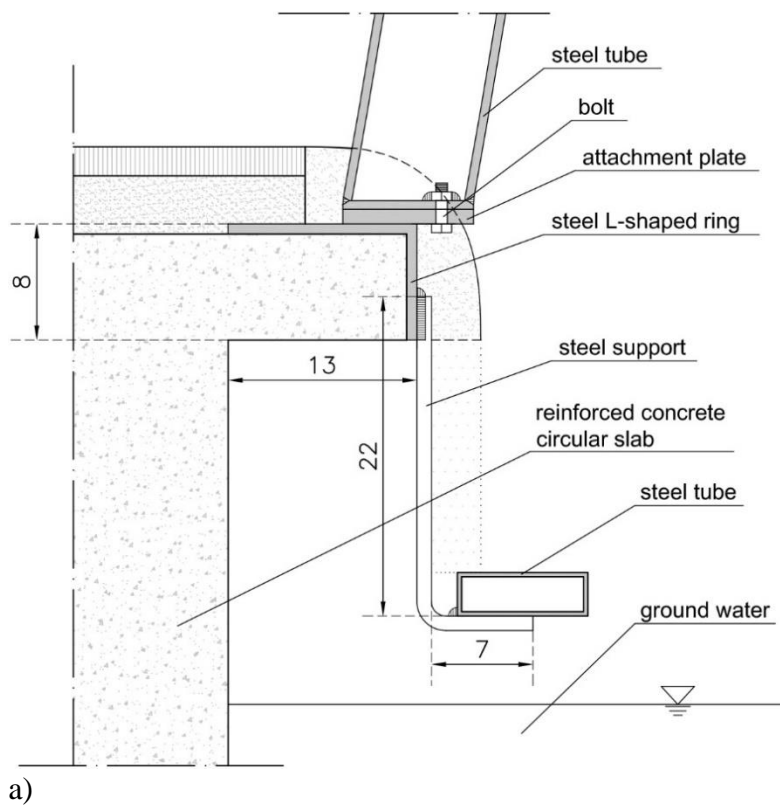
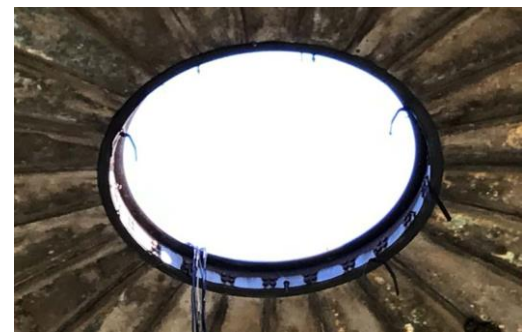
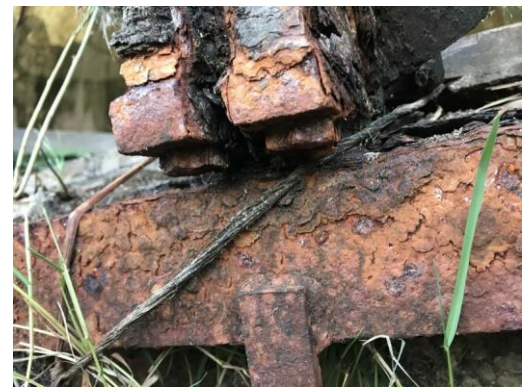
**Fig. 7** Attachement of the steel framework to the concrete base (a, c) and to the steel ring on the top (b). The detail of the cross section in correspondence of a tubular steel arch in a) (sizes in cm) was inferred by the investigation on site. The role of the hollow rectangular steel tube below is not clear: it was likely designed to support the mortar curb, which probably extended below the cantilever originally.

- onsite assembling of the repaired vaults, which will be connected to a reconstructed metallic structure at the basis (as in Fig. 7) and to a new top ring. All the metallic elements and the bolts will be made of the same kind of stainless steel used for the arches. The bolting system between the vaults will be the same originally used (Fig. 9). All the protective elements in Fig. 6, including mortar and sealing, will be reconstructed using materials exhibiting a suitable resistance to the specific environment of the dome;

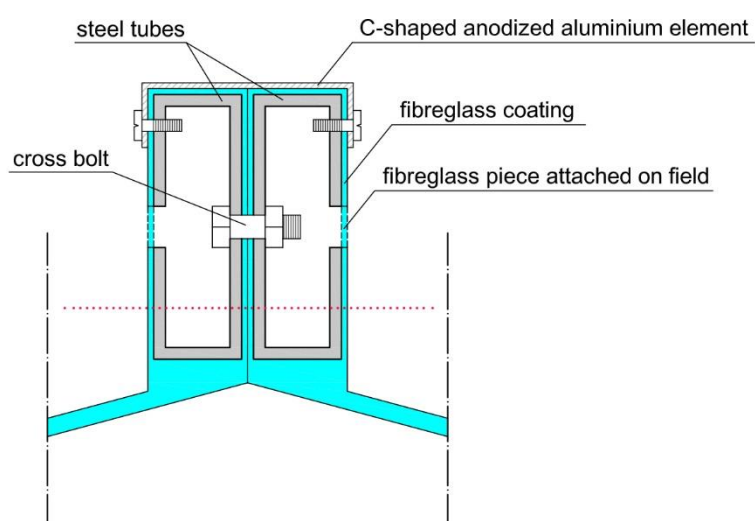
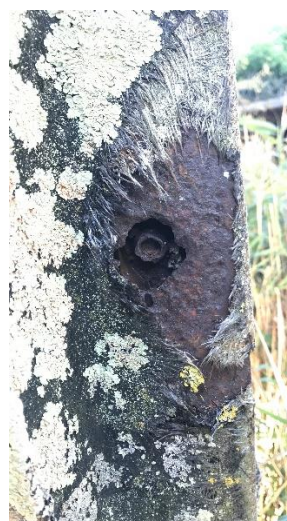
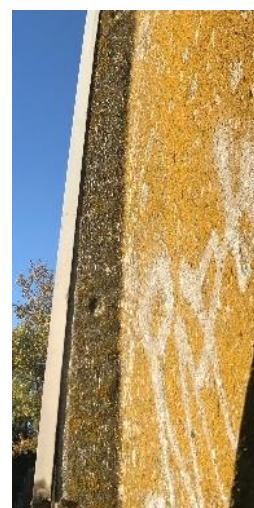
- Each couple of flanked tubular steel arches was cross bolted, the bolts being hidden inside the tubes. As the joining of the arches was made on site, bolts, whose diameter seems approximately 10-15 mm (it was not possible to determine the exact value, for the reasons explained above), were supposedly inserted by drilling through the fibreglass coating and the steel elements, finally the holes were covered with fibreglass patches. This assembling system can now be observed in few points, where the deterioration of fibreglass makes the holes visible. The distance between adjacent bolts can be deduced from local dips or swellings in the fibreglass along the ribs (Fig. 9) and resulted equal to about 1 m.

**Fig. 9** Join of flanked tubes: the cross section (*left*) and some photos (*centre* and *right*). The dotted red line indicates where the vaults could be cut for the repair intervention, as explained in Section 5. The bad conservation state of fibreglass, which is lacking in some points and is affected by dips or swellings in other points, allowed this joining system to be identified. On the right, it is also possible to observe the C-shaped anodized aluminium element still in place in the upper part of the dome.

- construction of a temporary supporting structure inside the dome;
- dismantling of the vaults. Operationally, a cut will be made in the position indicated by the dotted red line in Fig. 9, left. In this way, the internal surface of the vaults will be totally conserved and will likely be not affected by the dismantling operations. Conversely, the metallic tubes will be entirely removed and replaced (see below);

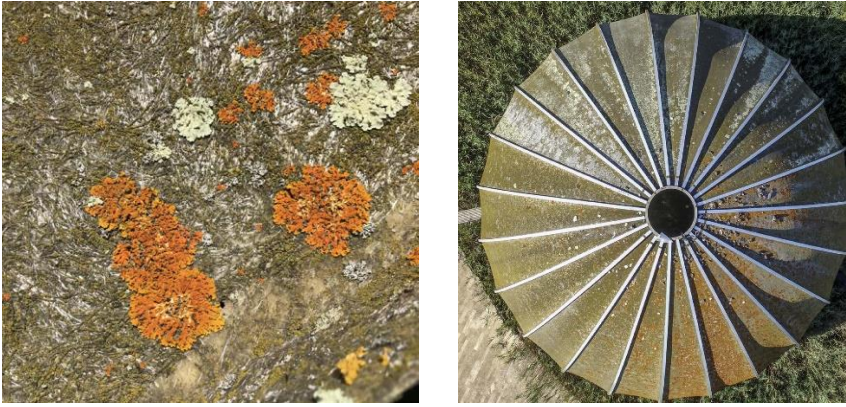
**Fig. 10** Lichens on the external surface of the dome. On the left: emerging mat and differences between lichens. On the right: north-oriented zenith view of the dome, where lichens of different colours depending on the orientation can be seen (the photo was taken through the drone described in § 3.1).

various species of lichens, which actually cover most of the surface. These lichens probably caused an additional loss of resin, due to their metabolic processes. This biodeterioration includes a series of chemical and physical-mechanical actions onto the polymeric substrate, such as the leaching of some chemical compounds (fragments of polymeric chains, as well as additives) used as nutrients, the secretion of aggressive substances (e.g., acids and enzymes), the penetration and growth by hyphae, and the blistering due to gas evolution [57, 72-78].

- repair of the external fiberglass surface, according to the following steps: cleaning, by removal of lichens and deteriorated fibreglass parts; application of a new layer of unsaturated polyester resin (and additional layers of fibre mat, if necessary) up to obtaining a smooth surface and a uniform thickness;

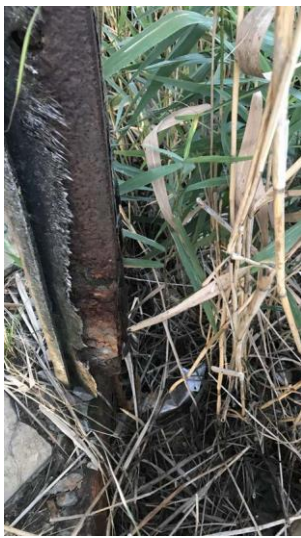
- The fibreglass layer that originally wrapped the steel framework is currently totally or partially absent in the low, periodically immersed, zone, due to deterioration. In some cases, the edge is sharp, while in other cases it is frayed due to the matrix decay. This kind of decay probably started in correspondence of the cross bolts (Fig. 11a).

**Fig. 11** a) Deterioration of the fibreglass layer that initially wrapped metallic tubes; b) corrosion of metallic framework near the base (two joined flanked tubes and their connection to the basement can be seen); c) rising of the level of ground water during the rainiest periods (courtesy of Antonello Zoffoli).

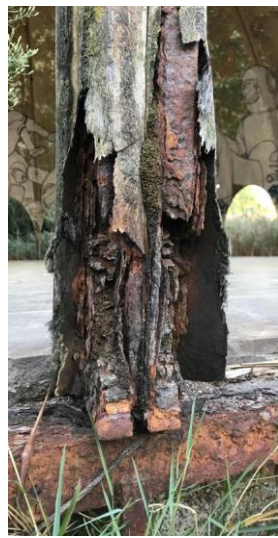
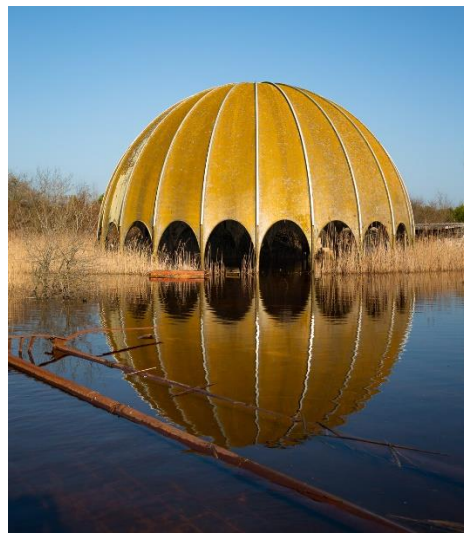
- The tubular steel profiles exhibit an impressive corrosion at the bottom, where, in addition to the lack of the fibreglass layer, they are immersed in ground water for some months a year (Fig. 11c). In some locations, they are in such bad conditions that it is possible to manually remove corroded flakes and entire portions of them are even lacking near the joints to the basement (Fig. 11b). Although the steel elements are not visible in the upper part of the dome, corrosion probably affects the whole metallic framework, as suggested by the presence of some rust leakages in the internal surface of the dome, along the joints between vaults.

- the use of carbon steel was not compatible with the periodic immersion of the base of the dome in brackish water (approximately from autumn to spring) and the high amount of chloride caused the perforation of the steel elements, which are now almost completely corroded at the basis. The original wrapping of the steel elements with fiberglass was obviously not enough for protecting steel from corrosion and it is even counterproductive, as it presently hinders the inspection of the corrosion state of the steel tubular elements.

- application of new stainless steel arches suitable for marine environment (e.g., AISI 316), in substitution of the existing steel frame. The entire substitution of the metal structure is expected to be cheaper and to prevent any galvanic corrosion deriving from the joining of two different kinds of steel. This substitution will also allow to calculate the new steel frame according to current regulations and to possibly increase the section and/or thickness of the steel tubes, if necessary. In fact, after the application of the stainless steel elements, they will

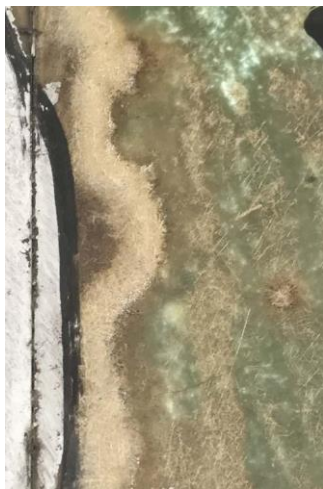
- In some areas of the dome intrados, fibres emerge, having the appearance of a scratched surface or of crust on the fibreglass, depending on the level of deterioration (Fig. 12a). Several local bulges can be observed too, similar to small craters surrounded by radial hair cracks. In some of these bulges the inner layers are exposed to the environment (Fig. 12b).

**Fig. 12** a) Fibers emerging from fibreglass inside the dome; b) local bulge on the internal surface of the dome.

- repair of the internal fiberglass surface where graffito is not present, according to the following steps: removal of powdering and/or detached parts, cleaning and repair of the defects in the fiberglass with unsaturated polyester resin;

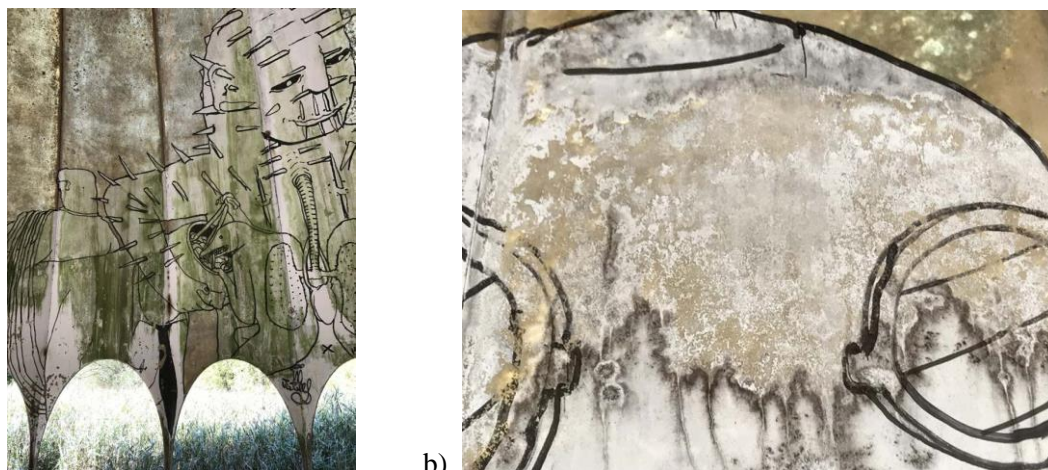
- The graffito by Blu is affected by several deterioration patterns. In the lowest zone it was vandalized by many writings. Up to about 2 meters in height, the paint tends to peel very easily, especially in correspondence of the vandal writings, while in other zones the paint tends to pulverize diffusely. In particular, the spray-painting used for the vandal writings seems directly responsible for the deterioration of the graffito, due to the incompatibility of the two overlapped layers. Indeed, the organic solvents employed in the spray paint dissolved the polymeric binder of the graffito underneath. Moreover, the fast drying of the writings usually involves a strong shrinkage that breaks the underlying weak paint of the graffito. In the northern vaults the white paint is widely covered by a green patina (Fig. 13a), while in the southern ones there are dark and blurred stains, which seem to be not simply due to the dissolution of black outlines of the graffito, since they are still sharp (Fig. 13b).

**Fig. 13** a) Green patina covering the white paint in the northern vaults; b) dark stains on the paint in the southern vaults (the pulverization of the white paint can be noticed).

The graffito arises challenging problems too, as it is constituted by water-based tempera paint, which is not fully compatible in terms of adhesion with the fiberglass substrate. Moreover, the condensation affecting the dome and its location in the middle of the fields caused the powdering of this water-sensitive paint and the growth of detrimental algae on the graffito (especially in the part exposed to north), threatening its conservation.

- pre-consolidation, cleaning and consolidation of the graffito, in order to preserve it during the subsequent phases. Given the nature of the materials (water-based paints applied over a smooth fiberglass substrate) and their deterioration (presence of algae, powdering and detachment of the paint from fiberglass), well-established cleaning and consolidation procedures for this specific case do not exist. Hence, it will be necessary to select the most suitable materials after some preliminary testing. The consolidant will be selected in order to improve the adhesion of the paint to the underlying fibreglass;

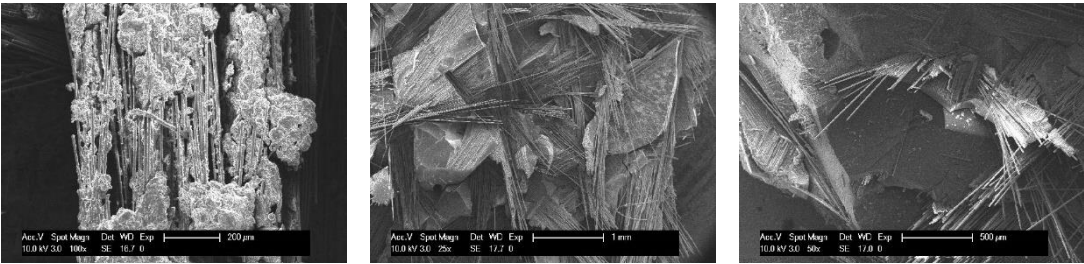
SEM images showed that the resin wrapping the fibres is not present anymore in many zones (Fig. 18, left). This erosion was mainly ascribed to the ageing of the polymer, likely due to hydrolysis, which consists in polymer bonds breaking due to prolonged exposure to water [57, 59, 66]. In the Woodpecker dome, this kind of degradation was exacerbated by the environmental conditions (see Section 4.2), involving a very high relative humidity all over the year, also combined with high precipitation during winter and high temperature during the summer season, which favoured hydrolysis. The direct and unsheltered exposure to solar radiation (and hence UV) and the presence of surrounding vegetation (providing O<sub>2</sub>) likely boosted the ageing of the resin. Once the resin layer started to deteriorate, the occurrence of freeze-thaw cycles and the presence of lichens keeping the surface moist for long time seem to have intensified the deterioration processes [57, 60, 68-71]. The arrangement of fibres, which is visible due to the lack of the matrix, confirmed that they are in the form of mat, as per preliminary hypothesis (Fig. 18, centre). The SEM image of the surface of a deteriorated fibreglass sample (Fig. 18, right) highlights the presence of a series of layers of matrix and mat, confirming that the vaults were manufactured by a hand layup process (see Section 4.1). Observing the fibres by SEM, no hair cracks were found (Fig. 19, left), despite the aggressiveness of environment where the dome is located, probably also thanks to the presence of the original protective coating (sizing) over the glass fibres [26-27, 55-56, 59]. The EDS analysis performed on a portion of the fibre surface not covered by the resin anymore (Fig. 19, centre) allowed to detect the presence of calcium (Ca) and the absence of sodium (Na) and potassium (K) (Fig. 19, right). Based on this, the mat was probably constituted by E-glass fibres [55-56], the most widespread type of fibres used in the production of fibreglass elements when the Woodpecker was built. Indeed, their low cost combined with good physical-chemical properties made these fibres attractive for several applications [26-27, 55-56, 59].

**Fig. 18** Fibreglass samples. On the left: SEM image of sample S4, affected by deterioration (marker = 200 μm). At the centre: SEM image of sample S5, affected by deterioration (marker = 1 mm). On the right: SEM image of sample S4 (marker = 500 μm).

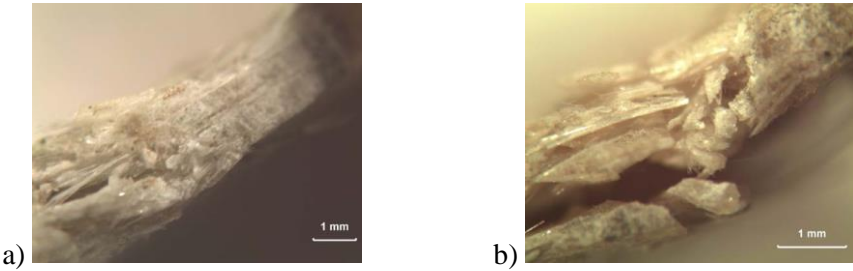
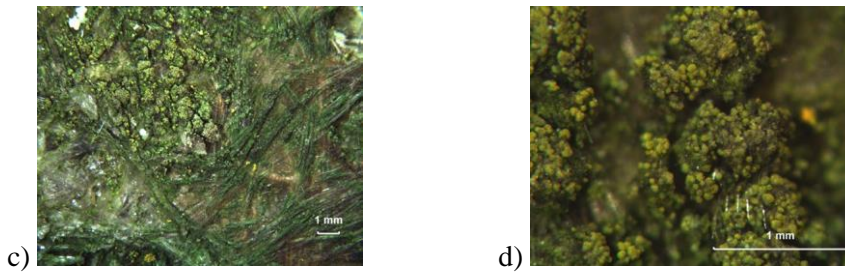
In Figs. 20a-b some significant SOM images of cross sections of a fibreglass sample are reported. A marked delamination, i.e., the separation of resin and mat layers, can be observed. This type of deterioration is detrimental, as it hinders a correct stress transmission within the composite material and compromises its mechanical performance. This loss of adhesion between the matrix and the reinforcement may be due to the breaking of strong bonds formed during reticulation process between the polymer matrix and the fibres sizing [26, 55, 59]. This deterioration can be accelerated by the presence of moisture at the interface, and by microbial decomposition of the sizing chemicals [55-56, 59, 66, 69, 72], although in this study no specific investigation on the nature of the adhesion mechanism (chemical or physical) and sizing was conducted.

In Figs. 20c-d, SOM images of the external surface of the fibreglass of the dome are reported. The fibre mat, which emerged due to the resin decay, became an optimum rough base for the growth of

**Fig. 20** SOM images of: a-b) cross sections of fibreglass sample S7, affected by delamination (marker = 1 mm); c) external surface of the fibreglass sample S4, with lichens growing on the mat (marker = 1 mm); and d) a detail of the lichens in c) (marker = 1 mm).

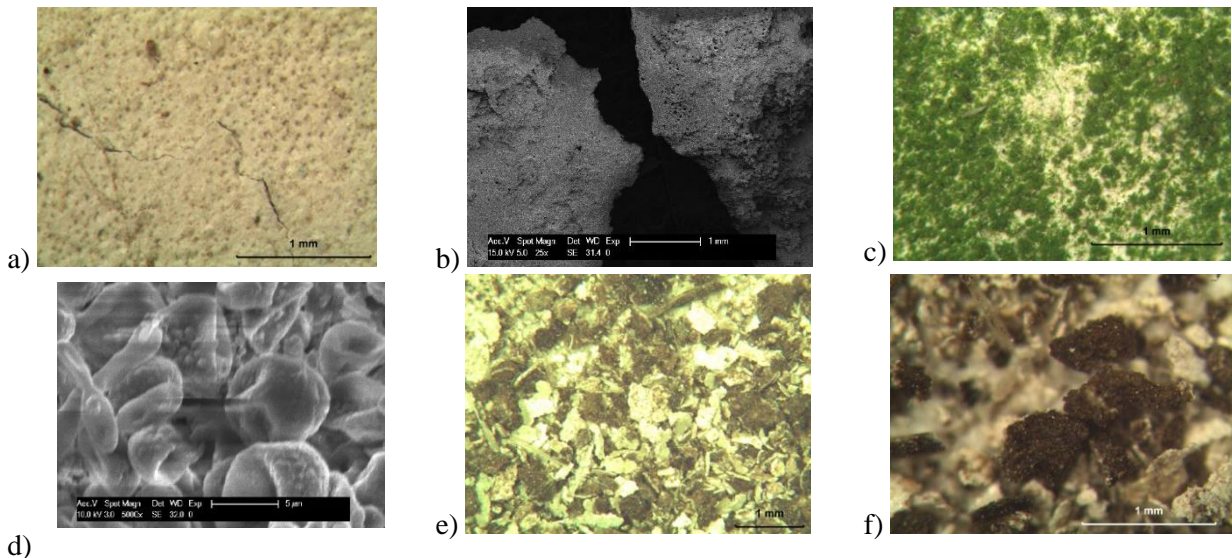
The materials of the graffito were characterized too. The surface of the white paint, observed by SOM, exhibited many pits and crevices (Fig. 21a) and the same paint, observed by SEM (Fig. 21b, sample on the right), revealed a microporous nature, which suggests that water was used as medium and the organic binder in the paint was in a low amount. Hence, it was concluded that Blu used a water-based paint [79] (tempera paint, probably), and the pits and crevices probably resulted from the evaporation of water and the shrinkage of the binder, respectively. The EDS analysis performed on the same sample (not reported here for brevity sake) supported this conclusion, as calcium, oxygen, carbon and silicon were the main elements found, together with a minor amount of titanium. This is compatible with the presence of an organic binder in the paint, with calcite and quartz as fillers and  $\text{TiO}_2$  as white pigment, the latter being typically used in water-based paints [80-81]. Given its nature, this paint can be expected to be not so compatible in terms of adhesion with the smooth and non-porous fibreglass substrate, and this certainly jeopardized the durability of the graffito. Moreover, tempera paint is water-sensitive and hence vulnerable to dry-wet cycles of moisture condensation, likely caused by the high relative humidity of the environment (see Section 4.2). The low adhesion to the substrate and the water-sensitivity of the paint caused the powdering phenomenon observed [82]. Notably, in the years when the graffito was painted, Blu was reported to change his painting technique from spray to brushing [29], and this can be ascribed to the use of water-based paints.

The surface of the black paint, observed by SOM and SEM, exhibited a more compact and homogeneous aspect than the white one (Fig. 21b, sample on the left), also because in the sample observed the black layer was applied onto the white paint. According to EDS analysis, the black paint is similar in nature to the white one, but obviously different for the pigment, as confirmed by the presence of iron (Fe) instead of titanium (Ti) [81, 83].

The SOM images of the green deposit over the white paint (Fig. 21c) and even more the SEM analysis (Fig. 21d) showed that this deposit is composed of microorganisms, which could be classified as algae, again connected to the possible moisture condensation occurring in north orientation. The almost exclusive presence of C and O found by EDS in this samples confirmed the biological nature of the patina. Also the solid dark brown powder found on the paint appears as a biological deposit, as shown by SOM images (Figs. 21e-f). Further investigations are running to characterize both deposits

**Fig. 21** a) SOM image of the white paint (sample S8), with pits and crevices (marker = 1 mm); b) SEM image with the white paint (sample S8) on the right and the black paint (sample S9) on the left (marker = 1 mm); c) SOM image of the white paint covered by the green patina (sample S10) (marker = 1 mm); d) SEM image of the green patina, composed of microorganisms (sample S11) (marker = 5 µm); e-f) SOM images of the powder that constitutes dark soiling (samples S12 and S13, respectively) (marker = 1 mm), where a substantial difference between white pieces (belonging to the paint) and dark pieces (belonging to the deposit) can be observed.
