The problem of conservation of XX century architectural heritage: The fibreglass dome of the Woodpecker dance club in Milano Marittima (Italy)

The problem of conservation of XX Century architectural heritage: the fibreglass dome of the Woodpecker dance club in Milano Marittima (Italy)

Abstract

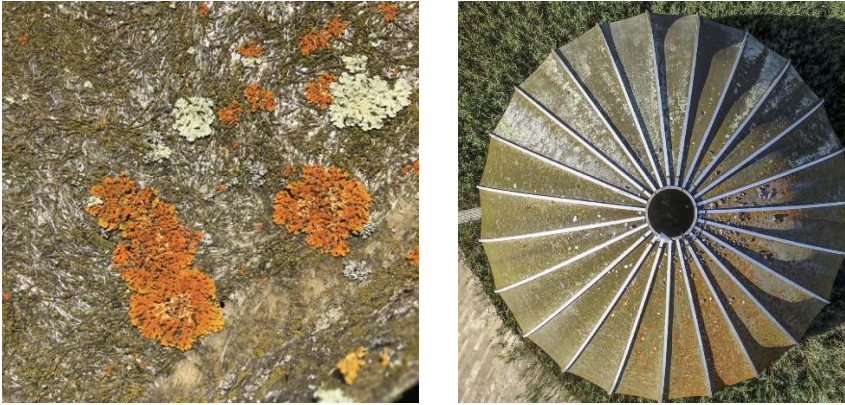
Fig. 10 Lichens on the external surface of the dome. On the left: emerging mat and differences between lichens. On the right: north-oriented zenith view of the dome, where lichens of different colours depending on the orientation can be seen (the photo was taken through the drone described in § 3.1).

various species of lichens, which actually cover most of the surface. These lichens probably caused an additional loss of resin, due to their metabolic processes. This biodeterioration includes a series of chemical and physical-mechanical actions onto the polymeric substrate, such as the leaching of some chemical compounds (fragments of polymeric chains, as well as additives) used as nutrients, the secretion of aggressive substances (e.g., acids and enzymes), the penetration and growth by hyphae, and the blistering due to gas evolution [57, 72-78].

- repair of the external fiberglass surface, according to the following steps: cleaning, by removal of lichens and deteriorated fibreglass parts; application of a new layer of unsaturated polyester resin (and additional layers of fibre mat, if necessary) up to obtaining a smooth surface and a uniform thickness;

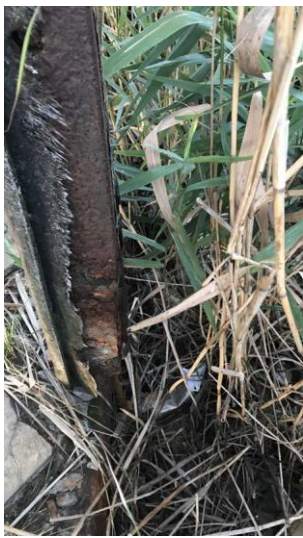
- The fibreglass layer that originally wrapped the steel framework is currently totally or partially absent in the low, periodically immersed, zone, due to deterioration. In some cases, the edge is sharp, while in other cases it is frayed due to the matrix decay. This kind of decay probably started in correspondence of the cross bolts (Fig. 11a).

Fig. 11 a) Deterioration of the fibreglass layer that initially wrapped metallic tubes; b) corrosion of metallic framework near the base (two joined flanked tubes and their connection to the basement can be seen); c) rising of the level of ground water during the rainiest periods (courtesy of Antonello Zoffoli).

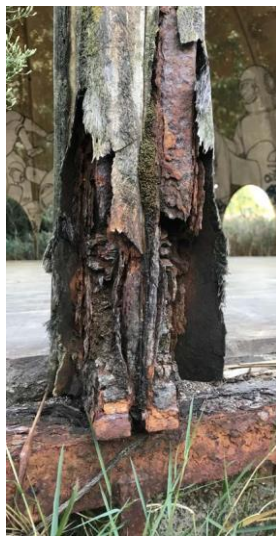
b)

- The tubular steel profiles exhibit an impressive corrosion at the bottom, where, in addition to the lack of the fibreglass layer, they are immersed in ground water for some months a year (Fig. 11c). In some locations, they are in such bad conditions that it is possible to manually remove corroded flakes and entire portions of them are even lacking near the joints to the basement (Fig. 11b). Although the steel elements are not visible in the upper part of the dome, corrosion probably affects the whole metallic framework, as suggested by the presence of some rust leakages in the internal surface of the dome, along the joints between vaults.

- the use of carbon steel was not compatible with the periodic immersion of the base of the dome in brackish water (approximately from autumn to spring) and the high amount of chloride caused the perforation of the steel elements, which are now almost completely corroded at the basis. The original wrapping of the steel elements with fiberglass was obviously not enough for protecting steel from corrosion and it is even counterproductive, as it presently hinders the inspection of the corrosion state of the steel tubular elements.

- application of new stainless steel arches suitable for marine environment (e.g., AISI 316), in substitution of the existing steel frame. The entire substitution of the metal structure is expected to be cheaper and to prevent any galvanic corrosion deriving from the joining of two different kinds of steel. This substitution will also allow to calculate the new steel frame according to current regulations and to possibly increase the section and/or thickness of the steel tubes, if necessary. In fact, after the application of the stainless steel elements, they will

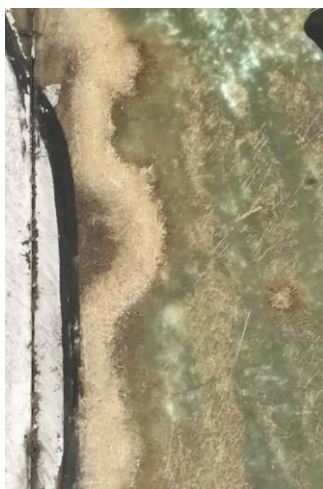
- In some areas of the dome intrados, fibres emerge, having the appearance of a scratched surface or of crust on the fibreglass, depending on the level of deterioration (Fig. 12a). Several local bulges can be observed too, similar to small craters surrounded by radial hair cracks. In some of these bulges the inner layers are exposed to the environment (Fig. 12b).

Fig. 12 a) Fibers emerging from fibreglass inside the dome; b) local bulge on the internal surface of the dome.

- repair of the internal fiberglass surface where graffito is not present, according to the following steps: removal of powdering and/or detached parts, cleaning and repair of the defects in the fiberglass with unsaturated polyester resin;
