# **Collapse and damage to vernacular buildings induced by 2012 Emilia earthquakes**

Bovo Marco<sup>1,\*</sup>, Barbaresi Alberto<sup>1</sup>, Torreggiani Daniele<sup>1</sup> and Tassinari Patrizia<sup>1</sup>

## **Abstract**

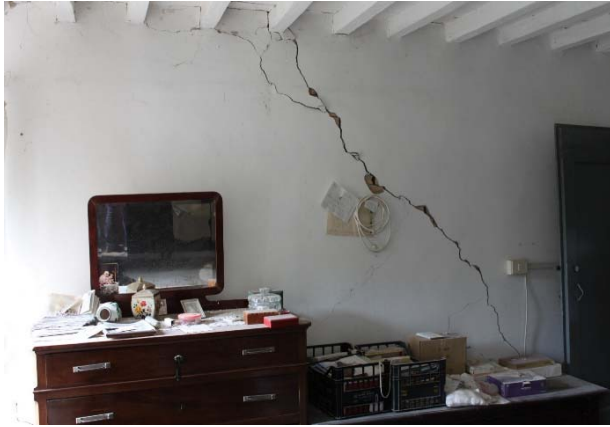
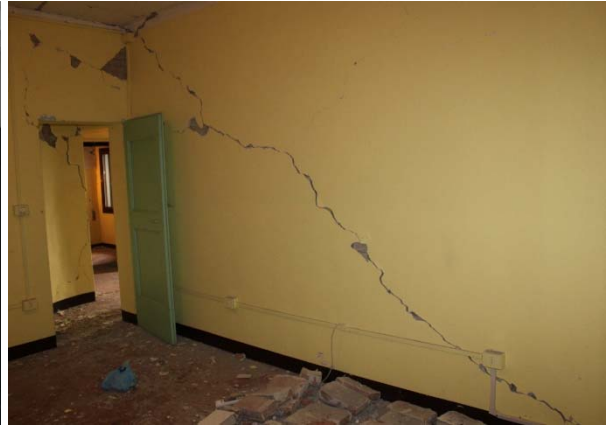
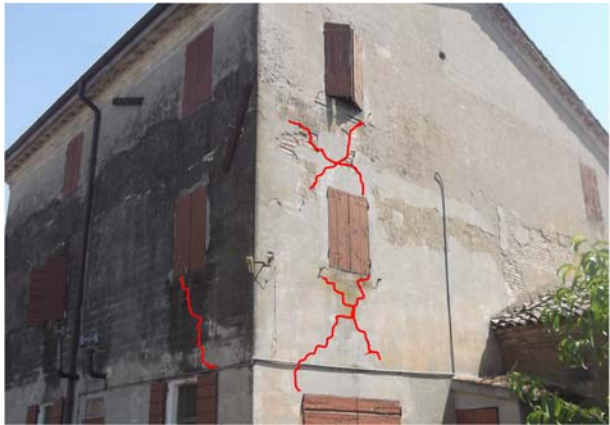
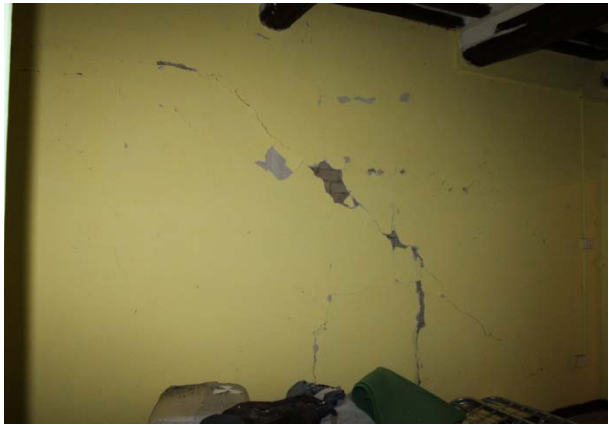
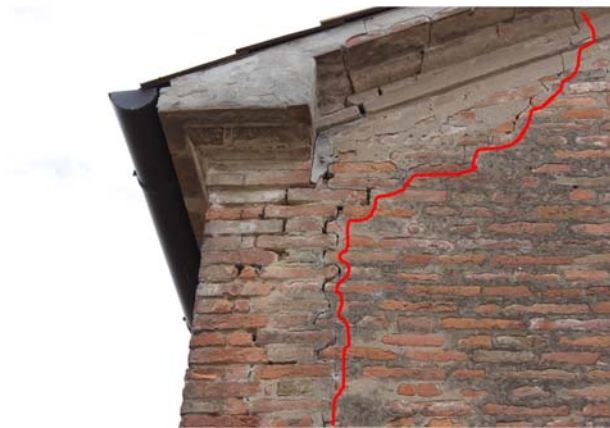
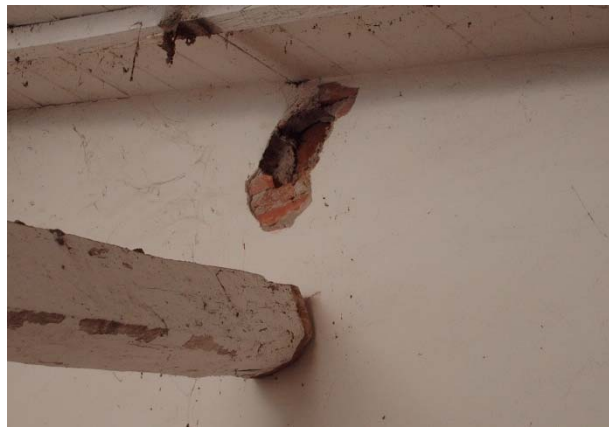
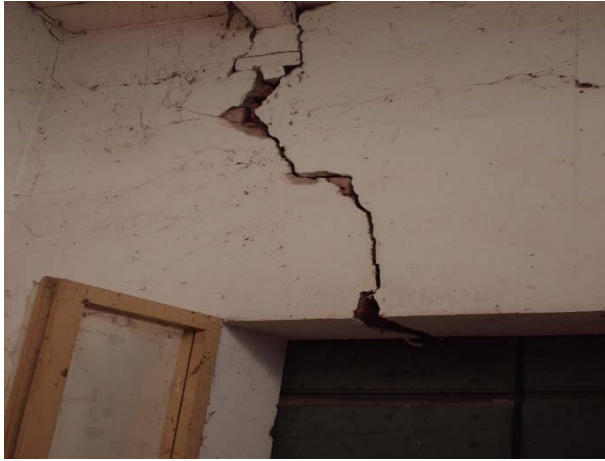
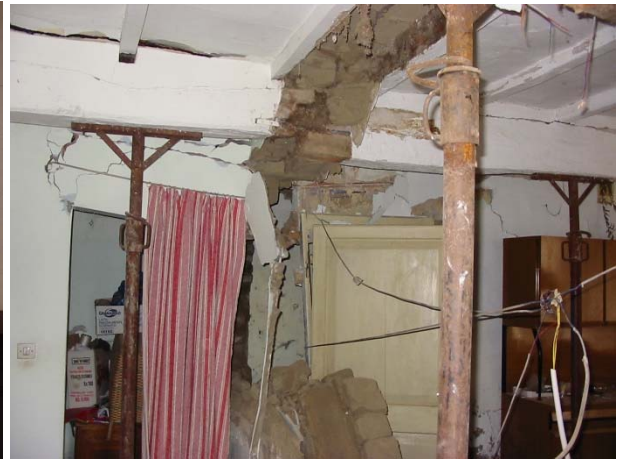
The damage observed for buildings in category A1 (isolated dwellings) are typically mode II mechanisms (i.e. mechanism in the wall plane [38]) to bearing and partition walls, as depicted in Figure 9a-b. Due to limited length and height compared to thickness, the mode I failure wall mechanisms (i.e. out-of-plane overturning, horizontal and vertical out-of-plane flexure) were not observed, even if the connections between orthogonal walls are in general very poor, as showed by the cracks in Figure 9c. Most of the damage must be attributed to the poor material properties of the masonry [15], realized in many cases with irregular texture and poor strength mortar [13]. Moreover, the floor-wall connection is rather lacking since in many cases, it was observed the sliding of beams from the masonry walls (see Figure 7b), or even the failure, due to loss of support, as documented in Figure 9d. In few cases, also failure of lintels (see Figure 9e) or masonry arches (Figure 9f) have been observed, typically involving permanent settlements to the horizontal structures of the floors.

Figure 9. Main damage to building category A1. Example of in-plane damage induced by seismic force on (a) partition walls (bldgs. #2 and #3) and (b) bearing walls (bldgs. #6 and #3); (c) Cracking of corner between two orthogonal masonry walls (bldg. #1); (d) Loss of support of a wood beams from the masonry walls (bldg. #2); (e) View of a lintel failed and (f) arch collapse (bldg. #20).

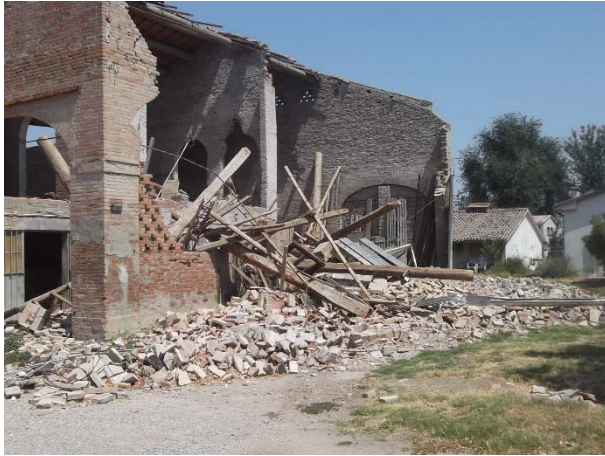
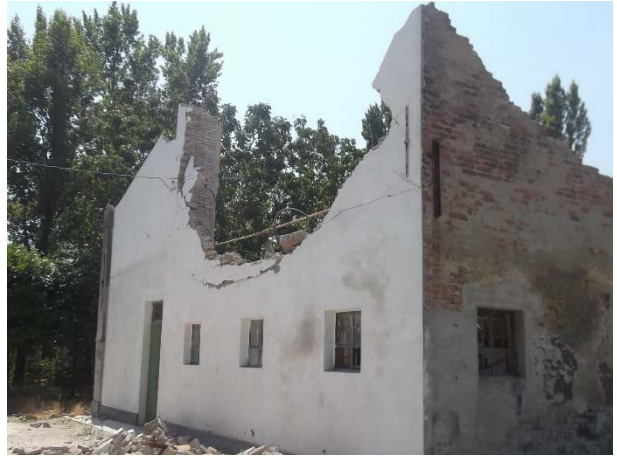
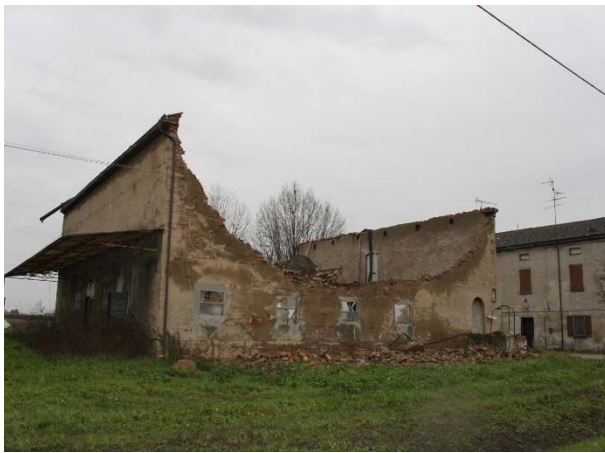
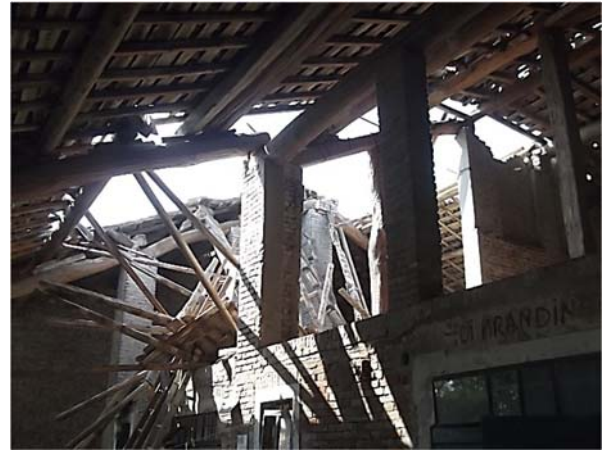
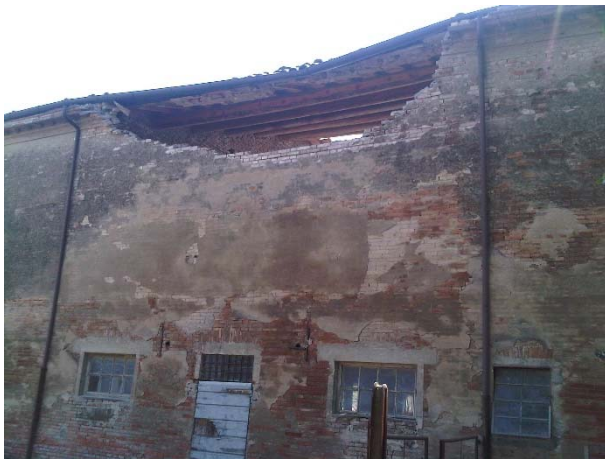
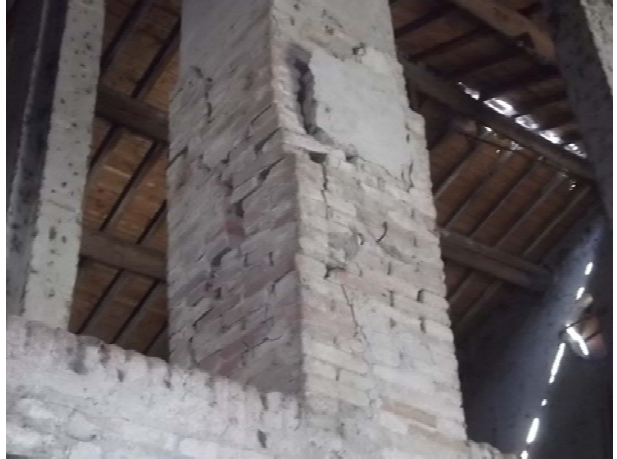
Several damage affected the A2 category of the stable-hayloft buildings. In fact, many collapses or severe damage and consequent building demolition were detected for this category. The typical structural physiognomy makes the stable-hayloft extremely vulnerable to seismic actions. In fact, in general they are very asymmetric, due to the irregular wall layout; they have a flexible roof at the top and very slender vertical elements. The principal causes of stable-haylofts collapse are to ascribe to overturning of walls and vertical and horizontal out-of-plane flexure mechanisms. A catastrophic example of collapse for overturning, involving a whole façade from foundations to roof, is reported in Figure 10a. A similar scenario is showed in Figure 10b, but in this case, the out-of-plane flexure collapse anticipated the overturning façade because of the

presence of some steel ties. Figure 10c shows the global collapse for horizontal flexure local mechanisms of another traditional stable-hayloft for out-of-plane horizontal flexure mechanism. Even if the behaviour of an existing masonry building subjected to moderate-strong earthquake is almost certainly nonlinear, the analysis of the elastic vibration modes of the structure could provide interesting information before severe damage or collapses occur [39]. As found in a wide literature review (see for example [40]-[43]), linear dynamic analysis of large masonry structures is always performed, prior to the application of more sophisticated approaches. In fact, linear analysis allows a quick preliminary assessment of the adequacy of the structural models before constructing more detailed models or local models of critical parts to be studied separately by means of more complex analyses [44]. In order to better understand the dynamic behaviour of a typical building of this category, the elastic finite element model (FEM) of the stable-hayloft showed in Figure 8, collapsed during the event of the May 29<sup>th</sup>, was realized. The global FEM is showed in Figure 11(a1). The walls in the FEM were modelled by means of 4-node Lagrangian shell elements. The masonry columns with elastic beams. For the masonry, elastic properties were selected the average values provided in [15] and obtained by the experimental in-situ tests. They were a Young modulus  $E=2.6\text{GPa}$  and a Poisson ratio  $\nu=0.25$ . The rigid floor of the stable area has been realized by introducing a 5cm thick RC slab (measured during on-field survey). The model was clamped at the base. As far as the roof is concerned, beam finite elements were introduced in order to model the structural wooden members accurately considering the flexible behaviour of the roof diaphragm. The elements have the cross-section dimensions detected during the building survey and an elastic modulus  $E= 8\text{GPa}$ , typical for wood classes in the investigated region, was considered. The wooden elements were considered pinned-pinned at their extremities.

As the distance from the epicentre region increased, generally vertical walls did not collapse but the buildings reported severe damage to roof elements and, in some cases, the main wooden beams fell down. This can be probably attributed to beam-wall relative displacement, causing unseating and loss of support of horizontal elements. In fact, due to the building asymmetry, introduced e.g. by non-regular infills, non-symmetric walls, presence of portico and stable, two different vertical elements could vibrate in asynchronous way, by imposing at the extremities of horizontal beams, tensile force bigger than friction force and able to activate the sliding mechanism. This particular situation is showed in Figure 10d, with pitched-roof collapsed without any apparent damage to the vertical elements.

As already detected during the aftermath surveys on historical masonry buildings [46], the unrestrained forces of the beams of a deformable pitched-roof, excited by the ground motion component in the plane of the beams, can cause the overturning of a limited portion of masonry panels close to the roof. This local damage mechanism, typical of historical churches [47], has been detected in few cases also for historical stable-hayloft as depicted for instance in Figure 10e. In some cases (one of them is reported in Figure 10f) the slender columns bearing the hayloft roof reported severe damage conditions in the proximity of their base (i.e. the roof of the stable), because the horizontal seismic displacements at the building roof imposed a considerable rotation at the base-section where they are clamped, originating an uncommon “plastic hinge”. The principal causes of collapse of this building category has to be ascribed to the high slenderness of the vertical walls or columns, coupled to the absence of a rigid floor diaphragm able to prevent the relative settlements between different vertical elements and avoid the sliding of roof beams from their seat. In some cases, the presence of steel ties avoids the overturning of the walls, but these devices were not sufficient to avoid the above-described catastrophic scenario.

Figure 10. Main damage to building group A2. Example of catastrophic stable-hayloft collapses for (a) overturning of the façade (bldg. #1), (b) out-of-plane vertical flexure (bldg. #18), and (c) horizontal flexure mechanism (bldg. #10). (d) Loss of support of the roof beams for the excessive deformations of the building (bldg. #4). (e) Overturning of a limited portion of masonry panels for the horizontal force transmitted by the beam elements of a flexible roof (bldg. #1). (f) Severe damage on a slender masonry column (bldg. #4).

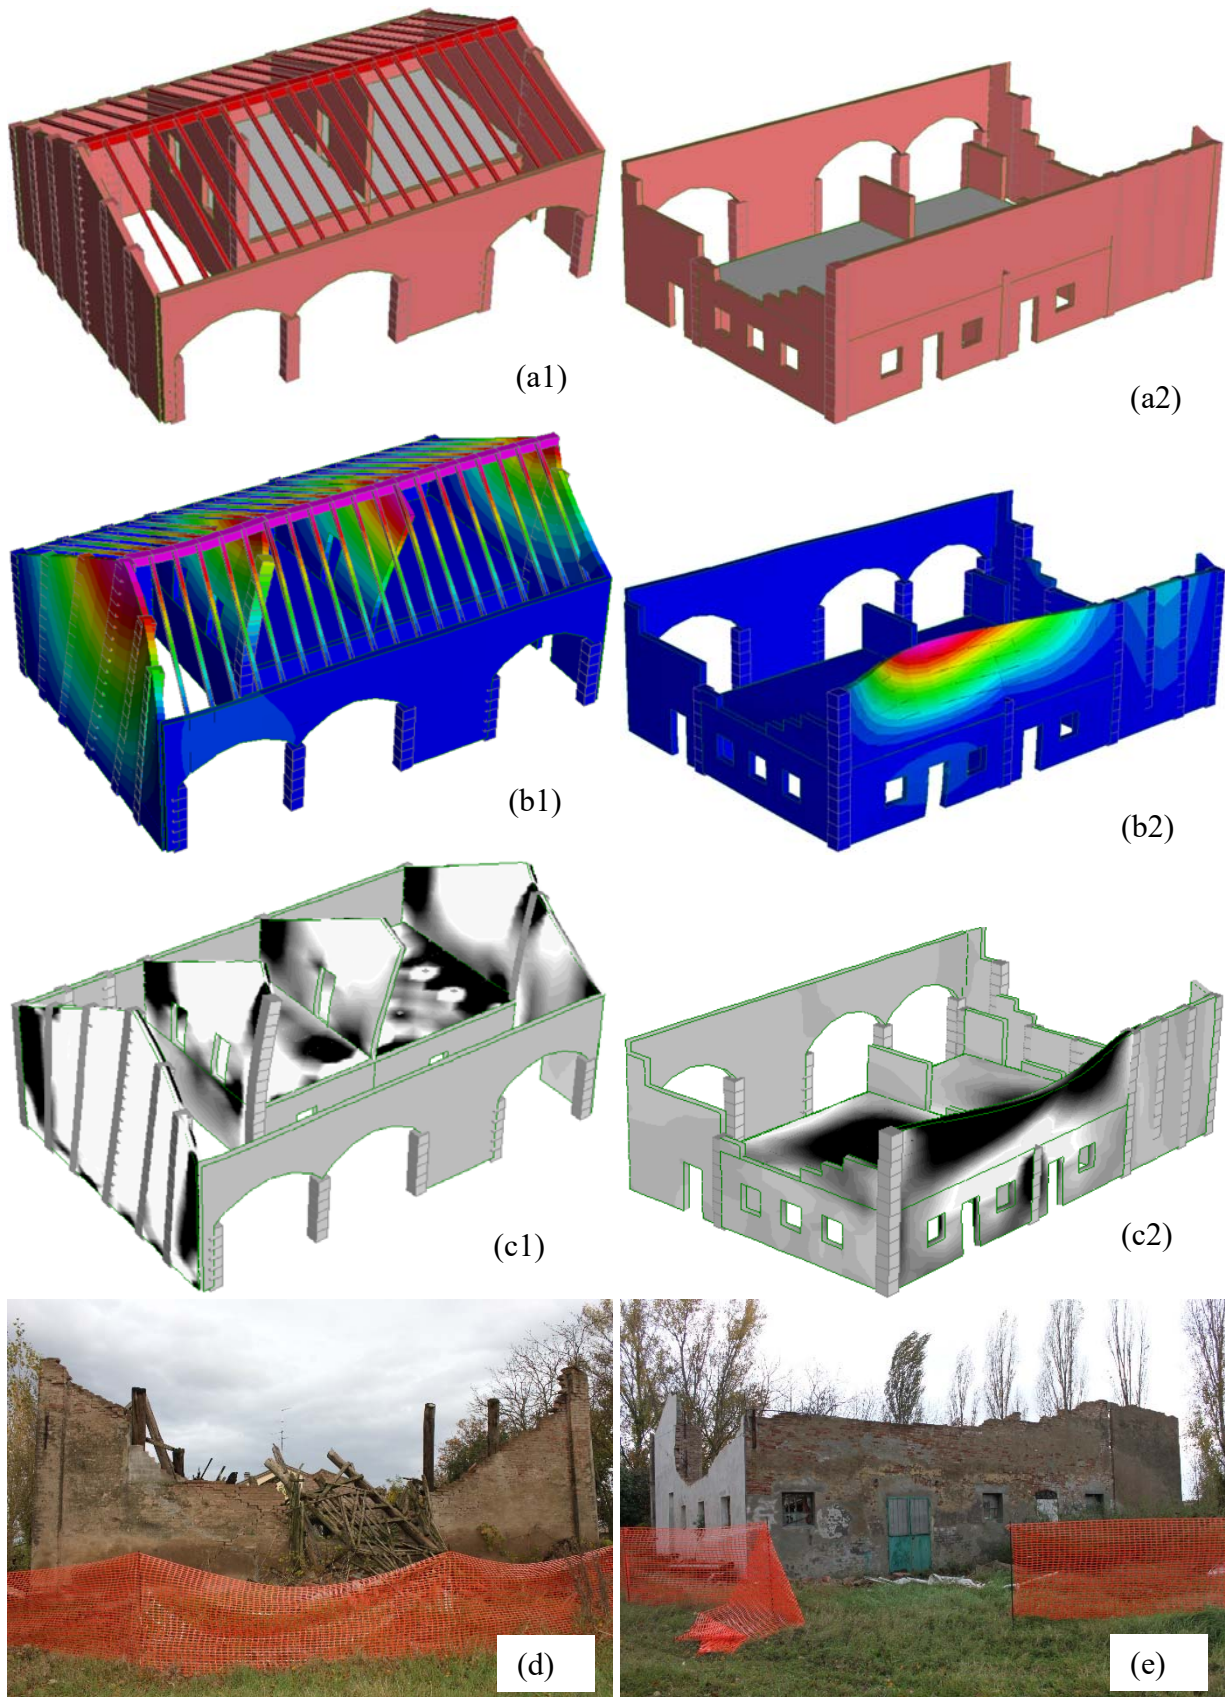
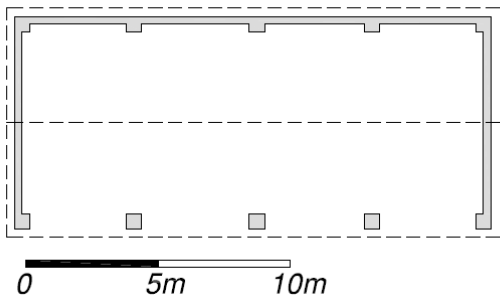
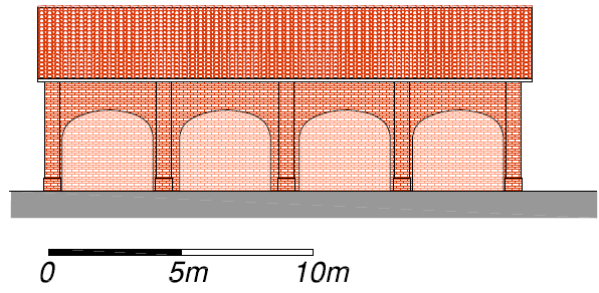
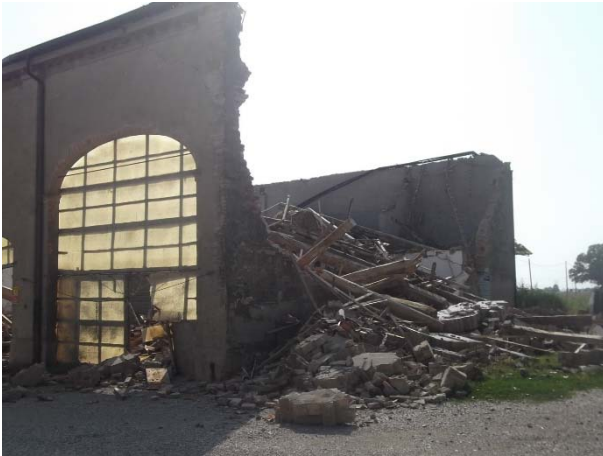
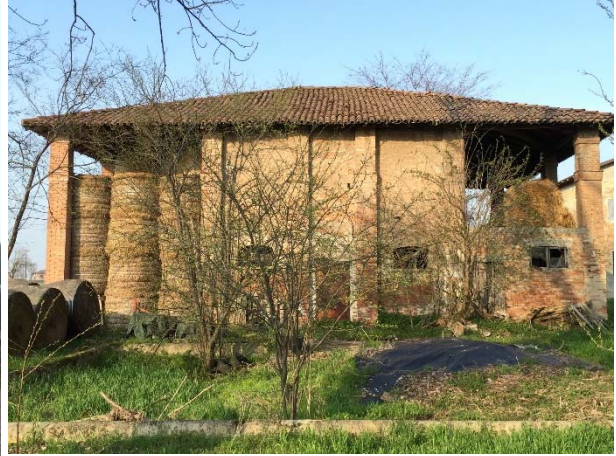
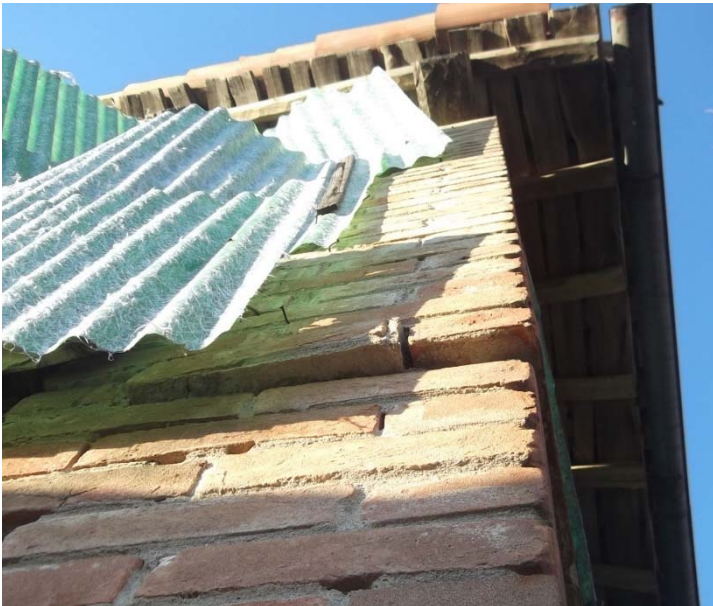
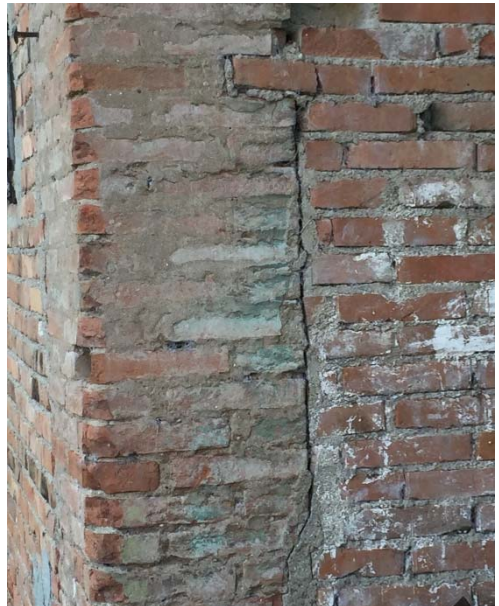
Due to reduced thickness, if compared to the other dimensions, the hinge restraint hypothesis may appear suitable for most of the structures in the categories A2 and A3. By means of the analysis of the displacements map of structures with first vibrating period around 1s, as the “barchessa” investigated here, the evaluation of the maximum displacements suffered during the event of May 29<sup>th</sup> provides values larger than 10cm for an epicentre distance of 15-20km (see Figure 5b2). This high seismic displacement demand could explain the overturning mechanisms observed in slender buildings, since in several cases it produced the exit of the vertical loads resultant from the wall base section.

The “casella” building, shown in Figure 12d, was modified from its original configuration over the years: the transverse (i.e. the shorter) façades were infilled by brickwork walls poorly connected to original corner columns, and an intermediate stiff floor was added. In this building, conversely to the “barchessa” response, the contemporary presence of strong asymmetry (for the presence of perimeter walls just on three out of four façades) and stiff intermediate floor probably magnified the torsion effects. In fact, Figure 12e shows the most important seismic-induced damage to the columns caused by the asymmetric behaviour of the building. Maybe due to torsion effects, the corner columns were literally cut at the level of the intermediate floor, and the residual settlements (of 2-3cm) highlighted in Figure 12e support this hypothesis. Furthermore, the lack of corner column-infill walls connections produced the detachment of the

walls during the seismic events (see Figure 12f). The structure was demolished few months after the earthquake since was judged not repairable. The different dynamic response between the two buildings and the main reasons of their severe damage could have been completely different, but the consequences were catastrophic in both the buildings. In the hope of the authors, the indications emerging from this lesson learned would be of help to define the most suitable strengthening interventions for still standing buildings of the same category, which represent an important cultural heritage of that region.

Figure 12. Main damage to buildings of category A3. (a) Plan view, (b) lateral view and (c) collapse scenario of a “barchessa” building (bldg. #22); (d) Lateral view of a “casella” (bldg. #11) with details of severe damage to (e) masonry columns due to excessive shear force imposed by torsion and (f) infill walls for detachment from the bearing columns.

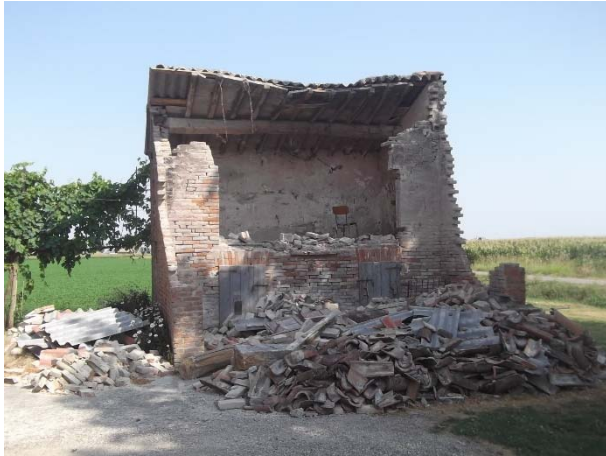
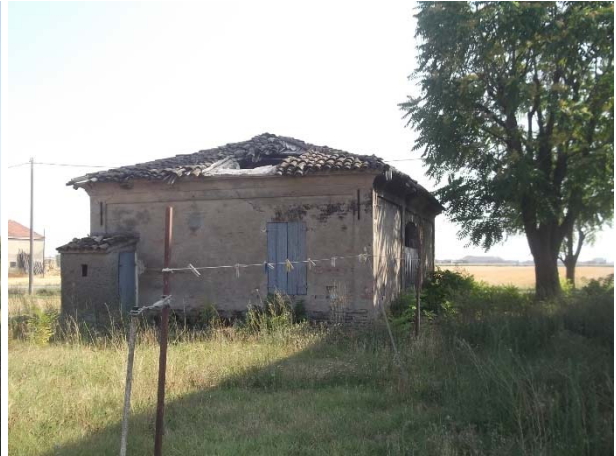
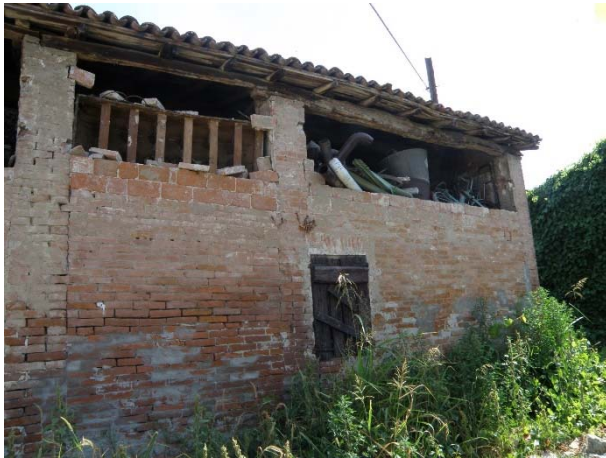
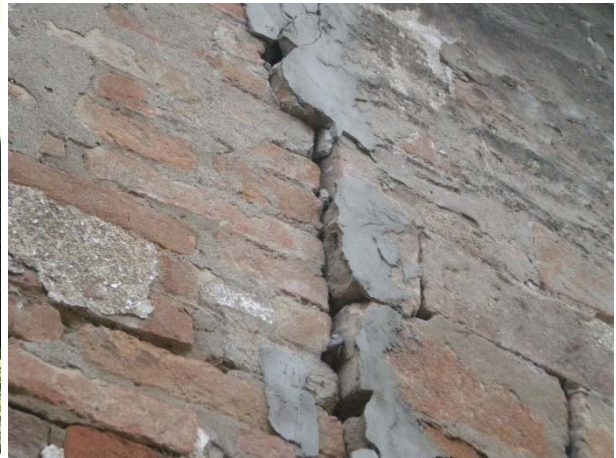
The typical damage to building category A4 are very similar to those observed for residential rural buildings of category A1, due to comparable geometries, but with amplified outcomes due to the poorer materials and construction techniques. In fact, as depicted for example in Figure 15a with regard to warehouse #14, the collapse of roof elements is one of the most recurring mechanisms, together with the in-plane failure of walls. Then, in many cases, the overturning of the infill panels non-adequately connected to vertical masonry columns was observed. An example is reported in Figure 15b. It shows a particular case of masonry infill collapse, where the bricks closing off the original openings were laid in their own plane, creating a panel extremely vulnerable to out-of-plane actions.

Figure 15. Main damage to buildings of category A4. Example of (a1-a2) structure collapse with loss of support of the roof structures (bldg. #21 and #14) and (b) overturning of masonry infill walls due to the erroneous arrangement of the bricks (bldg. #17). Picture (b2) shows the activation of the overturning mechanism but with no fall of the panel.

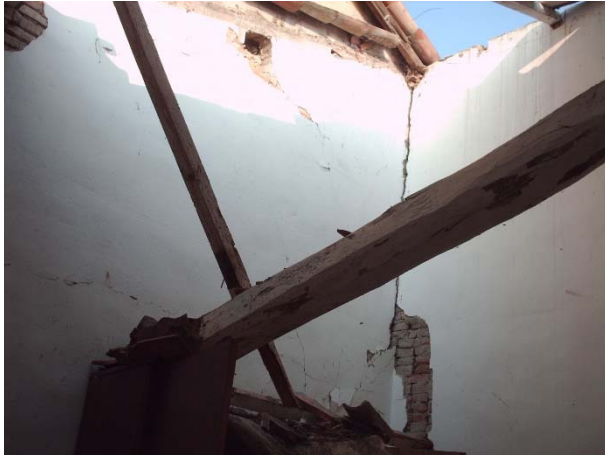
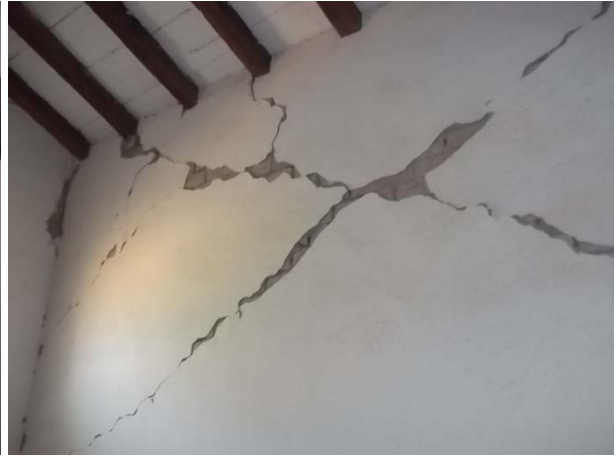
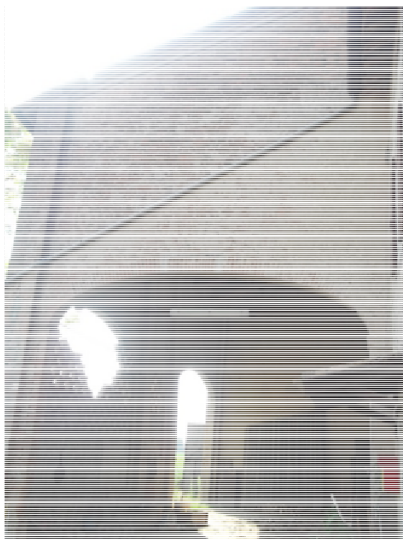
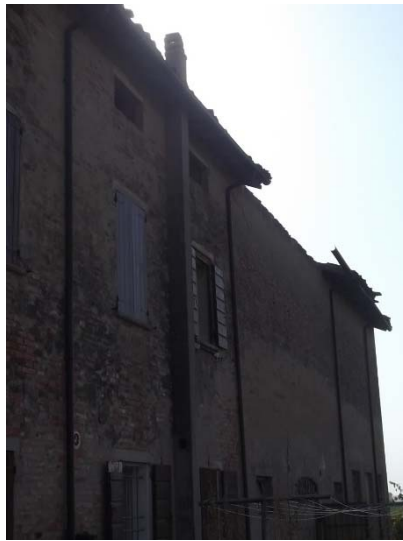
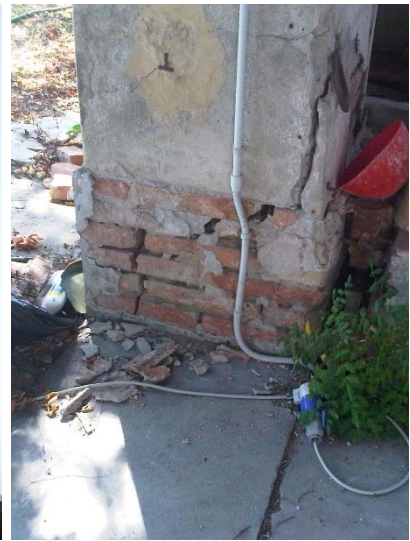
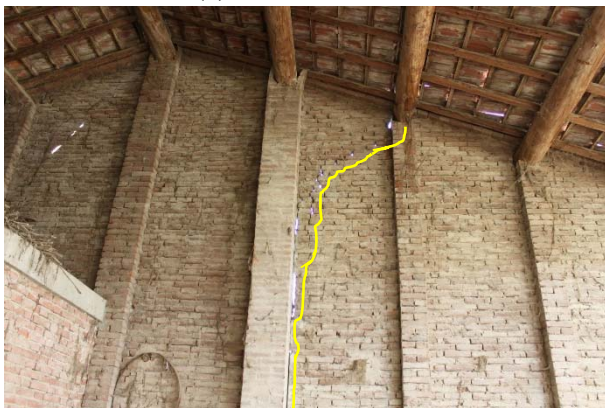
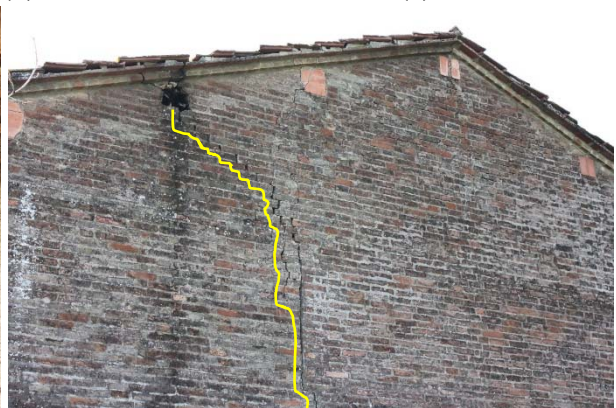
With reference to composed buildings (labelled as category B in this paper), it is worth to note that damage mechanisms observed during on-field inspections are very similar to those observed in isolated buildings, and the collapses can probably be ascribed to analogous causes. Moreover, few additional damage sources, to be attributed to the interaction between adjacent bodies, must be considered. In fact, due to the different use, the interacting bodies have often different storey level, inner height and wall slenderness, especially for building in category B1-2, mainly damaged by the 2012 earthquakes. As a result, in several situations, sliding and fall of roof beams (see Figure 16a), corner opening between non-properly connected orthogonal walls (see Figure 16b) were observed. Despite their slenderness (if measured on the hayloft side), sometimes the intermediate transverse walls reported X-shape cracks or bricks sliding typical of shear damage mechanism and did not collapse in local way because of the restraint guaranteed by intermediate storey on the other (i.e. home) side.

Among the observed seismic damage, it is worth to note those to non-structural elements. The failure or fall of these elements, even if non-responsible of building collapse, can represent a serious risk for people inside or nearby the building. In Figure 16c and d two typical examples are shown. The first is related to the failure of non-structural ornamental elements, like the “gelosie” (Figure 16c), holed infill walls typical of Northern Italy. The second refers to perimeter masonry cornice (Figure 16d), typically built with good external texture masonry, internally infilled by waste material with poor mechanical strength. Lastly, as mentioned above, in rural buildings it is not unusual to find porticos and wooden sheds commonly supported by thin masonry pillars. After the seismic events, some columns displayed cracking and damage at the base due to the large curvature prescribed in proximity of their connection to foundation elements. A typical crack pattern of the base portion is showed in Figure 16e. It is evident that the column base-section results partially no-longer working since it is detached by foundation plinth.

Figure 16. Detail of damage to category B buildings and non-structural elements. (a) Fall of timber roof beams from the intermediate wall in the composed bldg. # 8. (b) Shear cracks on a wall (bldg. #8). (c) Failure of “gelosie”, typical holed infill walls (bldg. #5). (d) Fall of a portion of the perimeter masonry cornice (bldg. #5). (e) Cracking at the base of a masonry column portico (bldg. #7); (f) Internal and (g) external view of the detachment of the infill panels from the bearing columns due to a poor connection (bldg. #12).
