The problem of conservation of XX Century architectural heritage: the fibreglass dome of the Woodpecker dance club in Milano Marittima (Italy)

Abstract

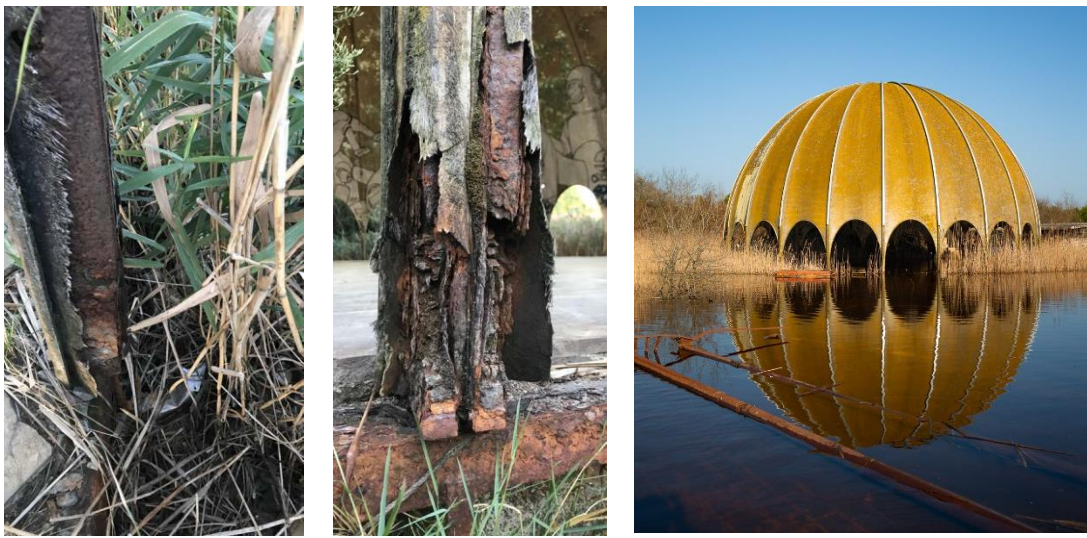
- The fibreglass layer that originally wrapped the steel framework is currently totally or partially absent in the low, periodically immersed, zone, due to deterioration. In some cases, the edge is sharp, while in other cases it is frayed due to the matrix decay. This kind of decay probably started in correspondence of the cross bolts (Fig. 11a).

- The tubular steel profiles exhibit an impressive corrosion at the bottom, where, in addition to the lack of the fibreglass layer, they are immersed in ground water for some months a year (Fig. 11c). In some locations, they are in such bad conditions that it is possible to manually remove corroded flakes and entire portions of them are even lacking near the joints to the basement (Fig. 11b). Although the steel elements are not visible in the upper part of the dome, corrosion probably affects the whole metallic framework, as suggested by the presence of some rust leakages in the internal surface of the dome, along the joints between vaults.

Fig. 11 a) Deterioration of the fibreglass layer that initially wrapped metallic tubes; b) corrosion of metallic framework near the base (two joined flanked tubes and their connection to the basement can be seen); c) rising of the level of ground water during the rainiest periods (courtesy of Antonello Zoffoli).

- the use of carbon steel was not compatible with the periodic immersion of the base of the dome in brackish water (approximately from autumn to spring) and the high amount of chloride caused the perforation of the steel elements, which are now almost completely corroded at the basis. The original wrapping of the steel elements with fiberglass was obviously not enough for protecting steel from corrosion and it is even counterproductive, as it presently hinders the inspection of the corrosion state of the steel tubular elements.

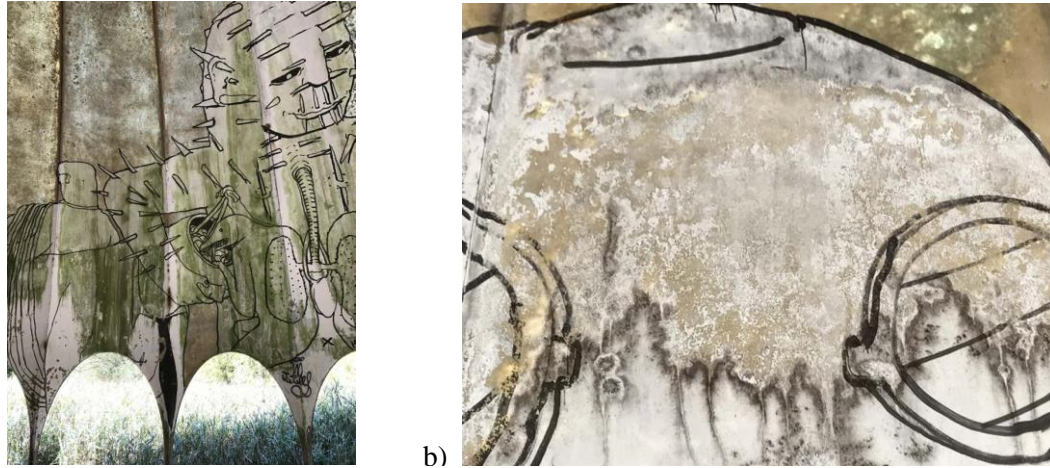
- The graffiti by Blu is affected by several deterioration patterns. In the lowest zone it was vandalized by many writings. Up to about 2 meters in height, the paint tends to peel very easily, especially in correspondence of the vandal writings, while in other zones the paint tends to pulverize diffusely. In particular, the spray-painting used for the vandal writings seems directly responsible for the deterioration of the graffiti, due to the incompatibility of the two overlapped layers. Indeed, the organic solvents employed in the spray paint dissolved the polymeric binder of the graffiti underneath. Moreover, the fast drying of the writings usually involves a strong shrinkage that breaks the underlying weak paint of the graffiti. In the northern vaults the white paint is widely covered by a green patina (Fig. 13a), while in the southern ones there are dark and blurred stains, which seem to be not simply due to the dissolution of black outlines of the graffiti, since they are still sharp (Fig. 13b).

Fig. 13 a) Green patina covering the white paint in the northern vaults; b) dark stains on the paint in the southern vaults (the pulverization of the white paint can be noticed).

The graffiti arises challenging problems too, as it is constituted by water-based tempera paint, which is not fully compatible in terms of adhesion with the fiberglass substrate. Moreover, the condensation affecting the dome and its location in the middle of the fields caused the powdering of this water-sensitive paint and the growth of detrimental algae on the graffiti (especially in the part exposed to north), threatening its conservation.

- pre-consolidation, cleaning and consolidation of the graffito, in order to preserve it during the subsequent phases. Given the nature of the materials (water-based paints applied over a smooth fiberglass substrate) and their deterioration (presence of algae, powdering and detachment of the paint from fiberglass), well-established cleaning and consolidation procedures for this specific case do not exist. Hence, it will be necessary to select the most suitable materials after some preliminary testing. The consolidant will be selected in order to improve the adhesion of the paint to the underlying fibreglass;

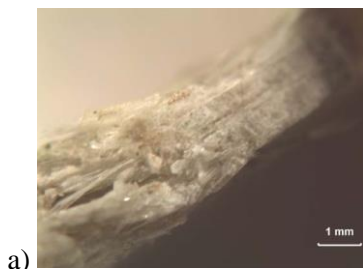
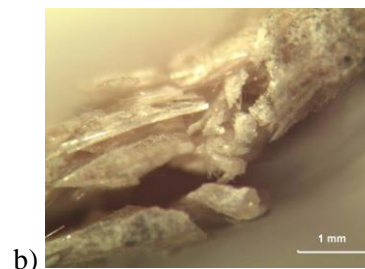
In Figs. 20a-b some significant SOM images of cross sections of a fibreglass sample are reported. A marked delamination, i.e., the separation of resin and mat layers, can be observed. This type of deterioration is detrimental, as it hinders a correct stress transmission within the composite material and compromises its mechanical performance. This loss of adhesion between the matrix and the reinforcement may be due to the breaking of strong bonds formed during reticulation process between the polymer matrix and the fibres sizing [26, 55, 59]. This deterioration can be accelerated by the presence of moisture at the interface, and by microbial decomposition of the sizing chemicals [55-56, 59, 66, 69, 72], although in this study no specific investigation on the nature of the adhesion mechanism (chemical or physical) and sizing was conducted.

In Figs. 20c-d, SOM images of the external surface of the fibreglass of the dome are reported. The fibre mat, which emerged due to the resin decay, became an optimum rough base for the growth of

Fig. 20 SOM images of: a-b) cross sections of fiberglass sample S7, affected by delamination (marker = 1 mm); c) external surface of the fiberglass sample S4, with lichens growing on the mat (marker = 1 mm); and d) a detail of the lichens in c) (marker = 1 mm).
