# An Approach to Risk Assessment and Planned Preventative Maintenance of Cultural Heritage: The Case of the Hypogeum Archaeological Site of Sigismund Street (Rimini, Italy)

This study presents a comprehensive approach to risk management and planned preventative maintenance (PPM) for cultural heritage, focusing on the hypogeum archaeological site beneath the Chamber of Commerce in Rimini, Italy. Hypogeal environments pose unique conservation challenges due to their microclimates, biological threats, and structural vulnerabilities. Applying the ABC Method—developed by ICCROM and CCI—this research systematically identifies, analyzes, and prioritizes risks associated with agents of risks. The methodology was complemented by the Nara Grid to assess the site's authenticity and cultural value, aiding in the delineation of risk areas and informing strategic conservation priorities. The study identifies efflorescence formation, flooding risks, and lack of management guidelines as extreme threats, proposing tailored treatments and practical interventions across multiple layers of control. Through environmental monitoring, empirical analysis, and a multidisciplinary framework, the research o

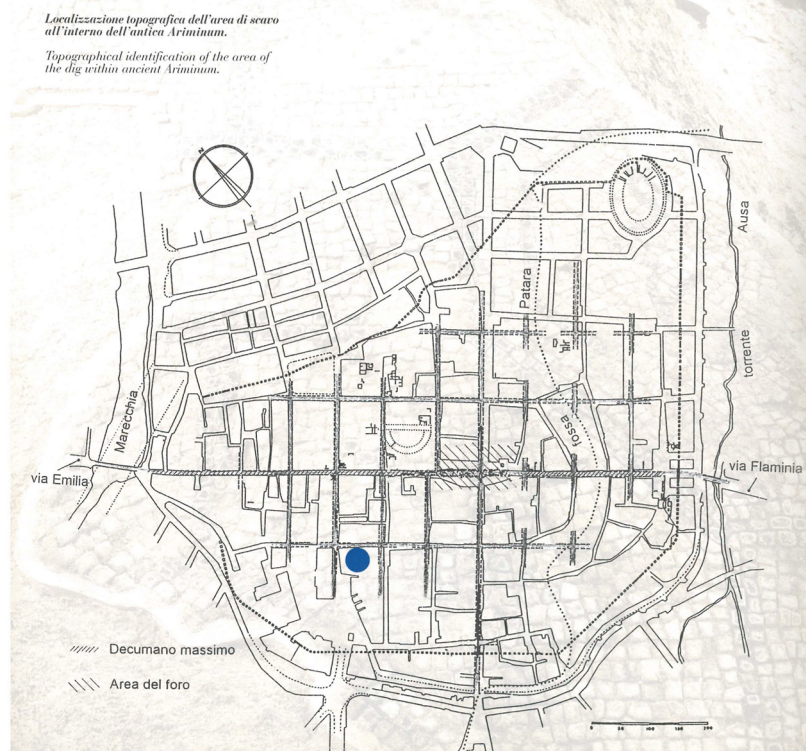
**Figure 2.** (a) Circled in red the extension of the archaeological site in Sigismund Street in the modern city asset of Rimini, Italy. Nearby can be found other recognized archaeological sites known as “Domus of the Imperial age” (on the right) and “Area of the Malatesta fortress, imperial Late roman sights, moat and ancient settlements” (on the left side) [23] In the left corner the Google street image of the Chamber of Commerce entrance [24]; (b) the blue dot indicates the topographic localization of the excavation in the ancient Roman Ariminum city [19] p. 1.

The site beneath the Chamber of Commerce in Rimini, shown in the modern settlement of the city in Figure 2a, is located in the western quadrant of the Roman-era settlement, within a district bounded by the city walls and main roadways connecting Porta Montanara, the forum, and the Tiberius Bridge as shown in Figure 2b. The insula has been occupied since the late Republican period, as evidenced by several residential structures, including a notable opus signinum floor. In the south-eastern sector, a 35-square-meter polychrome mosaic with floral motifs, stylistically dated to the first half of the 4th century, represents the only surviving evidence of a renovation phase within a context largely marked by Imperial-era remains. In the 5th century, a domus in the eastern sector of the Via Sigismondo excavation was altered to include an apsidal room decorated in opus sectile, which disrupted the public sewer system—highlighting the dominance of private interests over public infrastructure. The building retained a prominent role throughout the 5th and 6th centuries but eventually declined, leading to its abandonment and burial by the early Middle Ages [18–22].

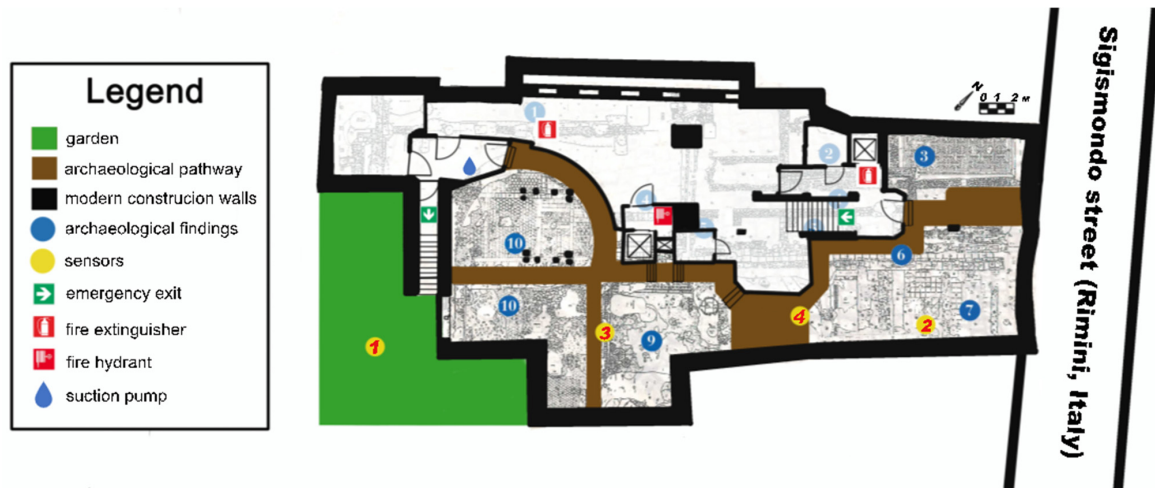
**Figure 4.** Visualization of the archaeological site in the underground floor of the Chamber of Commerce (Rimini).

According to the basement's emergency plan, both the internal and external staircases function as escape routes. In addition, the area is equipped with two fire extinguishers, a fire hydrant, and smoke-detection sensors. The groundwater level is regulated by a suction pump installed in a room adjacent to the archaeological site as displayed in Figure 4.

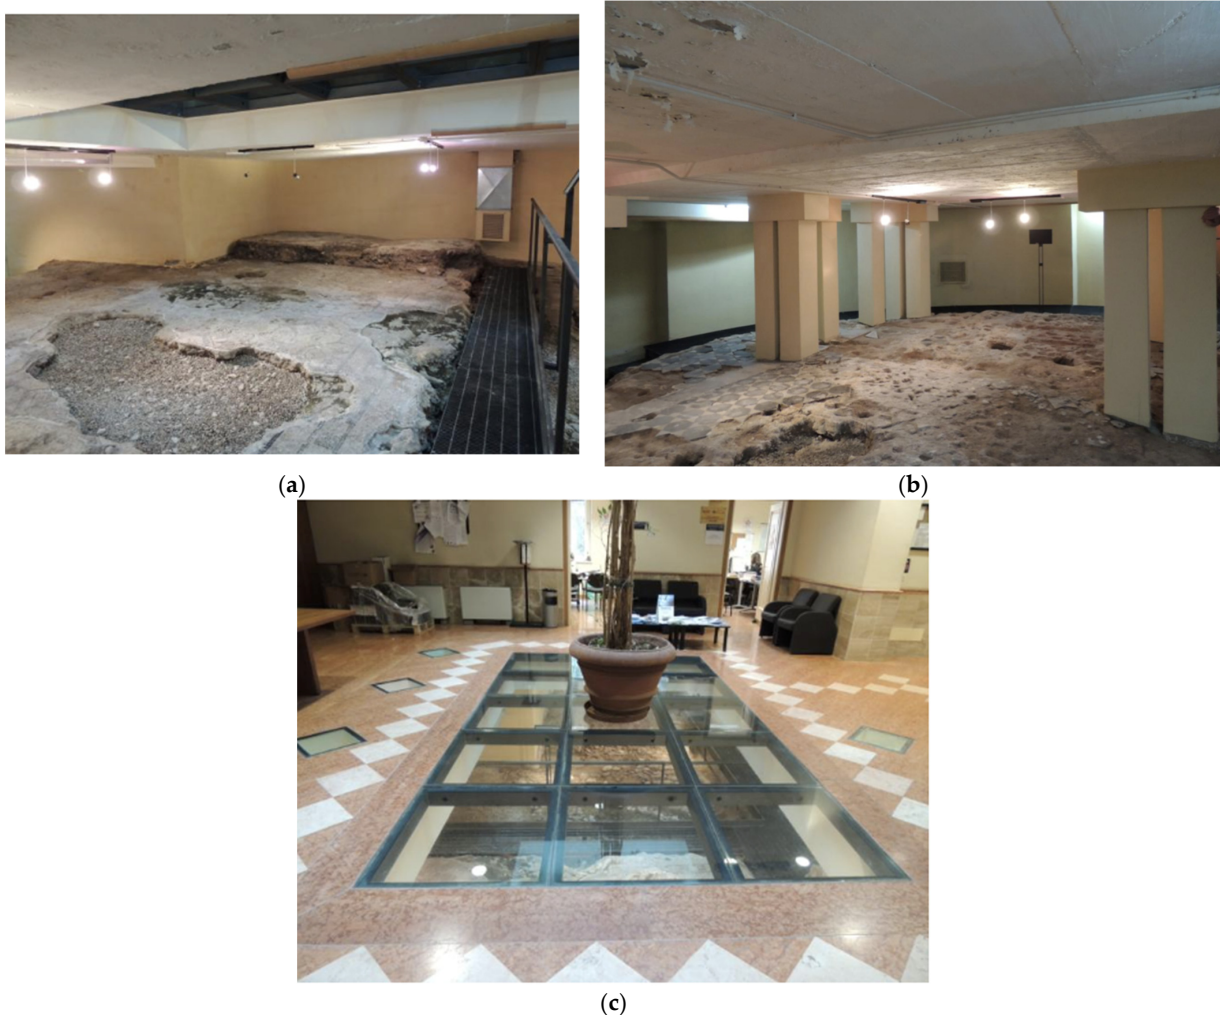
**Figure 5.** Photos taken inside the archaeological site and inside the Rimini Chamber of Commerce: (a) late Imperial Era mosaic. On the right is the metal boardwalk and at its end is a portion of the air circulating system. Shown are the halogen lighting system and portion of the ceiling glass; (b) large room with apse and opus sectile floor of late antiquity period illuminated by the halogen lighting system; (c) the glass floor in the waiting room on the ground floor of the Rimini Chamber of Commerce.

Currently closed to the public, access to the archaeological area is only occasionally granted, subject to approval by the Superintendence. The site can be reached via internal or external staircases or a lift, as displayed in Figure 4, and a metal boardwalk allows visitors to navigate across the various stratigraphic levels of the archaeological remains as shown in Figure 5a. The space is equipped with a manipulable air recirculation system (Figure 5a), and lighting is provided by a halogen lighting system (Figure 5a,b), as well as by sections of glass flooring in the waiting room above, which allow natural light to filter through from the skylight (Figure 5c).

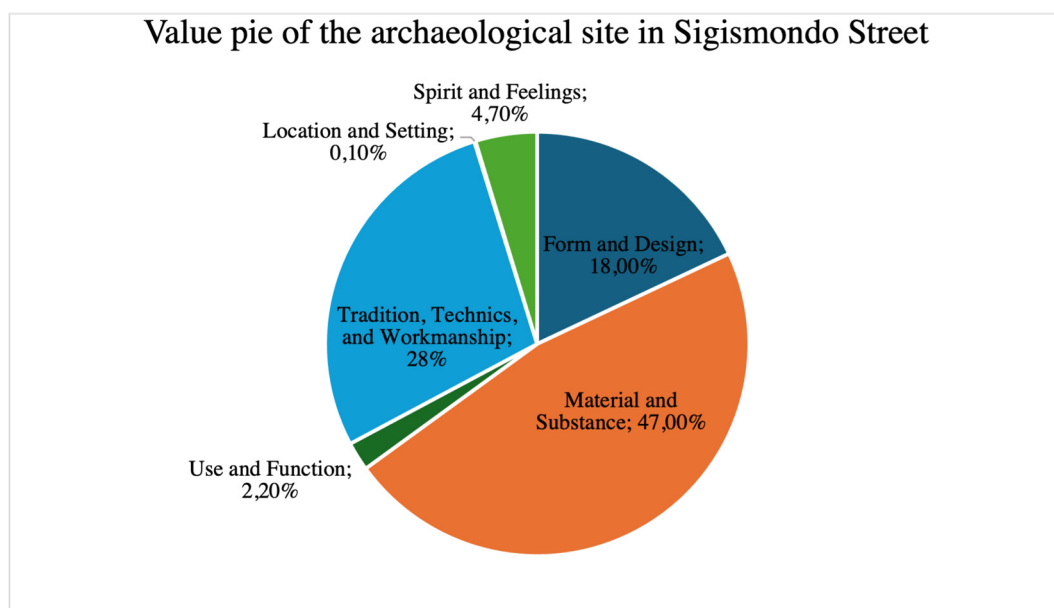
Figure 6. Value pie of the archaeological site in Sigismund Street.

The authenticity of the archaeological site is primarily defined by the original materials that have been preserved, as illustrated in the value pie in Figure 6. These materials are crucial for understanding historical floor construction techniques and the transformations of Rimini's urban fabric over time, shaped by socio-economic developments.

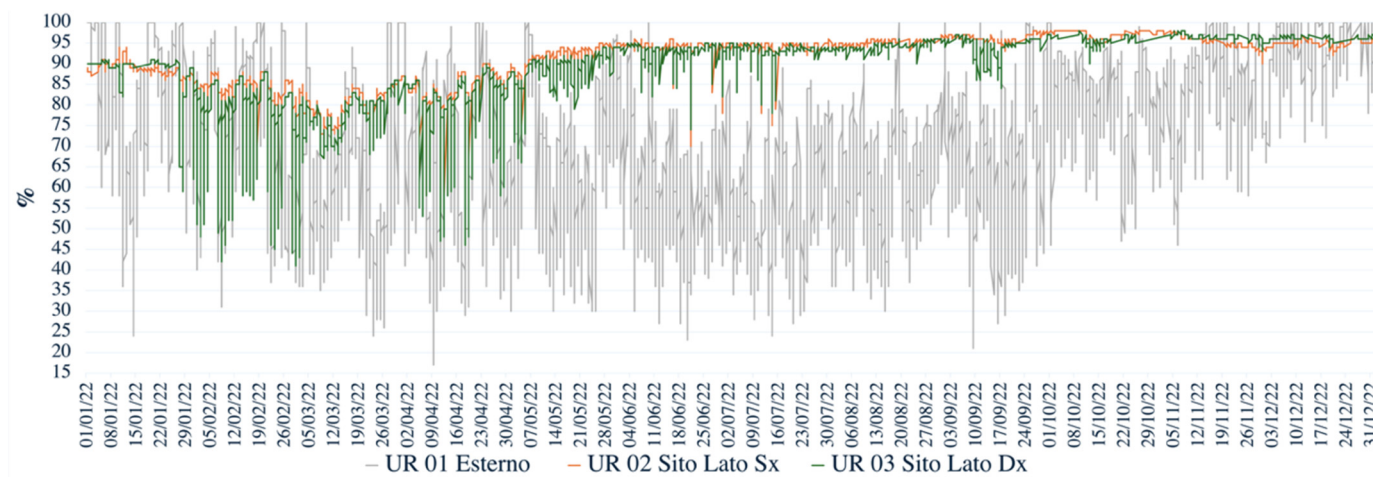
**Figure 9.** Relative humidity value trends (%) of 2022 year. UR2 internal RH left side (orange line), UR3 internal RH right side (green line), UR1 external RH (grey line).

During winter, relative humidity ranges from approximately 45% to 87%. Despite the lighting system being turned off during these periods—as confirmed by the illuminance data in Figure 10—ambient temperature variations persisted, indicating that lighting alone does not fully account for thermal changes. Notably, internal relative humidity during winter closely follows external humidity trends—particularly from early March to early April—suggesting a strong correlation.
