Seismic-induced damage in historical masonry vaults: A case-study in the 2012 Emilia earthquake-stricken area

Antonio Maria D'Altri, Giovanni Castellazzi, Stefano de Miranda, Antonio Tralli,
*Seismic-induced damage in historical masonry vaults: A case-study in the 2012 Emilia
earthquake-stricken area*, Journal of Building Engineering, Volume 13, 2017, Pages
224-243

Seismic-induced damage in historical masonry vaults: a case-study in the 2012 Emilia earthquake-stricken area

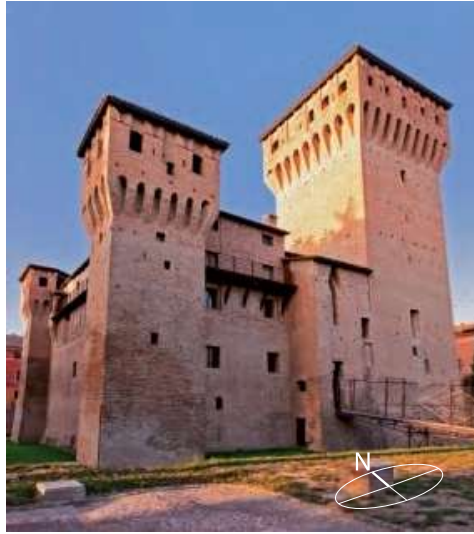
Figure 1: San Felice sul Panaro fortress.

100 The masonry vault which covers the Giulio II Hall in the main tower of the San Felice sul
101 Panaro fortress (Figure 1), a town located near the city of Modena (Italy), is investigated.
102 Such a cross vault (Figure 2) is located between the II and the III level of the main tower of
103 the fortress (the tower on the right of Figure 1) and is characterized by an almost squared
104 plan of approximately 6.5 meters, small ribs and a fresco (which portraits Saint Francis of
105 Assisi) on its North side (Figure 2(c)). This latter artistic element further increases the
106 heritage value of the case study, as commonly occurs for historical buildings [35, 36].

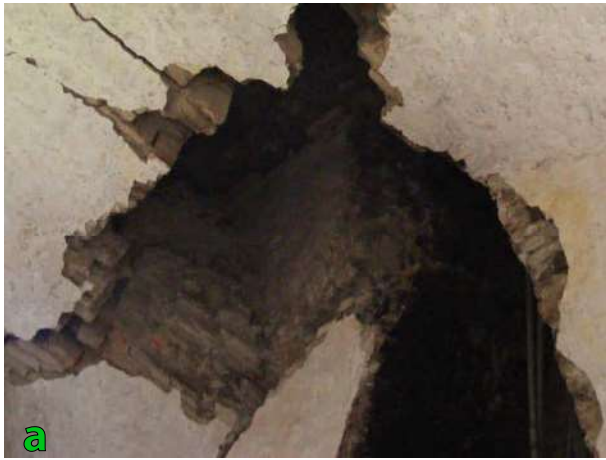
- 157 (a) a collapse of a part of the vault near the flue chimney (West side), see Figure 5(a);
- 158 (b) a main and very severe crack which substantially cut in two parts the Giulio II Hall,
 159 highlighted by blue arrows in Figure 4, see details in Figure 5(b);
- 160 (c) the detachment and collapse of the ribs, see Figure 5(c);
- 161 (d) a deep crack which starts from the upper extremity of the South-side-window, passes
 162 near the vault's keystone and ends in the opposite side, see Figure 5(d).

Figure 5: Giulio II Hall's vault major failures. The letters a, b, c and d are referred to Figure 4.

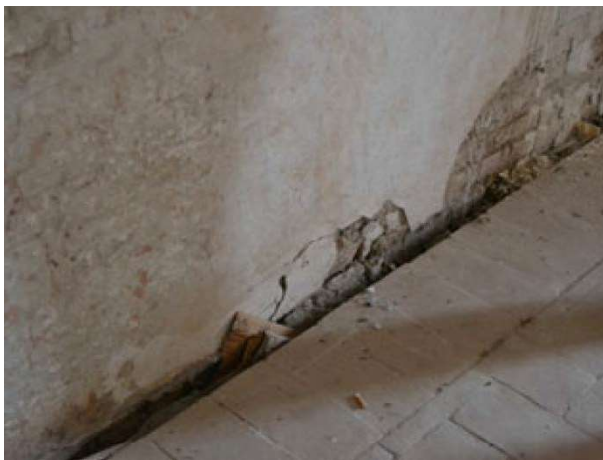
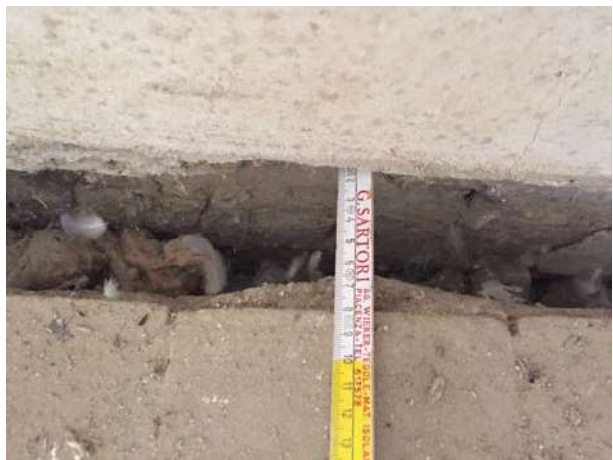
190 Finally, it has also to be pointed out that the perimeter wall of the East side of the
191 Giulio II Hall detached from the floor of approximately 6 centimeters (Figure 6), while in
192 the other sides no relevant detachments appeared.

Figure 6: Detachment between the floor and the East wall of the Giulio II Hall after the Emilia earthquake.

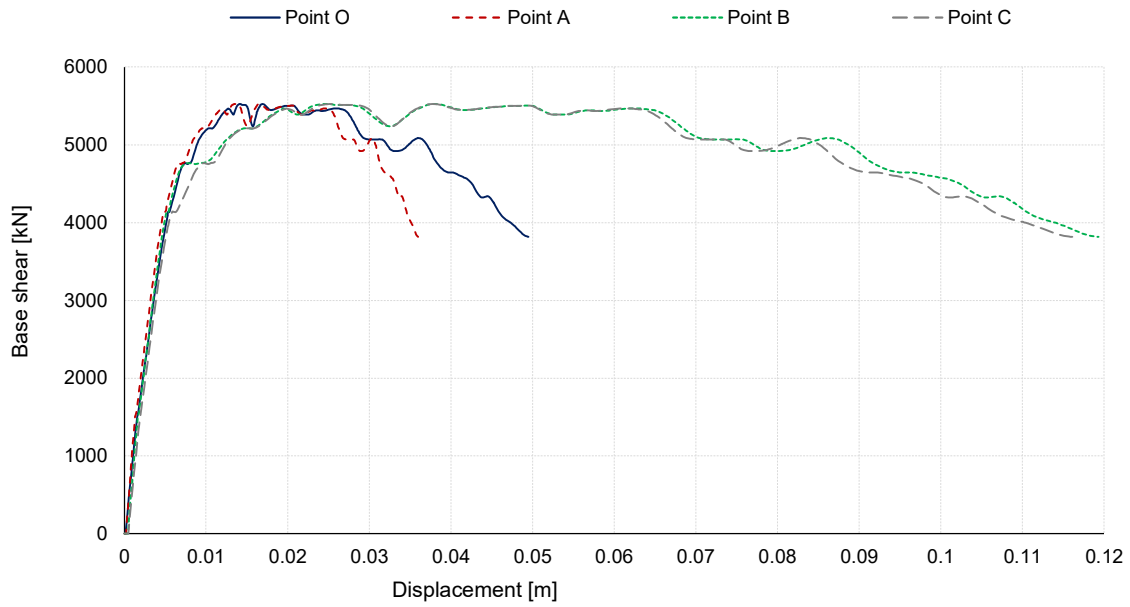
Figure 12: Base shear-displacement of the vault's abutments curve of the points depicted in Figure 9(c), South directed force.

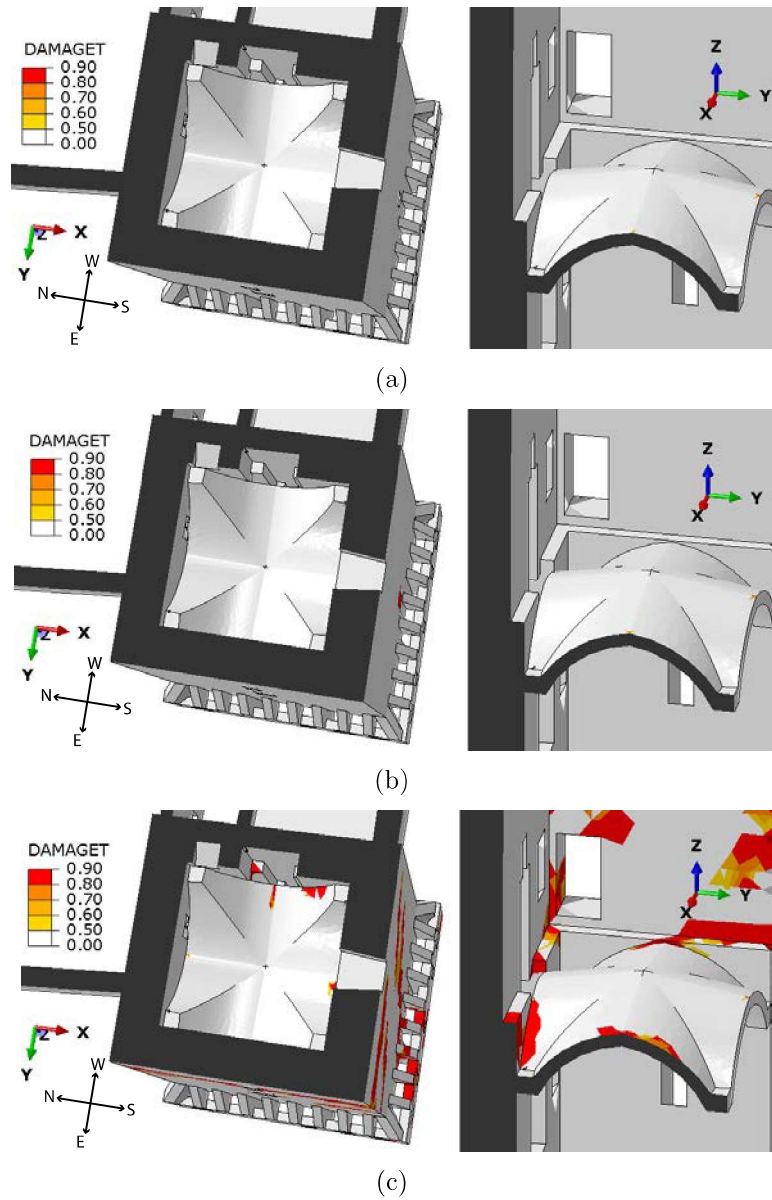
368 As far as the West directed force analysis is concerned, the strong interaction with the
369 adjacent building, which deeply limits the structure displacements along the West direction,
370 restricts the damage in the higher part of the tower's trunk and no significant cracks appear
371 in the vault (Figure 16).

Figure 16: Nonlinear static damage contour plots of the Giulio II Hall's vault, West directed force. Bottom views (left) and section views (right).

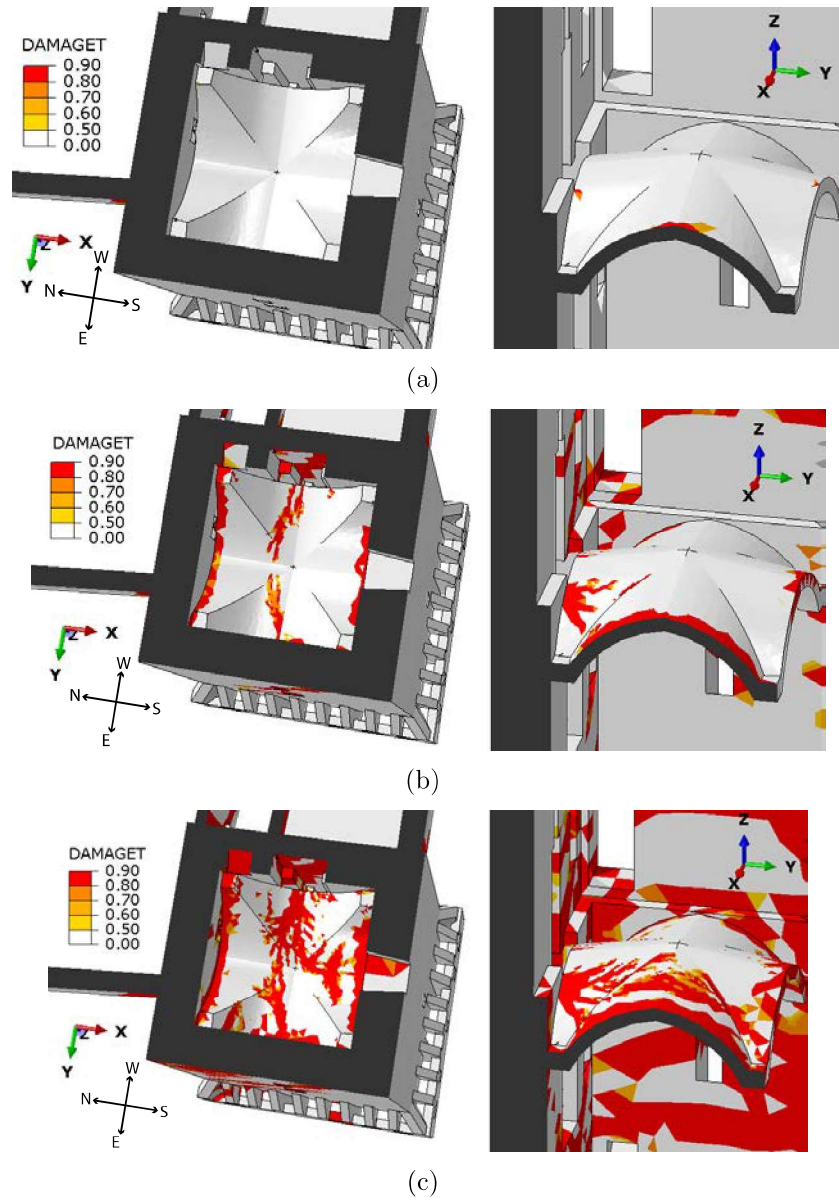
372 For what concern the South load case, as already noted in Figure 14, the points of the
373 sides parallel to the force direction tend to distance themselves in a similar way. This is also
374 confirmed by the damage contour plots of Figure 17 which show the progressive development
375 of a crack in the intrados perpendicular to the South direction.

Figure 17: Nonlinear static damage contour plots of the Giulio II Hall's vault, South directed force. Bottom views (left) and section views (right).
