Seismic-induced damage in historical masonry vaults: A case-study in the 2012 Emilia earthquake-stricken area

Antonio Maria D'Altri, Giovanni Castellazzi, Stefano de Miranda, Antonio Tralli,  
*Seismic-induced damage in historical masonry vaults: A case-study in the 2012 Emilia  
earthquake-stricken area*, Journal of Building Engineering, Volume 13, 2017, Pages  
224-243

# Seismic-induced damage in historical masonry vaults: a case-study in the 2012 Emilia earthquake-stricken area

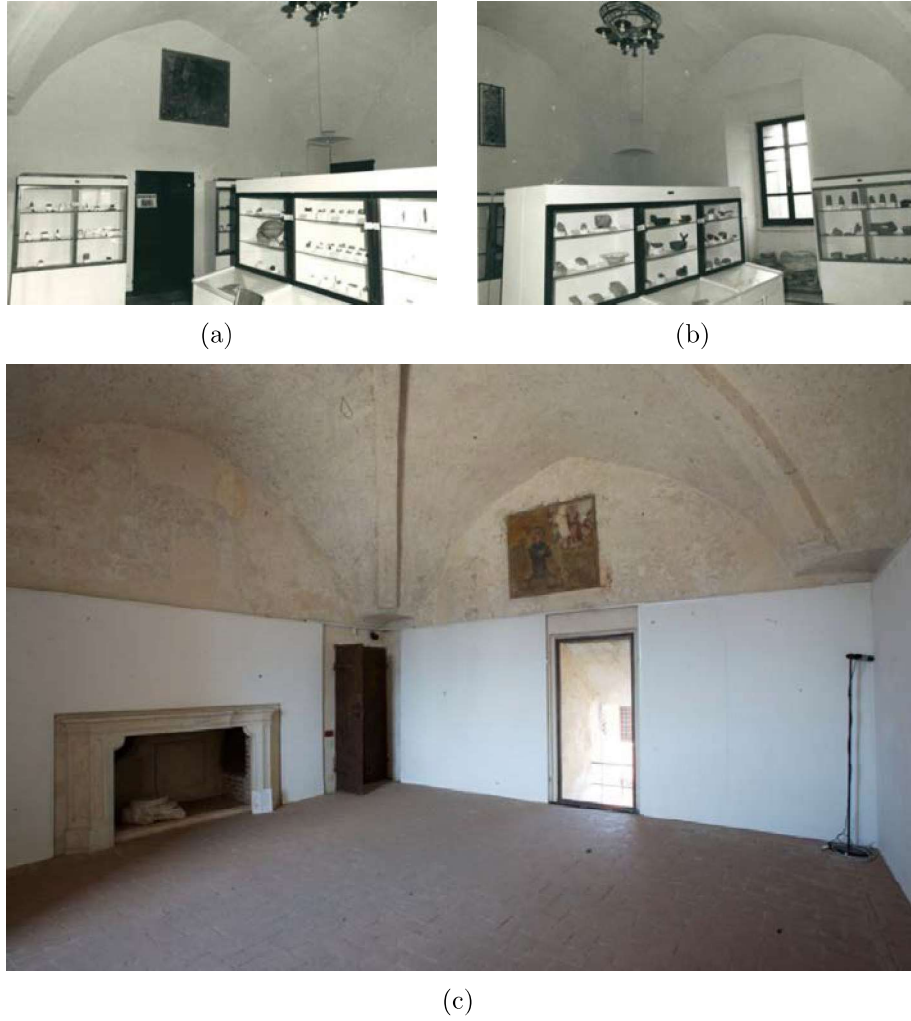
Among the more recent intended use of the Giulio II Hall, in 1999 the room was set up for an archaeological exhibit as depicted in Figure 2(a) and Figure 2(b). In 2012 the fortress, and consequently the Giulio II Hall's vault, was severely damaged by the Emilia earthquake. The last arrangement of the Giulio II Hall before the earthquake is reported in Figure 2(c). More details are reported in the following.

Figure 2: Giulio II Hall before the Emilia Earthquake.

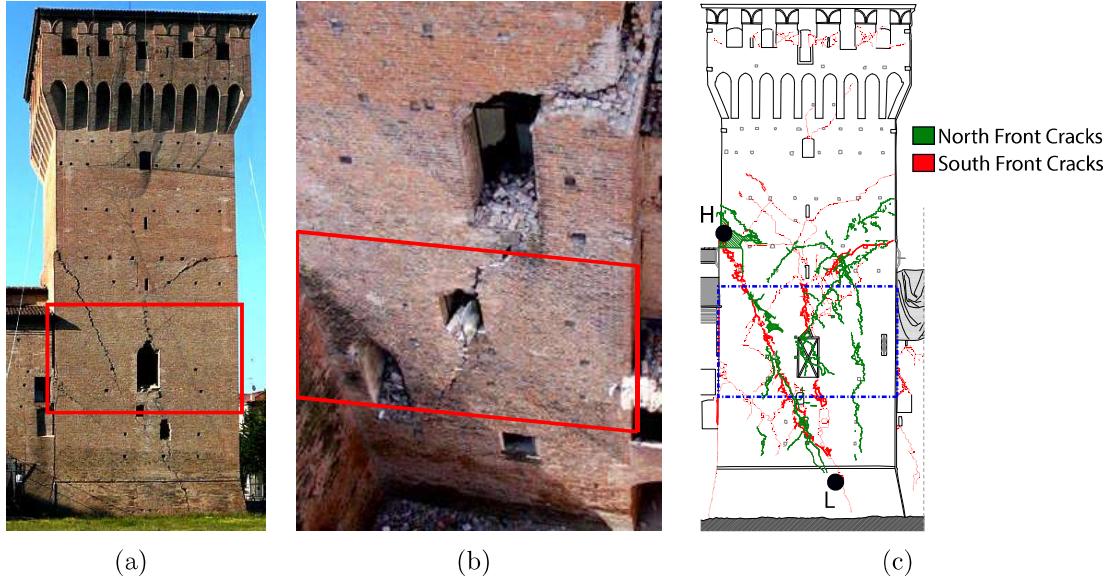
Emilian medieval fortresses due to the seismic sequence is reported in [43]. As a result, the fortress presented a widespread damage characterized by the collapse of the crowning of the minor towers and the appearance of several deep cracks on the main tower. In particular, the most relevant cracks appeared on the main tower consisted in diagonal cracks, clearly visible in the lower half of the South (Figure 3(a)) and North (Figure 3(b)) front. Approximately, these two main cracks are placed in the same plane, roughly perpendicular to the line individuated by points H and L in Figure 3(c).

In the Giulio II Hall (whose position is highlighted by red frames in Figures 3(a) and 3(b) and by a blue dotted frame in Figure 3(c)), the vault which cover the room has been interested by the presence of deep cracks and partial collapses, see Figures 4 and 5. In general, it can be noted that the big flue chimney which is present inside the West wall of

Figure 3: Main tower of San Felice sul Panaro fortress after the Emilia earthquake (2012): (a) Main tower's South front, (b) North front and (c) South and North fronts cracks superposition.

- the main crack (b) which passes through the vault along the N-S direction substantially links the two major diagonal cracks experienced by the main tower's South side (Figure 3(a)) and North side (Figure 3(b)), as also shown in Figure 3(c);

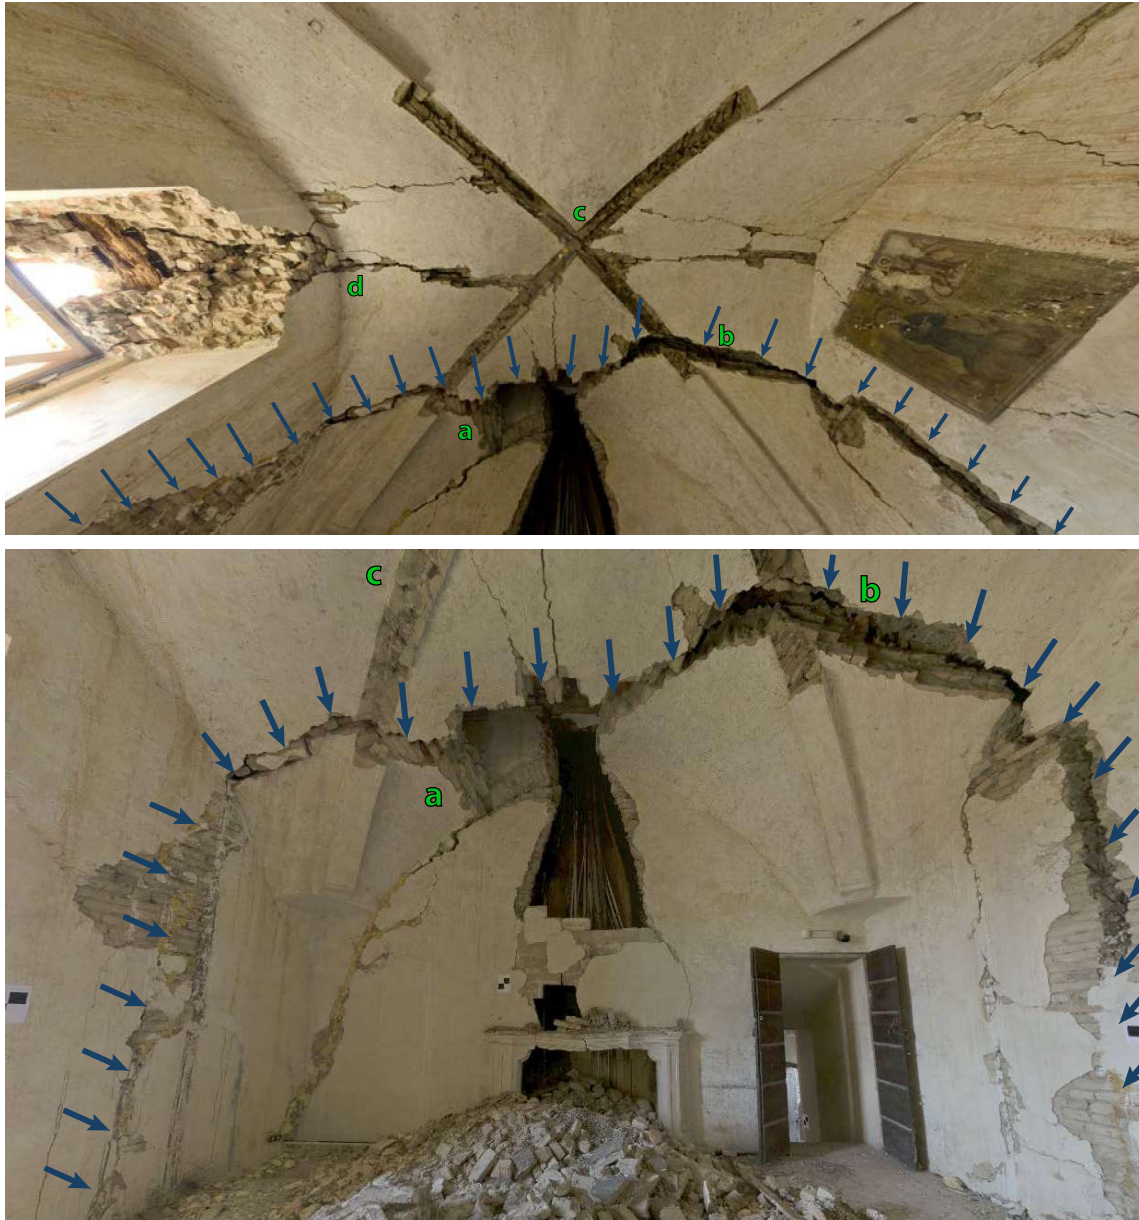
the tower could have weakened the masonry structure [43]. More specifically, by inspecting Figure 4, the presence of four major failures of the vault, which are highlighted by the letters a, b, c and d and are magnified in Figure 5, can be noted. In particular, by inspecting the vault intrados the more severe damages can be summarized as follows:

Figure 4: Giulio II Hall's vault after the Emilia earthquake.

Summing up, it emerges that the damages experienced by the vaulted structure during the earthquake are strictly linked to its historical evolution phases (e.g. failures (a), (c) and (d) in Figures 4 and 5) and to the seismic-induced damage experienced by the masonry tower, i.e. the vault's bearing structure (e.g. failure (b) in Figures 4 and 5).

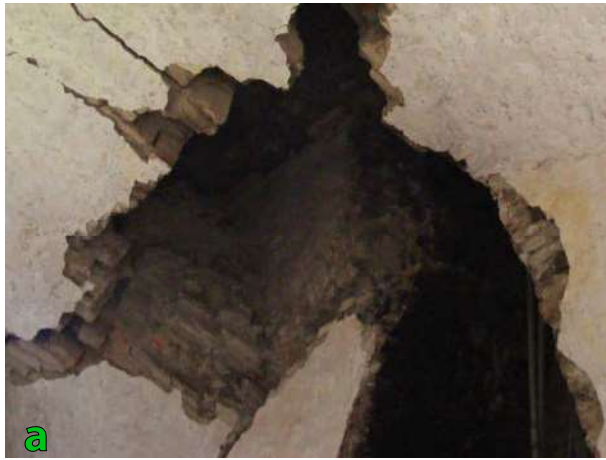
- (a) a collapse of a part of the vault near the flue chimney (West side), see Figure 5(a);
- (b) a main and very severe crack which substantially cut in two parts the Giulio II Hall, highlighted by blue arrows in Figure 4, see details in Figure 5(b);
- (c) the detachment and collapse of the ribs, see Figure 5(c);
- (d) a deep crack which starts from the upper extremity of the South-side-window, passes near the vault's keystone and ends in the opposite side, see Figure 5(d).

Figure 5: Giulio II Hall's vault major failures. The letters a, b, c and d are referred to Figure 4.

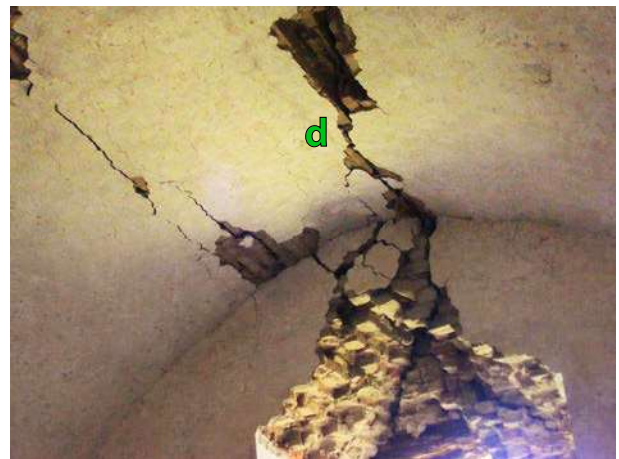
- the crack (d) starts from the window in the South side of the tower (Figure 5(d)). Such an opening was obtained by demolishing a portion of the wall, as said before. This fact, as well as the absence of an adequate lintel over the opening, could have weakened this part of the structure.

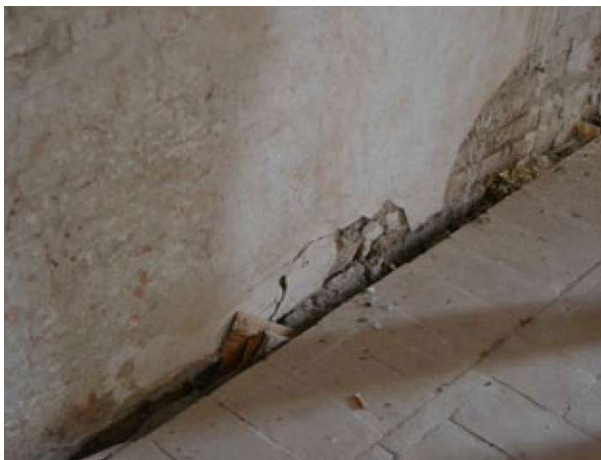
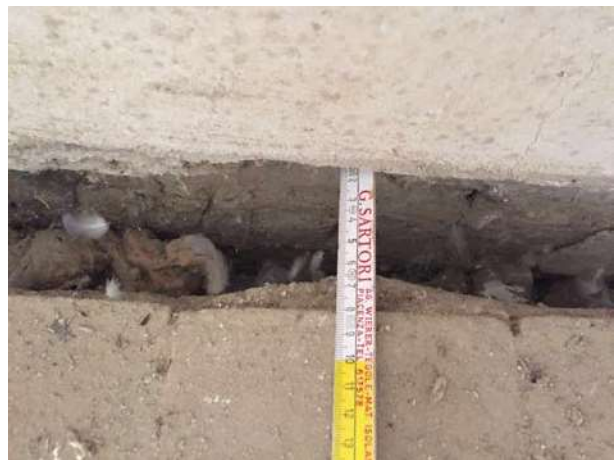
Finally, it has also to be pointed out that the perimeter wall of the East side of the Giulio II Hall detached from the floor of approximately 6 centimeters (Figure 6), while in the other sides no relevant detachments appeared.

Figure 6: Detachment between the floor and the East wall of the Giulio II Hall after the Emilia earthquake.

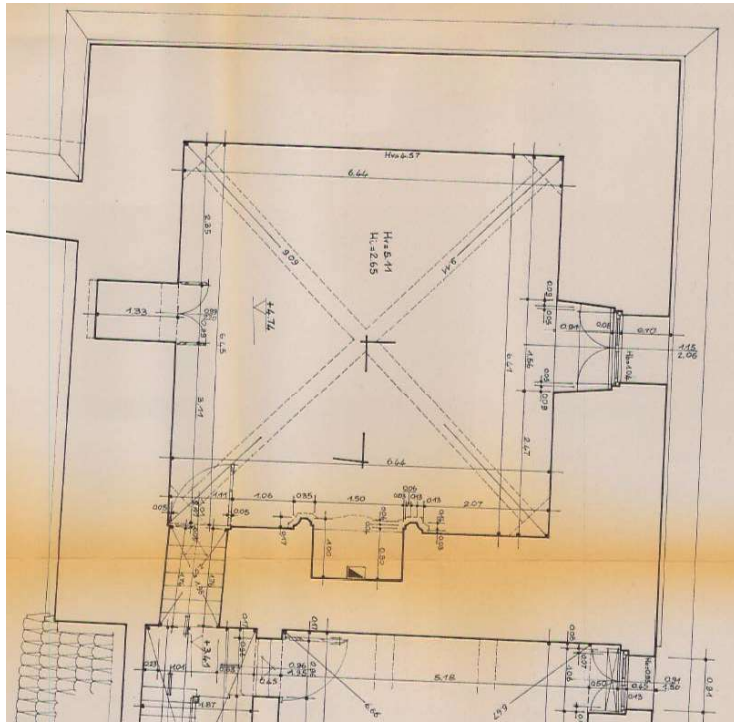
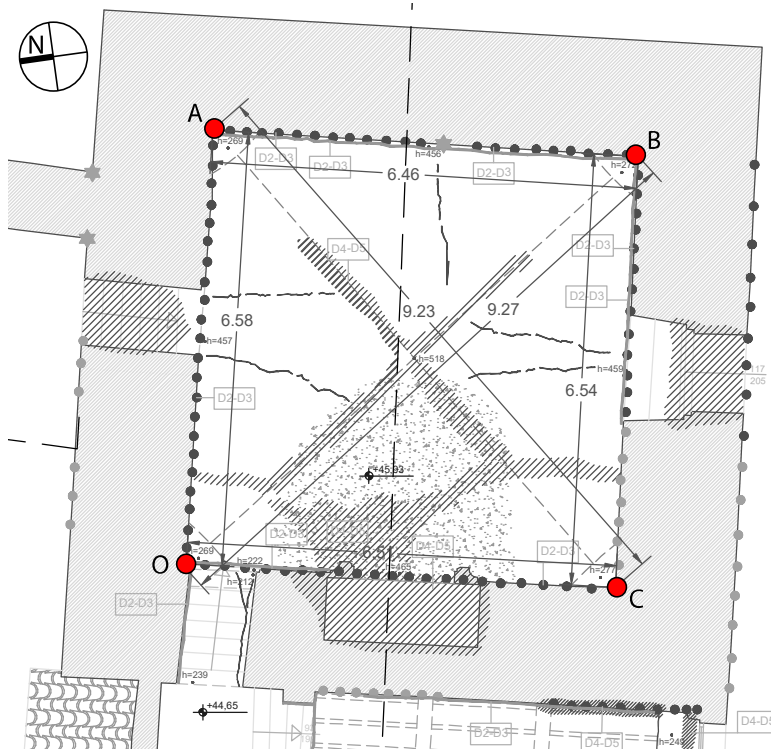
Aiming at quantitatively assessing the effects of the seismic action on the vault, a comparison between two different surveys, one made in 1985 (the only available before the earthquake) and one made in 2012 after the earthquake, has been carried out in terms of vault's abutments relative displacements. However, it has to be pointed out that the two geometrical surveys were conducted in different times with completely different techniques characterized by different accuracy. In particular, the first one was performed in 1985 with classical hand-based survey procedure, whereas the second one was carried out in 2012 with the laser scanner technique. Coarsely, if the first one guarantees the accuracy of some centimeters, the second one guarantees the accuracy of some millimeters. The comparison of the Giulio II Hall's vault plan before and after the seismic event is reported in Figure 7, while the comparison of its N-S section and its E-W section is reported in Figure 8. Concerning Figure 7, it should be noted that it is not precisely known at what height the plan of Figure 7(a) (1985 survey) is taken (there is about 1 m of uncertainty).

The resulting actual relative displacements of the vault's abutments measured between the plan of Figure 7(a) and the plan of Figure 7(b) are collected in Table 1. The letters O, A, B and C are referred to Figure 7(b). As can be noticed in Table 1, relevant relative displacements have been recorded: the two diagonals of the vault (OB and CA) measure an increase of length of more than 14 cm; the sides along the E-W direction measure an increase of length of 13 cm (OA and BC) whereas the sides along the N-S direction presented shorter relative displacements of 7 cm (CO side) and 2 cm (AB side). Due to the different nature of the two compared surveys, the quantities collected in Table 1 have to be considered as affected by some uncertainties of the order of magnitude of centimeters. No other experimental findings are available for the Giulio II Hall's vault (in terms, for instance, of endoscope tests) since its compromised safety condition did not permit any experimental test. Therefore, no detailed information of the stratigraphy of the vault are available. However, by visually inspecting the vault's deep cracks, the assumption of 42 cm thickness has been made.

Figure 7: Giulio II Hall’s vault plan: (a) before the earthquake (1985 survey) and (b) after the earthquake (2012 laser scanner survey).

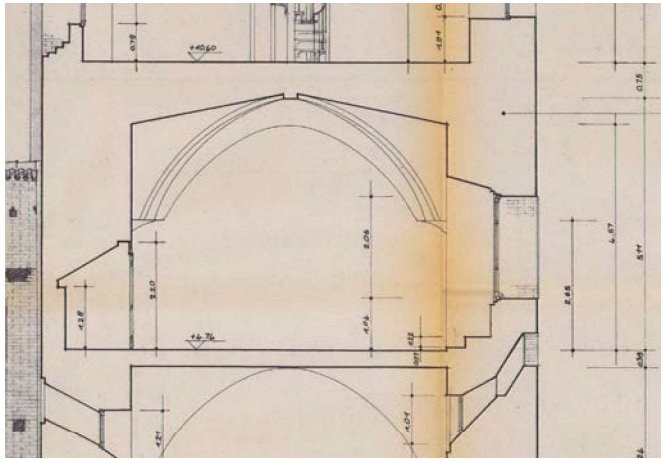
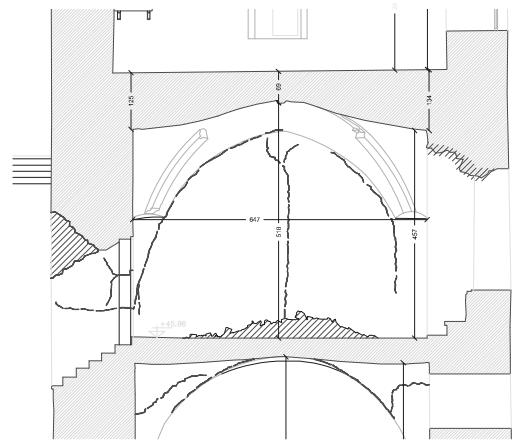
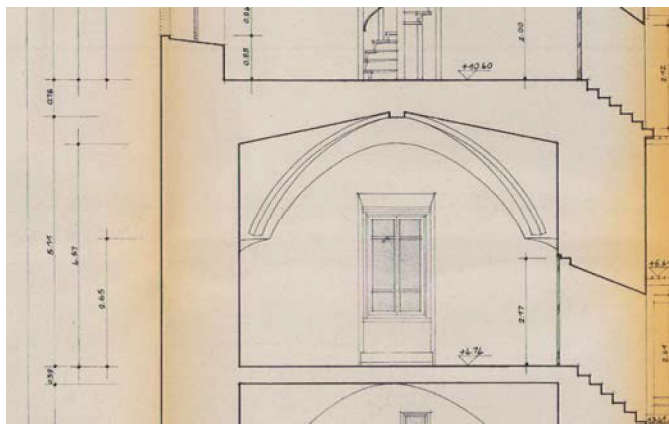
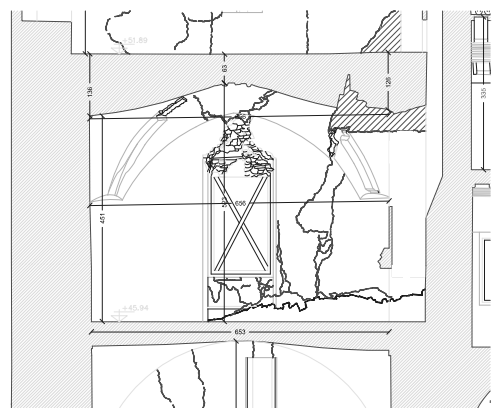
Figure 8: Giulio II Hall's vault sections: N-S section (a) before (1985 survey) and (b) after the earthquake (2012 laser scanner survey), E-W section (c) before and (d) after the earthquake.

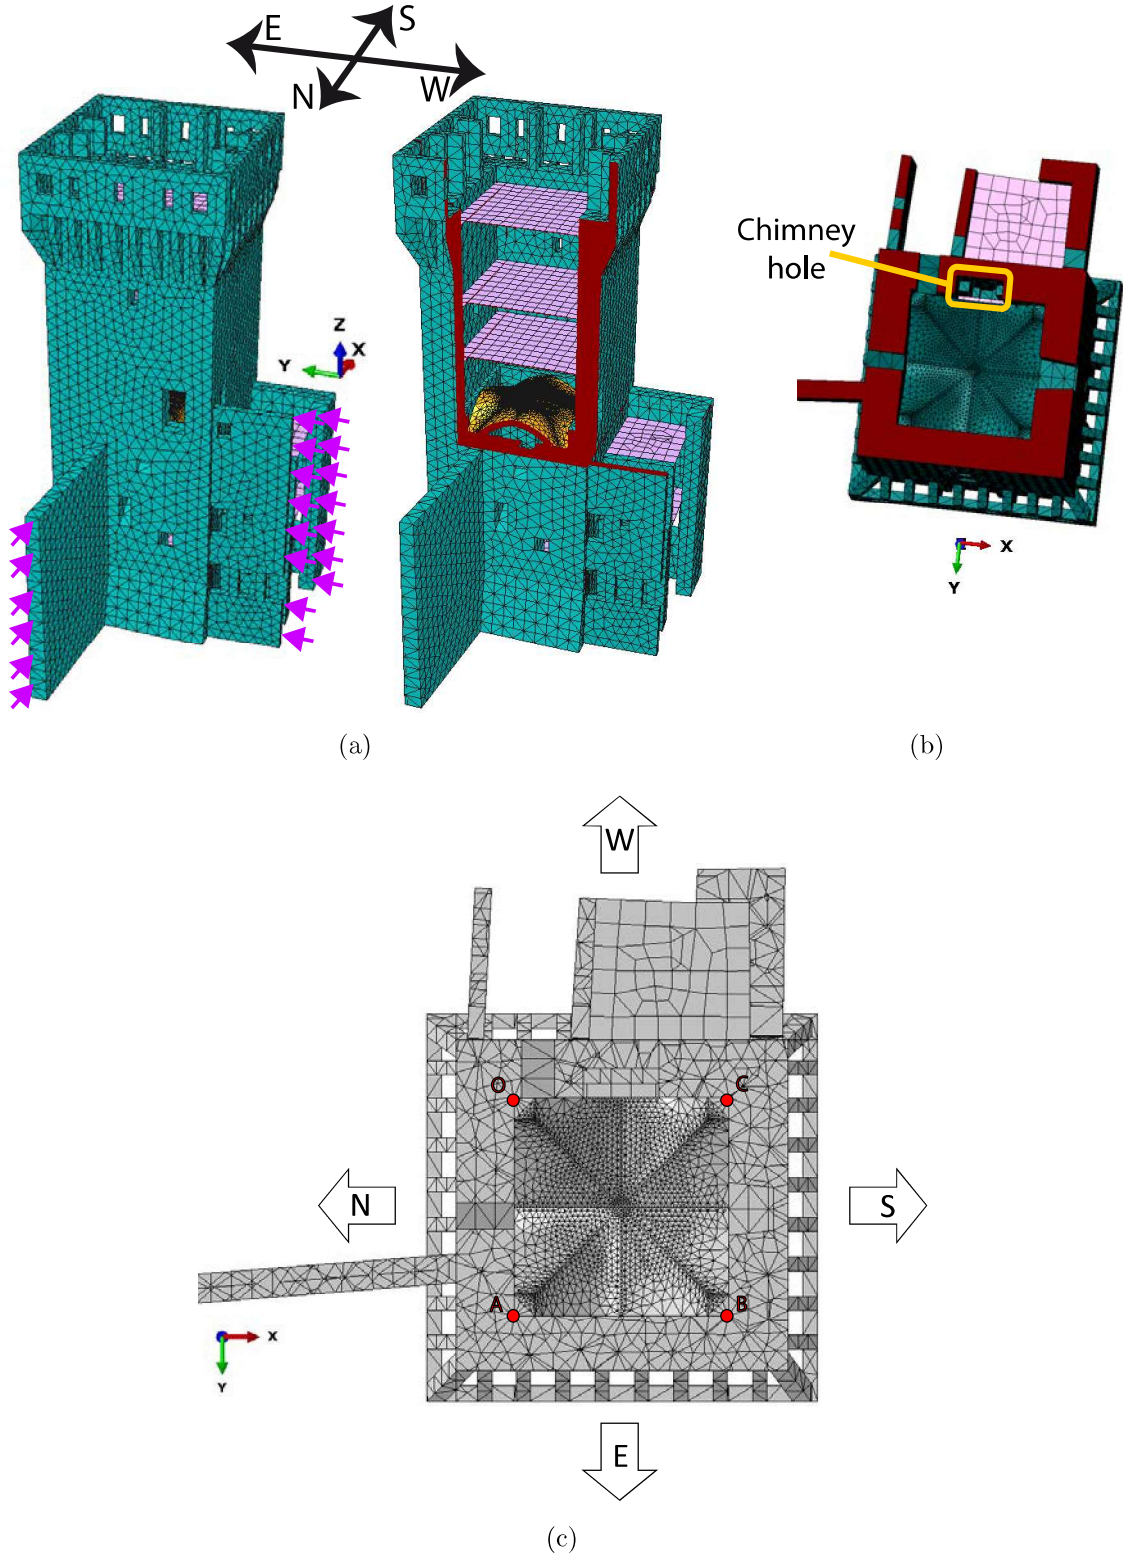
The 3D FE mesh of the tower, which includes the vault, is depicted in Figure 9. Horizontal axes of the model (X and Y) substantially correspond to the cardinal directions (S-N and E-W, respectively). In order to maintain acceptable the computational cost, the mesh design aimed at guaranteeing a fine description of the vault and a coarser description of the tower. In any case, the presence of at least three tetrahedron elements on the thickness of the tower trunk’s walls (Figure 9(c)) guarantees a reasonable accuracy in terms of global structural behavior of the tower. The adopted FE mesh counts 20,393 nodes and 79,459 tetrahedron elements.

As extensively discussed in [34], the seismic behavior of the tower is influenced by the presence of adjacent structural elements. Therefore, some portions of the adjacent buildings have been considered in the FE model (Figure 9(a)). Therefore, in order to approximately take into consideration the stiffness of the non-meshed parts of the fortress while keeping simple the model and low the computational effort, rollers have been inserted on the surfaces highlighted by purple arrows, see Figure 9(a).

Figure 9: Vault and the tower's 3D FE numerical modeling: (a) 3D FE mesh, (b) particular of the chimney hole and (c) Giulio II Hall's vault mesh with the considered points of the model, bottom view.

In order to investigate the seismic-induced damage in the considered historical cross vault, nonlinear static and dynamic analyses are performed on the 3D FE model depicted in Figure 9. The analyses are especially focused on the mutual interaction between the tower and the vault and, hence, particular attention is devoted to the vault abutments displacements. Figure 9(c) shows the considered points of the vault abutments used to compute displacements in the following analyses.

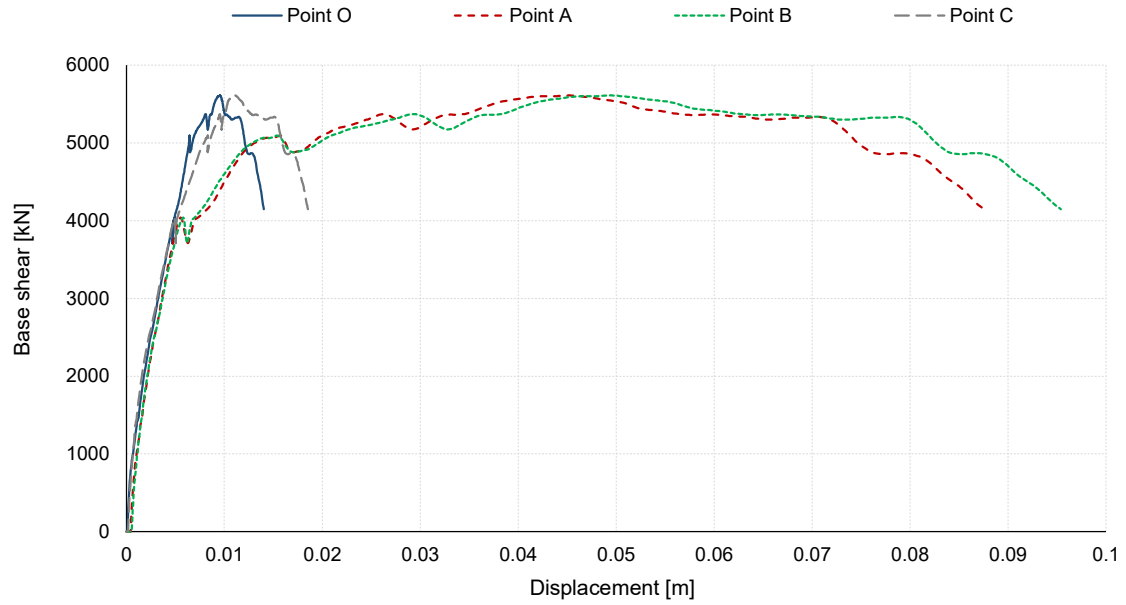
Figure 10: Base shear-displacement of the vault's abutments curve of the points depicted in Figure 9(c), East directed force.

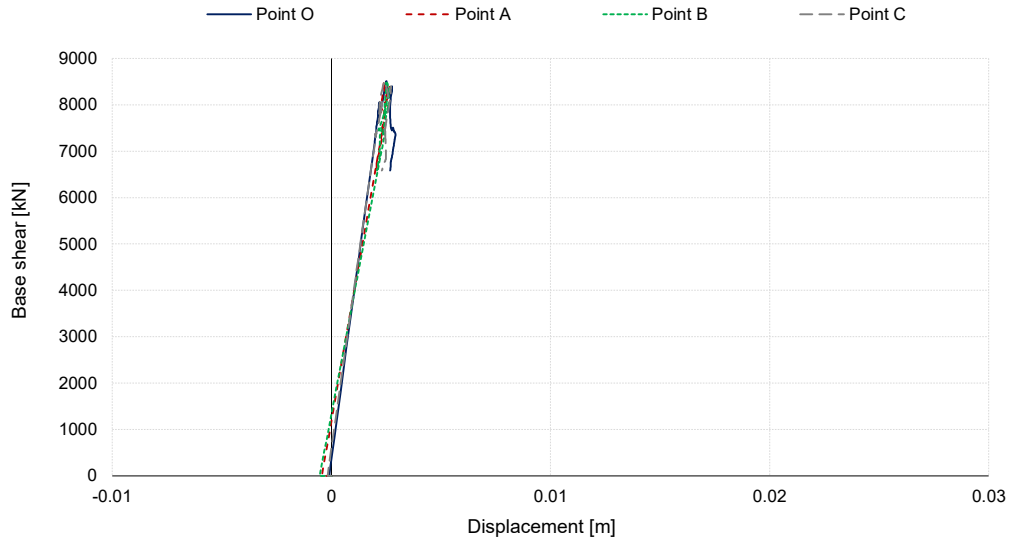
Figure 11: Base shear-displacement of the vault's abutments curve of the points depicted in Figure 9(c), West directed force.

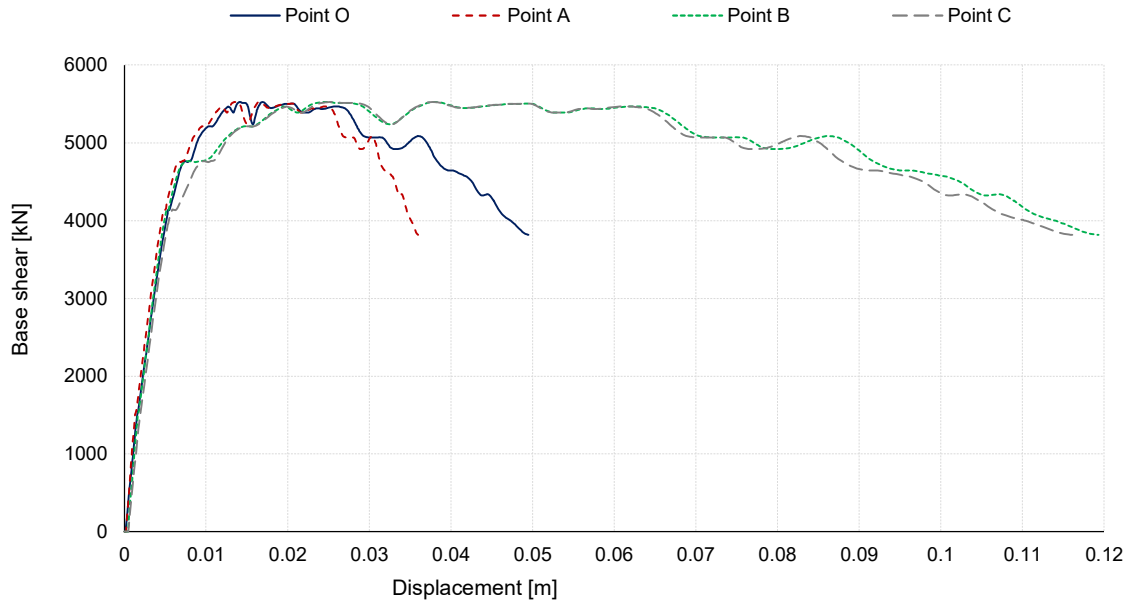
Figure 12: Base shear-displacement of the vault's abutments curve of the points depicted in Figure 9(c), South directed force.

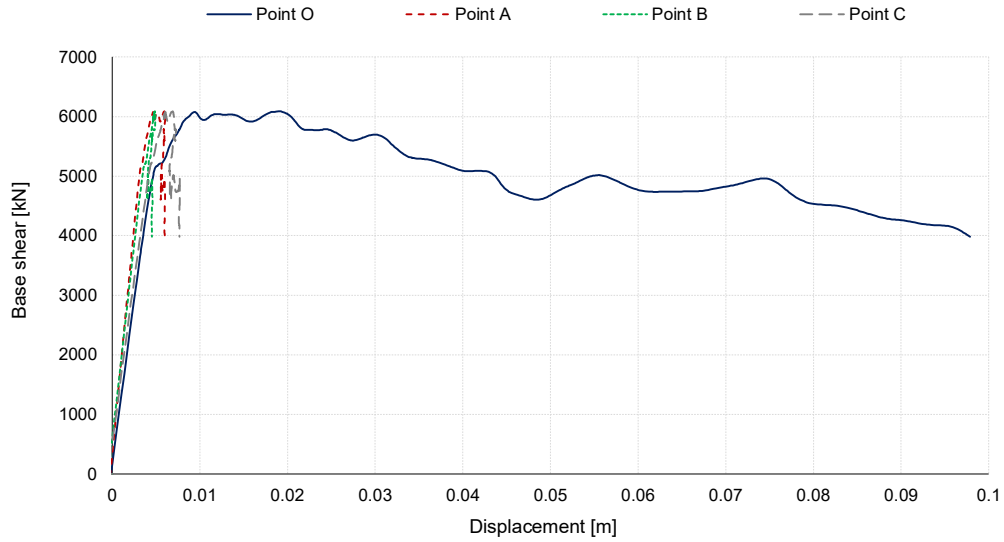
Figure 13: Base shear-displacement of the vault's abutments curve of the points depicted in Figure 9(c), North directed force.

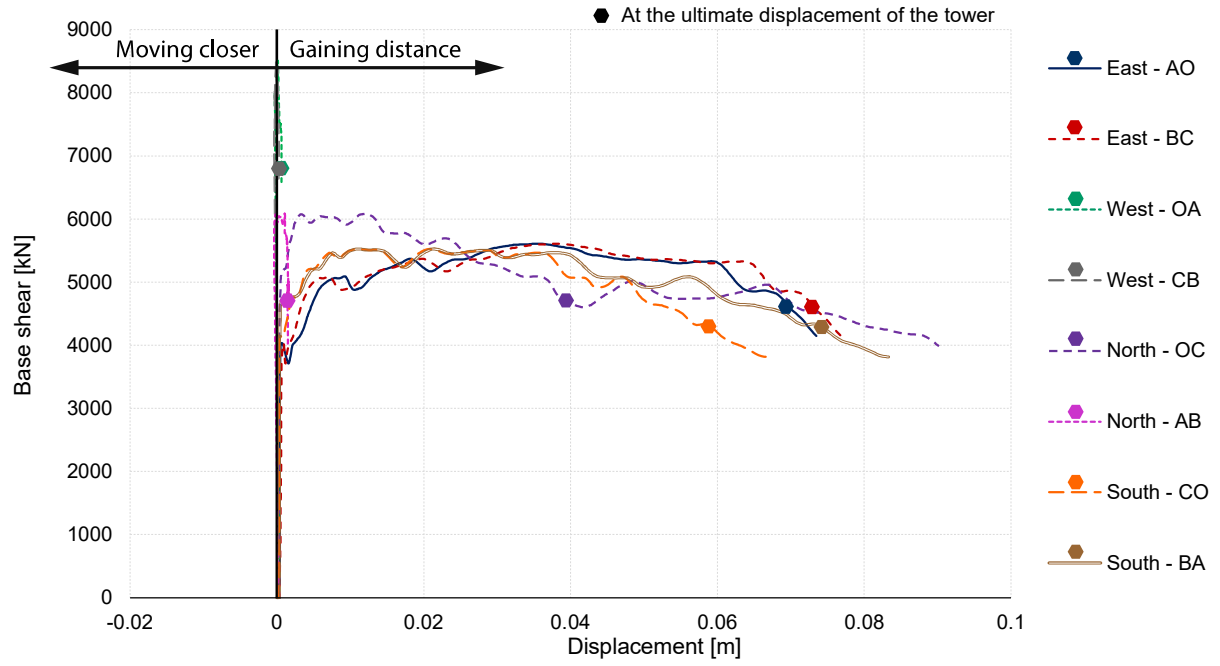
Table 3 collects the relative displacements of the vault's abutments at the ultimate displacement of the tower, i.e. when the base shear shows a drop of 20%. Such displacements are also highlighted on the curves of Figure 14 through a hexagon. As can be noted, the East and South load cases show greater relative displacements at the ultimate condition than the other load cases (included between 5.8 and 7.4 cm). This fact could also be addressed to the presence of adjacent structural elements in the other directions.

Figure 14: Base shear-relative displacement of the vault's abutments curves between the points depicted in Figure 9(c).

For what concern the South load case, as already noted in Figure 14, the points of the sides parallel to the force direction tend to distance themselves in a similar way. This is also confirmed by the damage contour plots of Figure 17 which show the progressive development of a crack in the intrados perpendicular to the South direction.

Concerning the North load case, due to the strong interaction with the curtain wall, the torsion of the tower is recorded (as reported in Figure 14) and the damage pattern of the vault (Figure 18) is conditioned by this effect. Indeed, in the vault intrados it emerges a crack which approximately tends to link the contact point with the curtain wall and the point C (Figure 9(c)) of the vault, see the progression of such a crack in Figure 18. This crack is in agreement with the actual crack specular to the failure (d) in Figure 4.

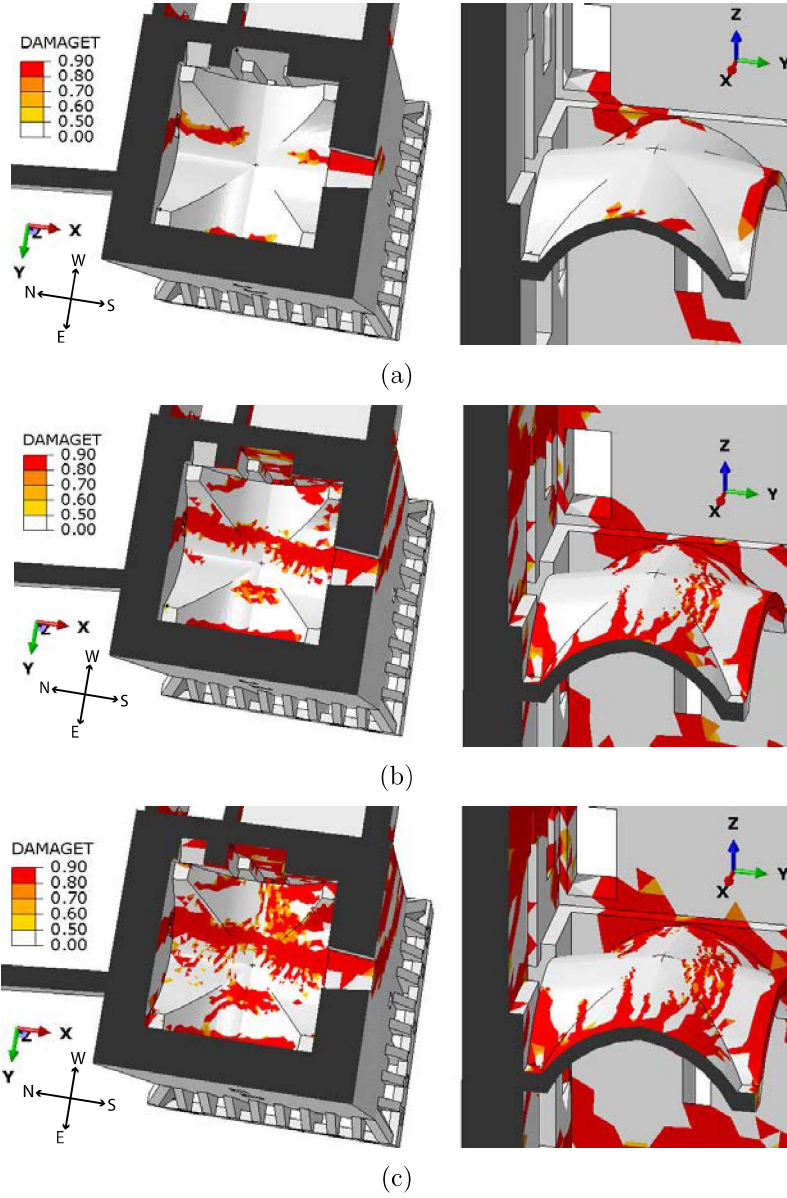
Concerning the East load case, the damage contour plots (Figure 15) show the development of a crack in the intrados which is perpendicular to the East direction. In particular, the development of this crack is already clear at the first considered instant, see Figure 15(a). In addition, such a crack is in good agreement with the actual crack pattern experienced by the vault, for instance compare Figure 15(b) with Figure 4 (failure (b)). Furthermore, from the second instant on out it appears a crack perpendicular to the East direction also in the vault extrados, see the section view of Figures 15(b) and 15(c). Although no reference is available for the vault extrados actual crack pattern, by inspecting Figure 6 it clearly appears that the main crack (b) crosses the whole thickness of the vault.

Figure 15: Nonlinear static damage contour plots of the Giulio II Hall's vault, East directed force. Bottom views (left) and section views (right).

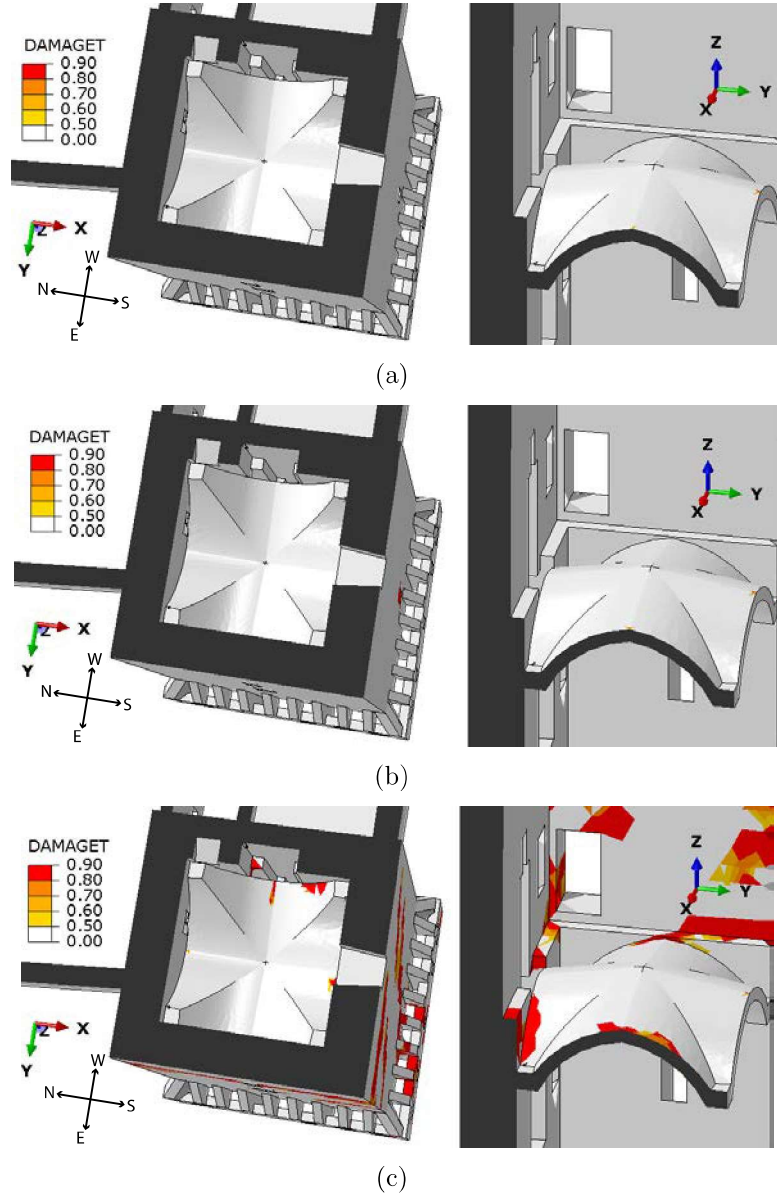
As far as the West directed force analysis is concerned, the strong interaction with the adjacent building, which deeply limits the structure displacements along the West direction, restricts the damage in the higher part of the tower's trunk and no significant cracks appear in the vault (Figure 16).

Figure 16: Nonlinear static damage contour plots of the Giulio II Hall's vault, West directed force. Bottom views (left) and section views (right).

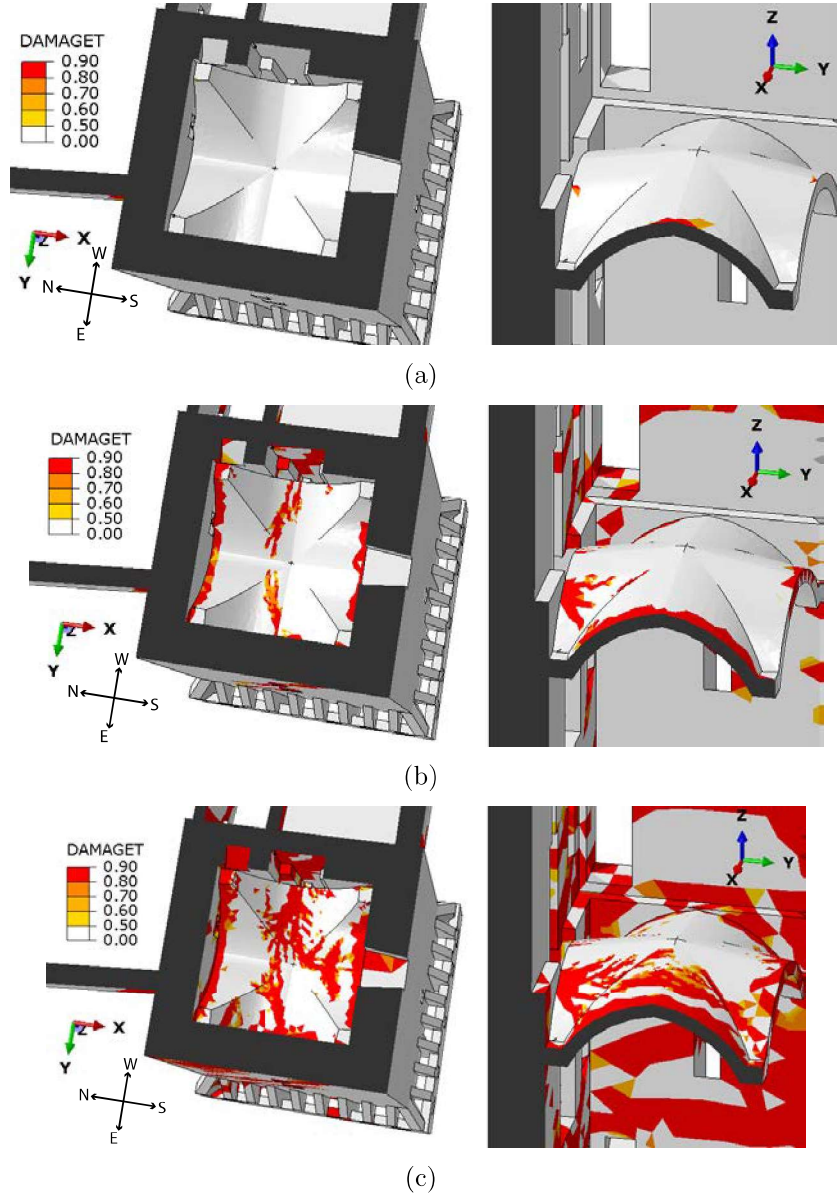
Figure 17: Nonlinear static damage contour plots of the Giulio II Hall's vault, South directed force. Bottom views (left) and section views (right).

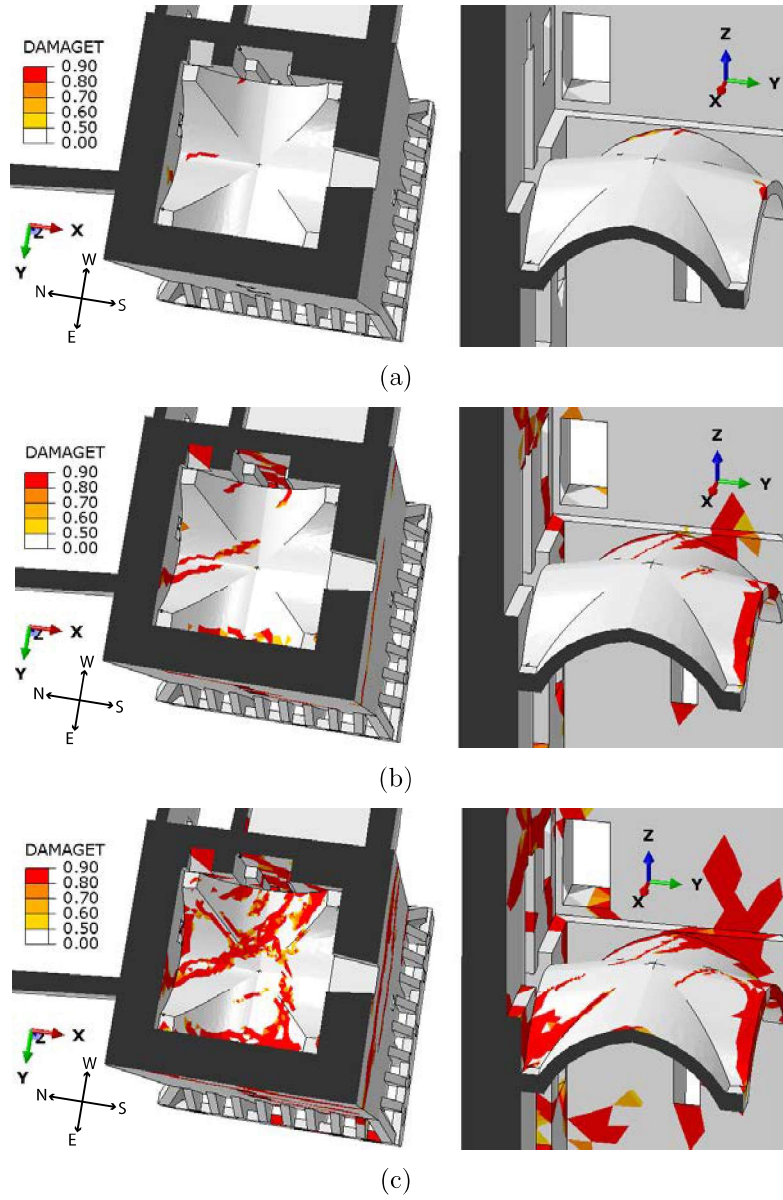
Figure 18: Nonlinear static damage contour plots of the Giulio II Hall's vault, North directed force. Bottom views (left) and section views (right).

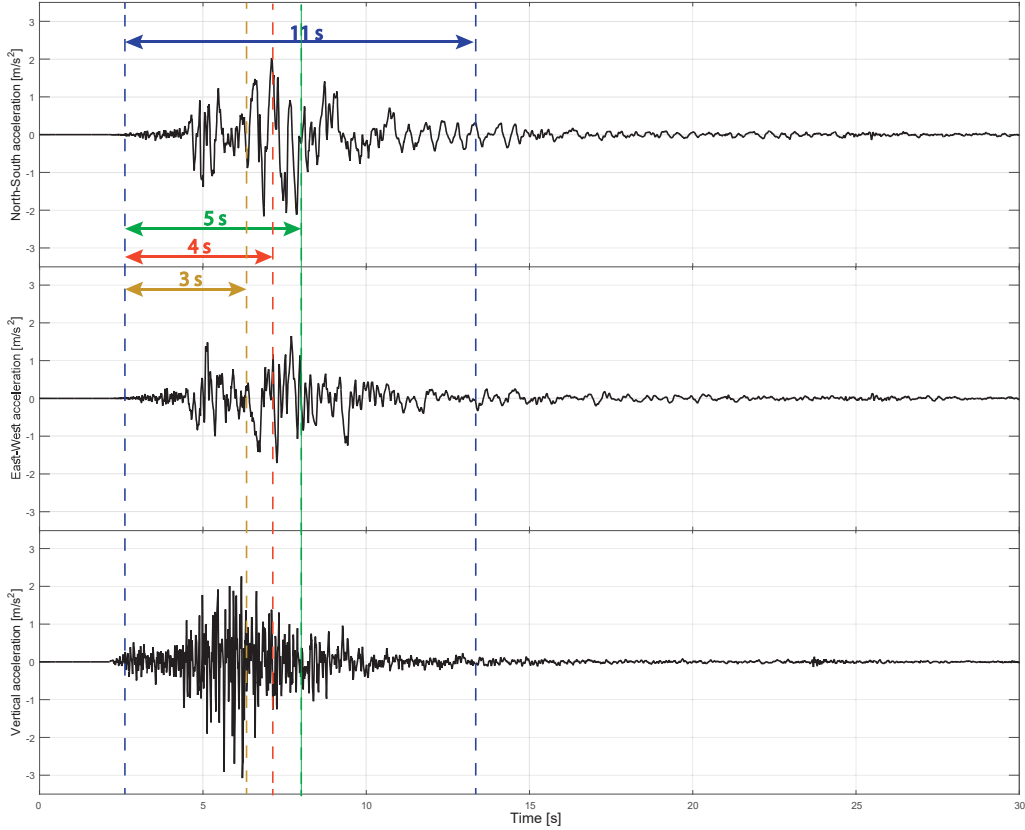
Nonlinear dynamic analyses have been performed using the only actual accelerogram available near to the fortress, recorded on May 29th at the *SANO* station (installed after the first seismic shock [40, 41]) located at approximately 150 m from the fortress. In particular, 11-seconds simulations have been performed by considering either the horizontal components only or also the vertical component of the accelerogram [42], see Figure 19.

Figure 19: Accelerograms recorded the May 29th 2012 at *SANO* station.

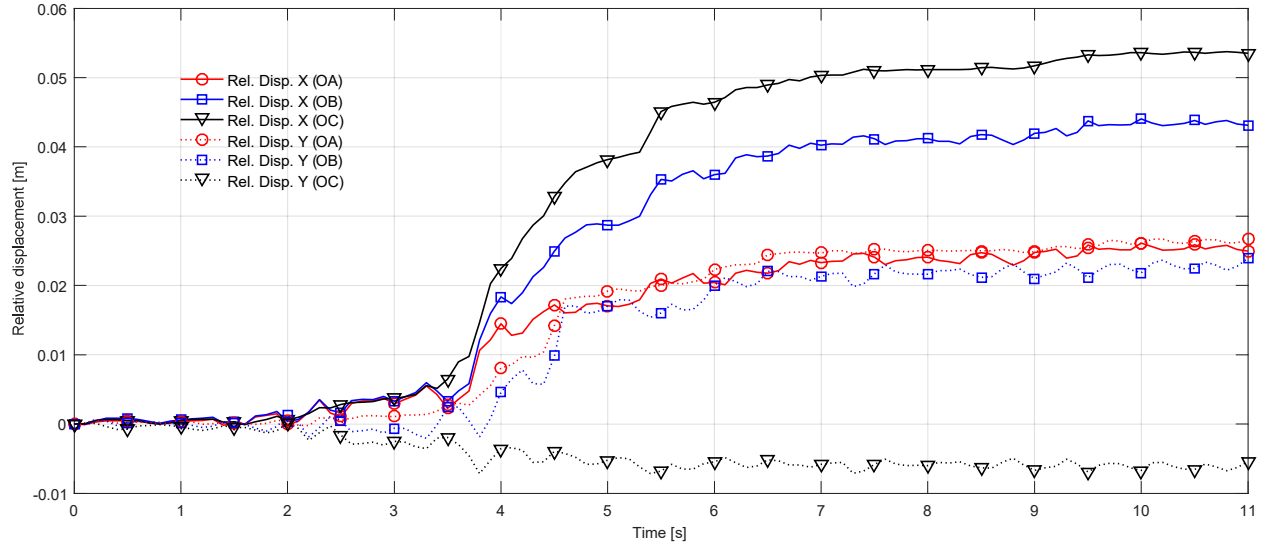
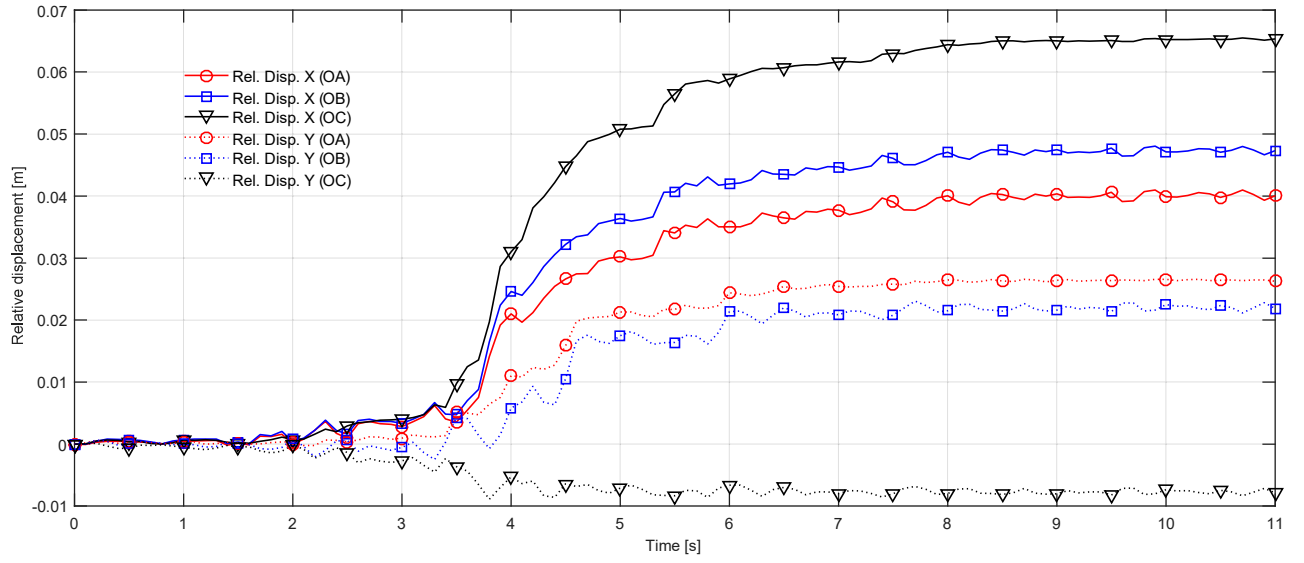
The time-histories of the Giulio II Hall's vault abutments relative displacements are reported in Figure 20 (computed with respect to the point O, see Figure 9(c)). As can be observed in Figure 20, the time-histories of the relative displacements of the vault's abutments of the case without vertical component of the earthquake (Figure 20(a)), are quite similar to the ones of the case with vertical component (Figure 20(b)). However, in the case with vertical component the relative and residual displacements are systematically greater than the case without. By inspecting such time-histories it appears that after the 3rd second of simulation (which corresponds more or less to the peak of the seismic input, see

Figure 20: Vault's abutments relative displacements time-histories measured in nonlinear dynamic analyses: (a) without and (b) with vertical component of the earthquake.

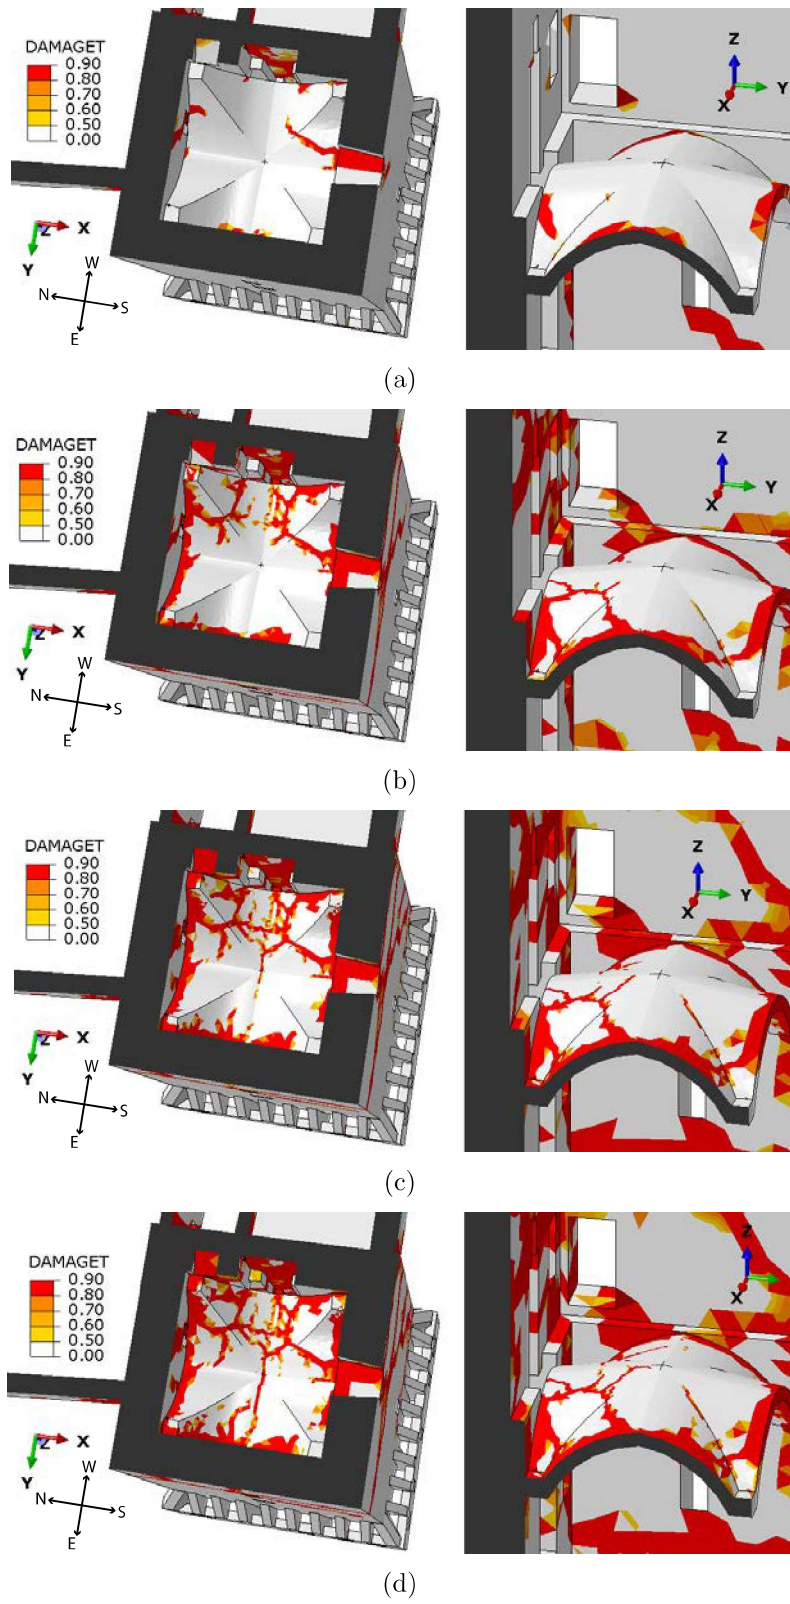
As far as it is concerned the damage evolution of the case without vertical component (Figure 21), after 3s (Figure 21(a)), cracks in the intrados of the vault begin to develop from the sides parallel to the E-W direction. Then, these cracks evolve and, at 4s (Figure 21(b)), the two limbs tend to link together in the central part. In addition, such limbs join the extremities of the chimney and, at 5s, they are completely connected creating a sort of "rectangle" just in front of the chimney (Figure 21(c)). This finding is in good agreement with the actual crack pattern experienced by the vault, i.e. with the collapse of the portion (a) which presents a pseudo-rectangular shape, see Figure 5(a). Such cracks are also present on the extrados, in a very similar way. Moreover, there is very a good agreement between the crack quasi-perpendicular to the E-W direction, which divides the vault in two parts, with the actual main crack (b) (Figure 4). Finally, the damage pattern at the end of the simulation (11s, see Figure 21(d)) is similar to the one at 5s (Figure 21(c)), as also confirmed by the time-history of the abutments relative displacements of Figure 20 where no substantial changes of displacements are recorded from 5s to 11s.

Figure 21: Nonlinear dynamic damage contour plots of the Giulio II Hall's vault, simulation without vertical component. Bottom views (left) and section views (right) at instants (a) 3s, (b) 4s, (c) 5s and (d) 11s.

pattern. By comparing the damage patterns of the simulations without and with vertical component (Figures 21 and 22, respectively) it appears that the latter is slightly wider than the first.
