Seismic-induced damage in historical masonry vaults: A case-study in the 2012 Emilia earthquake-stricken area

Antonio Maria D'Altri, Giovanni Castellazzi, Stefano de Miranda, Antonio Tralli,  
*Seismic-induced damage in historical masonry vaults: A case-study in the 2012 Emilia  
earthquake-stricken area*, Journal of Building Engineering, Volume 13, 2017, Pages  
224-243

# Seismic-induced damage in historical masonry vaults: a case-study in the 2012 Emilia earthquake-stricken area

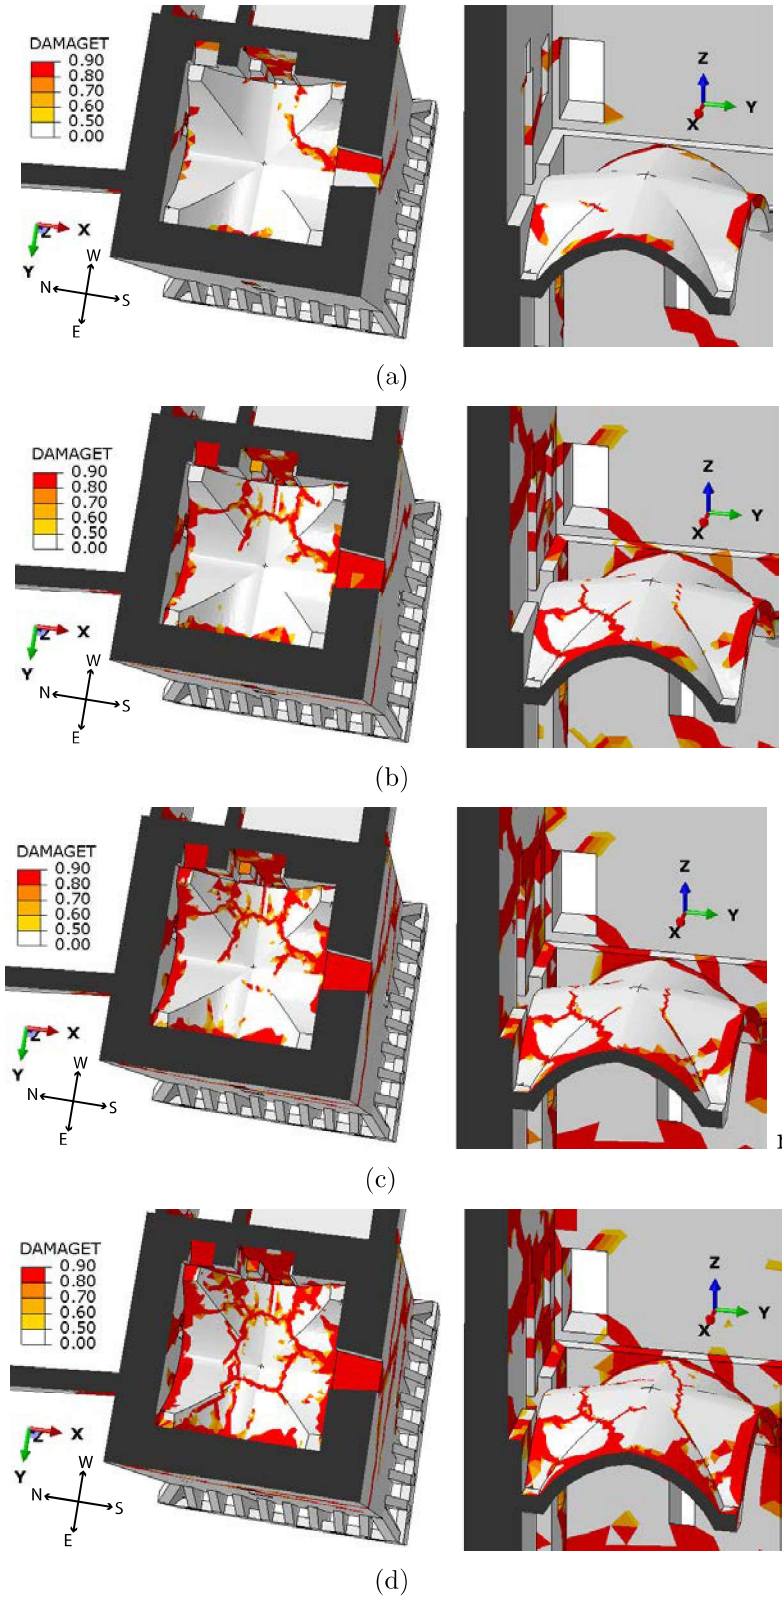
The damage pattern evolution in the simulation with vertical component (Figure 22) is similar to the one without vertical component (Figure 21). Indeed, also in this case a crack in the intrados of the vault arises (Figure 22(a)), which evolves in a sort of rectangle close to the chimney passing also through the vault in a direction quasi-perpendicular to the East direction. Therefore, also in this case there is a good agreement with the actual crack

Figure 22: Nonlinear dynamic damage contour plots of the Giulio II Hall's vault, simulation with vertical component. Bottom views (left) and section views (right) at instants (a) 3s, (b) 4s, (c) 5s and (d) 11s.

pattern. By comparing the damage patterns of the simulations without and with vertical component (Figures 21 and 22, respectively) it appears that the latter is slightly wider than the first.
