Calcium phosphate coatings for marble conservation: Influence of ethanol and isopropanol addition to the precipitation medium on the coating microstructure and performance

Sassoni E., Graziani G., Franzoni E., Scherer G.W., Calcium phosphate coatings for marble conservation: influence of ethanol and isopropanol addition to the precipitation medium on the coating microstructure and performance, Corrosion Science 136 (2018) 255–267

## **Calcium phosphate coatings for marble conservation: influence of ethanol and isopropanol addition to the precipitation medium on the coating microstructure and performance**

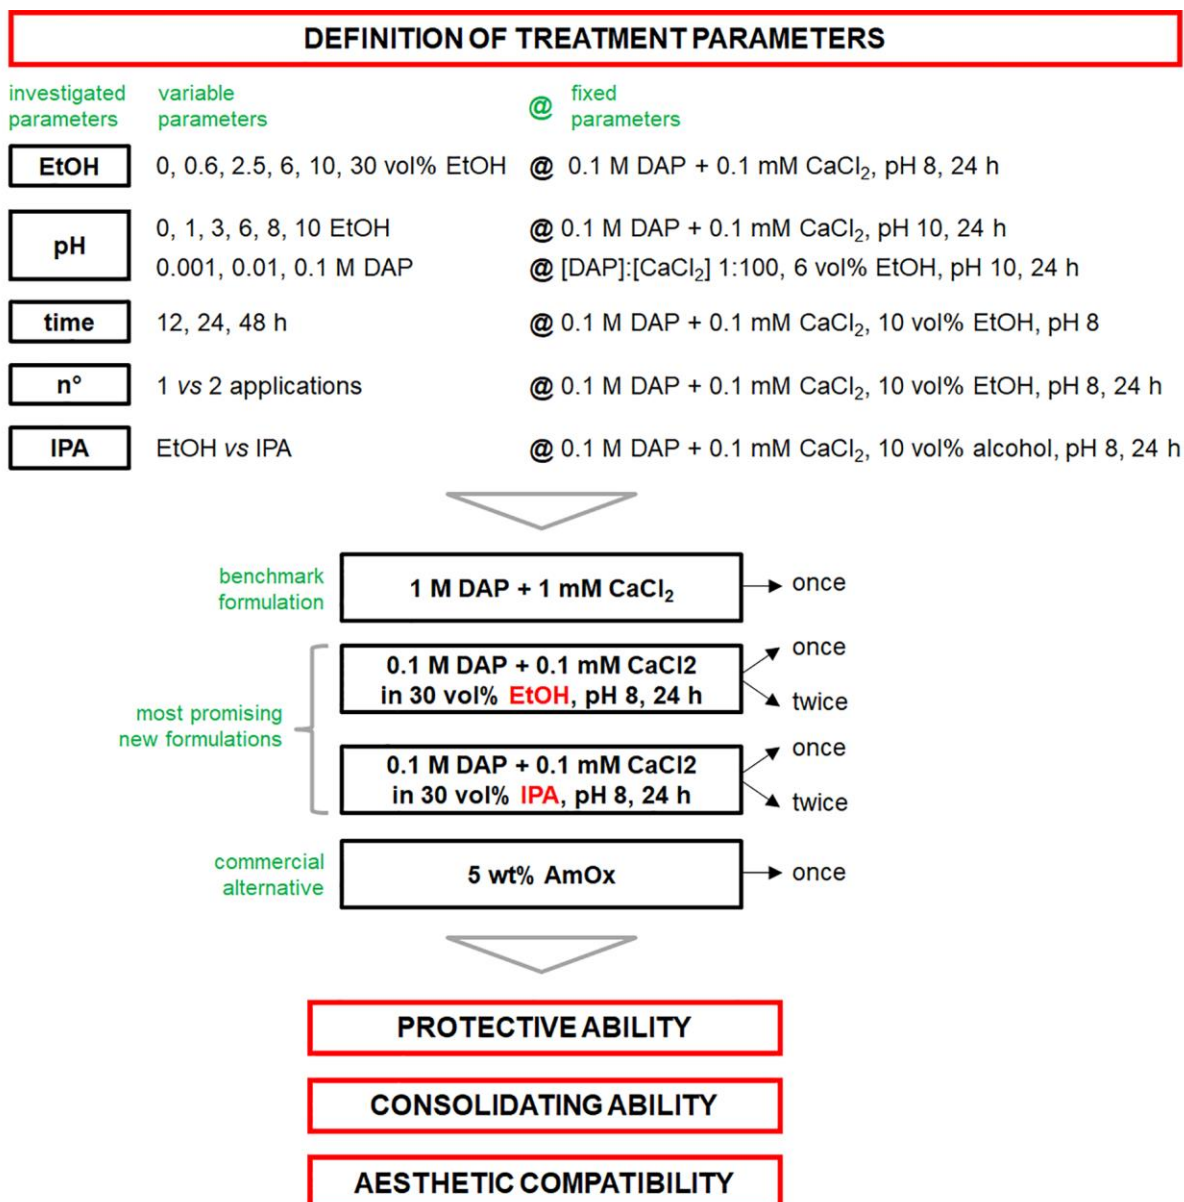
**Figure 1.** Scheme illustrating the investigated parameters and the whole rationale of the study.

The possible improvement of this formulation, in terms of surface coverage and microstructure, was investigated by exploring the influence of the parameters described in § 2.2.1 - § 2.2.5. A summary of the investigated parameters is reported in Figure 1. Treatment by a 5 wt% aqueous solution of ammonium oxalate (labelled as "AmOx") was also taken as a commercial benchmark. All treatments were performed by immersing a cubic specimen in a plastic container with 200 ml of solution and then rotating the containers to ensure stirring of the solutions during treatment. The treatment duration was 24 hours, unless otherwise specified. At the end of the treatment, the specimens were taken out of the solutions, rinsed with deionized water and then dried at room temperature. The features of the different coatings were determined as described in § 2.2.6.

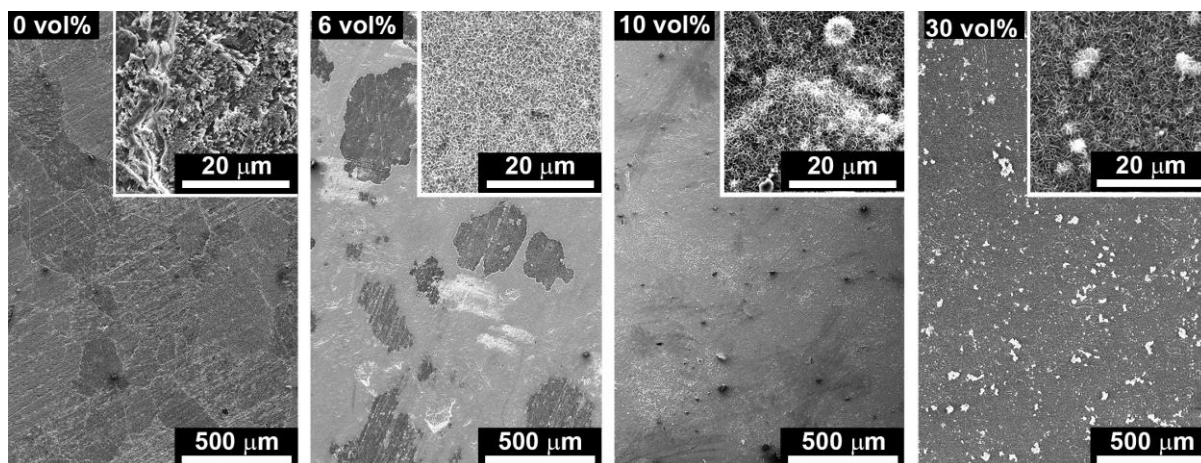
**Figure 2.** Coverage of marble surface by CaP coatings formed by reaction with a 0.1 M DAP and 0.1 mM CaCl<sub>2</sub> solution containing increasing amounts of ethanol.

When the DAP concentration was reduced and ethanol was added to the solution, cracking was prevented and a much denser microstructure was achieved (Figure 2), which allowed a significant improvement in the protecting ability (“EtOH” sample in Figure 2). The time required for pH increase from 4.75 to 5.75 was more than doubled (from 3.9 h to 8.3 h, Table 2), and the “EtOH” curve remained below the untreated reference “UT” for the whole duration of the test (Figure 9). When observed after the acid attack test (Figure 10), the coating exhibited no diffused detachment (unlike the “1 M DAP” sample), but still some cracking, which allowed the acid to reach the substrate and cause the increase in pH registered after some time.

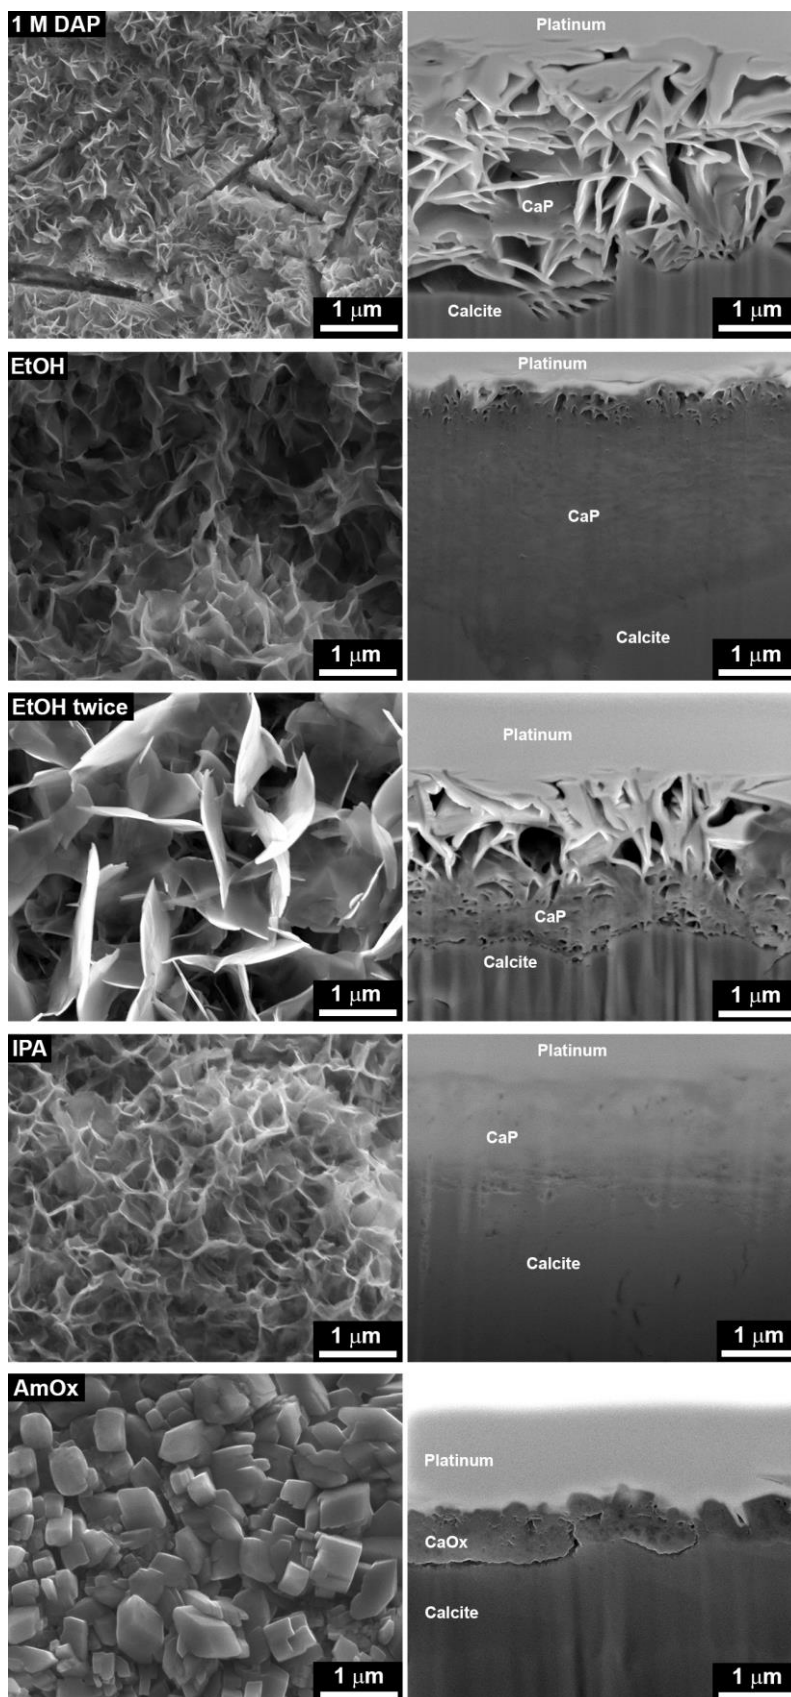
**Figure 3.** Surface morphology (left) and cross section (right) of marble samples subjected to different treatments.

Because repeated treatments had been found to significantly improve the surface coverage of marble particles by CaP coatings [22], the effect of repeating the “EtOH” treatment twice was investigated. As reported in Figure 3, this led to formation of huge CaP flakes on top of the coating, visible both from observation of the treated surface and in the FIB cross section (Figure 3). Even if the underlying layer exhibits a much denser microstructure than the superficial flakes, the adhesion at the coating-substrate interface seems worse compared to the single application, likely because the second treatment caused excessive growth and partial detachment of the coating from the substrate.

When repeated twice, the EtOH treatment performed a little worse, the curve basically overlapping with that of the “1 M DAP” sample (Figure 9) and the time for pH shift decreasing to 6.8 h (Table 2). Accordingly, diffused cracking was noticed when the sample was analysed after the acid attack test (Figure 10). The worsening of the treatment performance when repeated twice is in agreement with the less dense microstructure observed in the “EtOH twice” specimen (Figure 2), likely related to the excessive growth of the film during the second application.

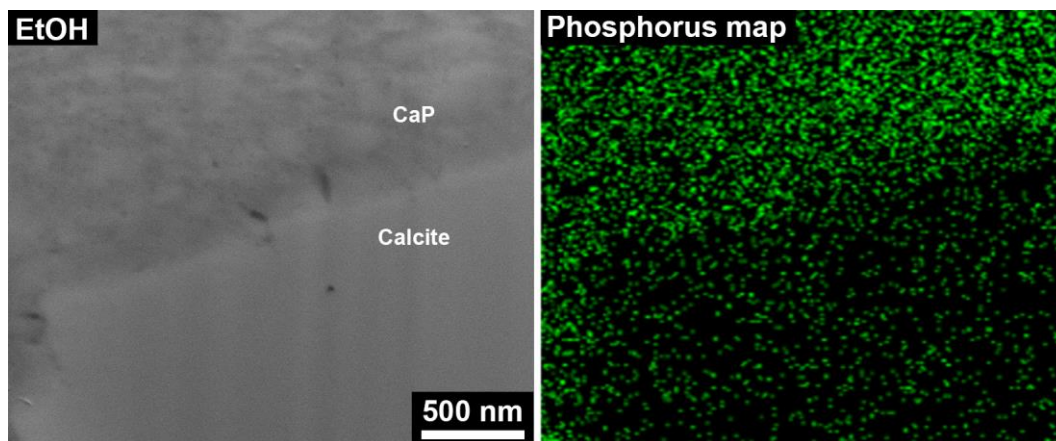
**Figure 4.** Interface between the calcite substrate and the CaP coating (left) and corresponding phosphorus map (right).

In addition to the increased surface coverage, ethanol addition also had a significant effect on the coating microstructure and tendency to crack. If one compares a specimen treated with a solution containing 0.1 M DAP, 0.1 mM CaCl<sub>2</sub> and 10 vol% ethanol (“EtOH” sample) with a specimen treated with a 1 M DAP and 1 mM CaCl<sub>2</sub> solution (“1 M DAP”), the following observations can be made. In both cases complete coverage of the marble surface is achieved. However, the “1 M DAP” specimen is affected by some cracking, likely developed during drying, while the “EtOH” specimen exhibits no visible cracks (Figure 3). In terms of porosity of the coating, FIB-SEM revealed that numerous large pores are present in the “1 M DAP” specimen (Figure 3), which are expected to negatively affect the acid resistance (cf. § 3.1.6). On the contrary, the “EtOH” specimen exhibits a much denser microstructure and no visible pores (Figure 3), apart from the top of the coating (right after the platinum layer), where the typical flower-like morphology of CaP is present. Notably, at the interface between the calcite substrate and the CaP coating (about 2-4 μm thick), good adhesion seems present (Figure 4).

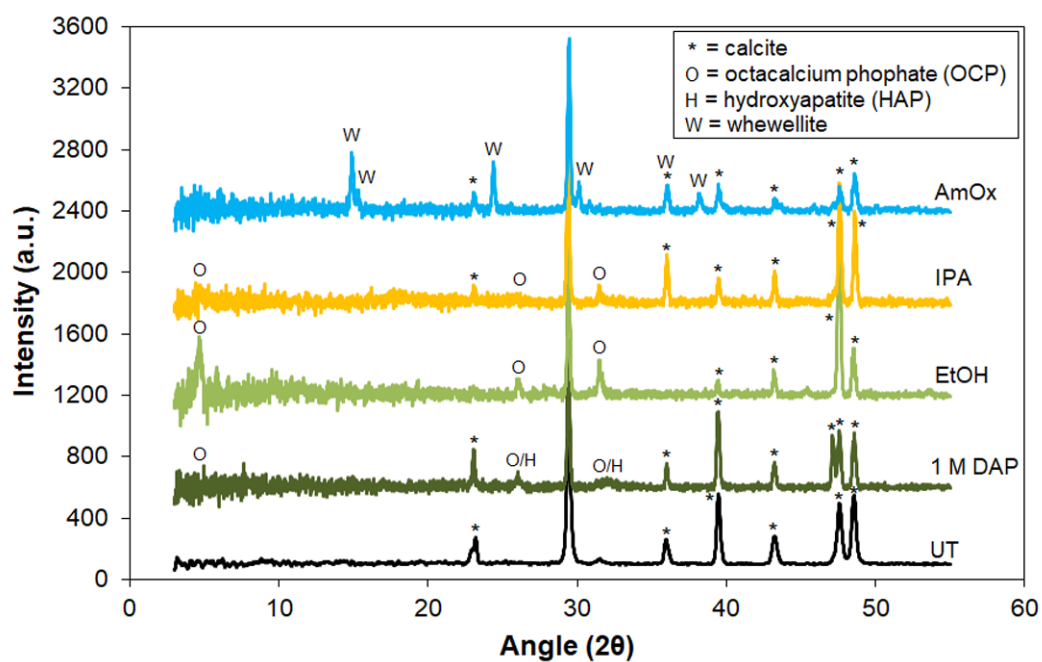
**Figure 5.** Mineralogical composition of untreated and treated specimens.

Consistently with the theoretical expectations, the amount of PO<sub>4</sub><sup>3-</sup> ions in solution when 10 vol% IPA was added was found to be much higher than when the same amount of ethanol was added (0.71 mg/l vs 0.32 mg/l, respectively), basically corresponding to a 30 vol% ethanol addition (0.76 mg/l) (Table 3). Accordingly, the microstructure of the CaP coating formed with IPA addition was even denser than in the case of ethanol, the interface between the calcite substrate and the coating being hardly distinguishable (Figure 3). In terms of composition, the coating consisted of OCP, as in the case of ethanol addition (Figure 5).

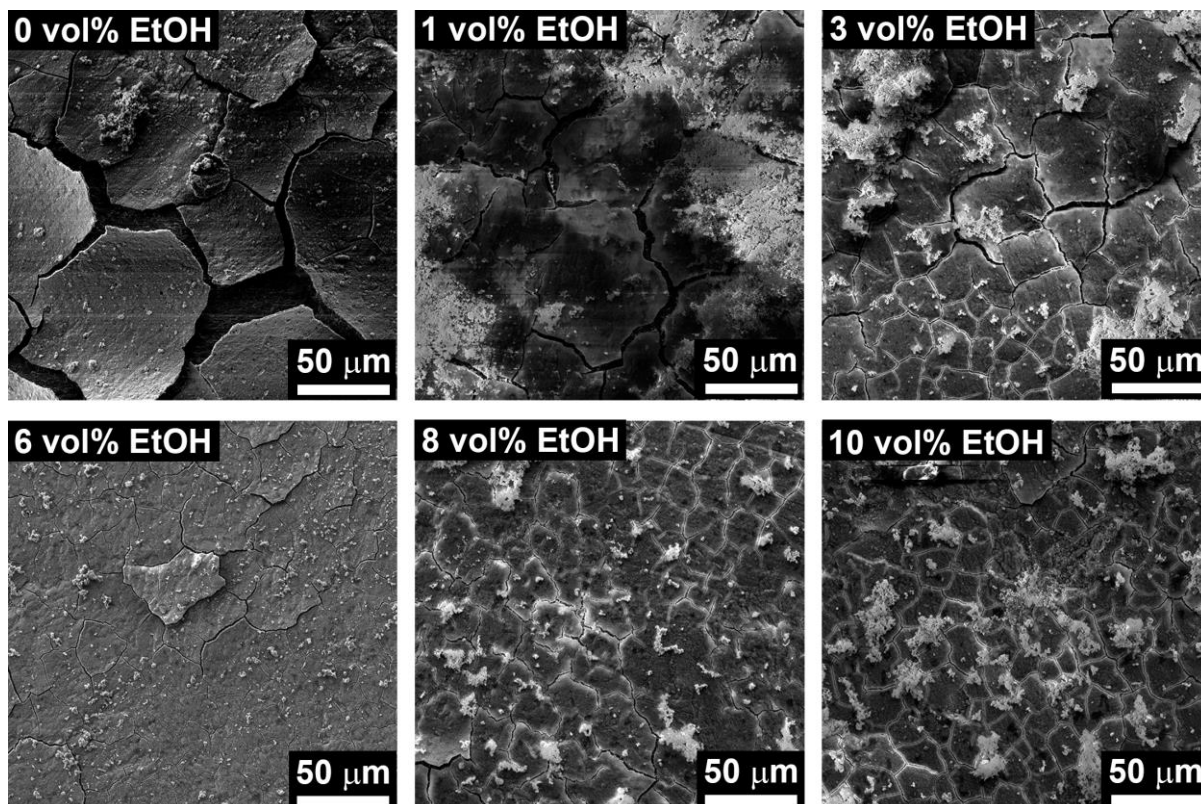
**Figure 6.** Morphology of CaP coatings formed at pH 10 for increasing amount of ethanol addition to the DAP solution.

Increasing the pH of the DAP solution to 10 using  $\text{NH}_4\text{OH}$  had a huge effect on the CaP coating development, as illustrated in Figure 6. Even with no ethanol addition, at pH 10 abundant formation of new phases occurred when marble was treated with a 0.1 M DAP and 0.1 mM  $\text{CaCl}_2$  solution, while no formation took place at pH 8 (Figure 2). This is a consequence of the higher amount of  $\text{PO}_4^{3-}$  ions originating from DAP dissociation at high pH [19]. However, because of excessive growth, the CaP coating is extensively cracked (Figure 6), which prevents effective acid protection. To try to avoid cracking, two routes were tested. First, increasing ethanol additions to the DAP solution were tested, to develop a more adherent coating with more refined

microstructure. As illustrated in Figure 6, a reduction in cracking and flake detachment was achieved, but cracks were not completely eliminated. Moreover, the combination of high pH and high ethanol additions led to an excessive  $\text{PO}_4^{3-}$  amount, which resulted in abundant precipitation of CaP particles over the coating (Figure 6). Therefore, considering that at higher pH a lower concentration of DAP could be enough to achieve complete surface coverage, a progressive reduction in DAP concentration from 0.1 M to 0.01 M and 0.001 M was tested (the  $\text{CaCl}_2$ :DAP concentration always being 1:1000). As illustrated in Figure 7, a DAP concentration of 0.01 M at pH 10 was enough to obtain complete coating of the surface. However, the coating exhibited some cracking (Figure 7). A further reduction of the DAP concentration by 10 times led to no coating formation (Figure 7), because the  $\text{PO}_4^{3-}$  content became too low. Since the boosting effect of high pH was always linked to cracking in the tested conditions, only treatments at pH 8 were considered for the prosecution of the study.

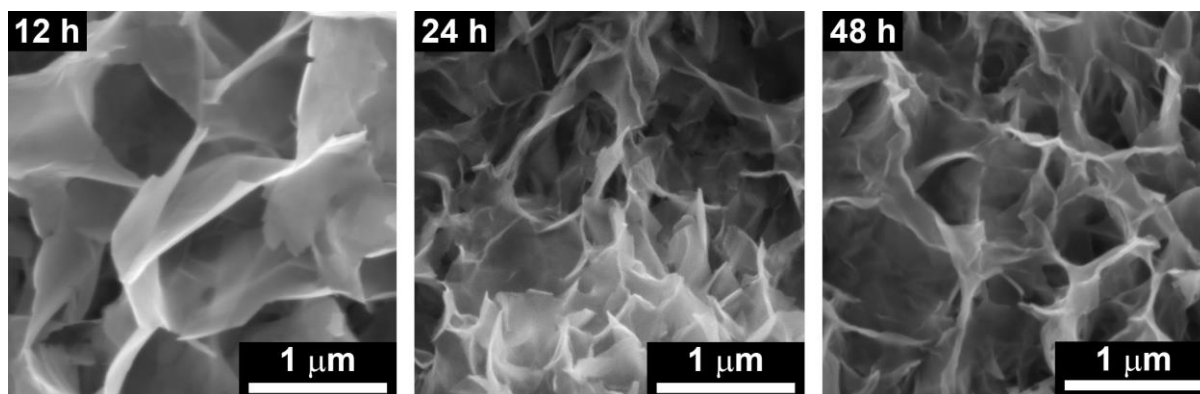
**Figure 8.** Morphology of CaP coatings formed after treatment for increasing time.

Considering that ethanol addition significantly favours formation of the new CaP coating, the effect of reducing the treatment duration from 24 to 12 hours was investigated. At the same time, because an evolution of the phase composition and microstructure has been reported in the literature passing from 24 to 48 hours (however in different conditions, especially without stirring of the DAP solution [43]), a longer reaction time was also considered. However, in the case of a solution containing 0.1 M DAP, 0.1 M  $\text{CaCl}_2$  and 10 vol% ethanol, no remarkable difference in the coating morphology was noticeable for the different reaction times investigated (Figure 8), hence treatment for 24 hours (as recommended in [3]) was adopted for further comparisons.

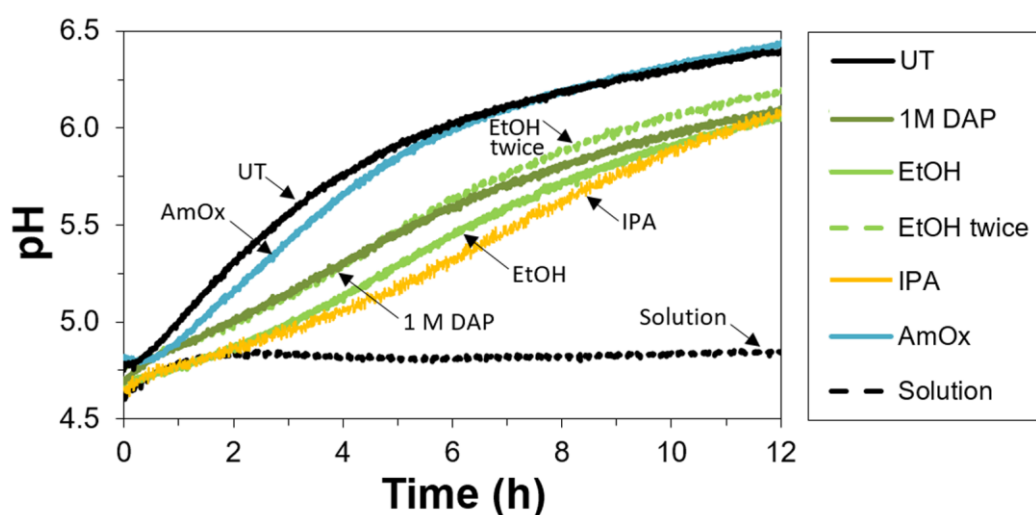
**Figure 9.** Acid resistance (in terms of pH increase over time) of untreated and treated specimens (the curves are averages for two specimens, one tested on the rougher surface and one tested on the smoother surface). The curve of the acid solution alone (with no sample) is illustrated as well.

For the most promising formulations of the phosphate treatments (namely, “EtOH”, “EtOH twice”, “IPA” and the reference “1 M DAP”, Table 2), as well as the reference conditions “UT” and “AmOx”, the results of the acid attack test are illustrated in Figure 9. Results are expressed in terms of pH increase over time of the acid solution simulating rain, in which the samples had been immersed. The appearance of the coating before and after the acid attack test is illustrated in Figure 10.

First, the stability of the solution pH when no sample was immersed was checked and no pH increase was in fact recorded. The “UT” sample caused a quick increase of pH during the test (Figure 9). This increase is due to H<sup>+</sup> ions in the solution being consumed as Ca<sup>2+</sup> ions are released from calcite [1]. Since the Ca<sup>2+</sup> concentration increases as the test proceeds, the rate of dissolution decreases, because the dissolved Ca<sup>2+</sup> ions remain in the solution [1]. At the end of the test, the marble surface is significantly etched, so that single grains and grains boundaries become apparent (Figure 10).

The “1 M DAP” treatment was able to provide some protection against dissolution, as denoted by the fact that the respective curve lies well below the untreated reference (Figure 9). For instance, if one compares the time required for the solution pH to increase by 1 unit (from 4.75 to 5.75), the “1 M DAP” treatment allowed an increase from 3.9 h (“UT”) to 7.3 h (“1 M DAP”) (Table 2). However, at the end of the acid attack test, the coating exhibited several areas where it had been detached and removed (Figure 9). This is a consequence of the presence of cracks and pores

The acid resistance of the “IPA” sample resulted improved with respect to the “EtOH” sample, especially at the beginning of the test (Figure 9), the time required for pH increase to 5.75 being the longest (8.7 h against 8.3 h for the “EtOH” sample and 3.9 h for the “UT” reference, Table 2). The ESEM observation of the coating after the acid attack test revealed that no diffuse detachment occurred, even if cracks are visible (similarly to the case of the “EtOH” sample) (Figure 10).

It is important to point out that, even if initially they exhibited sensibly different behaviours, the curves of the different phosphate treatments converge as the test proceeds, so that after 12 h only minor differences are present (Figure 9). This is a consequence of the fact that, even if the coating exhibits complete coverage and no cracks, still some sporadic defects can be noticed. As illustrated in Figure 11, when impurities are present over the marble surface, the formation of the coating is interrupted. The remaining bare areas are weak points, from where the attack on the marble surface can start and propagate to the adjacent areas, where the coverage was originally good. Moreover, it was observed that the continuity of the coating is sometimes abruptly interrupted at the boundary between two grains, so that one calcite grain has perfect coverage and the adjacent one remains almost bare (Figure 11). This is thought to be a consequence of the different orientation of calcite grains, which might be more or less favourable for the development of the CaP coating. In fact, epitaxial growth of HAP over calcite has been reported in the literature, but only along privileged crystallographic directions of the calcite and HAP crystals [48]. Along these directions, the distance between the phosphate groups in the HAP crystal closely matches the distance between carbonate groups in the calcite crystal, so that epitaxial growth can occur [48]. However, in marble where calcite grains have random orientation, this is generally not the case. Epitaxial growth might occur over those grains that have a particularly favourable orientation (over these grains, HAP nucleation is also favoured by the reduction in supersaturation needed for nucleation [48]) and from these grains the coating can spread to the adjacent ones with different orientation. However, when the coating development reaches grains with a particularly unfavourable orientation, formation over these grains may be impeded. Possible routes to overcome the influence of the underlying calcite crystals orientation on the development of the phosphate coating are currently being investigated.

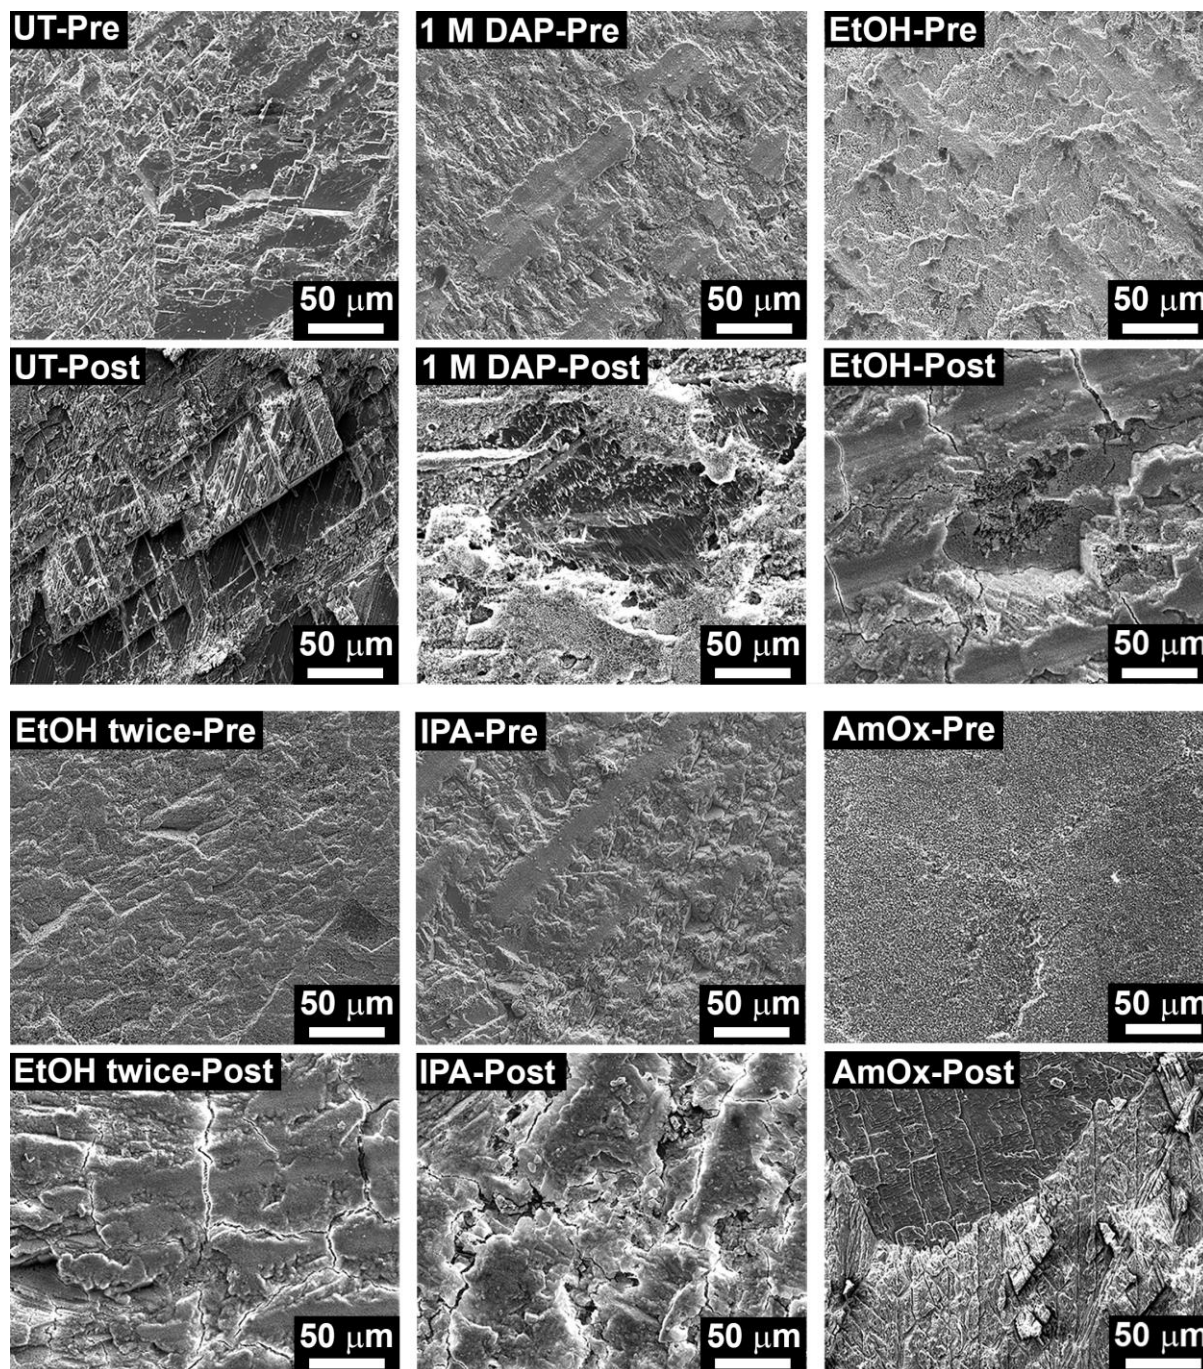
**Figure 10.** Surface morphology of untreated and treated specimens, before (“-Pre”) and after (“-Post”) the acid attack test.

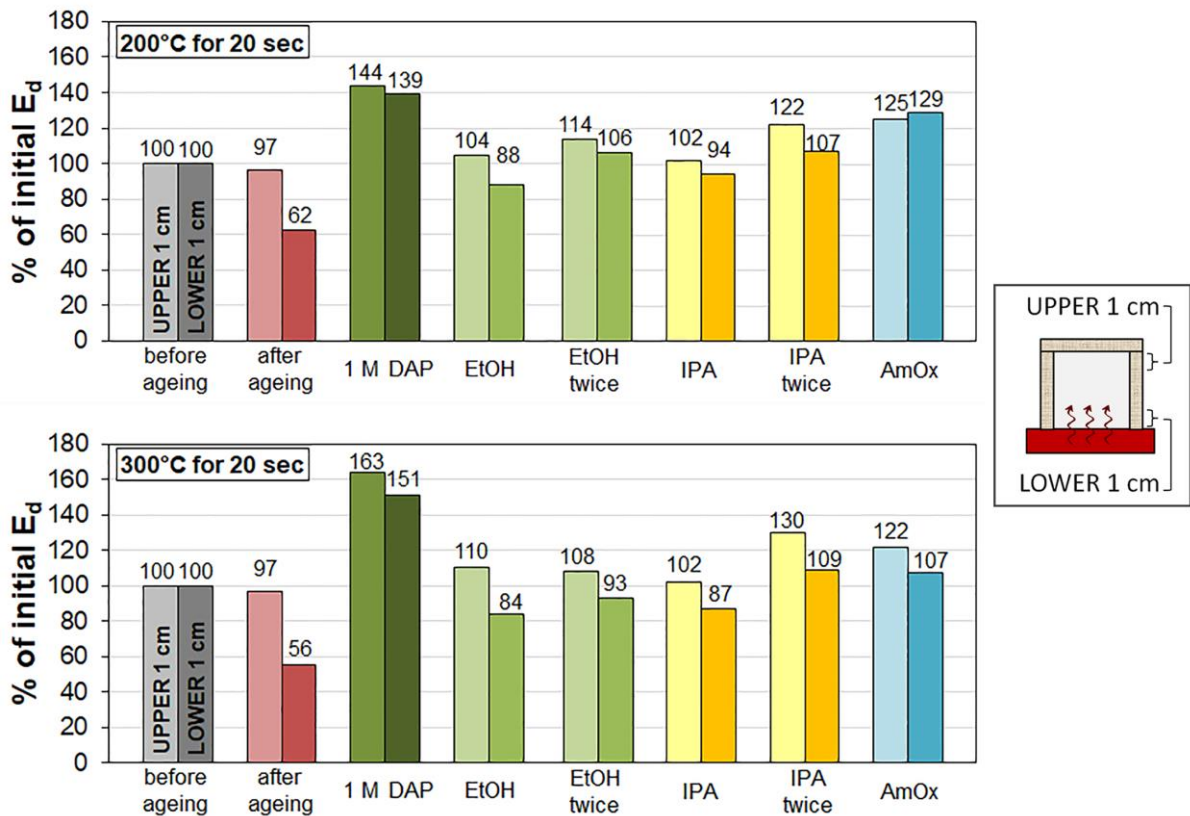
**Figure 12.** Variations in dynamic elastic modulus ( $E_d$ ), with respect to the initial value, after accelerated ageing and after consolidation by different treatments. Values refer to the lower and upper 1 cm of the specimens, which had been subjected to accelerated ageing as illustrated in the inset: one face of the specimens was put in contact with the hot plate (in red), while the sides and the top were wrapped with a high temperature resistant insulator (in grey), to ensure the uni-directional heat flux.

After accelerated ageing by contact with a hot plate for 20 seconds, in the first 1 cm from the heated surface the specimens exhibited a 38%  $E_d$  decrease after heating at 200 °C and a 44%  $E_d$  decrease after heating at 300 °C (Figure 12). These values are in very good agreement with those predicted by the mathematical model (35% and 42%, respectively) [28], which was used to calculate the heating temperature and time required to produce damage similar to that experienced in the field by naturally weathered marble [27-29]. At the same time, the upper 1 cm of the sample underwent no substantial  $E_d$  decrease (Figure 12), as expected.

Consolidation by the “1 M DAP” treatment proved to be the most effective among all the investigated treatments, being able to increase  $E_d$  in the weathered part up to 139% (samples heated at 200 °C) and 151% (samples heated at 300 °C) of the initial value. The higher consolidating efficacy in samples with higher initial damage is consistent with previous results obtained on limestone [21]. The fact that the “1 M DAP” treatment was able to increase mechanical properties the most, in spite of the presence of cracks and pores in the formed CaP layer, derives from the following fact. Whereas in the case of *protection* it is essential that the formed coating continuously cover the surface and be crack- and pore-free, in order to prevent acid from reaching the substrate, this is not as important in the case of *consolidation*. In this latter case, the main requirement is that the newly formed material be able to seal the tip of the cracks among grains [50]. If the crack tip is effectively sealed, then the continuity of the coating and the presence of cracks and pores are not as detrimental as in the case of acid protection (however, cracks in the coating might propagate to the crack between grains, so uncracked coatings are nevertheless preferable). A potentially negative aspect of the high consolidating effectiveness of the “1 M DAP” treatment is that not only the initially deteriorated part (lower 1 cm), but also the initially sound part (upper 1 cm) underwent a significant mechanical improvement (Figure 12). This is undesired, because over-strengthening of the sound part might lead to mechanical incompatibility between the treated part and the substrate, potentially leading to its detachment [51,52]. Therefore, treatments able to restore mechanical properties of the weathered part, without causing excessive strengthening of the sound part are recommended [51,53].

Specimens consolidated by “AmOx” exhibited remarkable mechanical improvement, second only to the “1 M DAP” specimens (Figure 12). In fact, the initial modulus in the weathered part was completely restored and even enhanced after a single application ( $E_d$  up to 129% and 107% in specimens heated at 200 and 300 °C, respectively), with considerable strengthening also of the sound part ( $E_d$  up to 122–125%). Such mechanical improvement is notable, considering that in a previous study we found the consolidating ability of the ammonium oxalate treatment to be very modest [29]. The poor consolidating behaviour of ammonium oxalate was ascribed to the reduced depth of formation of whewellite [29], owing to the very rapid reaction between the ammonium oxalate solution and calcite [54]. In addition to the different thickness of samples to be consolidated (1 cm in the present case, 2 cm in the previous case [29]), a possible explanation for the better results obtained in this study may be the different application technique. While in the previous study the ammonium oxalate solution had been applied by brushing [29], in the present study it was applied by vacuum impregnation, which likely allowed to achieve a deeper and quicker penetration of the consolidating solution into marble microcracks, leading to higher strengthening. However, it should be noted that, given the low resistance of the newly formed whewellite to dissolution in acid, it is not unlikely that most of the mechanical improvement induced by the “AmOx” treatment could be lost after prolonged exposure to rain.

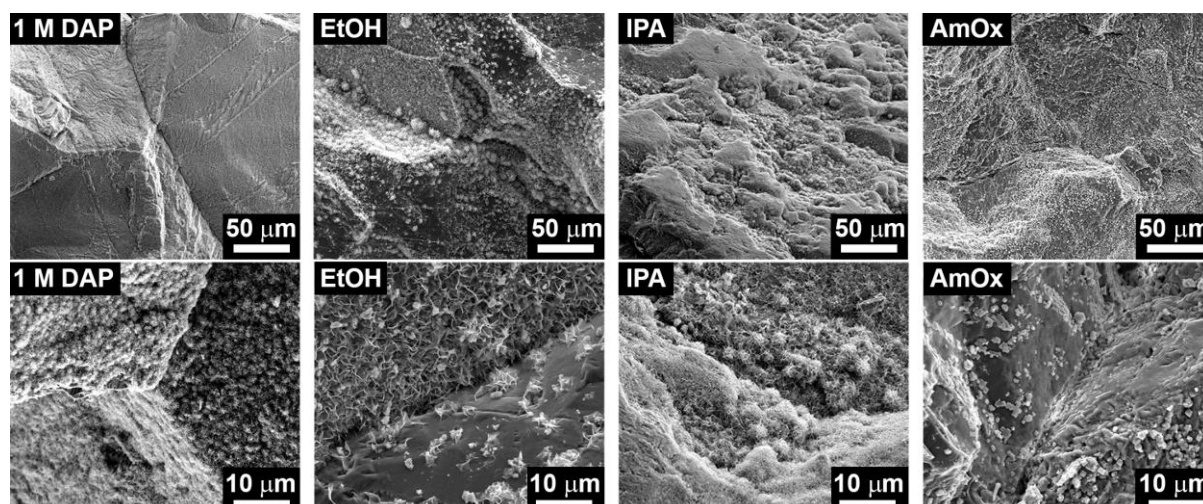
**Figure 13.** New phases formed inside microcracks between calcite grains after consolidation by different treatments.

After the  $E_d$  measurement, the formation of new phases in the microcracks among calcite grains was assessed by ESEM observation of fracture samples obtained by chisel from the tested specimens.
