# The effects of in-plane shear displacements at the springings of Gothic cross vaults

Carmela Carfagnini<sup>1</sup>, Simonetta Baraccani<sup>1</sup>, Stefano Silvestri<sup>1</sup>, Dimitris Theodossopoulos<sup>2</sup>

## Abstract

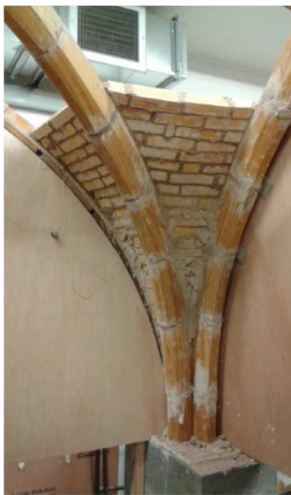
**Fig. 4:** (a) Springing built without falsework. (b) Plastic panels falsework for the subsequent courses.

The units were laid in rows for each web and were bonded with lime mortar. The construction started from the supports and each corner was built without falsework as the rows were quite vertical (Figure 4a), but a falsework was required when the row span and the web curvature increased (Figure 4b).

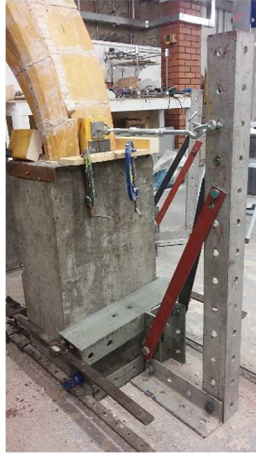
**Fig. 6 :** (a) The turn-buckle connected to a rigid steel reaction frame. (b) The position of the points monitored during the test.

Shear displacement to the springings on piers 1 and 2 was applied manually through a turn-buckle connecting each springing to a steel stiff reaction frame (Figure 6a). Space displacements of

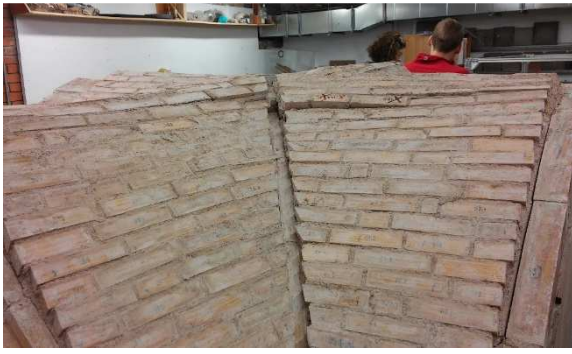
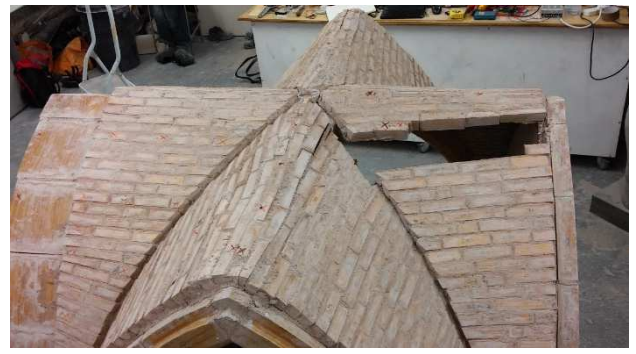
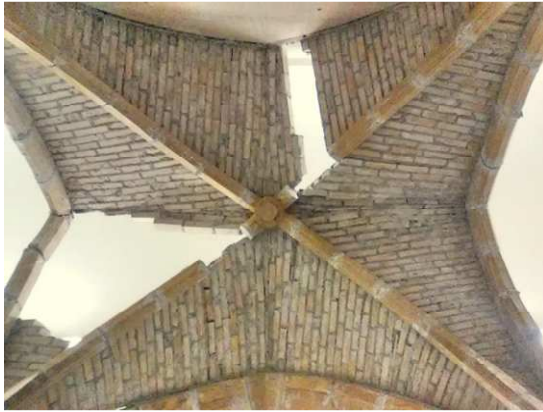
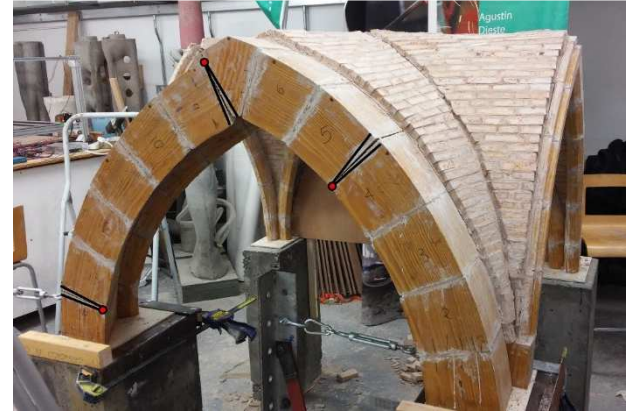
**Fig. 8:** (a) The crack pattern at the shear displacement of 30mm, (b) Collapses at a shear displacement of 35mm, (c) Partial collapse at the 50 mm stage, (d) Hinges on the nave arch at 45mm.

- during the 35 mm stage, partial failure of web F occurred (orange area in Figures 7 and 8b). The bigger crack at the 30 mm stage detached the voussoir on the rib 1-3 and this caused a rotation of the cracked web around the nave arch. A new long “sliding” crack also developed along the same rib on the intrados of the entire web C;

- further increasing of the shear displacement up to 45 mm caused a partial collapse in web C (yellow area in Figures 7 and 8c). The nave arch looked very deformed and hinges are clearly recognizable (Figure 8d);

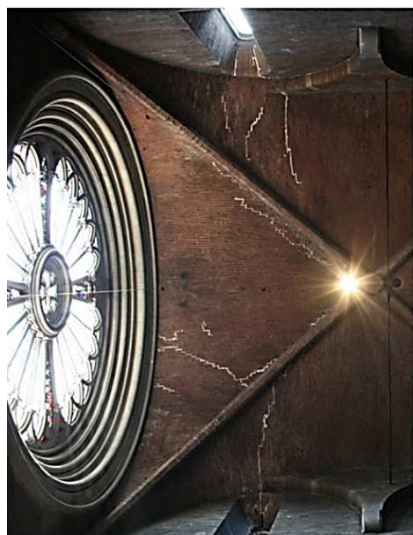
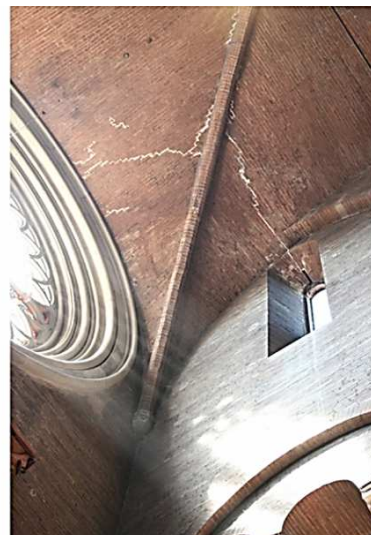
**Fig. 18:** Comparison between (a) the intrados of the tested vault and (b,c) the post-earthquake cracks observed in the intrados of the Modena Cathedral façade vault VI. The rigid edge is considered to lie along the rose window.

Figure 18 compares the intrados cracks of the tested vault with the post-earthquake intrados cracks observed in the vault of the nave next to the façade (V1). A similar pattern is observed: (i) two “opening” cracks formed on two adjacent webs at 45° with respect to the diagonal rib, (ii) sliding cracks along the ribs. The weakness is in both cases along the bed joints and the cracks start from the diagonal ribs spreading on the adjacent webs.
