Carfagnini, C., Baraccani, S., Silvestri, S., Theodossopoulos, D. (2018). The effects of in-plane shear displacements at the springings of Gothic cross vaults. *CONSTRUCTION AND BUILDING MATERIALS*, 186, 219-232 [10.1016/j.conbuildmat.2018.07.055].

# 1 **The effects of in-plane shear displacements at the springings of Gothic** 2 **cross vaults**

27 Masonry cross vault - Experimental test - Shear displacement - Springings

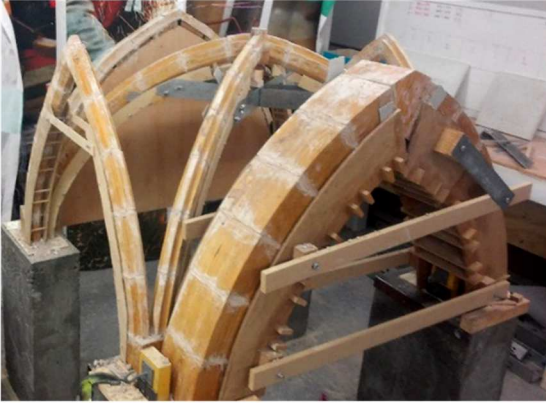
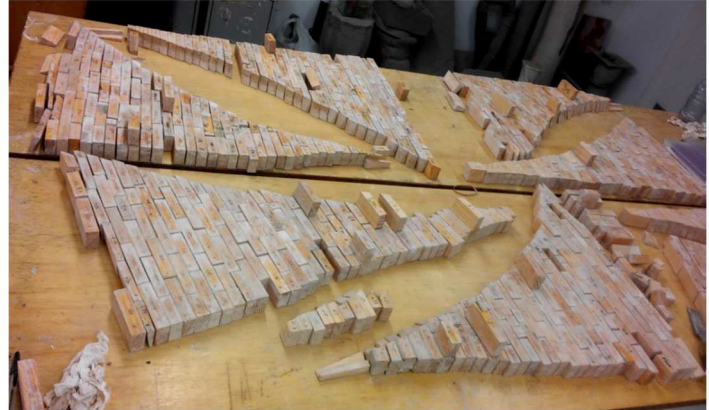
7 **Fig. 3:** (a) Construction of the vault arches. (b) Timber blocks for the webs.

1 Secondly, the webs were filled with timber blocks of uniform thickness. The blocks were cut and  
2 arranged to reproduce the masonry bond pattern and particular attention was paid to fit them along  
3 the ribs by forming a dihedral section specific for the end block of each row (Figure 3b).

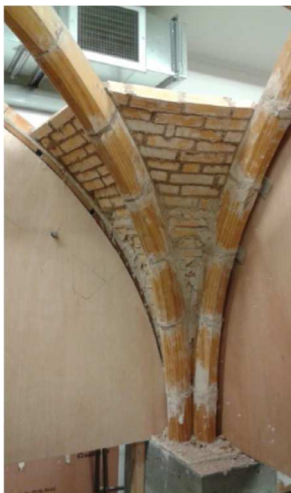
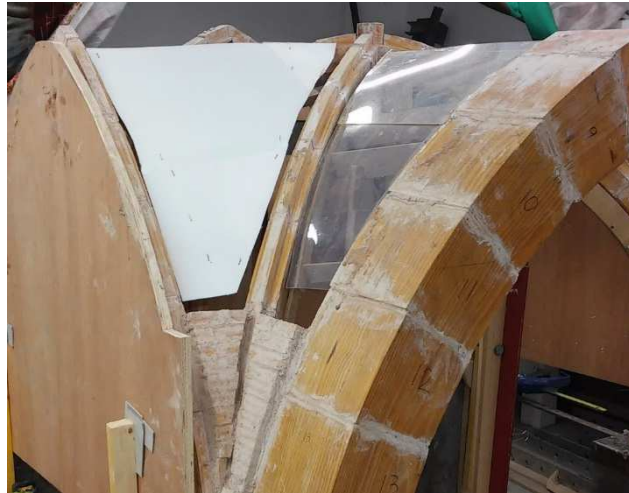
16 **Fig. 4:** (a) Springing built without falsework. (b) Plastic panels falsework for the subsequent courses.

9 The units were laid in rows for each web and were bonded with lime mortar. The construction  
10 started from the supports and each corner was built without falsework as the rows were quite  
11 vertical (Figure 4a), but a falsework was required when the row span and the web curvature  
12 increased (Figure 4b).

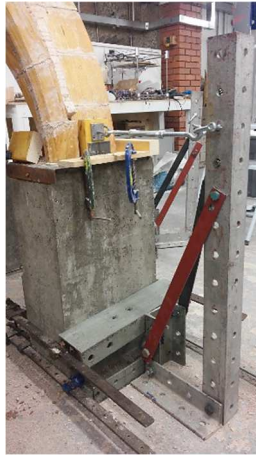
5  
 6  
 7 **Fig. 6 :** (a) The turn-buckle connected to a rigid steel reaction frame. (b) The position of the points  
 8 monitored during the test.

24 Shear displacement to the springings on piers 1 and 2 was applied manually through a turn-buckle  
 25 connecting each springing to a steel stiff reaction frame (Figure 6a). Space displacements of

1 selected extrados points were recorded by a Total Station, positioned to capture as much extrados  
 2 surface as possible (Figure 6b). In particular, points were chosen along the longitudinal and  
 3 transverse ridges, the transverse arches and the nave arch, as well as on the front webs (namely, A,  
 4 B, C and H).

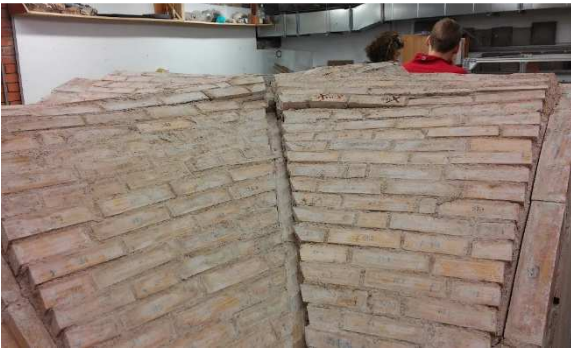
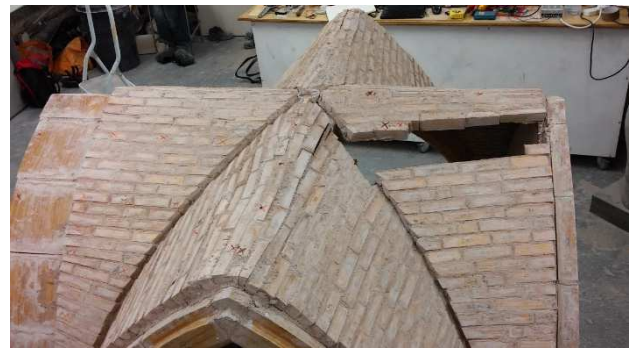
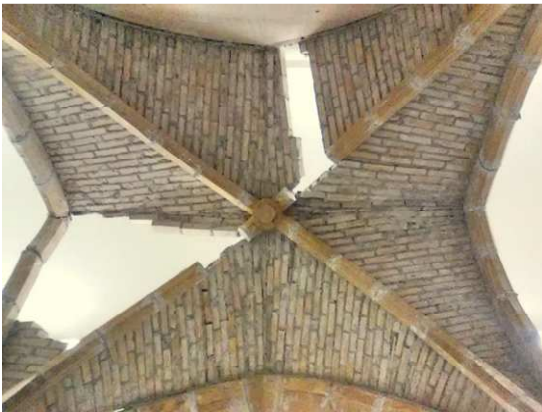
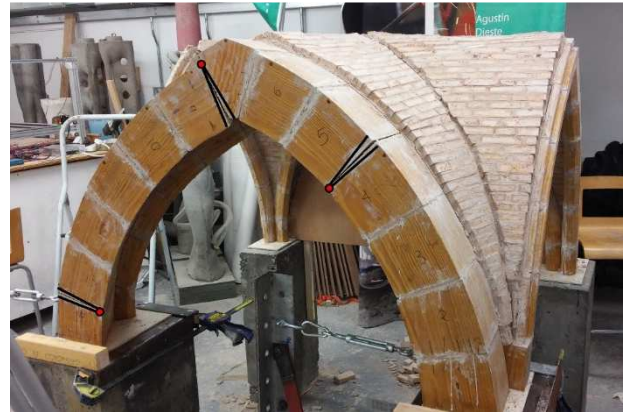
**Fig. 8:** (a) The crack pattern at the shear displacement of 30mm, (b) Collapses at a shear displacement of 35mm, (c) Partial collapse at the 50 mm stage, (d) Hinges on the nave arch at 45mm.

- 12 - during the 35 mm stage, partial failure of web F occurred (orange area in Figures 7 and 8b).  
13 The bigger crack at the 30 mm stage detached the voussoir on the rib 1-3 and this caused a  
14 rotation of the cracked web around the nave arch. A new long “sliding” crack also  
15 developed along the same rib on the intrados of the entire web C;  
16 - during the last stages more damage occurred. At the shear displacement stage of 40 mm, the  
17 cracks along the ribs (webs C and E) and along the nave arch extended to the whole length  
18 on the extrados. New cracks developed at the intrados of web A and E close to the keystone;  
19 - further increasing of the shear displacement up to 45 mm caused a partial collapse in web C  
20 (yellow area in Figures 7 and 8c). The nave arch looked very deformed and hinges are  
21 clearly recognizable (Figure 8d);  
22 - the shear displacement stage of 55 mm caused the failure of the whole web B and the

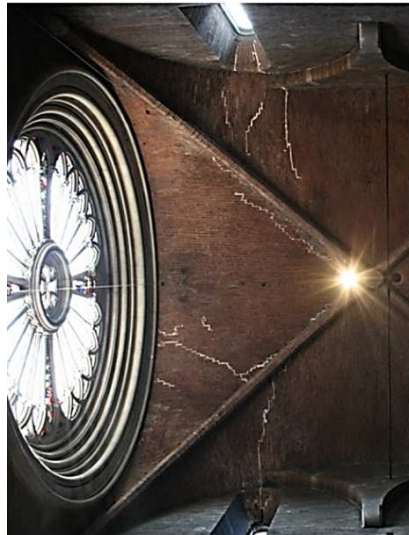
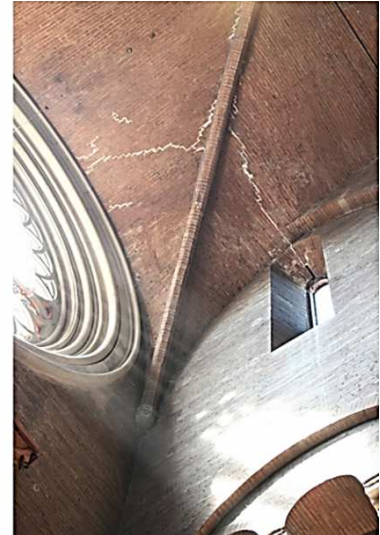
**Fig. 18:** Comparison between (a) the intrados of the tested vault and (b,c) the post-earthquake cracks observed in the intrados of the Modena Cathedral façade vault VI. The rigid edge is considered to lie along the rose window.

11 Figure 18 compares the intrados cracks of the tested vault with the post-earthquake intrados cracks  
 12 observed in the vault of the nave next to the façade (V1). A similar pattern is observed: (i) two  
 13 “opening” cracks formed on two adjacent webs at 45° with respect to the diagonal rib, (ii) sliding  
 14 cracks along the ribs. The weakness is in both cases along the bed joints and the cracks start from  
 15 the diagonal ribs spreading on the adjacent webs.
