Ferretti, F., Incerti, A., Tilocca, A.R., Mazzotti, C. (2021). In-Plane Shear Behavior of Stone Masonry Panels Strengthened through Grout Injection and Fiber Reinforced Cementitious Matrices. INTERNATIONAL JOURNAL OF ARCHITECTURAL HERITAGE, 15(10), 1375-1394 [10.1080/15583058.2019.1675803].

# **In-plane shear behavior of stone masonry panels strengthened through grout injection and Fiber Reinforced Cementitious Matrices**

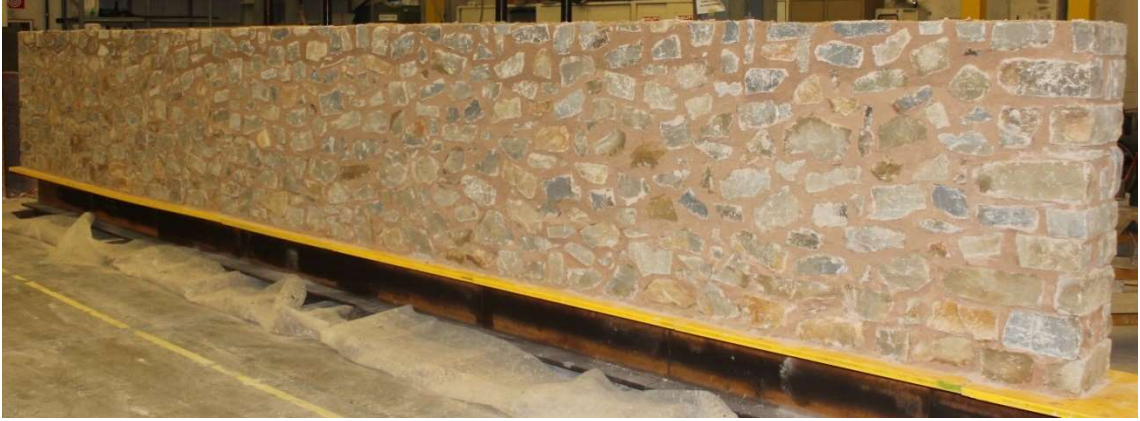
Figure 1. Stone masonry wall.

In the present experimental campaign, seven stone masonry panels were built by using rubble sandstones and natural hydraulic lime-based mortar. In more details, a unique continuous masonry wall, with dimensions  $7700 \times 1100 \times 300 \text{ mm}^3$ , was initially built and cured in laboratory conditions (Figure 1). The masonry pattern was arranged with two outer leaves and a chaotic internal filling, containing smaller stones and mortar and characterized by an average thickness of approximately 80 mm, depending on the dimensions of the stones. After 28 days of aging, the wall was cut to obtain seven square samples, having dimensions of  $1100 \times 1100 \times 300 \text{ mm}^3$ .

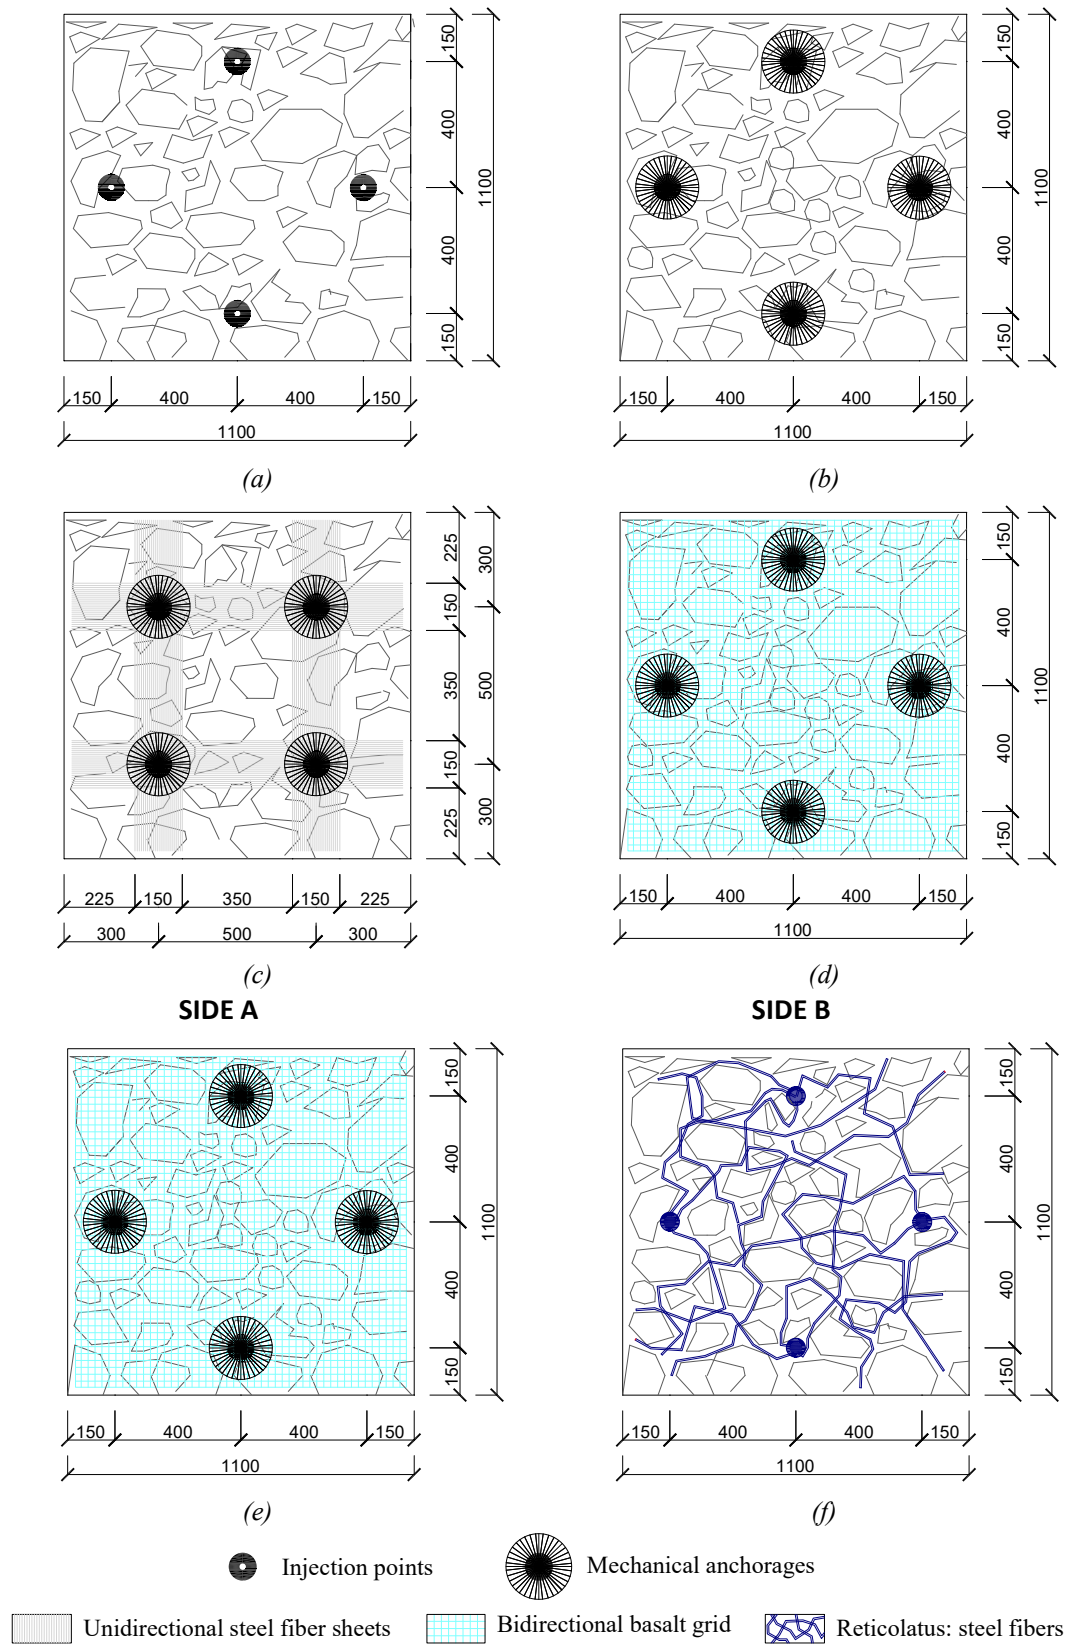
Figure 2. Layout of the adopted strengthening systems: (a) sample S\_I; (b) sample S\_I-MA; (c) sample S\_I-MA\_S600; (d) samples S\_I-MA\_B200 and S\_I-MA\_B400; (e-f) sample S\_I-MA\_B200-S600.

One unreinforced sample was used to provide for the reference behavior, while six panels were grout injected to fill the internal voids and improve the monolithic behavior of the specimens. This is a procedure typically adopted in-situ for the retrofitting of existing stone masonry structures. Among the injected samples, two panels were strengthened through grout injection only while four others were also strengthened by means of different FRCM systems: in more details, they were applied on both lateral surfaces of the samples (*SL* – symmetric layout) or on one side only (*AL* – asymmetric layout), using a continuous reinforcement (*C*) or a discontinuous one (*D*) according to configurations described in Table 1 and shown in Figure 2.

Continuous and symmetric strengthening layouts were characterized by the use of bidirectional basalt grids (B200 and B400), while the discontinuous strengthening was

obtained by using 150 mm wide unidirectional steel fiber (S600) strips. The asymmetric layout was characterized, on one side, by the application of a bidirectional basalt grid (B200), and, on the other side, by a reinforced structural repointing, executed according to the *Reticolatus* technique (Borri, Castori and Corradi 2011), using unidirectional steel fibers positioned inside the mortar joints. This technique can be adopted when there is the need of maintaining the stone masonry texture visible, e.g. in historical buildings. The characteristics of the tested samples are summarized in Table 1, while the detailed descriptions of the strengthening procedure and the testing program are presented in the following Sections.

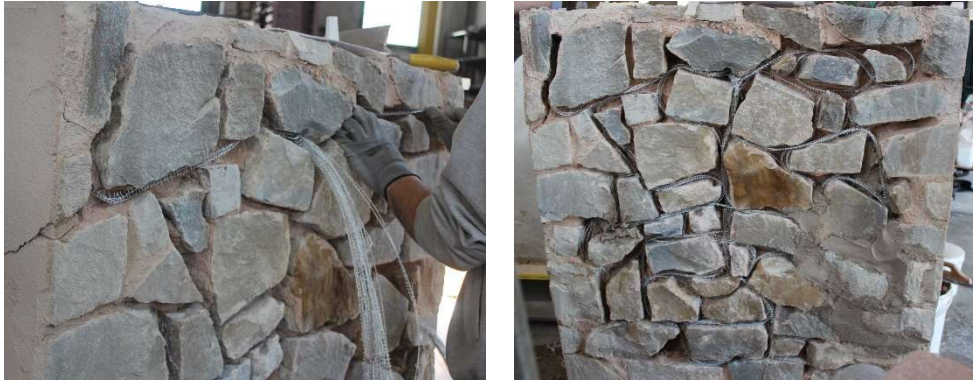
Figure 4. Reinforcing procedure for the sample S\_I-MA\_B200-S600, *Reticolatus* technique.

For the stone masonry panel strengthened with an asymmetric layout, the reported procedure is still valid, except for the fact that the continuous bidirectional grid was applied only on one side of the sample. On the other side, steel fibers cords (S600), anchored inside the drilled holes, were spread along the mortar joints according to the structural repointing scheme (*Reticolatus*), as shown in Figure 4.

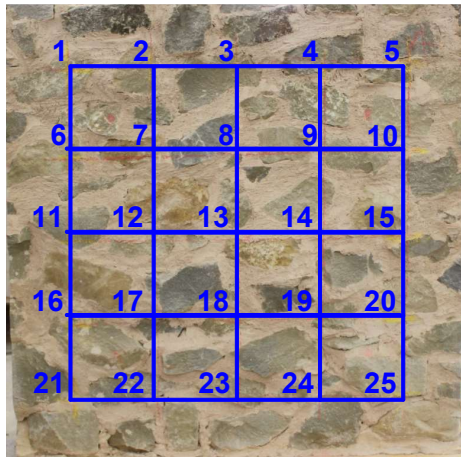
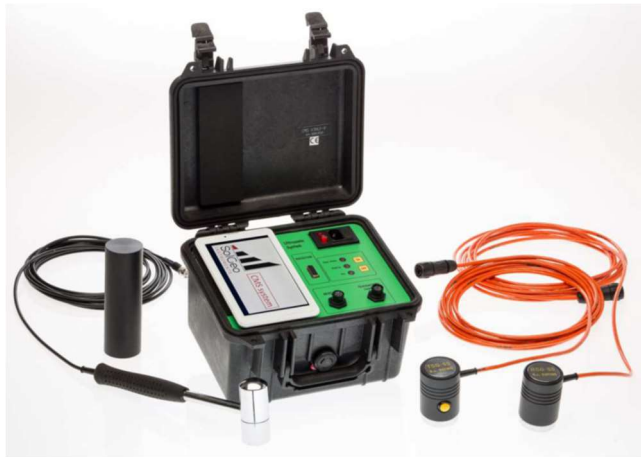
Figure 5. Sonic tests: (a) testing grid over the lateral surface of the samples; (b) test instrumentation.

Sonic test is a non-destructive technique usually adopted for the diagnosis of existing masonry buildings, allowing for the evaluation of material homogeneity and the identification of possible weaknesses inside the structural elements, such as voids and cracks. According to the direct arrangement of the test, chosen in the present experimental campaign, the sonic waves are generated by an instrumented hammer (emitting probe) that produces an instantaneous impact on the surface of the specimen. On the other side of the wall panel, a sensor (receiving probe) receives the signal. The time of flight, i.e. the time taken by the waves to travel through the thickness of the masonry wall, is measured to calculate the wave velocity, which is the main outcome of a sonic test and can give information about the material quality. Indeed, the wave velocity is influenced by the physical and mechanical properties of the material through which the wave travels.

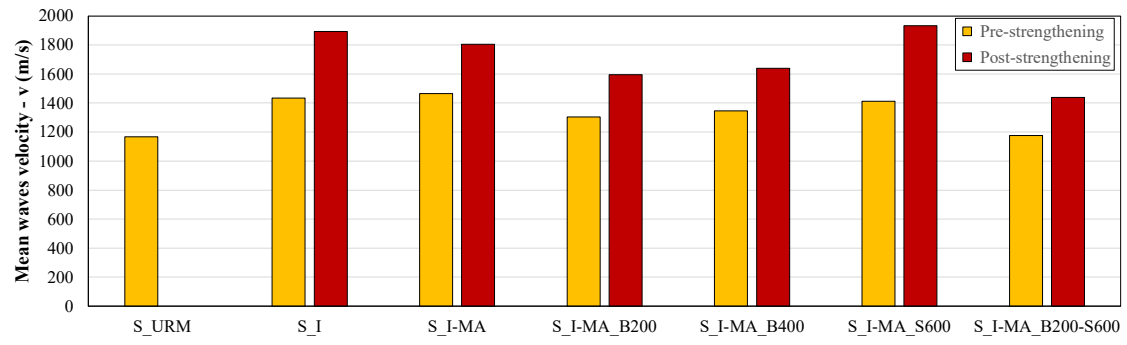
Figure 7. Sonic test results: average wave velocities.

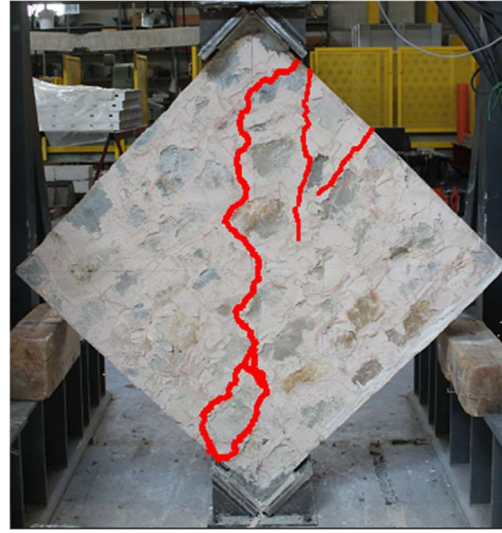
Figure 12. Failure modes: (a) S\_URM; (b) S\_I; (c) S\_I-MA\_B400; (d) S\_I-MA\_S600.

Concerning samples strengthened by means of grout injection only, the sample S\_I reached almost the same peak load of the unreinforced sample, while the peak load for the sample S\_I-MA was significantly higher. These results are not consistent with the fact that both the specimens underwent the same strengthening procedure, except from the use of mechanical anchorages. Even if the behavior of the samples can be improved by providing transversal connection between the wall leaves, the great difference observed in the load bearing capacity of the two specimens cannot be associated to the role of the mechanical anchorages only, especially considering an in-plane behavior (Ferretti et al. 2017). By looking at the detail of the cross section of the samples along the main fracture line (Figure 13), it is clearly visible that the two panels were characterized by very different conditions: the grout injection was very effective for the sample S\_I-MA (Figure 13b), while a great percentage of voids is still visible for the specimen S\_I (Figure 13a). This is the reason why the sample S\_I showed a shear behavior very similar to the one of the unreinforced specimen, especially in terms of peak load and failure mode

(Figure 12*b*). It is not possible to state that the grout injection on the sample S\_I was not effective at all, given that a stiffer behavior, with respect to the unreinforced sample, was observed. However, the value of the shear modulus for the sample S\_I was lower than the one of the sample S\_I-MA, confirming that the grout injection was really efficient, in terms of homogeneity provided to the masonry, only for the latter. Both samples failed with a mechanism similar to that observed for the unreinforced specimen, with cracks along the compressed diagonal. A more widespread state of damage was observed for the sample S\_I-MA, with the presence of several cracks. From these observations, it can be stated that analyzing the quality of grout injection is crucial for the study of the improvement given by the adopted strengthening systems.

towards the corners of the sample crossing the reinforcing fiber strips, which resulted damaged at the end of the test, showing the cracking of the matrix and the tensile rupture of few steel fibers (Figure 12*d*). Moreover, in correspondence with high values of horizontal strain, the detachment of the fiber strips extremities was observed. Since the first crack appeared where no reinforcement was placed (discontinuous arrangement of the strips), the increment in the load bearing capacity can be directly associated to the quality of the grout injection, which were verified as to be very efficient by looking at the cross section of the sample after the test, as shown in Figure 14*c*. It can be stated that, in this case, the FRCM strengthening system influenced mainly the post-peak behavior rather than the peak load and it was significantly damaged only in the final part of the test. Moreover, the increment in the shear modulus can also be explained with the fact that grout injection was efficiently performed on the sample. The situation in which the central portion of the panel is not strengthened with FRCMs, as for the chosen arrangement of the unidirectional steel fiber strips, is not the optimal one for the evaluation of the FRCM system improvement but it is anyway worthy of investigation since it corresponds to one of the worst conditions for the retrofitted masonry panel.

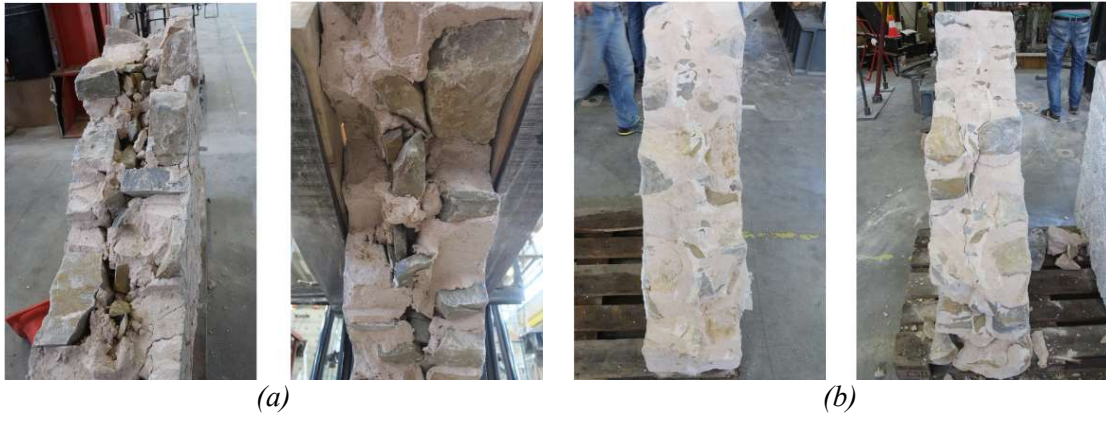
Figure 13. Detail of the cross section of the samples after the tests: (a) sample S\_I; (b) sample S\_I-MA.

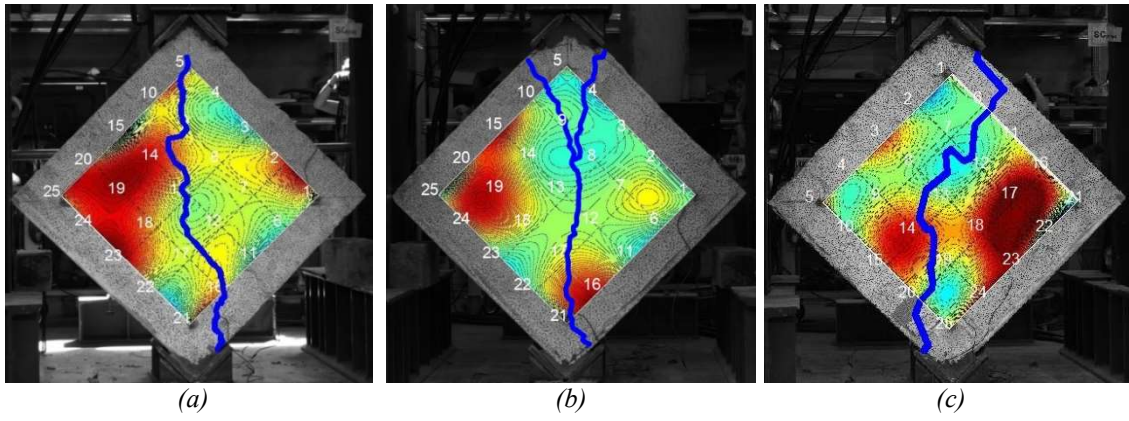
Figure 18. Comparison between sonic test results and failure mode of the diagonal compression test: (a) S\_I; (b) S\_I-MA\_B400; (c) S\_I-MA\_S600.

A comparison between the sonic test results and the failure modes observed from the diagonal compression tests is presented in Figure 18, where the main cracking pattern has been overlapped to the wave velocity maps for the chosen representative samples. By looking also at Figure 15 and Figure 16, a trend can be recognized, with the cracks starting at the center of the panels in correspondence with points characterized by very low local

wave velocities. The cracking propagation towards the corners was influenced by the quality of the specimens as well. Indeed, the fracture lines crossed the portions of the samples where quite low wave velocities were registered. These observations confirm the crucial role played by the grout injection on the overall behavior of the strengthened masonry panels. On the one hand, by increasing the effective resistant cross section, they were able to influence the response of the samples in terms of shear capacity, as already observed. On the other hand, the fact that they did not determine homogenous improvements to the quality of the stone masonry samples influenced the onset of cracking and its following propagation. More in detail, the greater the increase in the local wave velocity given by the injection in the center of the samples, the higher the peak load reached. Indeed, given that the failure in the diagonal compression tests started with the tensile cracking in the center of the samples, the increments given by the injection in terms of local wave velocity were more significative than increments in terms of average wave velocity. This finding can also explain the apparently incoherent result obtained for the sample S\_I, which was characterized by a very low value of peak load, despite the consistent increment in the average wave velocity measured from the sonic tests carried out after the strengthening procedure. In fact, a quite low value of the local wave velocity was registered for this sample in correspondence of the central portion of the panel where the diagonal crack started.

The state of damage of the FRCM strengthened samples at the end of the test was characterized by the presence of multiple fracture lines, not highlighted in Figure 18, involving both the masonry substrate and the matrix. The reinforcing fibers, indeed, were effectively able to transfer the tensile stresses to a wider area and to influence the failure mode of the samples. Considering all the results of the experimental campaign, it can be stated that the adopted strengthening procedures were all efficient in improving the shear behavior of stone masonry samples. In particular, the value of the peak load was influenced mainly by the grout injection, which were not completely effective for all the masonry samples, and, secondly, by the presence of the mortar matrix layers. The reinforcing fiber strips and grids, instead, determined mainly the “ductility” of the failure mode (post-peak behavior). As a confirmation, panels S\_I-MA and S\_I-MA\_S600 provided for the same shear capacity since they had similar effectiveness of grout injection, irrespective of the presence of an external reinforcement; on the contrary, after the onset of cracking, panel S\_I-MA showed a more brittle behavior, with the shear capacity rapidly disappearing. The negative slope of the post-peak curve was even larger than that of the unreinforced panel (S\_URM), suggesting that injection alone can improve the capacity, but it can also increase the brittleness of the failure.
