An experimental study of the bond behavior of twisted steel bars embedded in mortar cylinders and in the joints of masonry wallettes

Cristina Gentilini^{1a*}, Francesco Finelli^{2b}, and Christian Carloni^{3c}

Keywords: bond behavior, near-surface mounted technique, twisted steel bar, pull-out test, mortar cylinders, masonry wallettes.

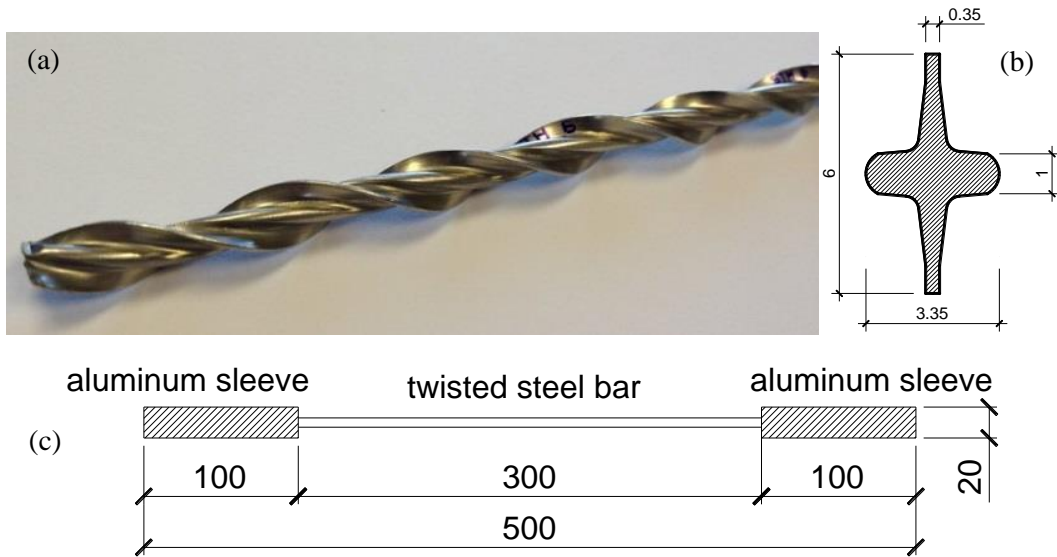
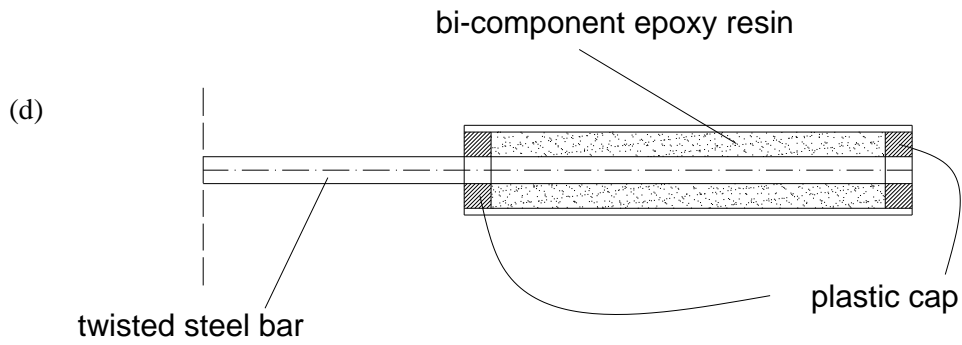
Figure 2. a) Photo of the twisted steel bar, b) cross-section of the helical-shape bar, c) specimen dimensions for the tensile test, and d) detail of the anchoring system for the tensile test. (Dimensions in mm).

The bars used for repointing were made of high-strength steel (AISI 316) and had a helical shape to improve adhesion (Figure 2a). The bars were formed from a circular steel wire, which was cold worked to obtain the cross-sectional shape shown in Figure 2b. Afterwards, the bars were twisted while applying a tension force to reach the final helical shape. Nominal diameter, ϕ , and cross-sectional area, A , were equal to 6 mm and 8 mm², respectively. Steel bars were tested to determine Young's modulus, E , and tensile strength, f_t .

Preliminary tests indicated that direct gripping of the helical bars would have damaged the bars and compromised the tension test results. Thus, to avoid undesired failure modes of the bars tested in tension, aluminum hollow cylinders were epoxy-glued at each end of the bars. The length of the cylinders (or sleeves) were determined through preliminary tests, and it was found that a length of 100 mm was sufficient to run the tension tests of the bars up to failure (Figure 2c). The bars were inserted into the sleeves, which were filled with a thixotropic bi-component epoxy resin and left to cure for at least 24 hours. The bars were placed concentrically in the pipes, plastic caps with a hole to insert the bar were applied at both end of each sleeve (Figure 2d). The total length of the bars was 500 mm, with a free length of 300 mm. A 100 kN universal testing machine was used for the tests and the load was applied at a constant stroke rate of 2 mm/min until failure of the specimen occurred. Three specimens, out of eleven bars tested, were equipped with a 100 mm-gauge length extensometer placed in the central portion of the bar to measure the elongation and determine Young's modulus (Figure 3a). To check if the gripping system (aluminum cylinders) could affect the test results, the location along the bar where rupture occurred was observed and reported (Figure 3b). The average tensile strength resulted equal to 1226 MPa (CoV=2%), while the average elastic modulus based on three tests was equal to 143 GPa (CoV=7%). Figure 3c shows the stress-strain curves for the three bars equipped with extensometer. After an initial linear-elastic branch, the bars exhibited a nonlinear behaviour followed by an almost-horizontal branch until tensile failure occurred.

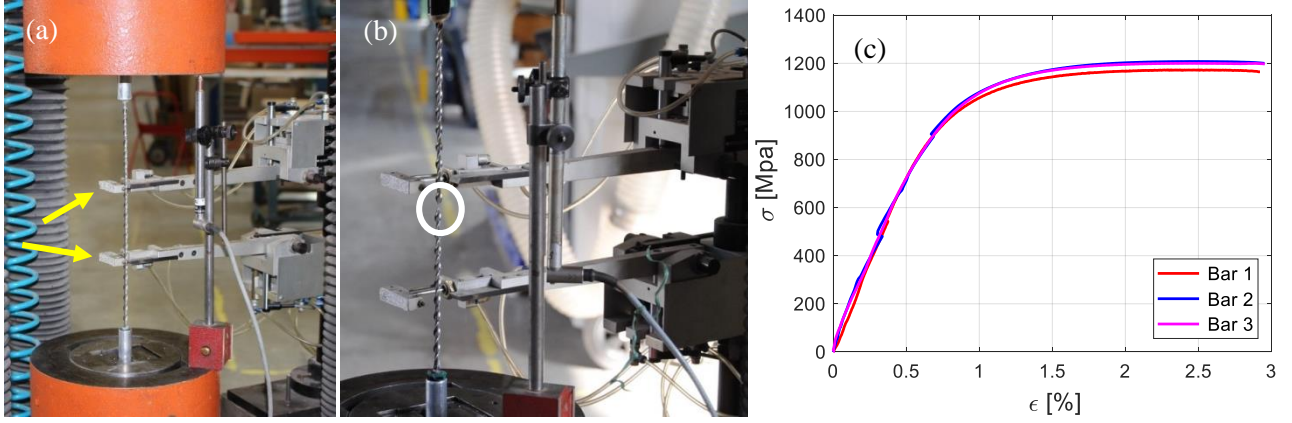
Figure 3. Mechanical characterization of twisted (helical shaped) steel bars: a) bar at the beginning of the tensile test (the extensometer employed to measure the bar length variation is indicated with yellow arrows), b) bar at the end (failure) of the test, and c) stress-strain curves.

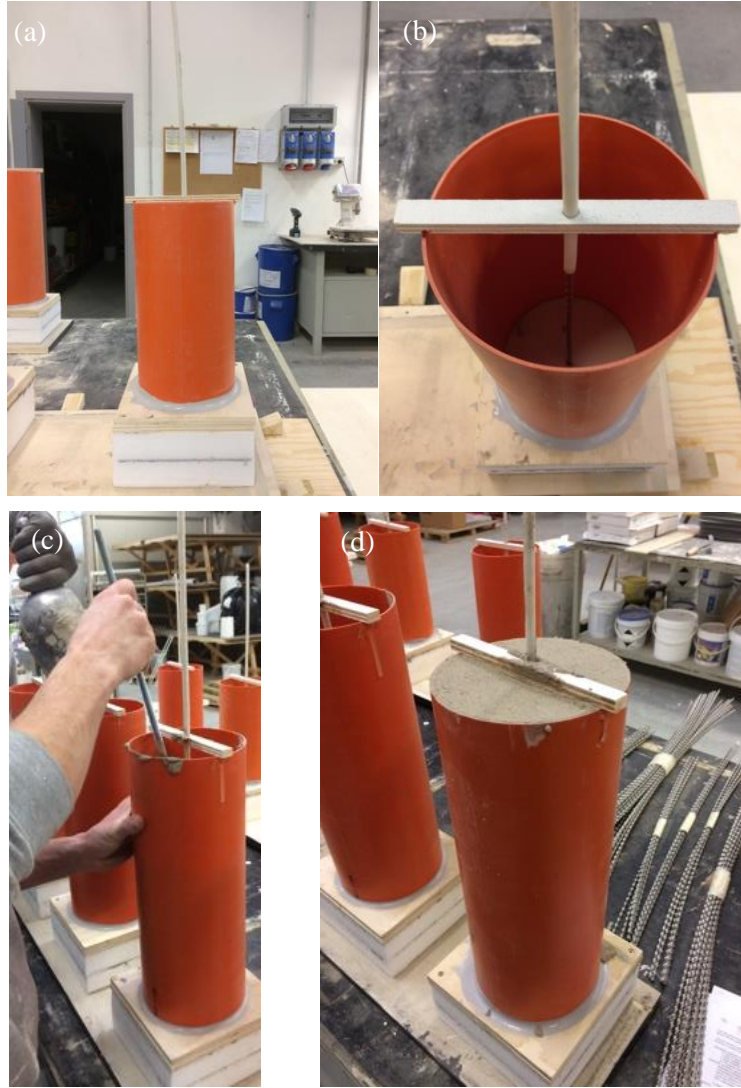
Figure 4. Construction phases of the cylindrical specimens: a) and b) the bar is positioned concentrically in the cylinder mold, a plastic tube is used to create a bond break of length equal to 50 mm from the top face of cylinder, c) mortar_s is manually rodded in order to avoid the formation of large voids, and d) the cylinders are left to cure in lab conditions.

Mortar cylinders of nominal diameter equal to 150 mm were cast with mortar_s and twisted steel bars of different lengths were embedded concentrically. PVC tubes were used as molds (Figure 4a). A length of 50 mm from the top of the cylinder was left unbonded, such that during the pull-out, failure was given to the bar pull-out and not to an incorrect tensile failure of the mortar cylinder [33, 34]. Plastic pipes were used to create the bond break (Figure 4b) and in order to avoid the formation of voids, the compaction of the fresh mortar was carried out manually with a rod (Figure 4c). The bonded length of the bar is named L_B in the remainder of the paper. The bar extended 300 mm and 100 mm from the top and bottom ends of the cylinders, respectively. Cylindrical specimens with different bonded lengths L_B , namely 150, 250, 350, 450, and 700 mm, were cast. The total height of those cylinders was 50 mm longer than the corresponding bonded length because of the additional unbonded length. Three specimens for each bonded length were constructed, which correspond to 15 cylinders in total (Figure 4d). Specimens were cured in laboratory conditions for two months under a polyethylene sheet. At the end of the two months, prior to testing an aluminum sleeve was installed at the end of the bar to improve gripping by the machine jaws. The sleeves were the same as the ones used in the direct tensile tests. They were 100 mm long, 2 mm thick, and were filled with epoxy. Specimens were named C-X-Z, where C stands for cylindrical, X is the bonded length L_B , and Z is the specimen number. A sketch of the geometry of cylindrical specimens C- L_B with a generic bonded length L_B is shown in Figure 5.

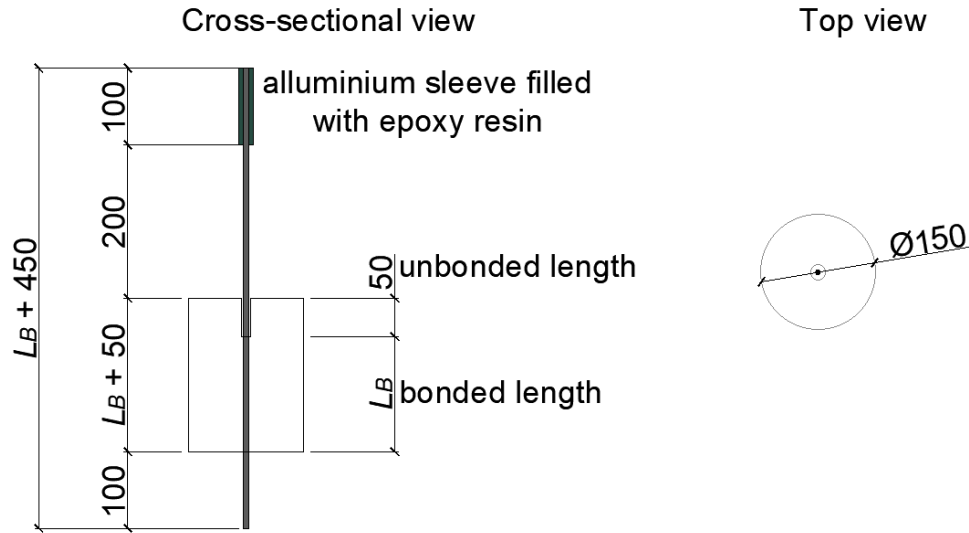
Figure 5. Sketch of a cylinder with a bar embedded for a length L_B : on the left, longitudinal section and on the right, top view. (Dimensions in mm).

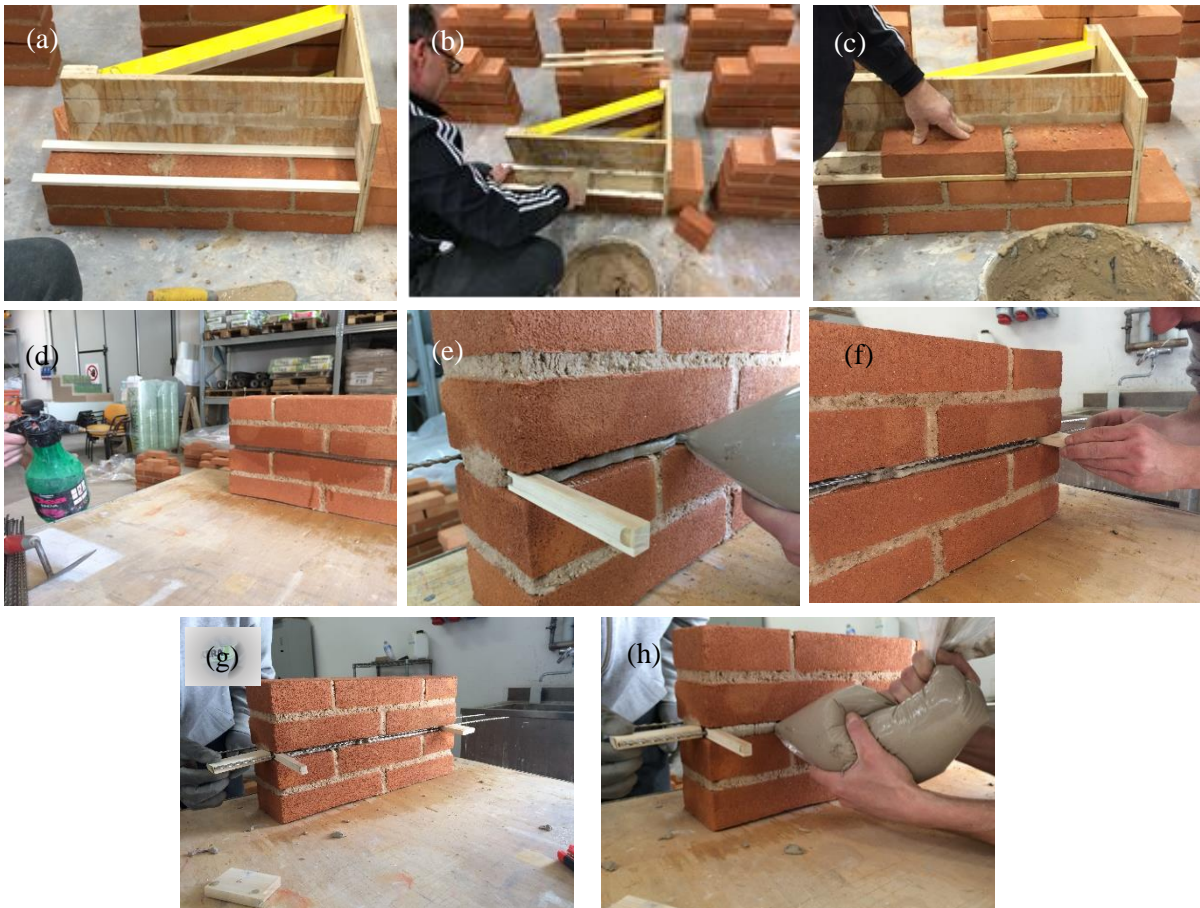
Figure 6. Construction phases of the masonry wallette with $L_B = 450$ mm: a) in the second layer two wooden slats placed symmetrically were used to create a groove, b) casting of the central mortar joint, c) bricks were placed on top of the central joint, d) after 7 days of curing, wooden slats were removed and the grooves were wet, e) the grooves were partially filled with a first layer of mortar_s, f) bar was pushed in the fresh mortar in order it was completely surrounded by mortar_s, g) insertion of wooden elements for correct bar positioning and f) a final layer of mortar_s was used to seal the grooves.

In the wallettes, only the central portion of the bars was bonded to the masonry specimens, while the end regions were left unbonded. In particular, an unbonded length equal to 50 mm was left from the top surface of the specimen at the loaded end, while on the bottom side, the unbonded length varied with the size of the specimens. In fact, the length of the specimens changed with the bonded length of the bar. Except for the 150 mm embedded length, for longer lengths, more than one brick was laid horizontally alternated by head joints. In detail, the wallettes with an embedded bar of 150, 250, 350, 450 and 550 mm had a total nominal length equal to 250, 410, 510, 510 and 640 mm, respectively. For all wallettes, the bars extended from the top and bottom surfaces of the specimens by 300 mm and by 100 mm, respectively. It should be noted that for each specimen, two bars (labelled bars A and B in the remainder of the paper) were inserted symmetrically on the opposite lateral surfaces of the wallettes along the central joint. One bar at the time was tested and it was assumed that the presence of one bar did not to influence the other during their test, since the distance between them was approximately 75 mm. To confirm this assertion, additional considerations are given in Sections 3.2 and 5. Different bonded lengths of the bars were considered and four masonry specimens were built for each bonded length, thus a total of 8 masonry specimens had the bars embedded with the same bonded length L_B . In order to make a comparison with the bond behavior of the bars embedded in the cylinders, the same bonded lengths were considered. However, masonry specimens with bars embedded for a length of 700 mm were not constructed due to limitations in the clearance height of the testing machine. An additional bonded length equal to 550 mm for masonry specimens was considered as a substitute of the 700 mm bonded length of the cylinders. Masonry specimens were cured for two months in laboratory conditions under a polyethylene sheet to facilitate the hydration of the binder, and after the curing period and prior to testing, a sleeve filled with epoxy was

installed at the end of each bar. Masonry specimens were named W-X-ZY, where W stands for masonry wallette, X is the bonded length L_B , Z is the specimen number, and Y stands for A or B depending on which of the two bars inserted in the specimen was tested. Figure 7 shows a sketch of a masonry specimen (W- L_B) with two bars bonded for a length L_B in the central bed joint.

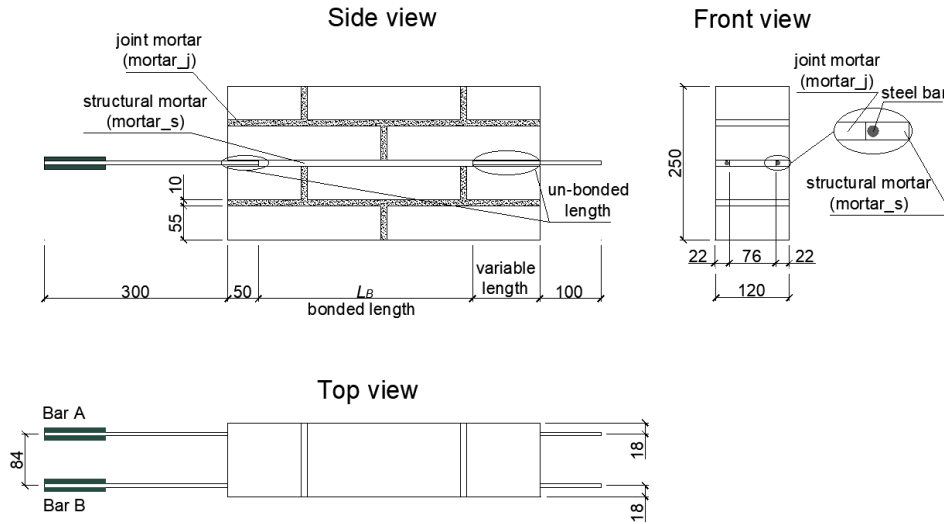
Figure 7. Sketch of a masonry wallette with two bars embedded for a length L_B in central bed joint.
(Dimensions in mm).

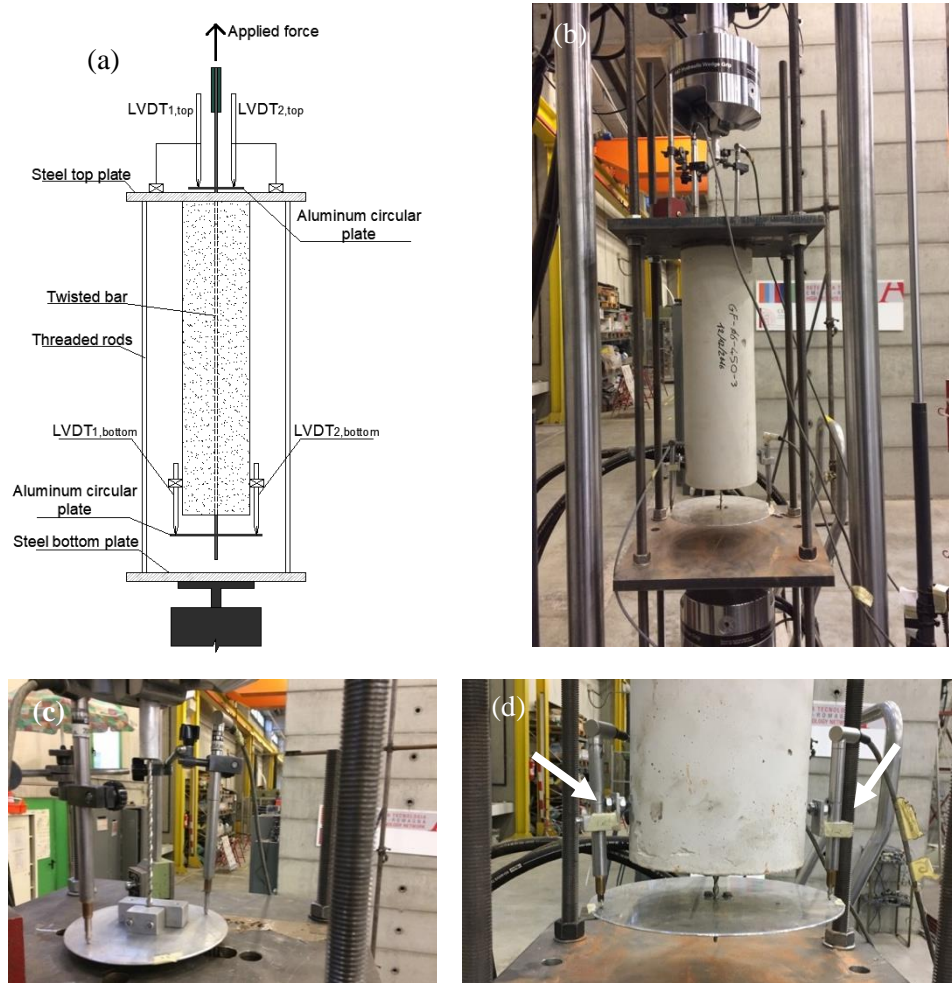
Figure 8. Pull-out test set-up for cylindrical mortar specimens: (a) sketch, (b) photo of representative specimen, (c) photo of LVDT_{1,top} and LVDT_{2,top} used to measure the loaded-end slip, and (d) photo of LVDT_{1,bottom} and LVDT_{2,bottom} used to measure the free-end slip (the arrows indicate the LVDT holders).

Tests were conducted using a 100 kN servo-hydraulic testing machine. Figures 8a and 8b show the sketch and photo, respectively, of the experimental set-up used for the cylindrical specimens. A steel plate (bottom steel plate in Figure 8a) was gripped by the bottom head of the machine through a stud bolted to the plate. The specimen was placed on the bottom plate using spacers since the bar was extending beyond the cylinder base. A steel plate, with an 80 mm-diameter central hole (top steel plate in Figure 8a), was placed on the top of the specimen and the two plates (top and bottom) were connected by means of four threaded rods. The helical bar was gripped by the top machine head through the aluminum sleeve. It should be noted that prior to placing the cylindrical specimen on the testing fixture, a rapid set self-levelling mortar was applied on the top surface of the cylinder in order to smoothen out the surface that was in contact with the restraining top steel plate and ensure an even distribution of the load. To measure the relative displacement between the bar and the cylinder, two linear differential displacement transformers (LVDTs) with a stroke equal to 20 mm were mounted on the top plate using magnets. These two LVDTs are named $LVDT_{1,top}$ and $LVDT_{2,top}$ in the remainder of the paper. They reacted off of an aluminum circular plate that was attached to the bar in the portion of it just above the top plate (Figure 8c). It should be noted that a circular plate was used since the helical bar rotated about its longitudinal axis as it was pulled out. The displacements measured by $LVDT_{1,top}$ and $LVDT_{2,top}$ are named s_{l1} and s_{l2} , respectively, while the average of the two measurements is defined as the bar slip at the loaded-end, s_l ,

in this paper. It should be noted that in the slip definition, the elastic deformation of the bar between the point where the LVDTs were placed and the beginning of the bonded area was considered [35]. Once the bar was clamped by the jaws, the spacers at the bottom were removed. Two LVDTs (stroke equal to 10 mm) named LVDT_{1,bottom} and LVDT_{2,bottom} were used to measure the relative displacement between the free-end of the bar and the base of the cylinder. The LVDT holders were screwed into the bottom lateral surface of the cylinder (Figure 8d). The LVDTs reacted off of an aluminum circular plate attached to the free end of the bar in the portion extending beyond the cylinder (Figure 8d). The displacements measured by LVDT_{1,bottom} and LVDT_{2,bottom} are named s_{f1} and s_{f2} , respectively, while the average of the two measurements is defined as the bar slip at the free-end, s_f , in this paper. All the tests were conducted in displacement control mode using the machine stroke. For the first part of the test until the peak load was attained, the stroke rate was equal to 5 $\mu\text{m/s}$. After the peak load was reached, the rate was increased to 0.05 mm/s until the end of the test.

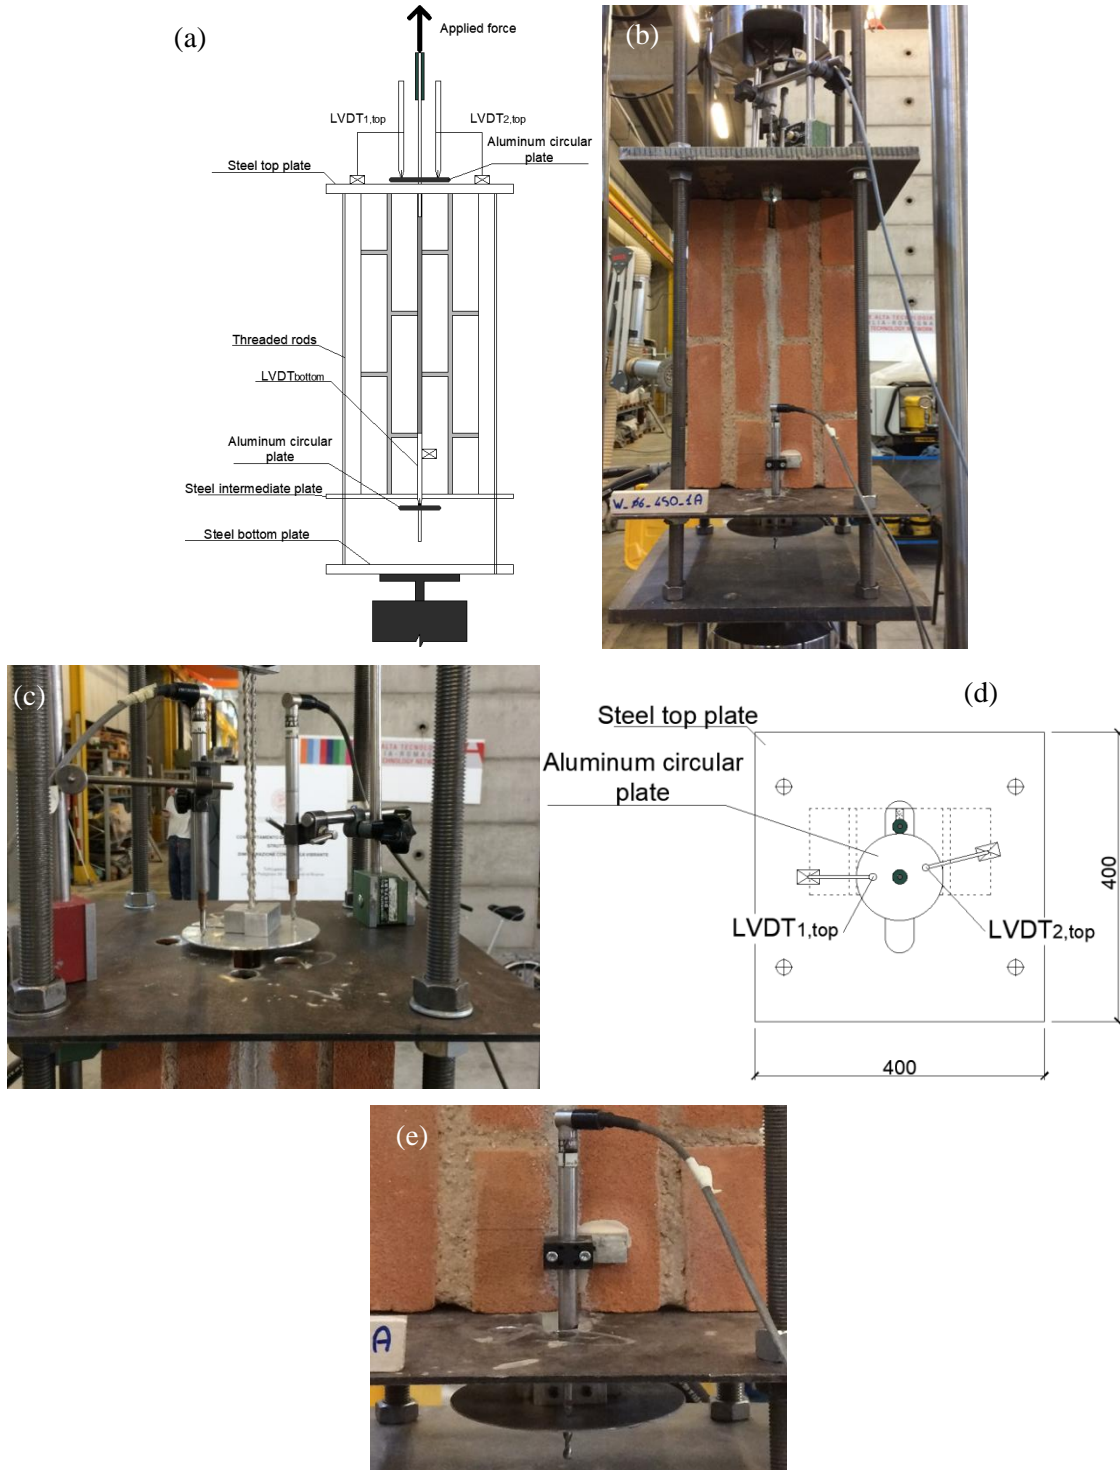
Figure 9. Pull-out test set-up for masonry specimens: (a) sketch, (b) photo of representative specimen, (c) photo of LVDT_{1,top} and LVDT_{2,top} to measure the loaded-end slip, (d) sketch of the top plate, and (e) photo of LVDT_{bottom} used to measure the bar free-end slip. (Dimensions in mm).

A similar set-up was used for the masonry specimens, as shown in Figures 9a and 9b. As for the cylinders, two LVDTs were mounted on the top plate (namely LVDT_{1,top} and LVDT_{2,top}) to measure the relative displacement between the bar loaded end and the masonry wallette (Figure 9c). It should be noted that for the masonry specimens the spacers at the bottom were replaced by an intermediate steel plate that supported the masonry wallette and had a central hole to let the bar at the bottom of the specimen extends through the plate itself. In addition, since for each masonry wallette, two bars were inserted in the mortar joints (one on each opposite longitudinal face of the wallette), when one of the bars was tested the masonry wallettes resulted eccentrically placed with respect to the center of the top plate (Figure 9d). Cardboard was used in between the top plate and the surface of masonry to avoid any stress concentration. Due to the eccentric placement of the masonry wallette with respect to the top plate, only one LVDT, named LVDT_{bottom} (Figure 9e), was used at the bottom of the specimen to measure the bar slip at the free-end, s_f . LVDT_{bottom} reacted off of an aluminum circular plate that was attached to the free end of the bar. Pull-out tests on masonry specimens were conducted under displacement control using the same rates as the cylindrical specimens. It should be noted that during the tests both for cylinders and masonry specimens, the top machine head was left free to rotate.

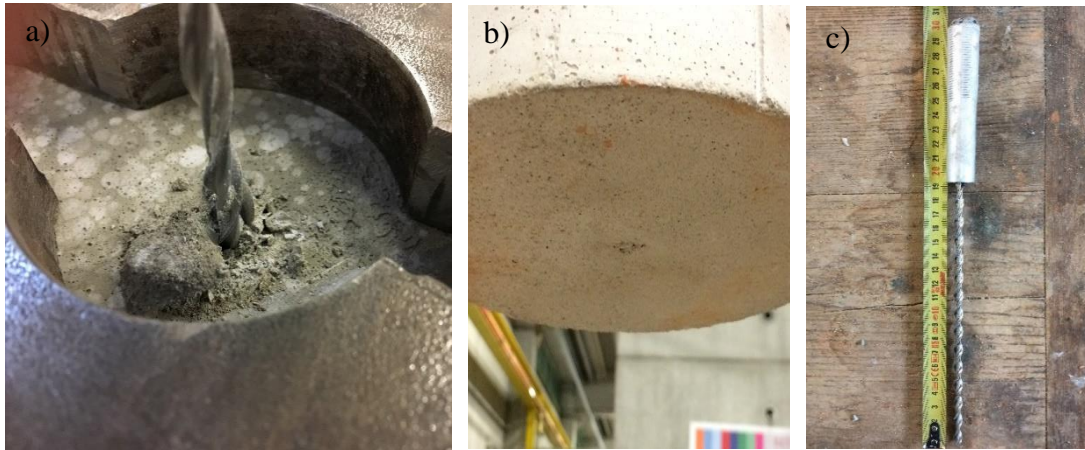
Figure 10. (a) Top; (b) bottom view of a representative cylindrical specimen at the end of the test; c) tensile rupture of the bar that attained for cylinders with $L_B = 700$ mm.

In this section, the results of 15 pull-out tests conducted on the cylindrical specimens are presented. Bars slipped out of the cylinders until the test was stopped because the maximum LVDT stroke was reached (Figure 10), except for cylinders with $L_B = 700$ mm for which bar rupture occurred. It should be noted that both top and bottom LVDTs were removed close to the attainment of their maximum stroke, and then the test was resumed until the machine stroke was close to its maximum. In Figures 11a and 11b, the applied load (F) versus loaded-end slip (s_l) and the applied load versus free-end slip (s_f) responses of a representative cylindrical specimen with bonded length $L_B = 150$ mm are plotted, respectively. In both Figures 11a and 11b, the applied load versus each LVDT readings curves are also reported together with their averages. It can be observed that the curves of each LVDT are very similar and overlapping with the average, which indicates that the bar was pulled out without any significant bending. In Figure 11c, the two average curves $F-s_l$ and $F-s_f$ are compared.

Due to the good agreement between the readings of the two LVDTs at the top as well as between the two at the bottom for all specimens, only the average curves are shown in Figure 12. Figures 12a, 12b, 12c, 12d, 12e collect the curves obtained from the pull-out tests for the cylinder groups: C-150, C-250, C-350, C-450 and C-700, respectively. All the responses are characterized by a similar shape, and the three branches as described above can be observed for all specimens, except for specimens with $L_B = 700$ mm, (Figure 12e), which are characterized by an initial pseudo-linear portion for low load values followed by a non-linear branch, since the bars failed due to rupture close to the cylinder top surface. It should be noted that in the case of bars with $L_B \leq 450$ mm (Figure 12a-12d), the slip at the free end is almost zero before the peak load is attained, while once the peak load is reached the free end slip increases significantly. Slips at the free end prior to the attainment of the peak load are zero for $L_B = 700$ mm. Analyzing the load-slip curves for all the specimens, the influence of the bonded length can be studied. The pull-out peak load F_m increases as the bonded length increases and, correspondingly, also the slip at the loaded end at peak, s_{ml} , increases, as reported in the literature [19]. Further, it can be noted that as the bonded length increases, the non-linearity of the first branch of the $F - s_l$ curves close to the peak load becomes more pronounced. In general, a good agreement among the curves for the specimens with the same bonded length is observed, which indicates repeatability and reliability of the tests. No splitting failure of the cylinders was observed in any specimen.

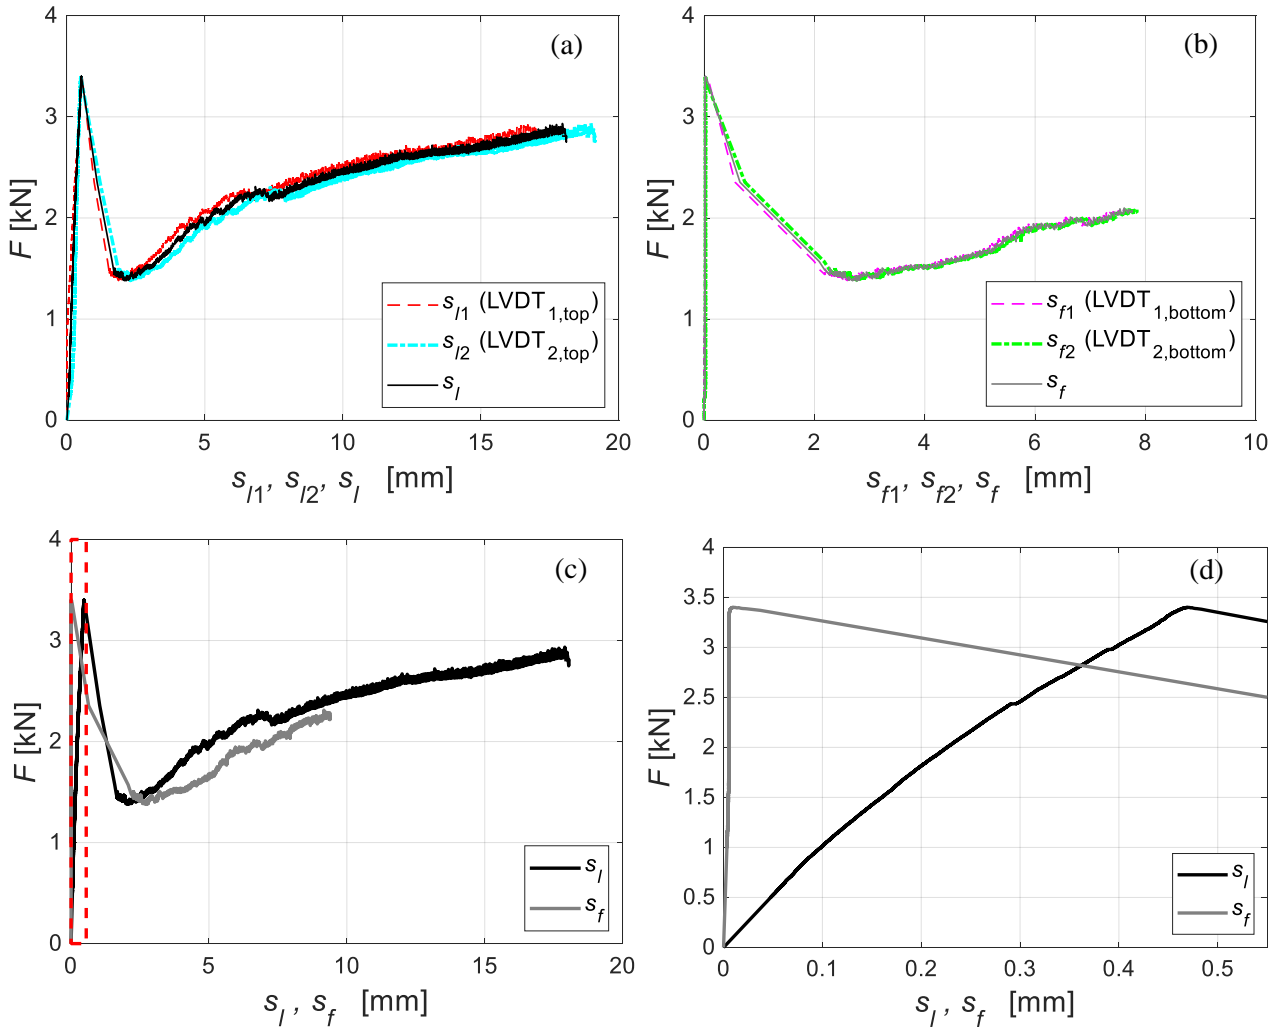
Figure 11. Load-slip curves of a representative cylindrical specimen (C-150-1, $L_B = 150$ mm): (a) $F - s_l$, $F - s_{l1}$ and $F - s_{l2}$ curves, (b) $F - s_f$, $F - s_{f1}$ and $F - s_{f2}$ curves, (c) $F - s_l$ and $F - s_f$ curves and (d) call-out of the $F - s_l$ and $F - s_f$ curves at the beginning of the test.

Referring to Figure 11c, three main branches can be distinguished in the $F - s_l$ curve: 1) an initial pseudo-linear portion for low load values followed by a non-linear branch until the peak load F_m is reached; 2) a load drop branch; and 3) an ascending almost-linear branch until the end of the test. In the first branch, the free-end slip is different from zero, although the values are very small, for the majority of the branch, as shown in the call-out (Figure 11d). In the third branch, the free-end slip increases almost linearly like s_l but with a lower rate.

During the pull-out test, due to its twisted shape, the bar was subjected to a combined action of tension and torsion. In fact, while elongating and slipping, the bar rotated about its longitudinal axis from the beginning of the test. It should be noted that the bar rotation could not be measured during the experimental tests, but it was easily observable by means of the rotation of the circular plates that were rigidly connected to the bar, see Figures 8c and 8d. Thus, even small bar rotations that occurred at the beginning of the test were made more visible by the plate rotation. After the load drop, visual observation during the test suggested that the bar rotation rate increased. At the end of the test, the bar rotation was partially released and a rotation in the opposite direction was observed as the bar was unloaded. This behavior was already pointed out also in another experimental campaign, where bars with the same cross-sectional shape were pulled out from bricks made of different materials in a similar test set-up [20].

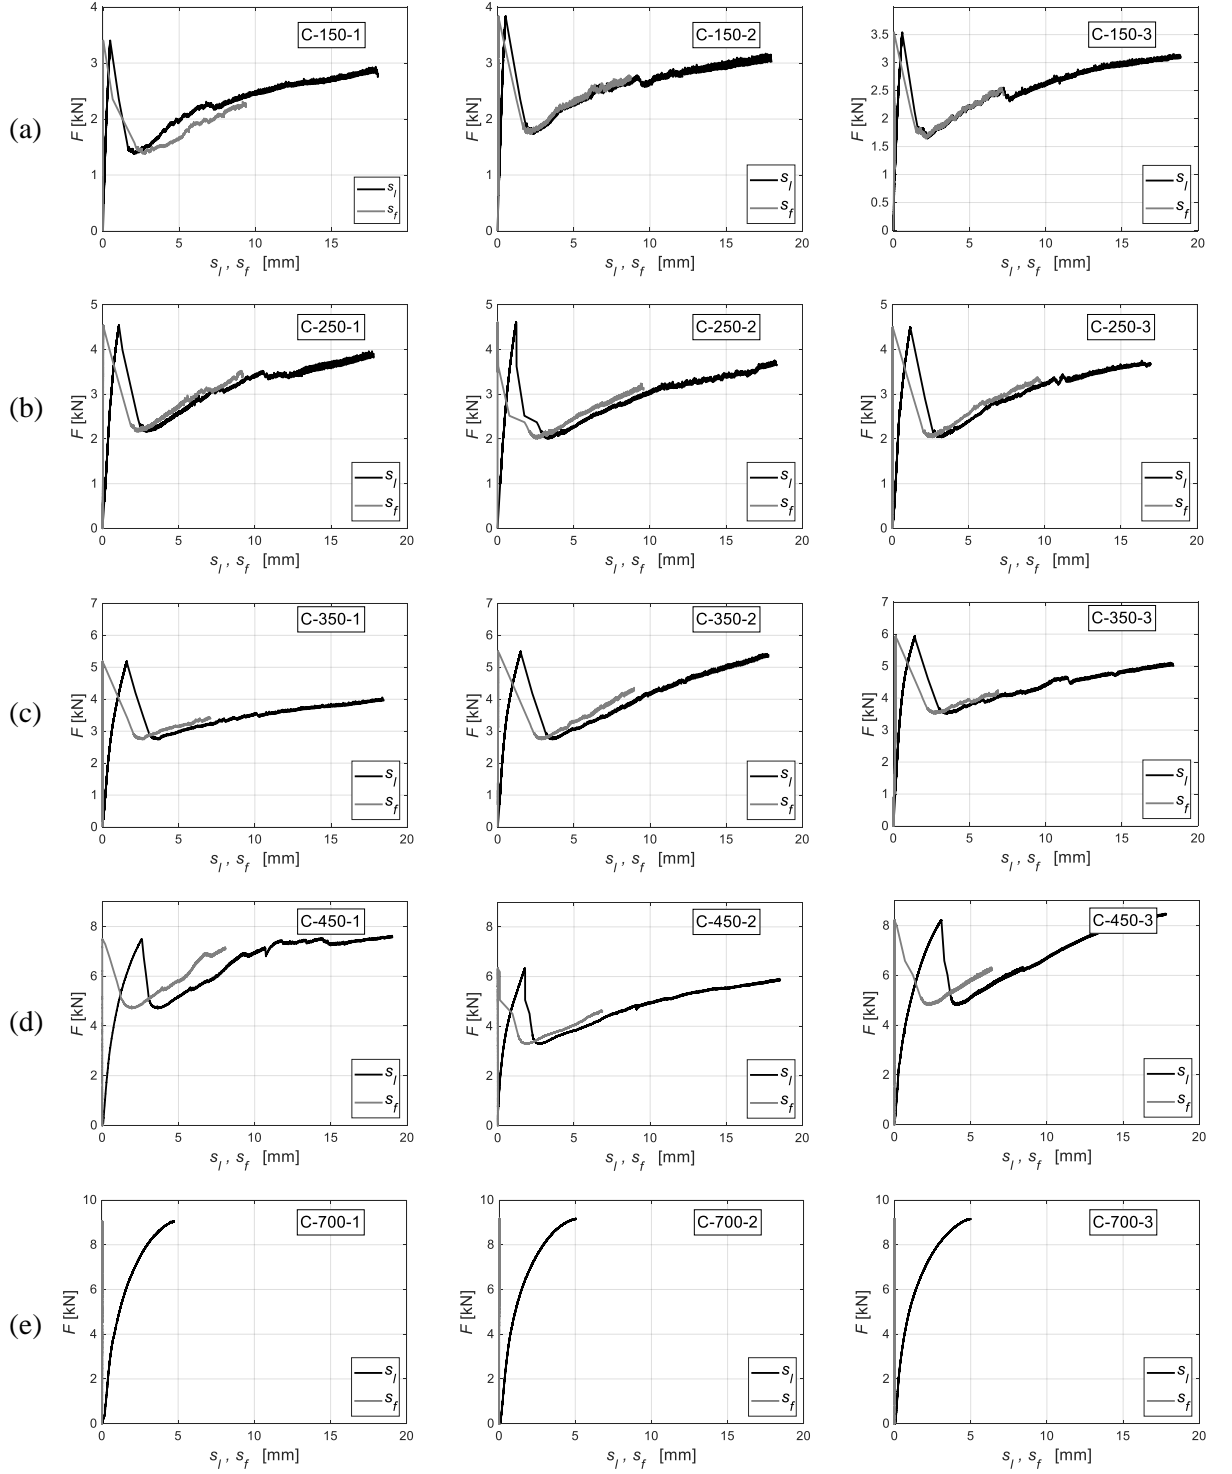
Figure 12. $F - s_l$ and $F - s_f$ curves for cylindrical specimens. In each row, curves for specimens with the same bonded length are collected: a) C-150; b) C-250; c) C-350; d) C-450 and e) C-700.

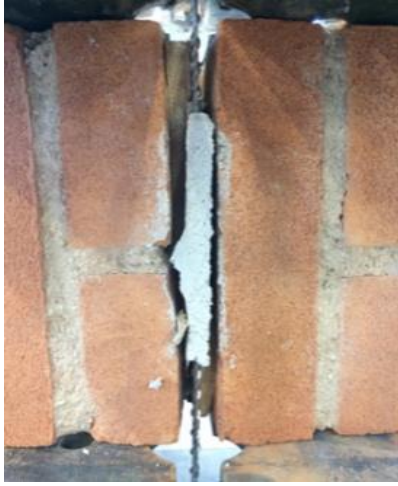
Failure mode A:
splitting of the masonry
wallette

Figure 13. Failure modes of the masonry specimens.

Two main different failure modes were observed during the tests on the masonry wallettes and are reported in Figure 13. In 8 tests, the mortar joint, where the bar was embedded, detached from the bricks as the bar was pulled out (Type A in Figure 13), which resulted in the splitting of the masonry wallette. The detachment of the mortar_s from the bricks occurred at the actual interfacial surface between mortar and brick with no mortar left attached to the brick. For those 8 specimens, it was not possible to test the second bar. Pull-out of the bar without detachment of the mortar joints occurred in the remaining 11 specimens (Type B in Figure 13). However, it should be noted that fracture of the mortar in the transversal direction near the loaded end (regardless of whether the mortar joint detached from the brick) was observed in 13 tests. This additional phenomenon was accounted for by adding an asterisk next to the failure mode, i.e. A* or B* depending on whether it occurred prior to failure A or B. Figure 13 reports, as an example, a B* failure. Only in two cases, the splitting of the specimen occurred with transversal fracture of the mortar (A* failure mode) at the loaded end. The bonded length seems to have small influence on the failure mode of the specimens, since failures A, A*, B, and B* were observed for both short and long bonded lengths and a no clear trend could be pointed out,

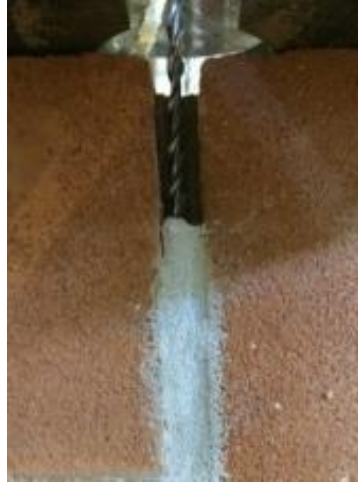
Failure mode B:
bar pull-out

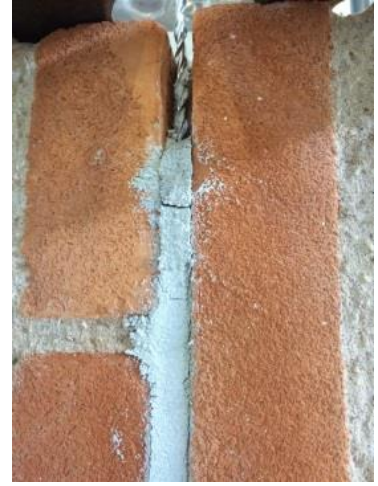
Failure mode B*:
bar pull-out with local
fracture of the mortar

although it should be noted that failure modes B and B* occurred more frequently for the longest bonded lengths.

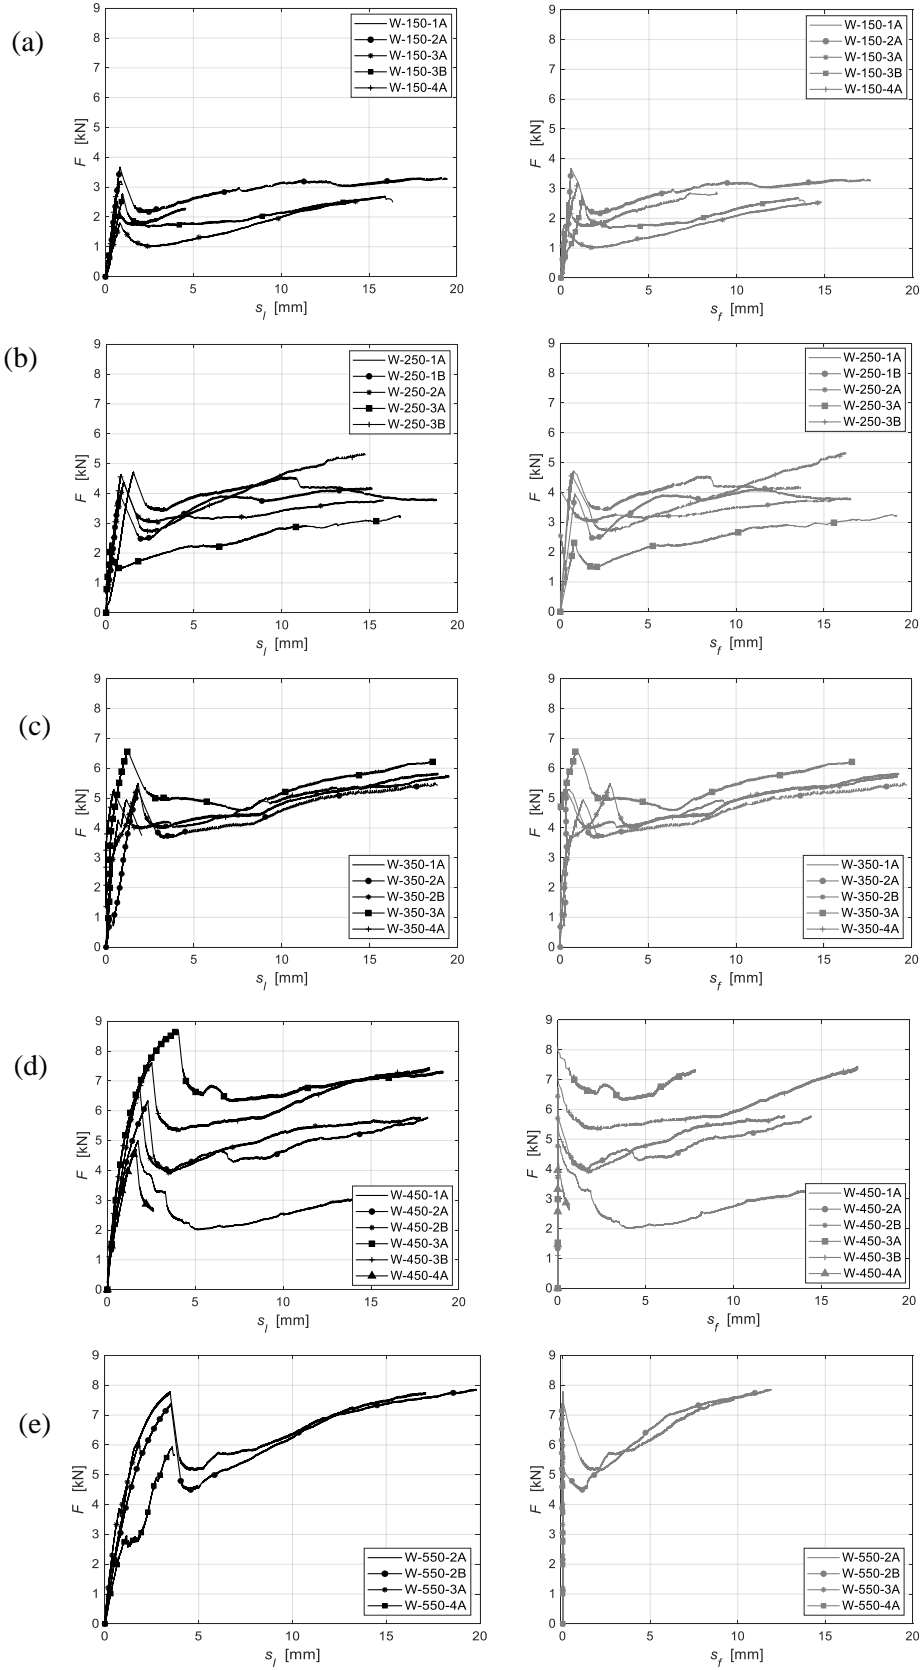
Figure 14. $F - s_l$ (on the left column) and $F - s_f$ (on the right column) curves for all masonry specimens. In each row, curves for specimens with the same bonded length are collected: a) W-150; b) W-250; c) W-350; d) W-450, and e) W-550.

Results of the tests on the bars embedded in masonry specimens are collected in Figures 14a-14e. In black, the $F - s_l$ curves and in grey, the $F - s_f$ curves, both reported in the same figure for bars with the same bonded length. The $F - s_l$ curves show a trend similar to that reported for the cylindrical specimens and are characterized by three main branches: 1) an initial linear part for low load values followed by a non-linear part until the peak load is attained. The free-end slip values corresponding to this branch are very small and increase as the peak load is reached; 2) the peak load is followed by a load drop associated with an increase of the slip; and 3) an ascending almost-linear branch until the end of the test. As for the cylinders, the phenomenon of bar rotation about its longitudinal axis was visible during the tests on the wallettes.

Results for bars with L_B equal to 450 and 550 mm, Figures 14d and 14e, respectively, show that the slip at the free end is very small before the peak load at the end of the first branch is attained, which suggests that the effective bonded length is close to these length values. It can be noted that in some cases, $F - s_f$ curves show some variability in the initial branch before the peak load is attained, i.e. s_f is greater than s_l , as in the case of specimen W-350-2B in Figure 14c. This behaviour can be due to the measurement system of the slip at the free end adopted in the case of masonry specimens. In fact, s_f is measured only by a single LVDT that reacted off of a circular plate attached to the free end of the bar. As stated before, during the test the bar rotates and the plate can be in some cases not perfectly horizontal, and this may result in a less reliable measurement of the free end slip.

In Figure 14, considering $F - s_l$ curves related to the specimens where both bar A and B were tested, i.e. W-150-3, W-250-1, W-250-3, W-350-2, W-450-2, W-450-3 and W-550-2, it could be noted that in some cases, curves are very close to each other (in particular, W-350-2A and B, W-450-2A and B, W-550-2A and B) and in other cases (in particular, W-150-3A and B, W-250-3A and B) bar B, which was tested after bar A, shows a better performance in terms of peak load F_m than bar A, envisaging that a bond degradation due to the previous testing of bar A was not present. In the remaining cases (in particular, W-250-1A and B, W-450-3A and B), curves related to bar A are higher than curves related to bar B. From these observations, the aspect of the possible interaction between two bars in the same specimens remains an open issue. Differences between two curves related to the same specimen may be also related to the inherent variability of the masonry and not because they interact. Additionally, since only 7 wallettes (out of 20) could be tested for both the bars, thus the possible interaction between two bars in a specimen still has to be confirmed by experimental evidence. In the light of the above-mentioned considerations, the fact that some specimens split apart when tested bar A, is a phenomenon more related to the problem of a poor brick/mortar adhesion than an interaction between bars.

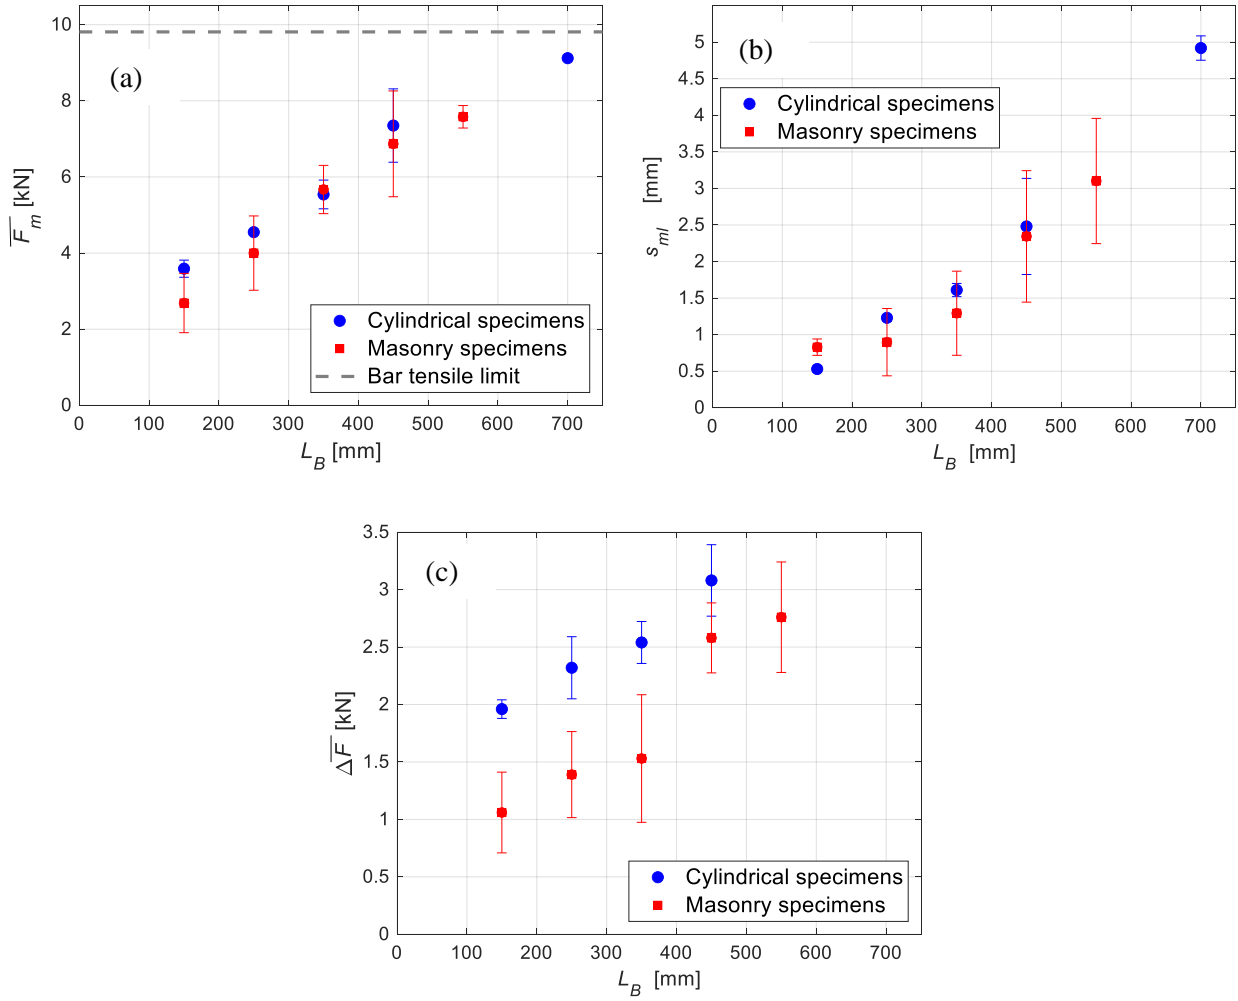
Figure 15. Relationship between (a) \bar{F}_m and L_B , (b) \bar{s}_{ml} and L_B and (c) $\Delta\bar{F}$ and L_B for cylindrical and masonry specimens with error bars.

In Figure 15a, the average pull-out load \bar{F}_m for both cylindrical and masonry specimens with the same bonded length is plotted versus the bonded length L_B itself. It should be noted that the value of \bar{F}_m for masonry specimens were computed without considering the specimens that exhibited splitting as soon as the first peak load was attained. Removing those specimens from the calculation of the average was necessary to consider the trend of consistent wallettes with the same type of failure, Table 2. As the bonded length increases, the pull-out load increases non-linearly while approaching the tensile limit of the bar. It is worth noting that the average peak load of cylinders differs than the one of masonry specimens by 33%, 14%, -2% and 7% for L_B equal 150, 250, 350 and 450 mm, respectively. Those differences are not negligible for some bonded lengths, but they should be interpreted in the context of the values of CoV for the peak load of masonry specimens, which are as high as 29% for L_B equal 150 mm. The differences in peak load between cylindrical and masonry specimens can also in part be attributed to the different confining role of the material surrounding the bar. In the cylinders, the mortar is able to provide a homogenous confining action, while in masonry specimens the weak plane at the mortar-brick interface might influence the confining action of the surrounding material. It should be mentioned that the properties of the mortar cast in large cylindrical specimens might be different from the properties of the mortar cast in a thin joint [29]. In addition, the eccentric position of the masonry specimens with respect to the load axis might have played a role in the bond behavior of the bar. The results indicate that testing cylindrical specimens might provide an upper bound of the bond behavior of the bars in actual masonry applications. It should be pointed out that additional tests on masonry specimens should be carried out in which a transversal compression on the masonry wallette is applied. The trend of Fig. 15a indicates that for both cylindrical specimens and masonry wallettes the effective bond length is greater than the bonded lengths tested. However, to confirm this trend, additional lengths should be considered.

Figure 15b shows the average of the slip at the loaded-end corresponding to the peak load, \bar{s}_{ml} , plotted versus the bonded length for cylinders and wallettes. The trend is very similar for the two types of specimens.

The average load drop, $\Delta\bar{F}$, is calculated as the average of the difference between the peak load and the load corresponding to the relative minimum after the drop for each specimen (Table 2). It could be seen in Figure

15c that $\Delta \bar{F}$ is increasing with increasing L_B . One possible explanation for the trend of $\Delta \bar{F}$ is that as the peak is reached, damage has occurred along the entire bonded length. Since the tests were run in LVDT stroke control, a load decrease is necessary after the peak to increment the controlling displacement. The load reaches a relative minimum after the peak that is associated with the condition of the surrounding mortar. In longer bonded lengths, the mortar close to the loaded end is further damaged prior to reaching the peak as the damage progresses along the bar. Thus, the increased damage of the mortar for longer bonded lengths could be responsible for the trend observed in Figure 15c. In other words, a more substantial damage of the mortar corresponds to less resistance as the bar tends to slip after the bond has been compromised.
