An experimental study of the bond behavior of twisted steel bars embedded in mortar cylinders and in the joints of masonry wallettes

Cristina Gentilini^{1a*}, Francesco Finelli^{2b}, and Christian Carloni^{3c}

Keywords: bond behavior, near-surface mounted technique, twisted steel bar, pull-out test, mortar cylinders, masonry wallettes.

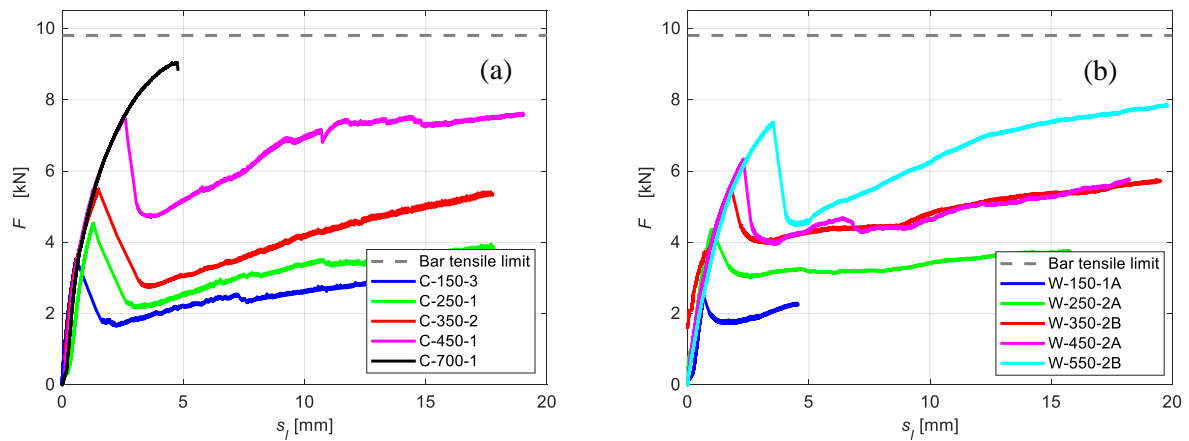
Figure 16. $F - s_l$ curves of representative a) cylindrical and b) masonry specimens for different bonded lengths.

In order to compare applied load versus loaded end slip curves for cylinders and masonry, one representative curve per bonded length for cylinders and masonry specimens is plotted in Figures 16a and 16b, respectively, where curves with the same color correspond to the same bonded length. It should be noted that in Figures 16a and 16b, only a curve per specimen type is reported, since the first branch overlaps both for cylinders and masonry wallettes with the same bonded length. As expected, a greater variability can be envisaged in the slope of the first branch for the masonry wallettes (see Figure 14, black curves) with respect to the cylinder results, however the fluctuations can be considered acceptable for this kind of specimens. Additionally, to realize Fig. 16b, only a curve with an average behaviour was selected since it was considered more representative of the average behaviour for that specific bond length.

The initial stiffness of the $F - s_l$ curves appears to be similar for specimens of the same type and different bonded lengths, which is an indication of the consistency of the results and the reliability of the test set-up. The curves tend to be non-linear close to the peak and the non-linearity is more evident as L_B increases. To further strengthen the comment above related to the trend of $\Delta \bar{F}$, it should be noted that after the relative minimum is reached, the last increasing branch appears to be linear with a slope that is consistent among the different bonded lengths. However, for both cylinders and wallettes, the last portion of the third branch is non-linear for the longest bonded length, related to the high degree of damage that accumulates along the bar as the peak is reached in the longest bars.
