A new accelerated salt weathering test by RILEM TC 271-ASC: preliminary round robin validation

Keywords Salt crystallization test · Round robin · RILEM TC 271-ASC · Sodium sulphate · Sodium chloride

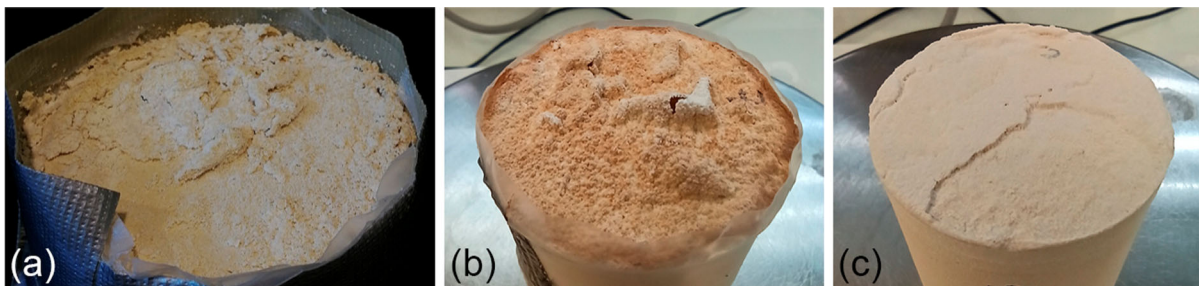
Fig. 6 **a** Decay and efflorescences in Migné specimens contaminated with 1 wt% Na_2SO_4 at the end of the test, before brushing off the evaporation surface; **b** decay in Migné specimen contaminated with 5 wt% Na_2SO_4 at the end of the

test, before brushing off the evaporation surface; **c** decay in Migné specimen contaminated with 5 wt% NaCl at the end of the test, after brushing off the evaporation surface

Migné specimens contaminated with 1 wt% Na_2SO_4 presented chromatic alteration, powdery and/or cauliflower-like efflorescence, and loss of cohesion in the form of scaling/flaking and granular disintegration (Fig. 6a). Damage initiated in the first propagation cycle and increased with subsequent cycles. With 5 wt% Na_2SO_4 , chromatic alteration, efflorescence and progressive loss of cohesion were also observed (Fig. 6b). However, in at least one case, the mass loss recorded due to powdering/chalking/flaking at the end of the test was surprisingly less, compared to the test with 1 wt% Na_2SO_4 ; this was attributed to the fact that salt crust remained attached to the surface of the specimens. Figure 4 depicts the amount of material loss with the use of 1 wt% and 5 wt% Na_2SO_4 concentration in the various labs involved in the testing of this substrate. The results show considerable variation, both between labs and within each lab, mainly due to the presence of the salt crust on the surface of the test specimens, which inhibited (at least temporarily) material loss and encouraged cryptoflorescence and pore clogging.

Migné specimens contaminated with NaCl at 5 wt% and 10 wt% concentration showed a similar type of damage: loss of cohesion in the form of powdering, scaling and spalling of the surface layer (Fig. 6c). The amount of material loss varied (Fig. 4), depending on whether the surface layer detached or not. At two of the three laboratories involved,

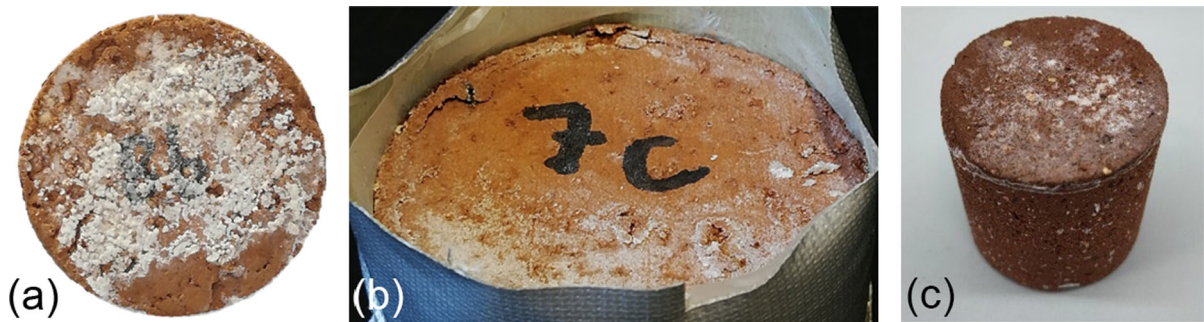
Fig. 10 **a** Decay and salt crust on Red brick specimens contaminated with 5 wt% Na_2SO_4 at the end of the test, after brushing off the evaporation surface; **b** surface of Red brick specimen contaminated with 1 wt% Na_2SO_4 , at the end of the

test, before brushing off the evaporation surface **c** decay in Red brick specimen contaminated with 5 wt% Na_2SO_4 , at the end of the test, before brushing off the evaporation surface
