Enhancing the durability of historic brick masonry: The role of diammonium phosphate and chitosan in reducing salt-induced damage

Marrone, C., Franzoni, E. (2025). Enhancing the durability of historic brick masonry: The role of diammonium phosphate and chitosan in reducing salt-induced damage. JOURNAL OF CULTURAL HERITAGE, 73, 150-157 [10.1016/j.culher.2025.03.004].

# Enhancing the durability of historic brick masonry: the role of diammonium phosphate and chitosan in reducing salt-induced damage

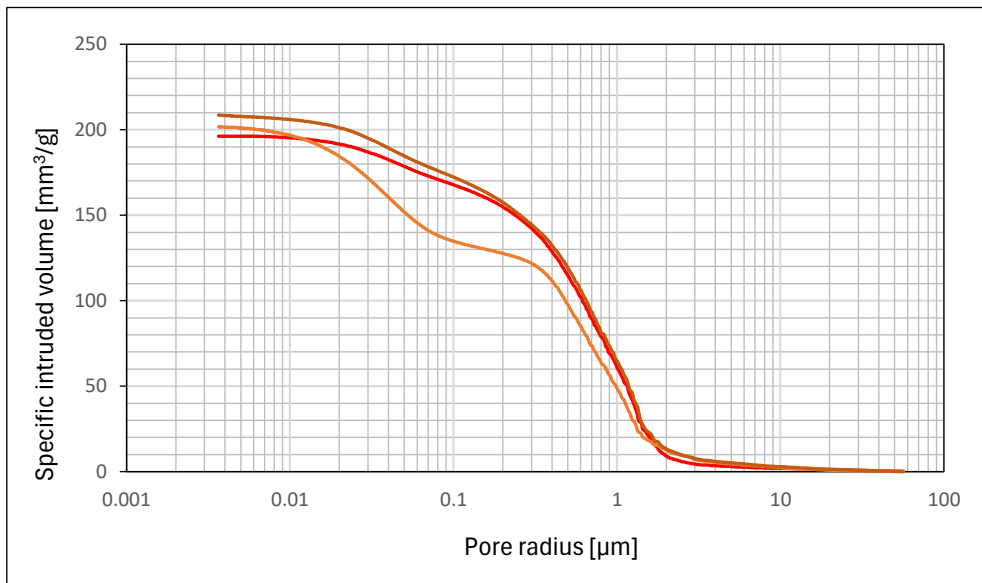
**Fig 2.** Pore size distribution of three samples coming from different bricks, determined by MIP.

molle Terre di Romagna classico rosso” (soft mud bricks, Terre di Romagna classic red), are handmade and this production process results in some irregularity and a porosity distribution similar to that of historical bricks often encountered in heritage architecture. As a matter of fact, the soft mud (“pasta molle”) technology involves mixing clay with over 40% water by weight to achieve a desired level of workability. This high-water content results in a more porous structure compared to bricks made with other methods. The properties of the selected brick in terms of porosity were evaluated through mercury intrusion porosimetry, MIP (Thermo Scientific Pascal 140 for macropore and Thermo Scientific Pascal 240 for micropore) on three bricks and the results are reported in Fig 2 and Tab 1.

The total porosity of the selected bricks aligns with the most common range found in historical samples (25-35%), as reported by [41]. Additionally, the distribution of pore sizes in the bricks overlaps that found in another study on ancient bricks [44], particularly in the submicron range (<1 µm), which constitutes the majority of the pore volume in both cases.

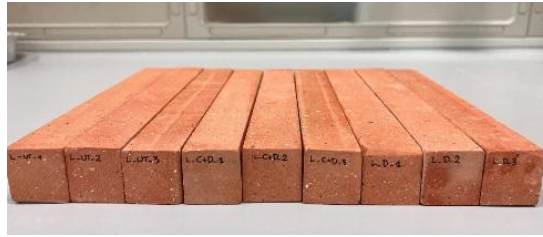
**Fig 3.** Brick samples selected for the experiment ( $3 \times 3 \times 25 \text{ cm}^3$ )

Nine prismatic samples (3×3×25 cm<sup>3</sup>, Fig 3) were prepared by sawing three bricks. Three samples served as untreated controls ("UT"). The remaining six samples were treated with DAP through a 24-hour partial immersion (samples laid horizontally in the solution with an immersion depth of approximately 1 cm), followed by rinsing to remove residues and drying in an oven at 40°C until constant weight. Subsequently, three of these samples received additional treatment with the chitosan solution ("D+C"), following the same procedure of immersion, rinsing and drying. The other three, treated with DAP alone, were labelled as "D".

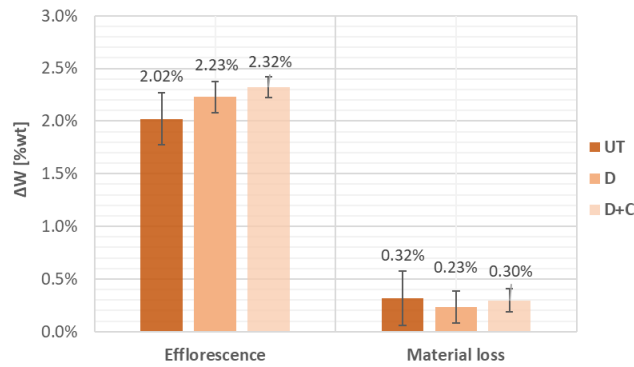
**Fig 5.** Weight percentages of the salt and solid fractions in the debris, based on the weight of the brushed prisms.

The analysis conducted on debris and efflorescence removed from the samples at the end of the test supports the earlier findings (Figure 5 and Table 6). The salt fraction observed in the untreated samples was lower compared to the treated ones, and the samples that received the combined treatment of DAP and chitosan exhibited the highest amount of salts in the debris. This suggests that the synergistic action of DAP and chitosan may have facilitated the formation of efflorescence rather than subflorescence. The solid fraction of debris collected from untreated samples was higher than that removed from the treated ones, indicating that the treatments effectively reduced material loss. Although there was only a slight difference between treated and untreated samples, the results are still positive, demonstrating that the treatments helped preserving sample integrity by reducing degradation. The improvement in salt resistance of bricks with DAP alone can be attributed to its role in increasing tensile strength and promoting a rough pore surface that facilitates capillary flow to the exterior, thereby fostering efflorescence over harmful subflorescence [25], as evidenced by the higher amount of efflorescence observed with DAP compared to untreated bricks.
