A COMPREHENSIVE 3D GEOLOGICAL MODEL OF THE NORTH-EASTERN SECTOR OF THE SAN LEO PLATEAU

KEYWORDS: 3D geological model, geomechanical analysis, remote sensing, landslide volume

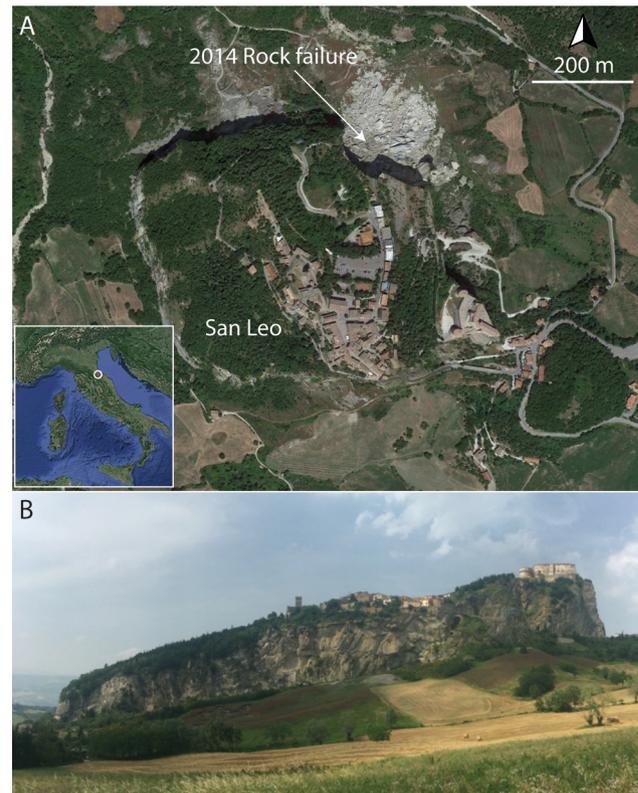
Fig. 1 - A) Location of the San Leo plateau and 2014 failure. Source: Google Earth, 2019. B) View of the town from South

The town of San Leo, situated in the Northern Apennines of Italy, is a scenic spot renowned for its cultural heritage, being one of the most visited locations across the country (Fig. 1A-B). Due to the slope instability of the rocky plateau over which the city lays, the area has been declared a site with consolidation requirements since 1951.

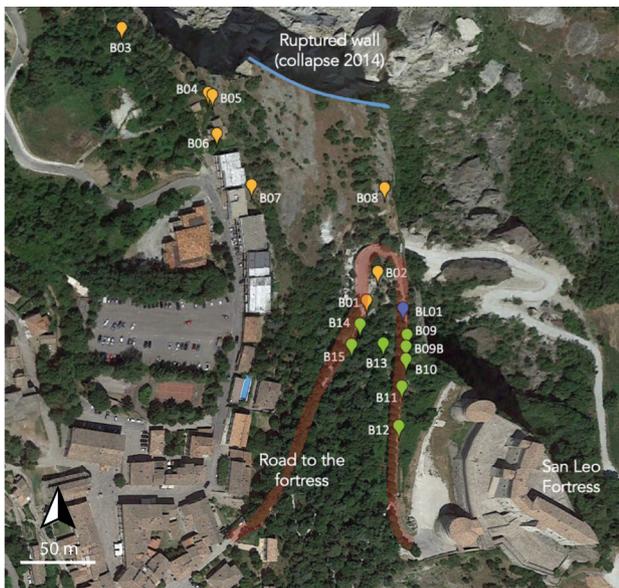
Fig. 2 - Location of the boreholes in the north-eastern sector of the plateau (Source: Google Earth, 2019)

In this research, data obtained from different surveys methods were combined into a single 3D geological model. The surface geometry of the model was reconstructed by combining 3D point clouds derived from TLS and UAV surveys. The software CloudCompare was used to register and merge the point clouds, and to extract the orientation and persistence of surficial geostructural features. Geotechnical logging of seventeen boreholes, distributed across the San Leo slab (Figure 2), was also performed to measure the orientation and spacing of discontinuities. Eight boreholes (B01-B08) were drilled for the installation of the monitoring system along the crown of the 2014 landslide event. Eight boreholes (B09B and B09 to B15) were drilled along the road approaching the San Leo fortress in the south-eastern zone of the slab. A vertical borehole (BL01), drilled on the road along the eastern cliffs, was also logged.

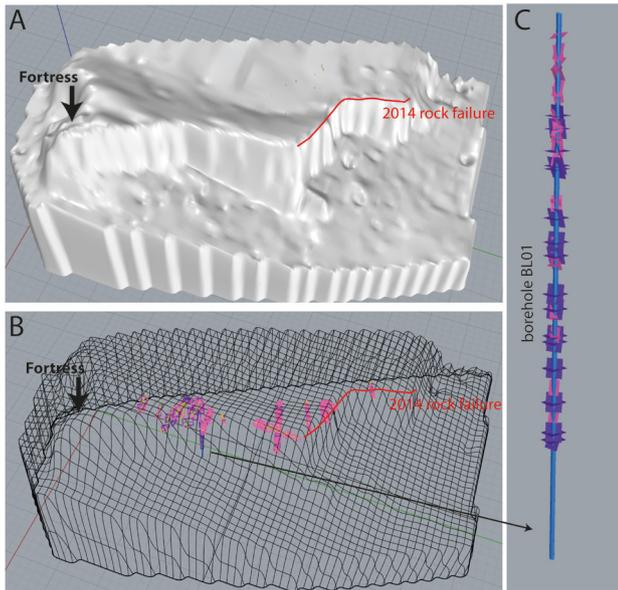
Fig. 3 - A) 3D model representation of the San Leo Plateau. B) Wireframe of the 3D model of San Leo plateau with borehole data included. C) 3D representation of Borehole BL01

Using the location, orientation, and length of the boreholes (Tab. 1), it has been possible to reproduce their geometry in the 3D model, together with the intersected discontinuities. Figure 3 shows the resulting 3D geological model (visualized in Rhinoceros 3D), including the 3D model of one of the boreholes (BL01) displayed as an example (Fig. 3C).

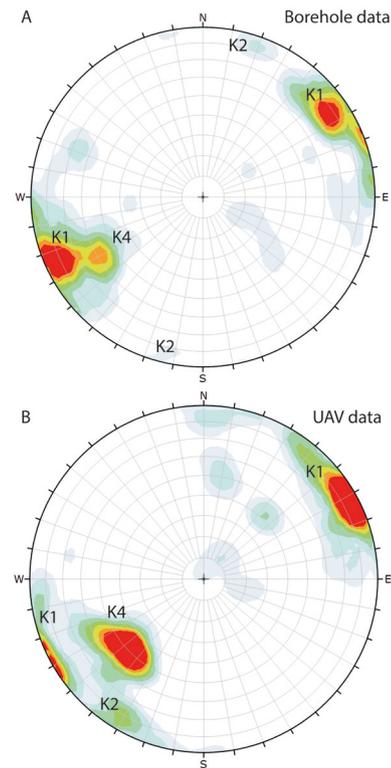
Fig. 4 - Discontinuity sets identified through boreholes (A) and UAV (B) data

A total of 554 fractures have been extracted from boreholes, 73 of which are open and 481 closed. Overall, three discontinuity sets have been identified through the stereonet of borehole data (Fig. 4A). This agrees with discontinuity sets extracted from the TLS/UAV 3D point clouds (Fig. 4B and Fig. 5A) and with previous studies (SPREAFICO *et alii*, 2015).

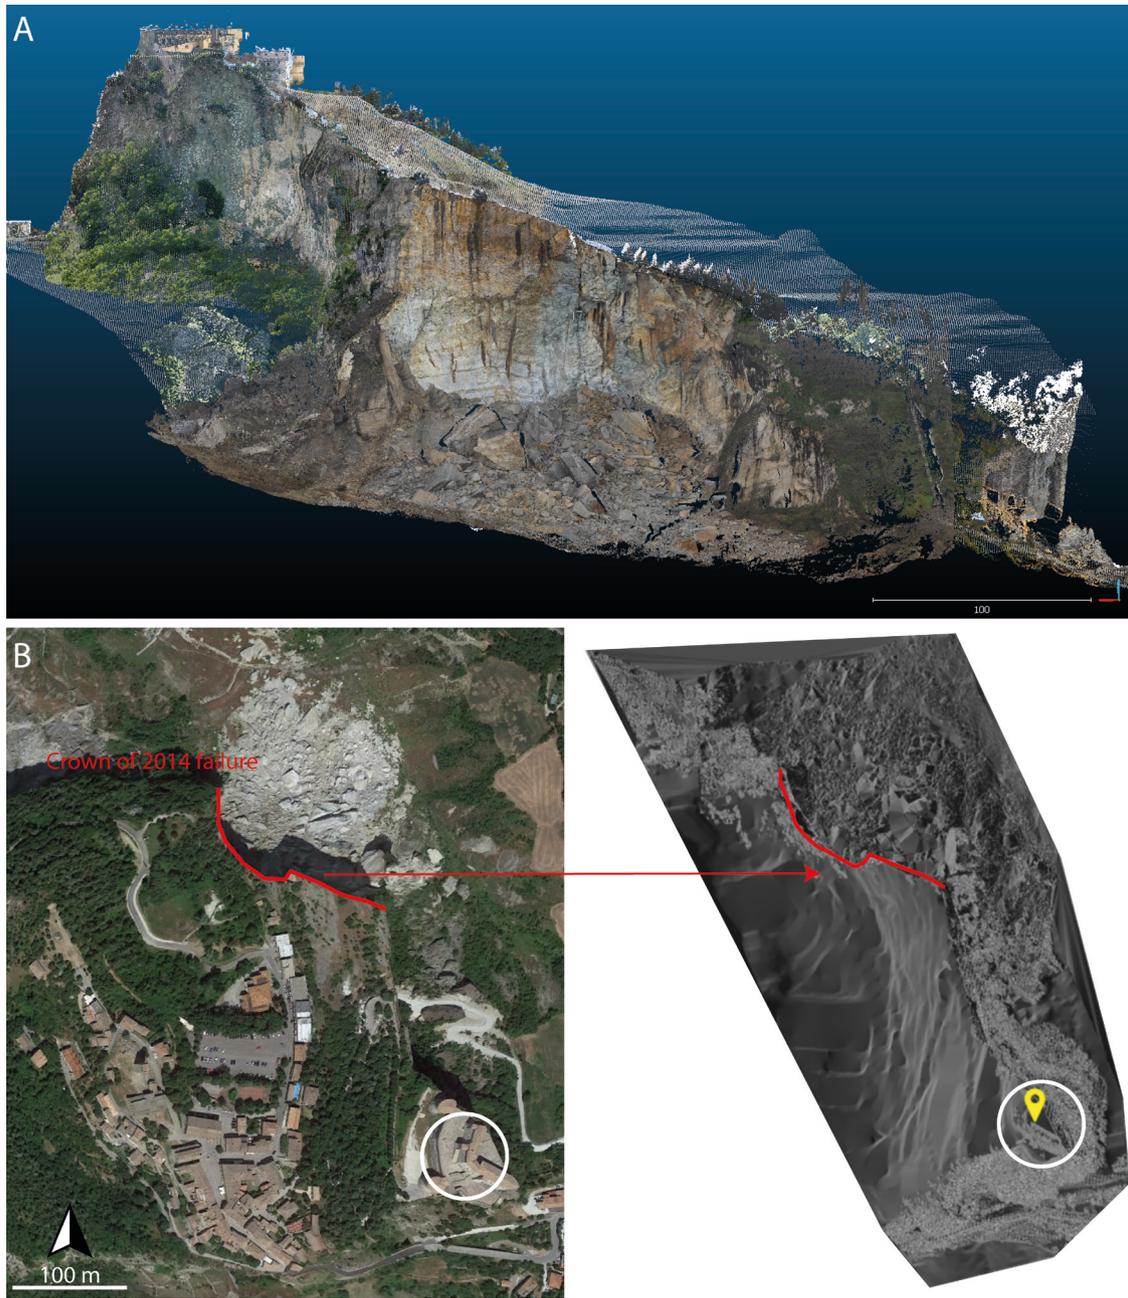
Fig. 5 - A) 3D point cloud extracted from TLS and UAV surveys. B) Area affected by the 2014 rock failure and 3D representation of the same area in the 3D Rhinoceros model. The white circle shows the location of the fortress, visible in the far left of the point cloud in A

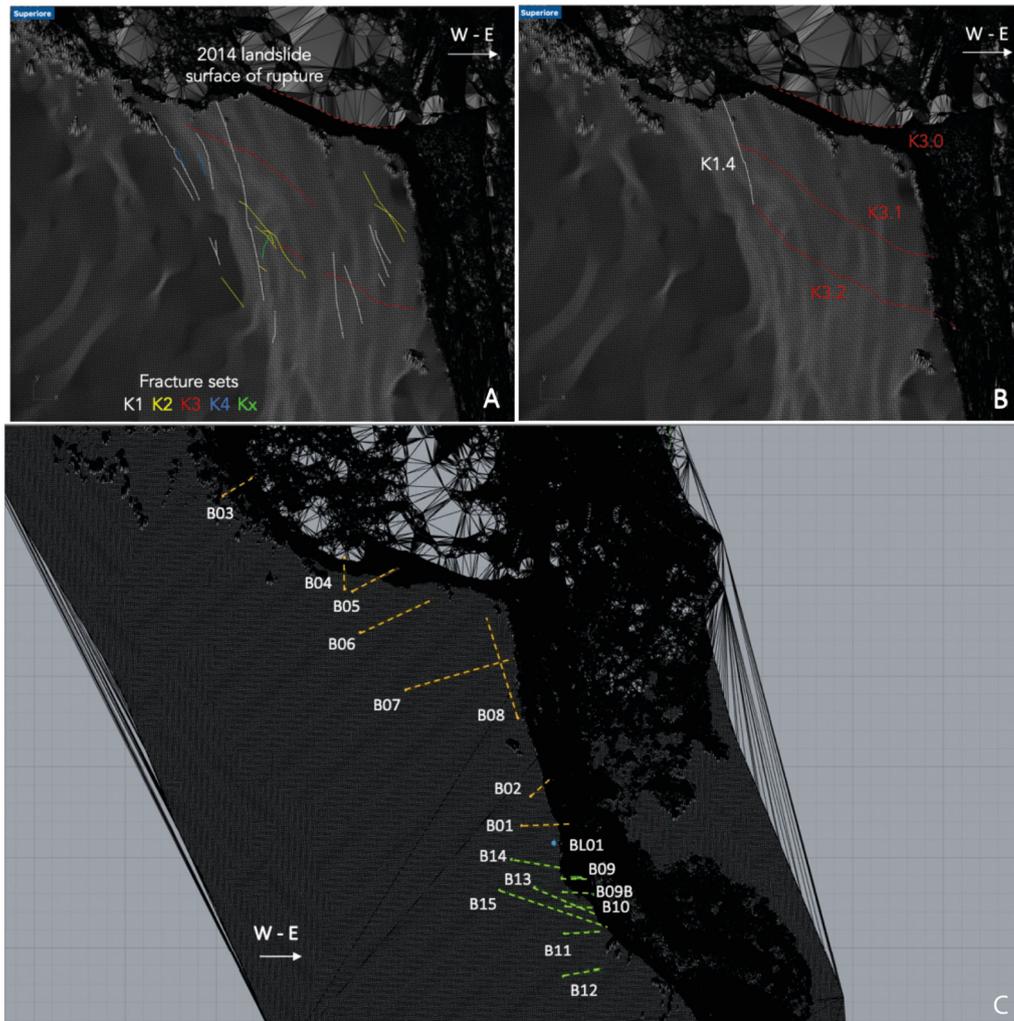
Fig. 6 - A) Fractures identified on the slab summit. B) Fractures involved in possible failure scenarios. C) Boreholes location and traces in a plan view

A good agreement was also noted between the highly persistent open fractures identified on the top of the rocky plateau and the sets extracted from borehole data and TLS/UAV point clouds. The joint sets K1 and K2 display a very high inclination and a NNW-SSE direction (due to their similarity, these two sets appear as a single set, K1, in the stereonet). The fracture set K3 display a high inclination and NW-SE direction. The set K4 has a direction similar to K1/K2, but with a lower dip angle (around 50°). The western lateral release surface is parallel to the set K1. This part of the rupture surface is referred to as K1.4. The northeastern cliff edge pertaining to the crown of the 2014 landslide presents the same geometry of K3 fractures. The surface of rupture is formed, in general, by planes with high dip angles, at least 70°, and dip directions towards the northeast or the southwest, ranging from 20° to 40° or 200° to 220°, respectively. Due to this, the rupture surface as a whole has been named K3.0 (Fig. 6B). Two parallel

fractures associated with the joint set K3, referred to as K3.1 and K3.2 and respectively located 25 m and 45 m behind the crown, were also identified on the summit of the slab and are (Fig. 6B).

Once the geometry of surficial major discontinuities has been defined, the fractures K1.4, K3.1 and K3.2 have been extended in depth using their dip and dip direction. Then, all the boreholes crossing the extruded surfaces were analyzed (Fig. 6C) to verify the presence of fractures with similar geometry in proximity of such intersection (accounting for a tolerance of ± 0.2 m with respect to the approximate location). It has been found that K3.1 intersects boreholes B04, B05 and B08 at a depth of 13 m, 9.50 m, and 8.50 m, respectively. The K3.1 fracture does not extend throughout the boreholes B06 and B07 and therefore is not continuous within the rock mass and its continuity decreases towards the center of the plateau.

Two collapse scenarios of the northeastern sector of the plateau have been evaluated. The 2014 slope failure exploited the pre-existing discontinuity plane K3.0 (Fig. 6B). The same kinematics have been emulated for the fractures K3.1 and K3.2, located approximately 25 m and 45 m south from the present-day scarp, respectively. The superficial fractures K3.1 and K3.2 have been considered the failure surfaces of the simulated scenarios. For both scenarios, the fracture K1.4 was considered a lateral release surface. Since the discontinuity planes involved in the rock slope failures have been extended and included within the 3D model of the San Leo plateau, it has been possible to define the potential volume of the rock failures along K3.1 and K3.2 (Fig. 7).

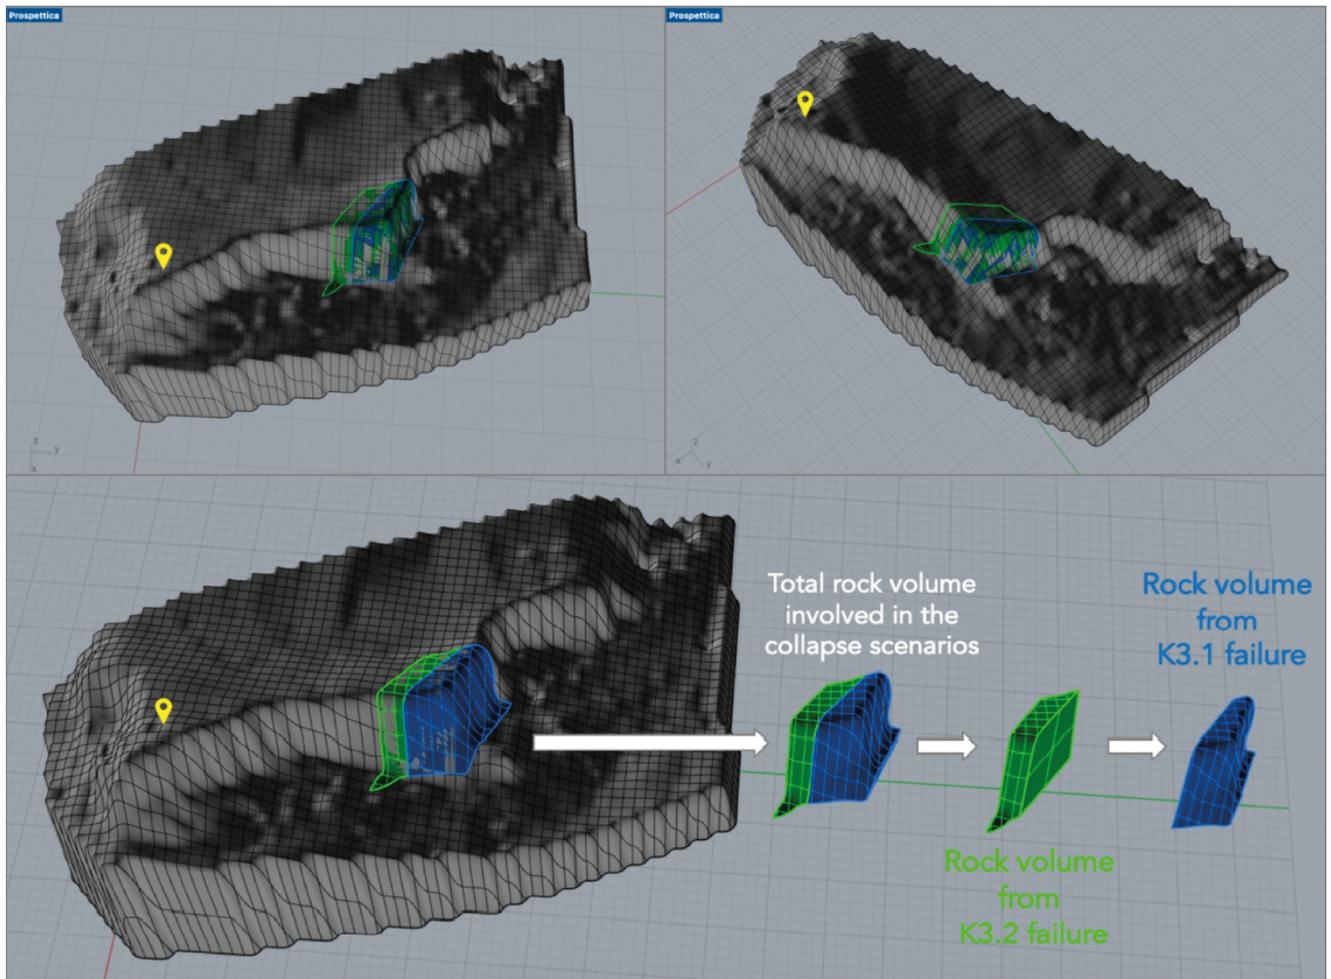
Fig. 7 - Rock volume involved in the collapse scenarios along the K3.1 and K3.2 discontinuity planes

The first collapse scenario, corresponding to the failure of the rock mass bounded by fractures K3.1 and K1.4, implies a

cliff retreat between 20 and 30 meters along the northeastern edge, generating a failed volume of 240,000 m³. The second scenario would generate a further cliff retreat of additional 20 to 25 meters. The rock volume collapsing in the case of failure along the K3.2 discontinuity plane amounts for an additional 188,000 m³. In the event of a single failure along the K3.2 discontinuity plane, the cliff edge would be subject to a 40- to 50-meters retreat with respect to the K3.0 discontinuity plane (i.e., the 2014 surface of rupture), generating a volume of 428,000 m³. These values are comparable with the 300,000 m³ volume displaced in the 2014 landslide, which resulted in a 40 m cliff retreat, approximately. It is noteworthy to mention that the two landslides simulated in the present study could also trigger further collapses of the north-eastern scarp, as it actually occurred during the 2014 event, implicating the displacement of an even greater rock volume.
