Article

Robustness Analysis of Historical Timber Roofs: A Case Study of the Gaggiandre Shipyard at the Arsenale of Venice

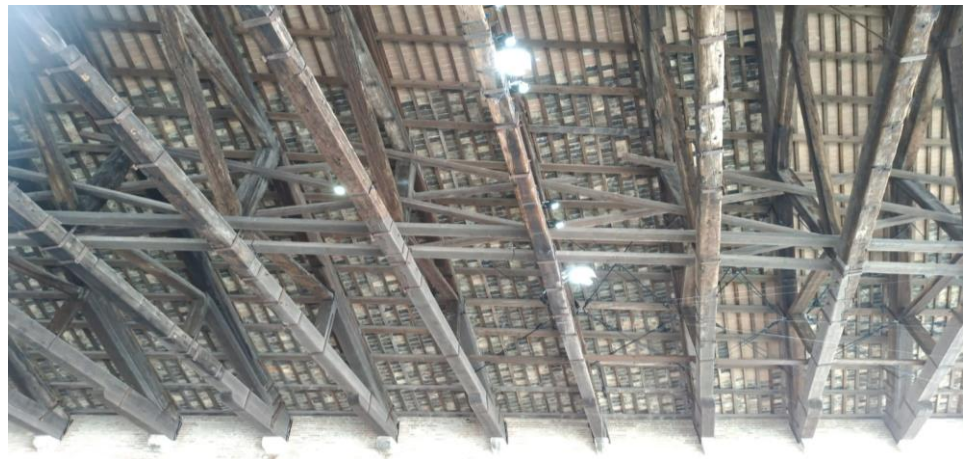
Figure 2. Bottom view of the roof.

The roof of the Gaggiandre shipyard, supported by continuous clay brick masonry walls, consists of a series of composite type timber trusses, with a length of about 25 m, which are among the largest of the 16th century (Figure 2). Figure 3 shows some construction details of the roof, i.e., the suspension of the tie element (Figure 3a) and detail of the support of the truss on the masonry, realized with a stone cantilever and barbican (Figure 3b).

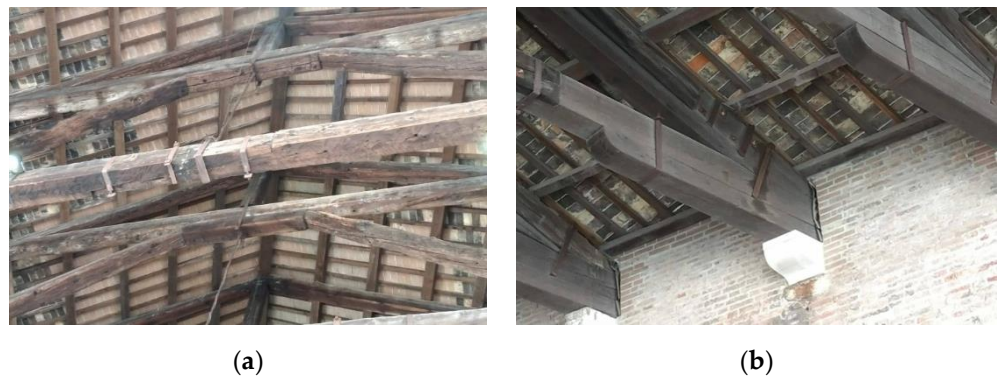
Figure 3. Construction details of the roof: (a) suspension of the tie element; (b) support on the masonry by a stone cantilever and barbican.

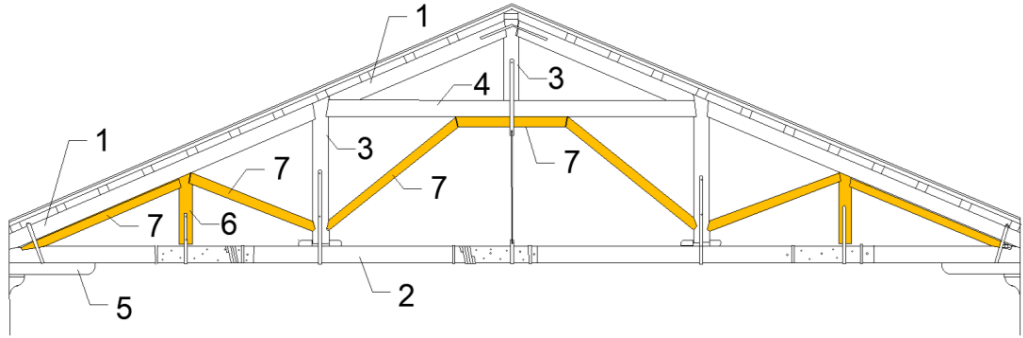
Table 1. Size and nomenclature of the main structural elements.

Roof Truss-Structural Element ID and Nomenclature	Cross Section Dimension B × H [cm]	
1	Inclined Strut	26 × 35
2	Tie	26 × 35
3	King Post	26 × 35
4	Horizontal Strut	26 × 35
5	Shelf	26 × 35
6	Additional King Post	26 × 28
7	Additional Strut	26 × 20

The two roofs belonging to the Gaggiandre shipyard consist of a truss structure, with a span approximately equal to 25 m, made of struts, ties, and King Posts. The dimensions of the structural elements that compose the truss are reported in Table 1 and follow the ancient Venetian measure called foot, “piede”, which corresponds to 34.77 cm and represents the main reference measure of the time. In fact, the tie, the four struts, and the King Posts have a section of about one foot by $\frac{3}{4}$ foot. The bottom tie is divided into three segments joined by particular double step nodes named “Dardo di Giove”. The angle between the strut and the bottom tie is equal to 24° with a truss height of about 5 m. The length of the truss elements is reported in Figure 7 both for the original and the retrofitted configuration. The spacing between the trusses is variable, ranging from 206 to 210 cm, equal to about 6 Venetian feet.

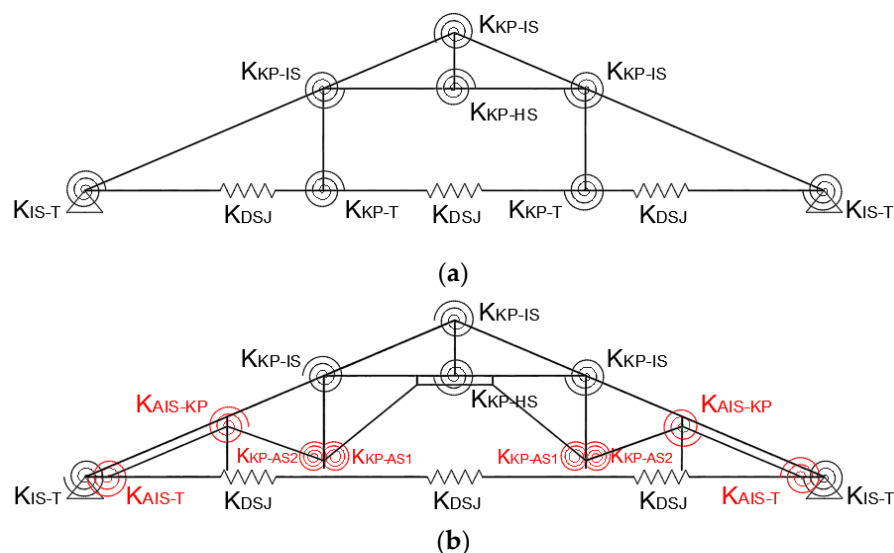
Figure 8. Modeling of the truss accounting for the nodal stiffness: (a) 1—original; (b) 2—post intervention.

Two different configurations of the wooden roof trusses, the original (model 1) and the retrofitted (model 2) one, respectively, are analyzed by using 2D models and adopting beam elements (Figure 8). Particular attention is paid to the nodal joints and boundary conditions.

Two comparative modelings of the nodes of the structures were performed: the first neglects the rotational stiffness of the nodes, therefore all the nodes are treated as hinges, while the second (hereinafter referred to as the letter “R”) considers the nodal stiffness (Figure 8), the value of which has been adequately calibrated on consolidated results available in literature. In particular, in the more refined modeling, the interactions between the structural elements are defined as follows: (i) the double step-joints of the segments of the bottom tie were modeled as equivalent springs whose axial stiffness is defined in accordance with Refs. [17,18]; (ii) the step-joints of the strut-tie and King Post-strut connections are modeled considering a rotational stiffness defined in accordance with Ref. [19]; (iii) the joint between the bottom tie and the King Post in the original configuration of the truss is modeled considering the rotational stiffness defined in accordance with Ref. [20]; (iv) the interaction between the original struts and the new additional reinforcing struts is modeled with rigid elements (trusses), having an axis perpendicular to the axis of the strut elements in order to reproduce the flexural coupling but allowing for the reciprocal sliding. This modeling criterion is also used to reproduce the interaction between all the horizontal strut elements as well as the tie-barbican connection.

elastic modulus parallel (E_0) and perpendicular (E_{90}) to grain, and in terms of mean shear modulus G . In Table 2, the values considered for the nodal stiffnesses are also reported, considering the nomenclature introduced in Figure 8.

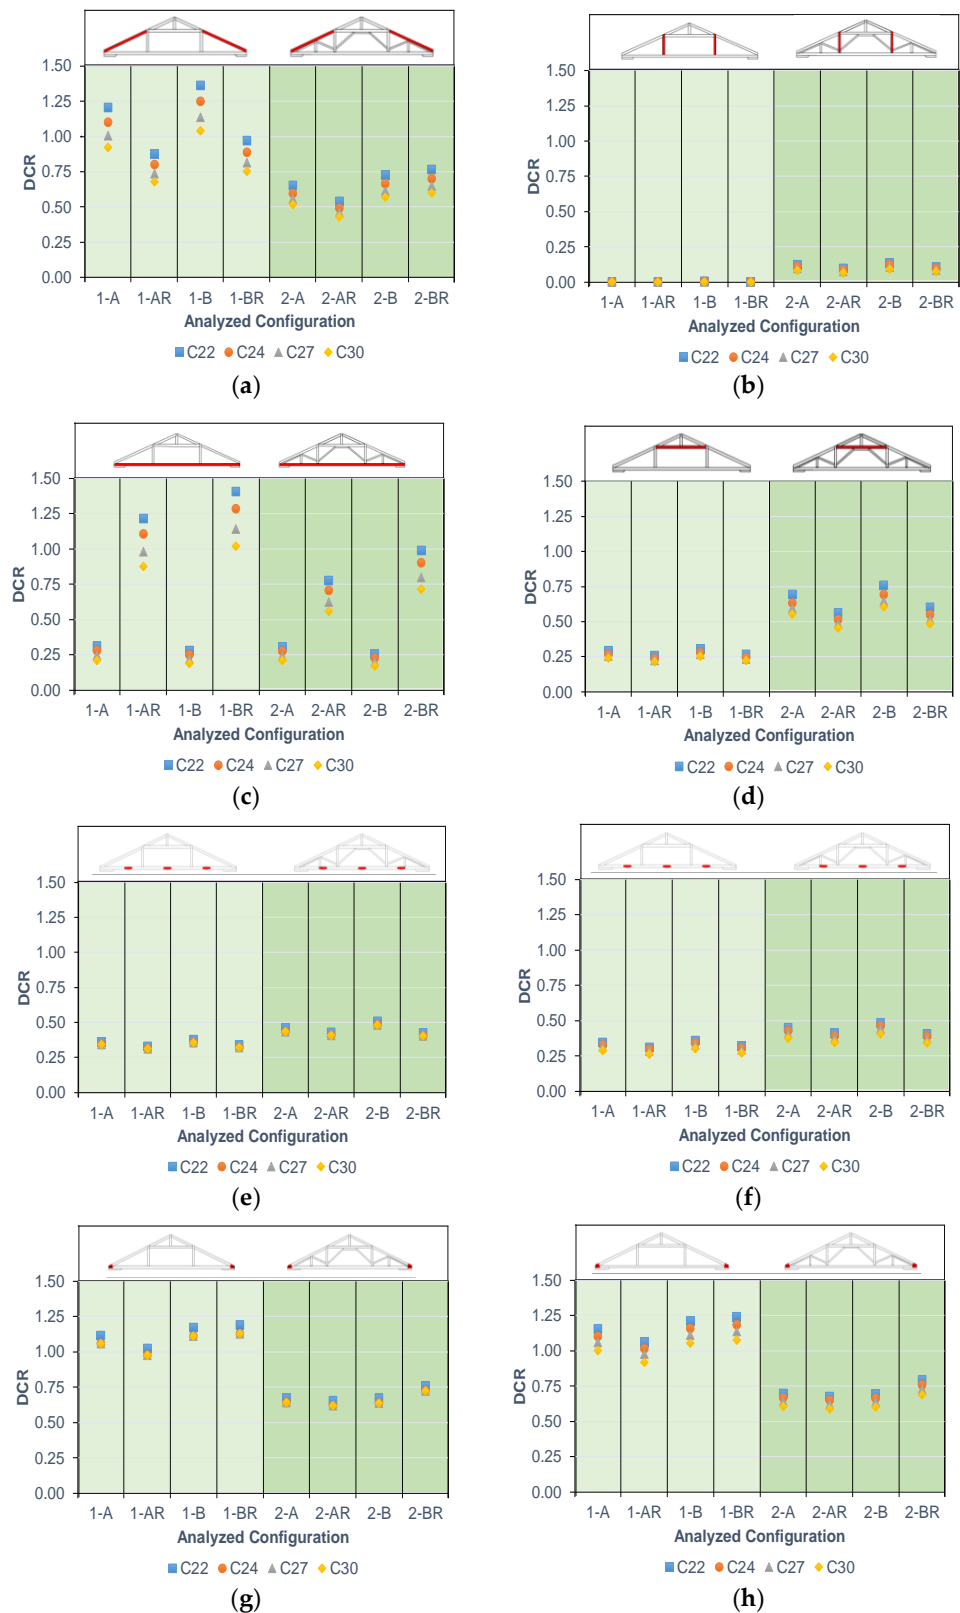
Figure 9. DCR for the most significant structural elements and nodes: (a) Strut-bending/compression; (b) King Post-traction; (c) Bottom tie-bending/traction; (d) Strut-bending/compression; (e) "Dardo di Giove" joint-shear; (f) "Dardo di Giove" joint-inclined compression; (g) Step joint-shear; (h) Step joint-inclined compression.

In this section, the main results obtained from the linear static analyses (LSA) of the different configurations, in terms of the Demand–Capacity Ratio (DCR) of the element or of the carpentry joint, are reported. In particular, the demand is expressed as the stress component obtained by the internal forces (i.e., bending moment, axial, and shear forces) resulting from LSA, while the corresponding capacity is evaluated by the relationships reported in Section 6 of Eurocode 5 [22]. The safety verification of each element/joint is satisfied if $DCR \leq 1$. The results of the most relevant verifications are reported in Figure 9 for the different models and loading conditions considered, i.e., original (1) or retrofitted (2) configuration, symmetrical (A) or asymmetrical (B) snow load, accounting for the nodal stiffness (R) or not.

It can be observed that in the original configuration some elements and joints of the truss are not verified ($DCR > 1$), even considering a high strength class timber.

The 19th-century reinforcement intervention has resulted in different stress distributions on the elements of the truss, which show a DCR less than 1, even for the lowest timber strength classes. In particular, it can be observed that: (i) the reinforcement system added during the 19th-century retrofitting interventions reduces the effective length of the lower strut; (ii) in the original configuration, the King Post has a low level of stress, while in the retrofitted configuration it shows a traction state of stress; (iii) the horizontal strut is more stressed after the retrofitting intervention due to the redistribution of the stresses that involves the lower struts system; (iv) the DCR of the step joint in the main strut-tie connection exceeds 1 in the original configuration, except for the cases in which high strength timber classes and semi-rigid node are considered, while the addition of an inclined strut and the metal support allow for a better redistribution of stresses reducing the DCR of the joint; (v) the DCR of the “Dardo di Giove” joint is less than 1 in all the considered configurations; (vi) the asymmetric load condition implies, in general, a greater DCR of the structural elements for both the considered configurations.

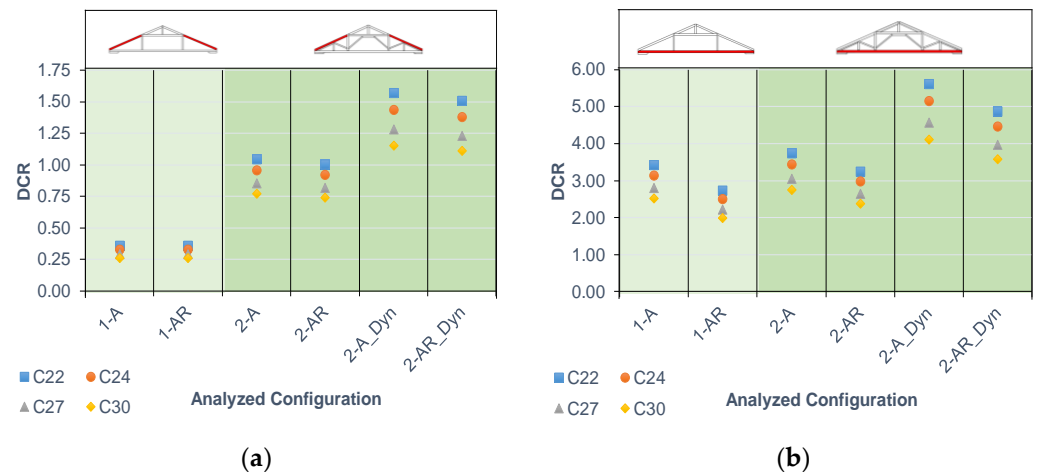
Figure 11. Robustness analysis—DCR for the most significant structural elements: (a) Strut-bending/compression; (b) Bottom tie-bending/traction.

Figure 11 shows the results of the verifications of the elements that are found to be the most stressed in the robustness analyses, where an accidental load combination is considered, for both the original and post 19th-century intervention configurations (the analyses with dynamic amplification are identified with the label “Dyn” in the graphs). It is observed that both configurations of trusses are not robust in their plane. In particular, for all configurations, the bottom tie is not verified due to the excessive bending stress (which particularly exploits the sections weakened by “Dardo di Giove” joints) even if with lower DCR for the original configuration. With regard to the strut, it can be observed that the verification against bending/compression is satisfied in the original configuration, while it is not satisfied in the retrofitted configuration due to the bearing mechanism activated by the reinforcing trapezoid substructure.

The models that consider the nodal stiffness provide lower values of the DCR for the structural elements, as a demonstration that the degree of interlocking provided by the carpentry joints contributes positively to the overall strength of the truss.

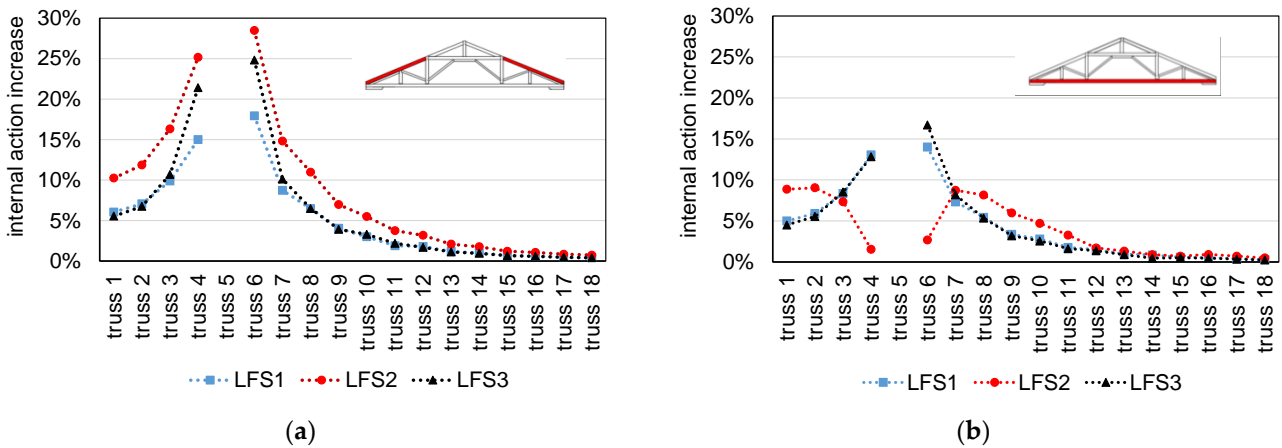
Figure 14. Variation of the internal actions on the main elements of trusses for the different LFS: (a) inclined struts; (b) bottom tie.

For the three failure scenarios, the variation of the axial force on the main elements of the roof trusses is evaluated with respect to the undamaged configuration. All the analyses and related structural checks are carried out considering the lowest timber strength class, i.e., C22 in accordance with EN 14081 [15]. As an example, Figure 14 shows the percentage changes, calculated as the ratio between the axial force in the damaged and the undamaged configuration, related to the inclined struts and the bottom tie for all the roof trusses.

The results show that the trusses next to the damaged one evidence a significant increase in the axial forces. This increase is reduced by moving away from the damaged truss; the furthest trusses are practically not affected by any variation in the axial force; thus, they do not participate in the mechanism of redistribution of the loads.

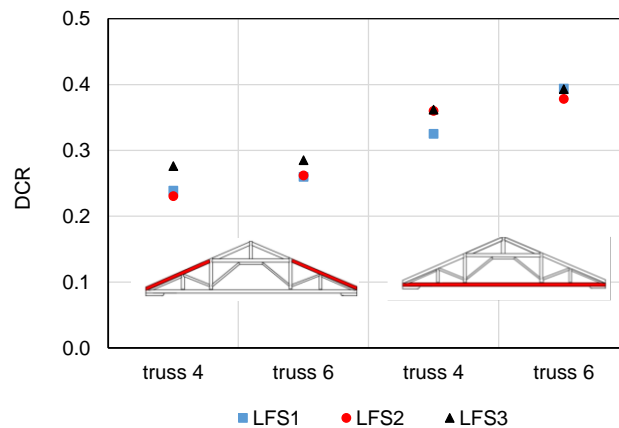
Figure 15. DCR of the struts and of the bottom tie of trusses 4 and 6 for the different LFS.

To verify the possibility of activating an ALP-type bearing mechanism, the maximum DCR of the trusses that are the most stressed (i.e., trusses 4 and 6) is evaluated since they are next to the damaged truss. The results are reported in Figure 15 for the different LFS, in terms of DCR of the inclined struts and bottom tie for trusses 4 and 6. For both the elements, the values of DCR are always lower than 1 for all the considered LFS.

The results of the verifications show that, although there is a significant increase in the DCR of the elements of the trusses with respect to the undamaged configuration, the elements are always verified. The bracing system is also suitable to withstand the actions induced by the local damage to a truss, with DCR always lower than 1. The LFS3 turns out to be the most severe scenario for the bracing system as it must compensate for both failure modes, i.e., internal disassembly phenomena and loss of support of the damaged truss.
