Tarozzi M., Pignagnoli G., Benedetti A. (2020). Identification of damage-induced frequency decay on a large-scale model bridge. ENGINEERING STRUCTURES, 221, 1-12 [10.1016/j.engstruct.2020.111039].

1 Investigation of damage-induced frequency 2 decay on a large scale model bridge

3 Mirco Tarozzi ^{a*}, Giacomo Pignagnoli ^a, Andrea Benedetti ^a

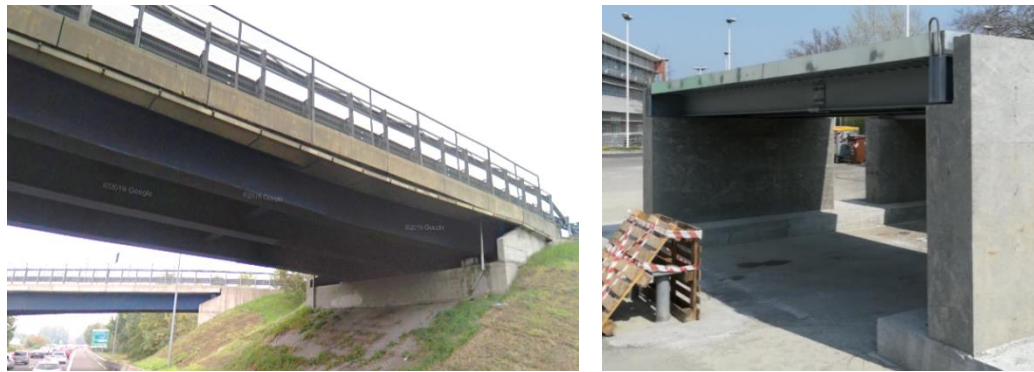
116
117 Figure 1. The bridge crossing the A14 highway (on the left) and the scaled model under
118 investigation (on the right).

111 The composite steel-concrete bridge deck under study is the 1:4 scaled model of
112 an existing bridge crossing the A14 highway in Italy, near the city of Bologna
113 (Figure 1). The scaling phase involved only the geometrical dimension, whereas
114 the properties of the materials were selected according to the common design
115 practice.

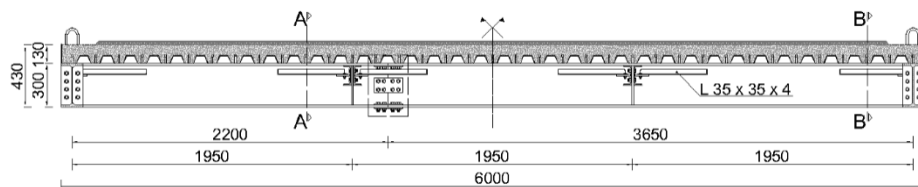
Figure 2. Longitudinal vertical section C-C of the steel deck.

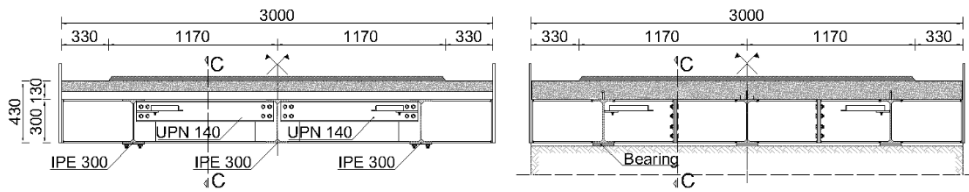
Figure 3. Transverse vertical sections A-A and B-B of the steel deck.

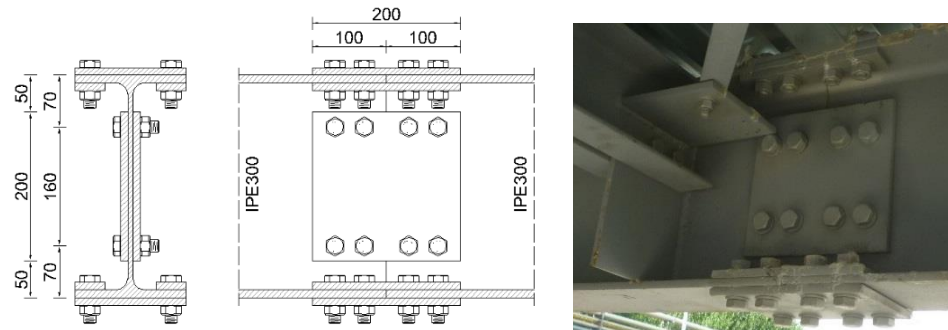
189 Figure 5: Bolted twin plate splices at one-third of the main beam length.

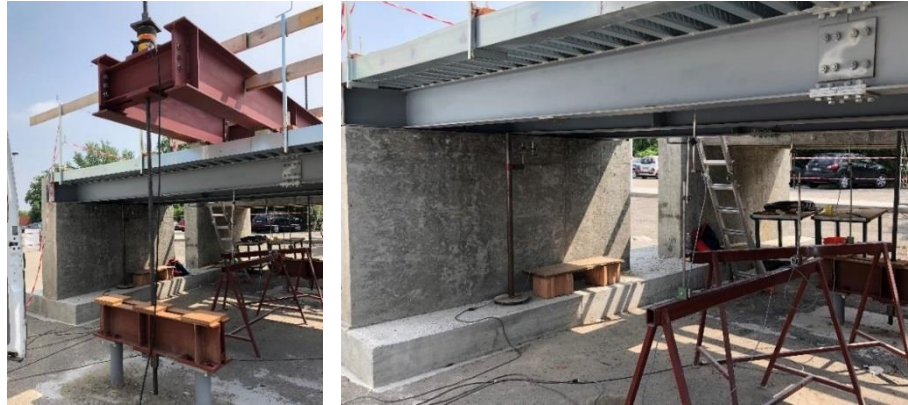
208 Figure 6: Static load test setup: on the left is shown the static loading system; on the right is
209 visible the data acquisition system.

204 applied by the two hydraulic jacks. The beam was properly designed by a
205 stiffness criterion, to minimize its deformation during loading.

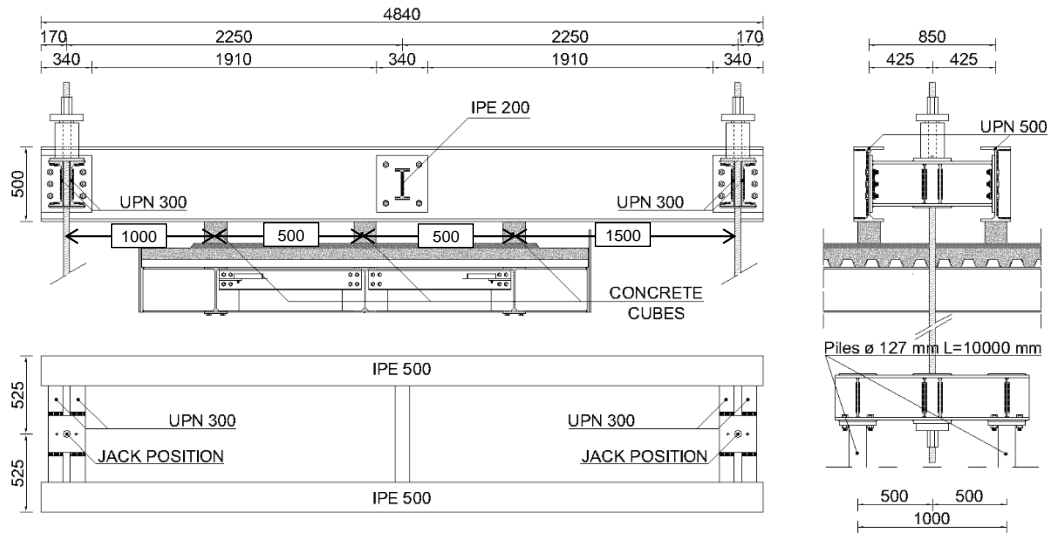
210 Since in the bridge deck there are three main beams and the loading is performed
211 by a pair of beams, there are on the deck six loading points (Figure 7).

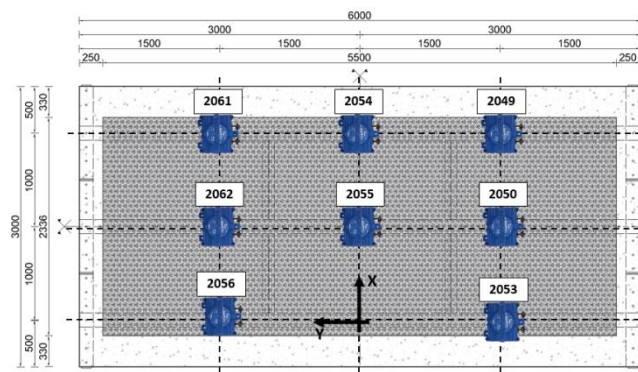
243 Accelerations were measured at a sampling rate of 2000 Hz with a set of eight
244 tri-axial Sensr CX-1 mems accelerometers arranged according to the setup of
245 Figure 9. The CX-1 is an accelerometer developed by SENSR using the MEMS
246 technology, and it can measure the acceleration with the resolution of 10^{-6} g
247 within the range $\pm 1.5g$. This sensor was widely used by the authors [36, 37, 38]
248 for other experimental campaigns, and performed very well in all environmental
249 conditions.

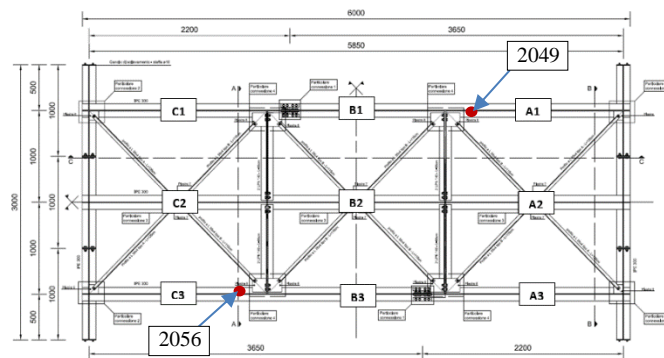
270 Figure 10. Accelerometers configuration in case of damage stages

261 According to the capacity of the recording system, eight CX-1 [41] were used
262 during the initial dynamic identification stage, whereas in the following phases
263 only two accelerometers were employed, considering this setup as typical of
264 continuous damage monitoring in simple bridges. In particular, only the CX-1
265 named 2056 and 2049 were adopted for the dynamic investigation at each stage
266 of damage realization. These sensors were fixed on the lower flange of the two
267 external beams at a quarter of their length (Figure 10).

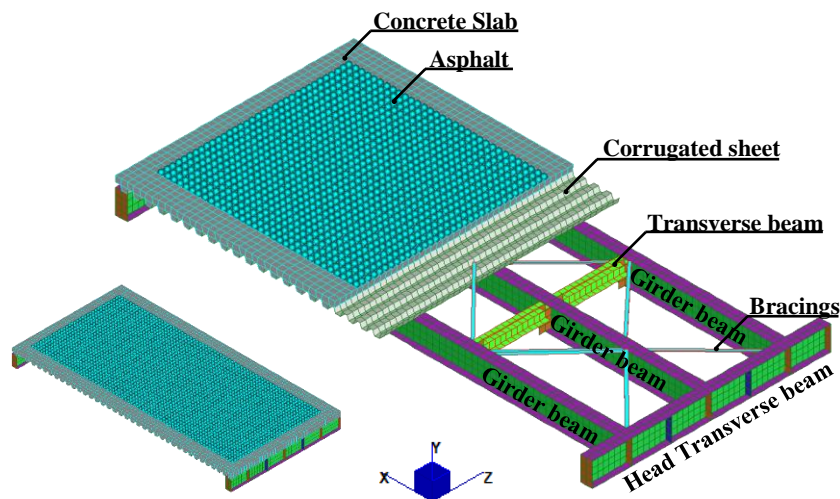
316 The sketch of the numerical model is provided in Figure 11, in which each
317 different colour means different mechanical properties assigned to the element.

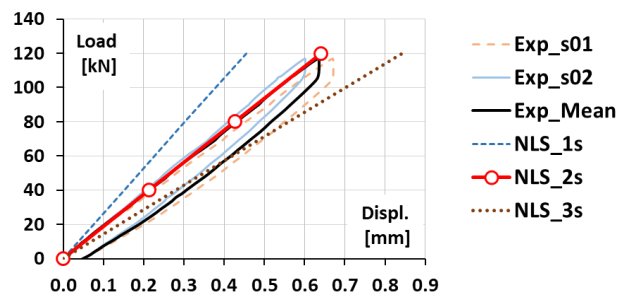
383
 384 Figure 12. Plot of the Load-Displacement curve measured at the supports compared with the
 385 curves of the linear static analysis performed on FE model.

372 Figure 12 and Figure 13 show a very good agreement among the experimental
 373 displacements and those obtained by a series of linear analyses performed by
 374 gradually increasing the load applied to the model. In particular, Figure 12
 375 illustrates the values of the two support deflections “Exp_” during the loading
 376 test compared with those obtained through the numerical LSA. The calibration
 377 was set by matching the black line (experimental average), with the results of the
 378 central girder supports in the FE model (red line). On the other hand, the static
 379 tests allowed also triggering the value of the static Young’s modulus for the
 380 concrete slab. The tuning of the support stiffness and the concrete elastic
 381 modulus led to a very good fit among the experimental and the numerical
 382 displacements on the mid-span section for all the three girders (Figure 13).

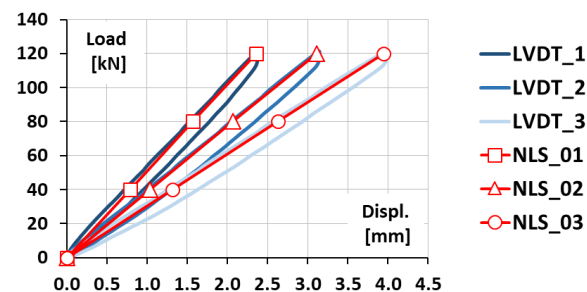
386
 387 Figure 13. Plot of the Load-Displacement curve measured at the midspan of the main beams and
 388 those reconstructed by performing a linear static analysis.

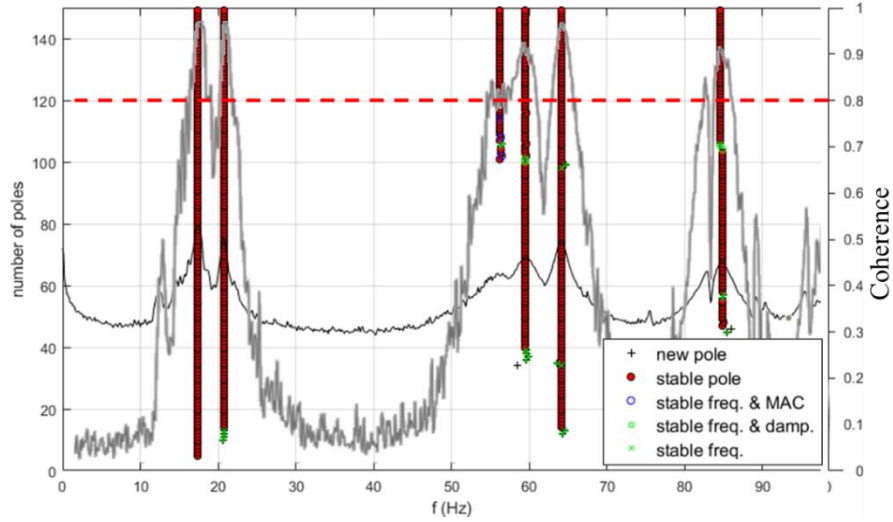
419 Figure 14: Plot of the first normalized singular value (black line), the SSI plot and the Coherence
 420 (grey line).

402 The vibration modes of the bridge are represented by the local maxima of the
403 first singular value (SV) line (Figure 14), obtained by processing time windows
404 of 16384 samples, considering an overlap of 50% between segments and
405 adopting a Hanning window to reduce the leakage. Then, the SSI_COV
406 algorithm was used to validate the FDD outcomes. The inputs for the SSI
407 method strongly influence their results, for this reason, they were chosen
408 accordingly to what suggested by *Magalhães et Al.* [49, 53]. In the present
409 application, good results were achieved with a time lag of 1 second and a model
410 order equal to 140.

411 The lowest six amplification peaks are sharply shown in Figure 14, in which the
412 first averaged normalized singular value, stable poles and the coherence are
413 identified with the black line, the aligned red circles and the grey line.

414 A coherence value higher than 0.8 means that the measured signals are well
 415 correlated and thus noise shows a low influence. Instead, low coherence values
 416 indicate that the signals are strongly influenced by noise. For this reason, the
 417 spectrum part associated with coherence lower than 0.8 can be neglected.

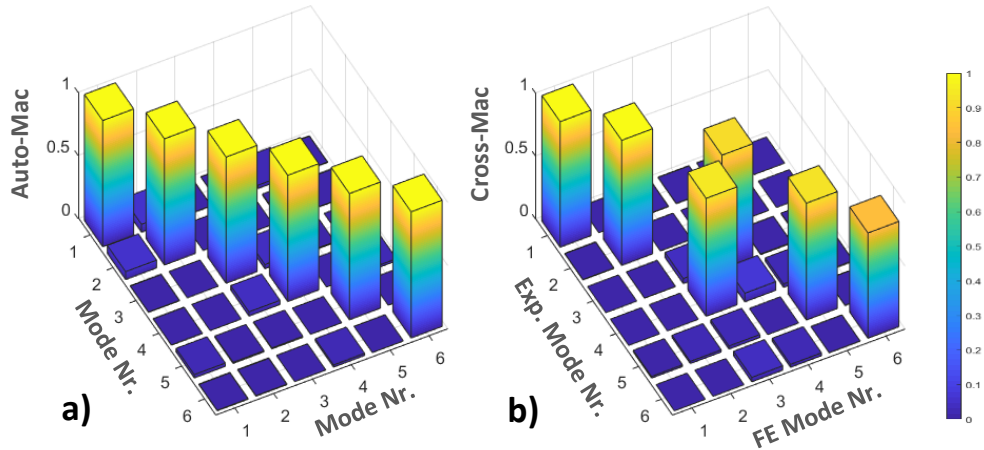
449
 450 Figure 17. Bar-plots of the AutoMAC (a) and CrossMAC (b) computed on the set of the
 451 experimental modal shapes and among the experimental and numerical modal shape sets.
 452 The numerical values of the CrossMAC bar chart depicted in Figure 17.b are
 453 listed in the matrix of Table 3.

444 By computing the MAC values of the identified mode shapes, the orthogonality
 445 error of the modes can be checked (Figure 17). On the other hand, the MAC
 446 cross-correlation of the numerical modal shapes with the experimental ones
 447 gives a mark of the soundness of the FE model as a counterpart of the real
 448 structure.

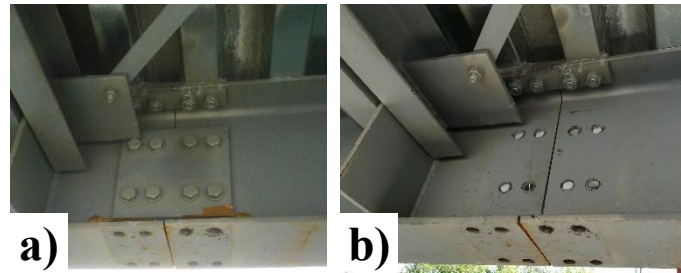
462 Figure 18. Progressive removal of the bolted plates: (a) removal of the bottom flange splice
463 plates, (b) removal of flange and web splice plates.

457 The damage equivalent to a crack involving the flange, or the flange and the web
458 of a beam, was obtained by removing respectively the flange bolted twin splice
459 plates, or both the flange and the web splice plates (Figure 18).

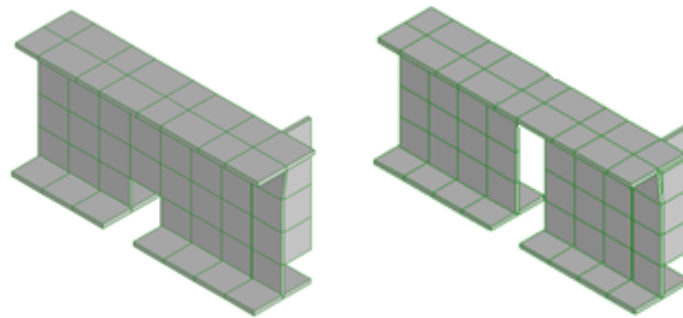
480 Figure 19: On the left the damaged condition D1, while, on the right, the Condition D2.

474 The presence of the simulated damage in the numerical model was taken into
475 account by cutting away the shell elements filling the gap between the two
476 disconnected (unbolted) flange or web plates. For the sake of illustration, the

477 damage conditions D1 and D2 are sketched in the following figure (Figure 19),
478 by representing the portion around the cut section.

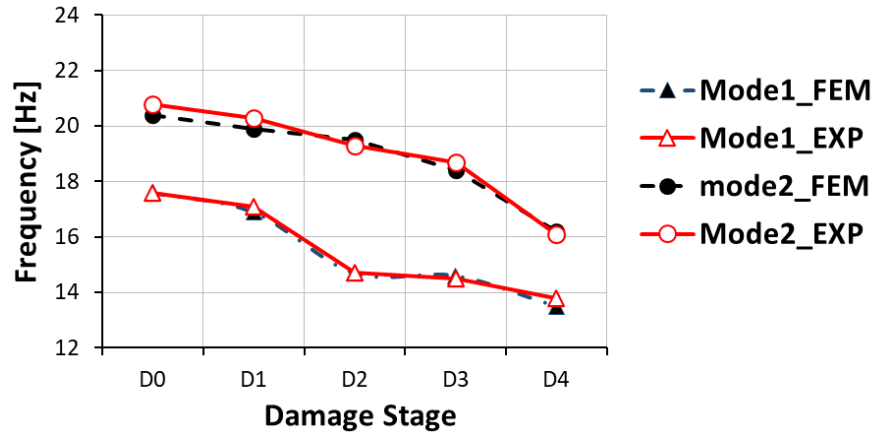
Figure 20. Frequency decay due to the presence of damage

482 At the end of the experimental campaign, all the data of the subsequent four
483 damage phases were processed, by extracting the variations of the two lowest
484 frequencies. Then, the variations of the same frequencies were computed from
485 the model by progressively deleting the elements simulating the damages as in
486 figure 12. In this way, the data reported in Figure 20 were obtained.

487 Both the first and the second mode are very sensitive to the damage. The
488 experimental data showed an almost linear reduction in frequency with the
489 progressive severity of the damage state.

490 The FE simulation led to a very good fit between the detected frequencies with
491 those obtained performing the numerical modal analysis on the progressively
492 changed model. The relative error on all the phases remained always below 3%
493 of the experimental value. The dynamic tests were performed using only two
494 accelerometers without a roving sensor technique [54]. It allowed to sharply
495 identify only the first two natural frequencies, the decay of which is illustrated in
496 Figure 20 describing all the damage states. Since the aim of the paper concerns
497 the evaluation of the stiffness and the fundamental frequency variations due to
498 the damage level, higher modes were not taken into account. Further analyses
