Nanolime, nanosilica or ammonium phosphate? Laboratory and field study on consolidation of a byzantine marble sarcophagus

NANOLIME, NANOSILICA OR AMMONIUM PHOSPHATE? LABORATORY AND FIELD STUDY ON CONSOLIDATION OF A BYZANTINE MARBLE SARCOPHAGUS

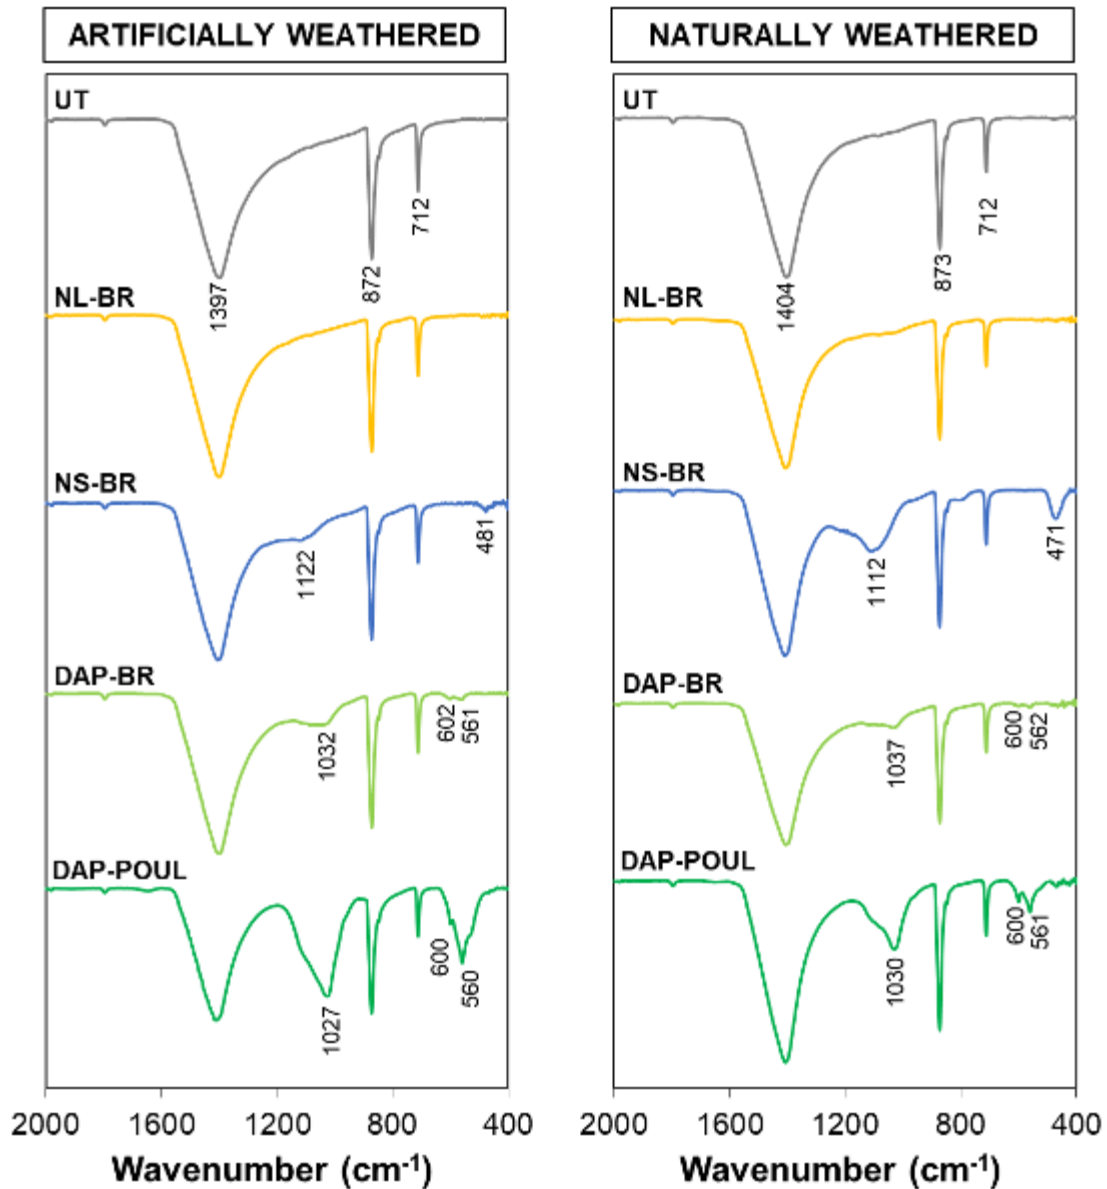
Figure 6. FT-IR spectra of untreated and treated specimens of artificially and naturally weathered marble (the position of bands owing to calcite is reported in the untreated reference and omitted in the treated samples for a better readability).

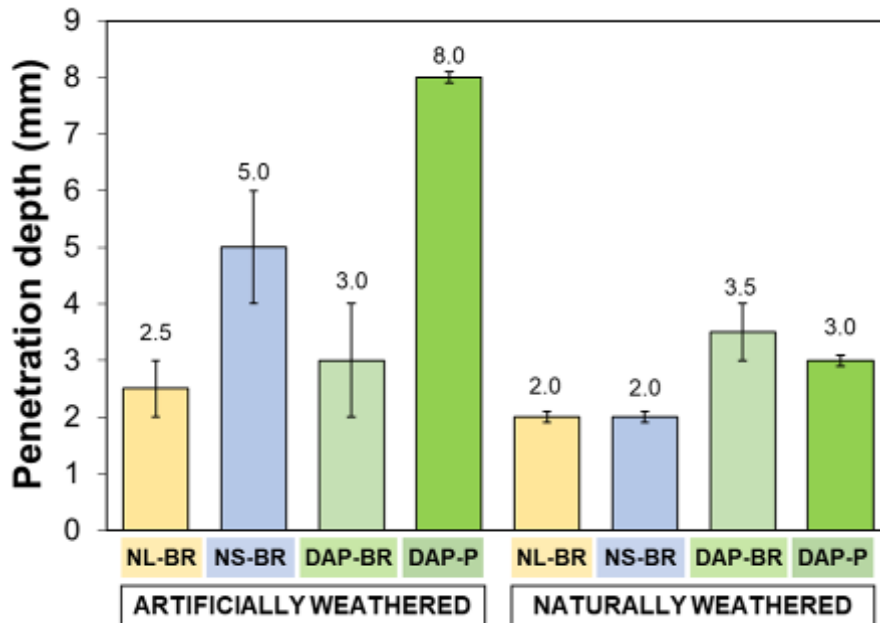
Figure 8. Penetration depth of the consolidants into artificially and naturally weathered specimens (values are averages for 2 specimens, bars indicate the difference between the average and the maximum/minimum values).

The depth of penetration of the liquid consolidants into artificially and naturally weathered specimens is illustrated in Figure 8. In general, the penetration depth was higher in the “ART” specimens (2.5 to 8 mm) than in the “NAT” ones (2 to 3.5 mm), which is consistent with the higher porosity and higher sorptivity of the “ART” specimens (cf. § 3.1.4). On either type of substrate, the highest penetration depth was registered for the DAP solution, reaching 8 mm when applied by poulticing on the “ART” specimens and 3.5 mm when applied by brushing on the “NAT” ones. In both types of substrate, the nanolime suspension exhibited the lowest penetration depth (2 mm in the “NAT” specimens, 2.5 mm in the “ART” ones). The nanosilica dispersion exhibited a deeper penetration in the “ART” specimens (down to 5 mm), compared to the “NAT” ones (limited to 2 mm). In the case of the “ART” substrate, having higher porosity than the “NAT” one, the penetration depth of nanosilica was likely helped by the very small size of the nanoparticle (10-20 nm, according to the product’s technical data sheet). In the case of the “NAT” substrate, the low porosity and the low sorptivity are thought to be the limiting factors responsible for the scarce penetration depth of both nanoconsolidants.

In any case, the trends in penetration depth illustrated in Figure 8 offer useful information to understand the different consolidating abilities of the various treatments, reported in Figure 9. The consolidating ability was evaluated in terms of ultrasonic pulse velocity (*UPV*), which has been historically used to evaluate the conservation state of marble, based on the damage classification proposed by Köhler [96]. An adaption of this classification is illustrated in the upper graph in Figure 9. According to this damage classification, the conservation state of marble can be distinguished in 5 different classes, ranging from the “fresh” condition ($UPV > 5$ km/s) to the “disintegrated” condition ($UPV < 1.5$ km/s) [96].

In the “ART” samples, consolidation by nanolimes caused the lowest alteration in the pore system (open porosity only decreasing to 2.4%), consistently with the limited penetration depth of this treatment (Figure 8). The other consolidants caused slightly more pronounced alterations in the pore size distribution, especially in the amount of coarse pores. The resulting open porosity ranged between 1.9 and 2.4%, but in no case did complete pore occlusion take place, consistently with previous results [29,30].

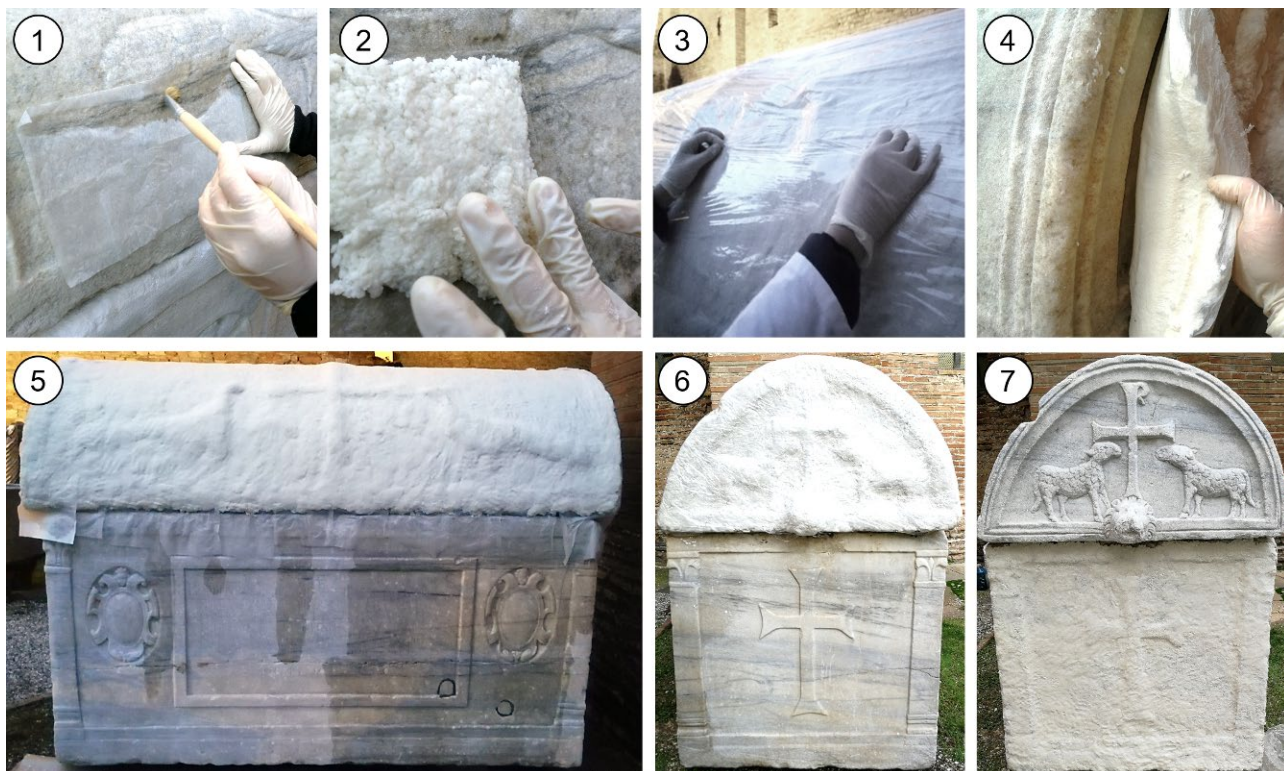
Figure S1. Consolidation of the sarcophagus by ammonium phosphate: (1) application of Japanese paper onto the marble surface by wetting with the DAP solution; (2) application of the poultice imbued with the DAP solution; (3) wrapping with a polyethylene film to prevent evaporation; (4) removal of the poultice after 24 hours; (5) view of the cover after application of the poultice; (6) view of the cover after wrapping with the polyethylene film; (7) application of the poultice onto the lower part of the sarcophagus.

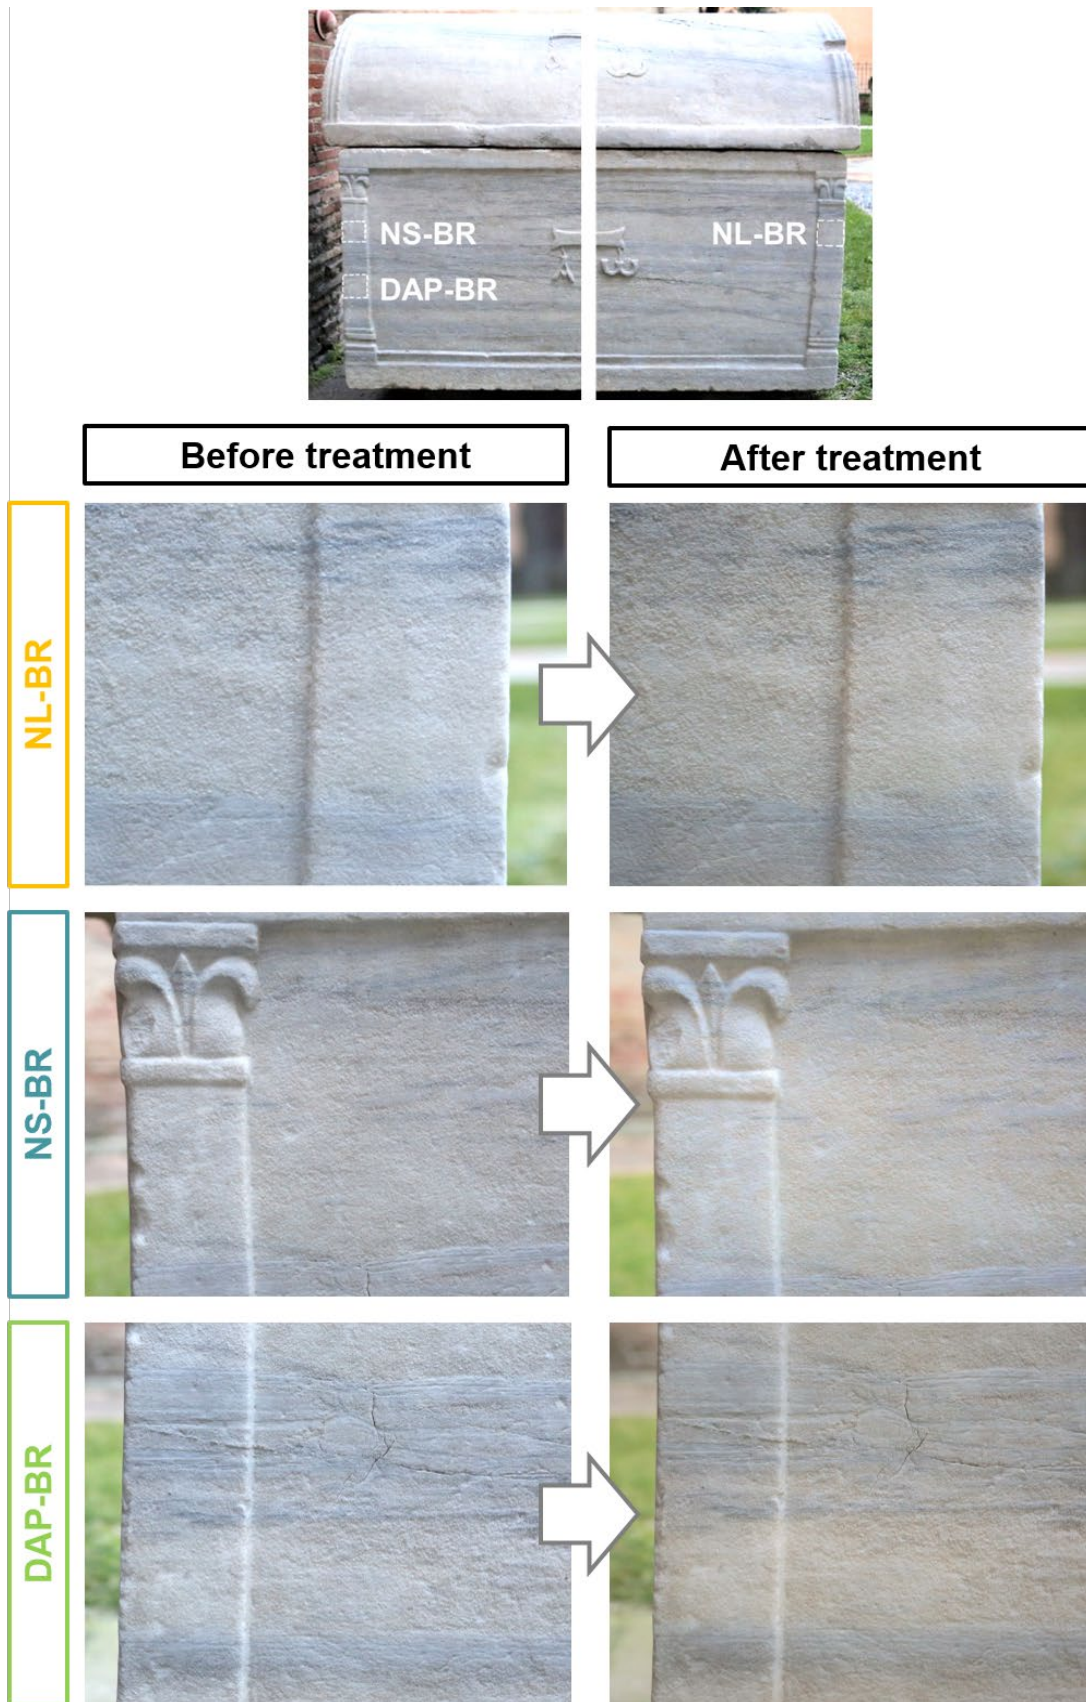
Figure S2. Aesthetic appearance of the test areas before and after consolidation with “NL-BR”, “NS-BR” and “DAP-BR”. The difference in lighting owing to the different time and period of the year when the photos were taken, before and after consolidation, makes it difficult to evaluate the overall chromatic alteration, but it is possible to notice the absence of any white hazes or surface staining.

In terms of aesthetic compatibility, none of the consolidants caused dramatic alterations of the marble surface, as illustrated in Figure S2.
