# Wire Ropes and CFRP Strips to Provide Masonry Walls with Out-Of-Plane Strengthening

Elena Ferretti

**Abstract:** The present paper deals with an improvement of the strengthening technique consisting in the combined use of straps—made of stainless steel ribbons—and CFRP (Carbon Fiber Reinforced Polymer) strips, to increase the out-of-plane ultimate load of masonry walls. The straps of both the previous and the new combined technique pass from one face to the opposite face of the masonry wall through some holes made along the thickness, giving rise to a three-dimensional net of loop-shaped straps, closed on themselves. The new technique replaces the stainless steel ribbons with steel wire ropes, which form closed loops around the masonry units and the CFRP strips as in the previous technique. A turnbuckle for each steel wire rope allows the closure of the loops and provides the desired pre-tension to the straps. The mechanical coupling—given by the frictional forces—between the straps and the CFRP strips on the two faces of the masonry wall gives rise to an I-beam behavior that forces the CFRP strips to resist the load as if they were the two flanges of the same I-beam. Even the

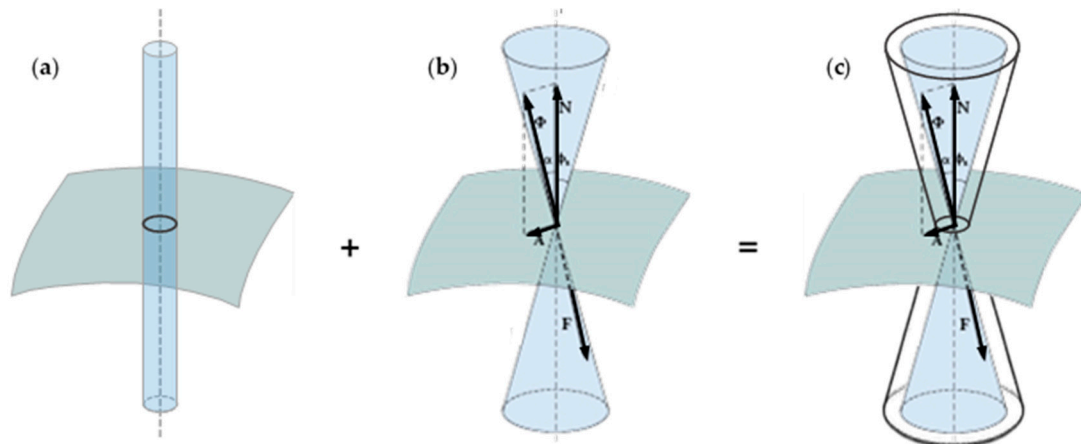
**Figure 1.** How the addition of a physical bond—represented by (b) the conical limit surface of static friction—changes the limit surface in static conditions from (a) the cylindrical surface of the chemical bond to (c) the double truncated cone of the cohesive static friction [1].

masonry walls provides a physical bond that overlaps with the chemical bond given by the resin alone. As shown in Figure 1, this modifies the limit surface of the interface bond—which becomes a cohesive physical bond—allowing the FRP strips to withstand higher shear forces before delaminating from the masonry wall under bending loads. This increases the delamination load of the FRP strip on the tensioned side of the bent wall.

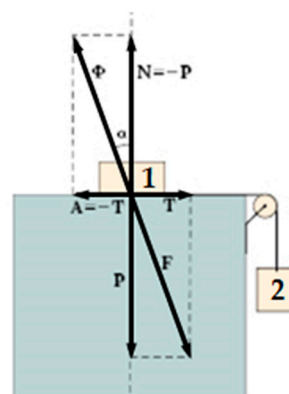
**Figure 2.** Body 1 at rest under the combined action of its weight force and the shear force provided by body 2: Active and reactive forces developed on the support plane.

- **N** is the normal force that develops as a reaction to the weight force **P**, exerted by the body at rest in Figure 2 (body 1): **N** is equal and opposite to **P**;
- **A** is the frictional force that develops as a reaction to the shear force **T**, exerted by the hanging body in Figure 2 (body 2): **A** is equal and opposite to **T** as long as body 1 is at rest;
- **Φ** is the resultant of the active forces, **N** and **A**, and is applied to body 1;
- **F** is the resultant of the reactive forces, **P** and **T**, and is applied to the support plane.

The angle between **Φ** and its component vector **N** is  $\alpha = \tan^{-1} A/N$ . Furthermore, the aperture of the cone of static friction is twice the angle of static friction,  $\phi_s$ , which, assuming to eliminate body 2 and progressively incline the support plane of Figure 2, measures the maximum inclination angle that allows body 1 not to slide on the inclined plane.

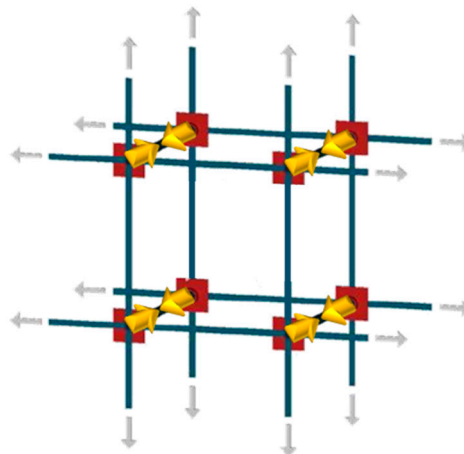
**Figure 3.** Nodal forces transferred by the CAM straps: Balanced forces in gray and not balanced forces in yellow [1].

The main target of the CAM system, patented in 1999 by Dolce and Marnetto, is to provide the wrapped masonry with an additional state of hydrostatic stress, which increases the safety factor of the masonry building. Nevertheless, a more accurate analysis of the actual mechanism for transferring stresses from the straps to the nodes of the masonry units [2,3] showed that the CAM system does not actually provide a hydrostatic state of stress. In the specific case of a rectangular CAM net, for instance, the straps act in the plane of the wall with pairs of equal and opposite nodal forces, while the nodal forces in the wall thickness are not counteracted (Figure 3). Consequently, the rectangular retrofitting system does not transfer any in-plane force, while it provides an out-of-plane compression to the nodes.

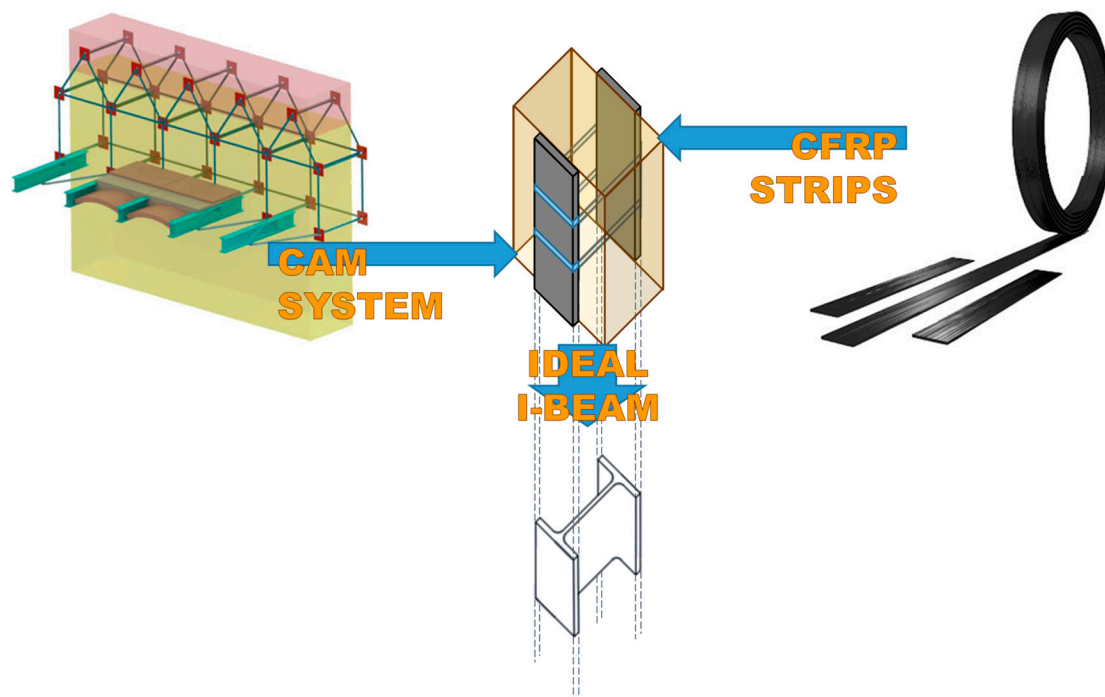
**Figure 4.** The transverse connections between the FRP strips give rise to an I-beam behavior [1].

A useful application of the straps/strips combined technique consists in placing the FRP strips vertically, one in front of the other on the two faces of a masonry wall (Figure 4). In this case, an additional advantage in terms of reinforcement overlaps with the benefits of the cohesive physical bond on the stretched side: When tied by the CAM straps as in Figure 4, the two FRP strips work together due to the transverse connection established by the CAM system (Figure 5). The resulting strengthening effect under bending loads is the same as that provided by a bracing FRP I-beam, which acts as an embedded buttress without having to cut the masonry wall to insert it.

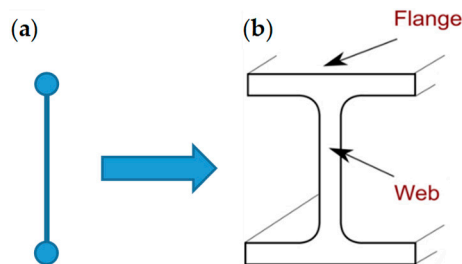
**Figure 5.** Concept of the straps/strips combined technique: Two FRP strips tied by CAM ribbons behave as (a) two mass points connected by a stiffness constraint, which is the ideal scheme of behavior of (b) a bent I-beam in its cross-section.

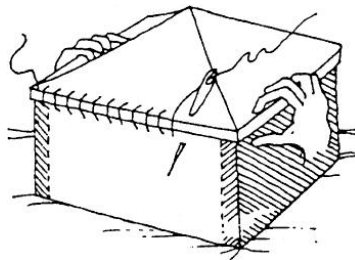
**Figure 6.** The effectiveness of structural connections provides box-type behavior to the building.

- It consists of a three-dimensional continuous strengthening system that leads to a box-type behavior of the retrofitted building (Figure 6).
- It establishes good transversal connections, which are particularly useful in cases of multi-layer masonry walls with weak connections between the vertical layers.

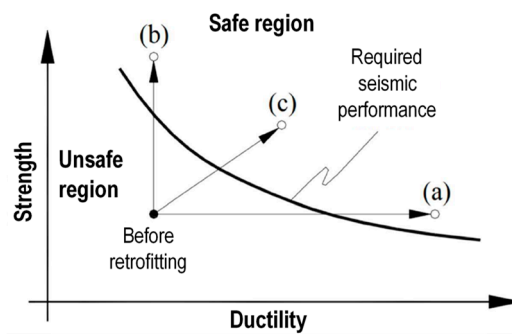
**Figure 7.** Comparison between retrofitting systems: An FRP reinforcement leads the structure to point (b), increasing strength but not ductility; a three dimensional reinforcement with steel ribbons leads the structure to point (a), increasing ductility but not strength; the combined technique leads the structure to point (c), increasing both strength and ductility.

- It continues to wrap the wall even after masonry crushing, allowing the damaged building not to collapse. This high degree of ductility (Figure 7) allows the combined technique to survive structural damage, acting as both a reinforcement system and a protection device.

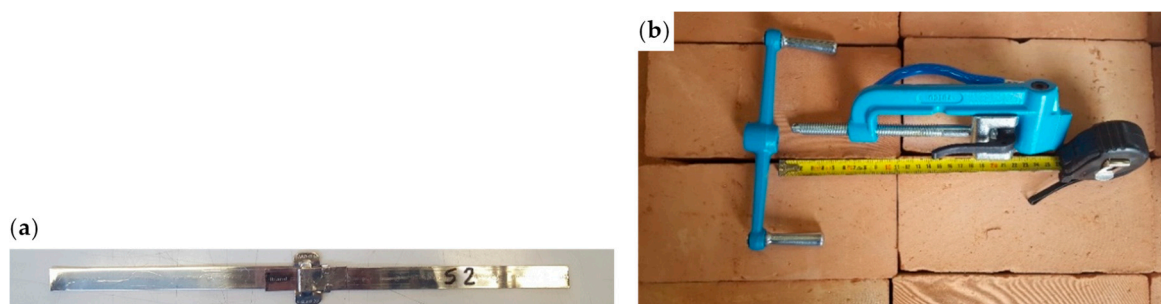
**Figure 8.** The fastening system of Reference [1]: (a) one fastened specimen for the characterization of the junctions and (b) the manual strapping tool used to fasten the steel ribbons.

Figure 8 shows a sealed ribbon and the manual device used to pre-tension the ribbons during strapping.

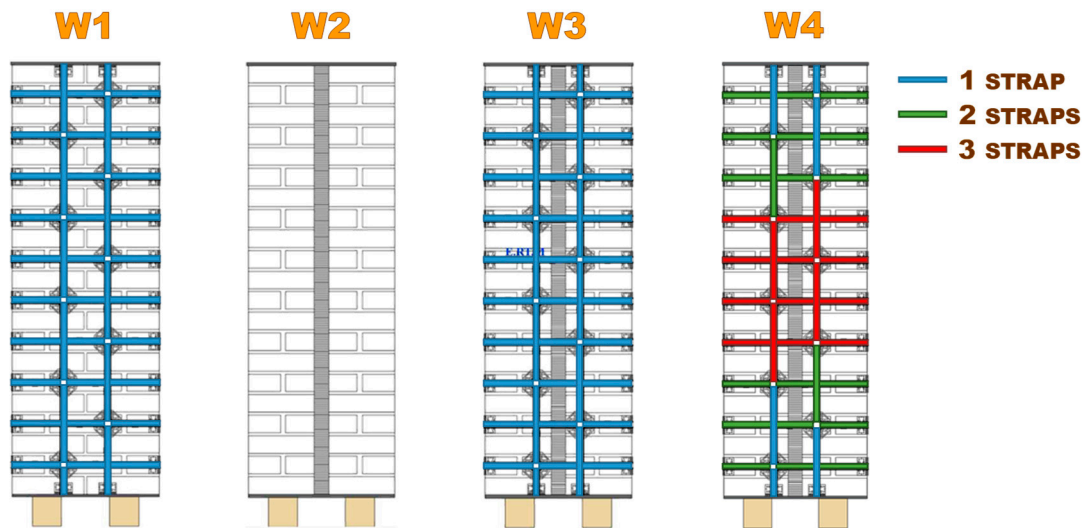
Figure 9. Arrangement of the straps for Specimens W1, W2, W3, and W4.

W3). Although the CAM system allows the use of up to four straps per loop, in specimens W1 and W3 there was only one strap per loop (Figure 9). After testing, the experimenters restored Specimen W3, modified the number of straps per loop as shown in Figure 9, and performed a further three-point bending flexural test on the restored specimen (Specimen W4). For details on the reason for the diversified number of straps per loop of Specimen W4, see [1].

The increased number of longitudinal and transverse straps near to the middle cross-section of Specimen W4 (Figure 9) also decreases the load drop at delamination (Figure 10). This improves the overall behavior in real applications, since excessive load drops in the strengthened structural element can cause serious overloads in adjacent structural elements, which can collapse.

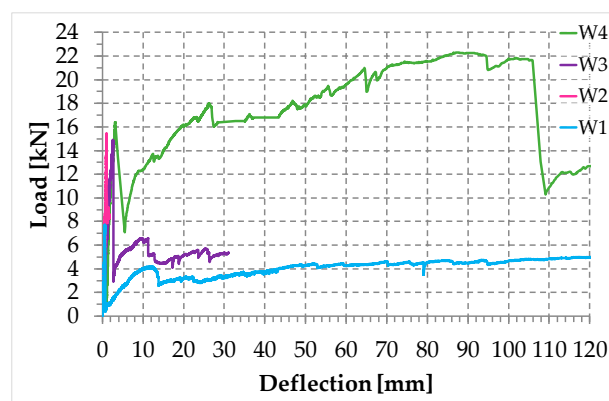
Figure 10. The load/deflection diagrams for the four specimens of the experimentation on the first combined technique.

During the flexural tests, some LVDTs (Linear Variable Differential Transformers) acquired the absolute displacements on the lower faces. The deflections in Figure 10 are the relative displacements in the central points of the lower faces, calculated as differences between the absolute displacements in the central points and the ends. The position of the instruments prompted the operator to interrupt the flexural test of Specimen W3 well in advance of Specimen W1 and Specimen W4. This is the reason why the load/deflection diagram for Specimen W3 is shorter than for Specimens W1 and W4.

The load/deflection diagrams in Figure 10 clearly show that both strength and ductility increase with the combined technique (Figure 7). In particular, for Specimens W3 and W4, the delamination loads are comparable to that of Specimen W2 (given only by the CFRP strips) and the post-peak ductility is comparable to that of Specimen W1 (given only by the steel straps). Actually, due to the high ductility, Specimens W1, W3, and W4 did not undergo a real collapse until the end of the test, which was necessary to avoid damage to the instrumentation. This means that the resilience of these specimens is extremely high: It recalls the resilience of FRP wrapped columns [38–41].

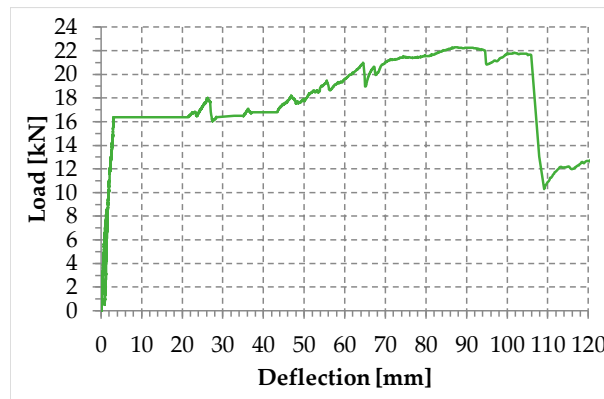
**Figure 11.** Load/deflection diagram for the first combined technique, in a hypothetical flexural test performed in the load control.

Since the post-delamination load of Specimen W4 increases up to recover and exceed the delamination load, the load/deflection diagram in the load control follows the horizontal path between the delamination load and the recovered load (Figure 11). The increase in load after the horizontal path of Figure 11 is of fundamental importance for the overall stability in real applications. In fact, as long as the increase in the displacement along the horizontal path is compatible with the resilience of the structure, the increase in the load beyond the recovered load avoids the redistribution of the load on the adjacent structural elements, which are no longer in danger of overloading.

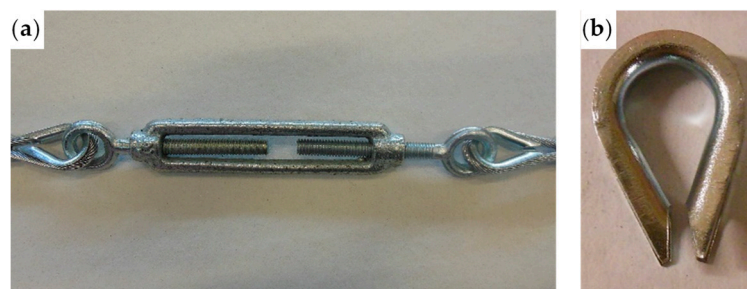
**Figure 12.** The fastening system of the second combined technique: (a) Two Flemish eyes connected by an eye-eye turnbuckle and (b) detail of the thimble placed inside a Flemish eye.

In the fastening system of the second combined technique, both loose ends of each steel wire rope form a Flemish eye (Figure 12a), which is a loop-shaped end, fixed back on the steel wire rope. A thimble installed inside the loop (Figure 12b) prevents the steel wire rope from bending too tightly when a device connected to the loop concentrates the load on a small contact area. Furthermore, the thimble protects the steel wires on the inside of the loop from abrading and pinching.

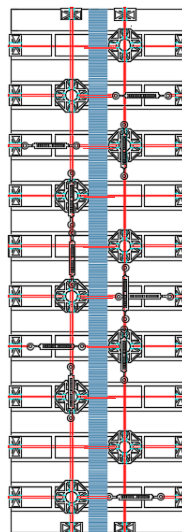
**Figure 13.** Layout scheme of the straps for the second combined technique.

Section 3 will present the results of the first experimental program carried out on the second combined technique. As for Specimens W3 and W4 of the first combined technique (Section 2.1), the experimentation consisted of performing a three-point bending flexural test on a wall specimen strengthened with straps and CFRP strips, positioned so as to obtain an I-beam behavior from the mechanical coupling between the two techniques (Figure 13). For comparison purposes, the materials and dimensions of the masonry wall and the layout of the straps are the same as those used for the first combined technique (Figure 13). In particular, the holes follow the quincunx pattern—as for Specimens W3 and W4 (Section 2.1)—and belong to intersecting three-dimensional nets.

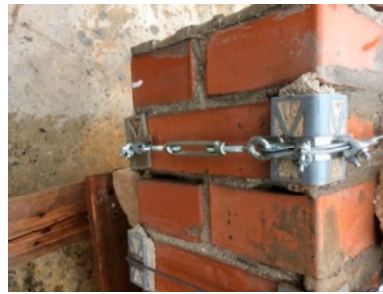
Figure 14. The fastening system along the lateral face of the brick wall (23 cm).

The eye–eye turnbuckles of the shorter horizontal straps are too long to lie on the two main faces. However, they find an optimal positioning on the lateral faces of the masonry wall, which is a two-headed wall (Figure 14), with Bolognese type bricks ( $24.5 \times 5.5 \times 11$  cm). As the dimensions of the brick wall are  $50 \times 146 \times 23$  cm, the Bolognese bricks do not exactly fit the length of the wall. Therefore, it was necessary to shorten the end bricks of Figure 15a to obtain the desired length.

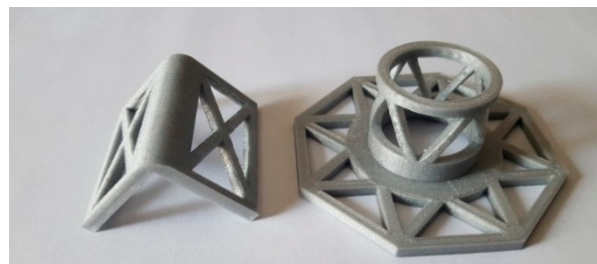
**Figure 16.** 3D printed rounded angle (on the left) and funnel-shaped plate (on the right) [1].

At the corners of the straps, the second combined technique uses the same protective elements as those of the first combined technique (Figure 16), that is, funnel-shaped plates and rounded angles printed with FDM (Fused Deposition Modeling), a technology that allows us to fix some intrinsic geometrical limits of hot forming. The choice of the material and the optimization of the shape of the 3D printed protective elements are part of the experimental program. For both the 3D printed plates and angles, the corners in contact with the straps are rounded, while those in contact with the edges of the wall are at  $90^\circ$ . Moreover, the truss shape of the flat parts increases the contact area between mortar and protective elements, improving adherence (Figure 17).

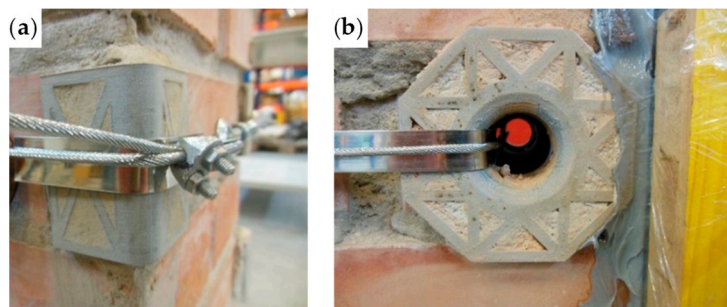
**Figure 17.** The pieces of steel ribbons positioned under the straps at the corners of the protective elements: details of (a) a rounded angle and (b) a funnel-shaped plate.

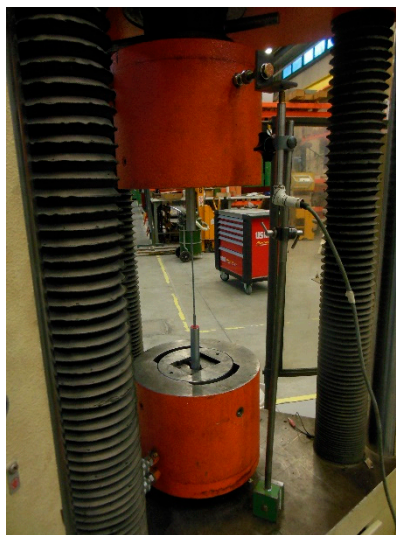
**Figure 19.** Positioning the LVDT (Linear Variable Differential Transformer) to measure the displacement of the crosshead.

ASTM A931 [46] covers the tensile testing of steel wire ropes and strands at room temperature. Figure 19 shows the experimental set-up of the tensile test performed on one spiral strand rope of the experimentation. As usual for steel ropes, an LVDT measured the crosshead displacement to obtain the extension of the specimen (Figure 19). In fact, due to high-energy specimen failures, using a traditional contacting extensometer means there is a risk of damaging and/or transforming the extensometer into a projectile. To avoid this, it is necessary to remove the extensometer prior to specimen failure. However, since the specimen will be under load, this entails a significant risk for the operator, as there is the possibility that the specimen will break during the removal of the extensometer. Furthermore, if the extensometer remains attached to the sample, reduction in rope diameter (Poisson effect) and twisting can cause the contact points to slip or the device to fall off. It could also happen that the edges of the knife cause stress concentrations, leading to premature failure.

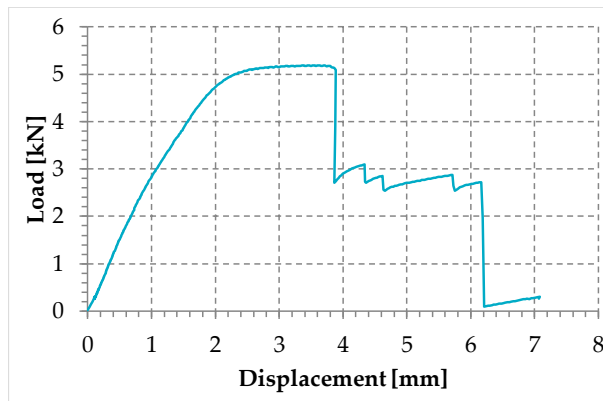
Figure 20. Load/displacement diagram of the steel wire rope used in the experimentation.

Figure 20 shows the load/displacement diagram of the tested specimen, while Figure 21 shows the specimen after failure. The load drop in Figure 20 for a displacement of almost 3.9 mm corresponds to the moment in which the steel wire rope began to fray. The fraying occurred at one end of the specimen (right end in Figure 21a,c), while on the other end the individual steel wires of the specimen twisted (left end in Figure 21a,b). Each load drop in Figure 20 occurred due to the failure of one or more fraying steel wires. The first load drop did not immediately bring the sample to failure and further load increases were possible after it, as the remaining steel wires took up the load. A similar load redistribution occurred after each steel wire failure. This allowed the specimen to reach a final displacement equal to about 182% of the displacement of first fraying, with an average residual load during the fraying that is about 52% of the maximum load.

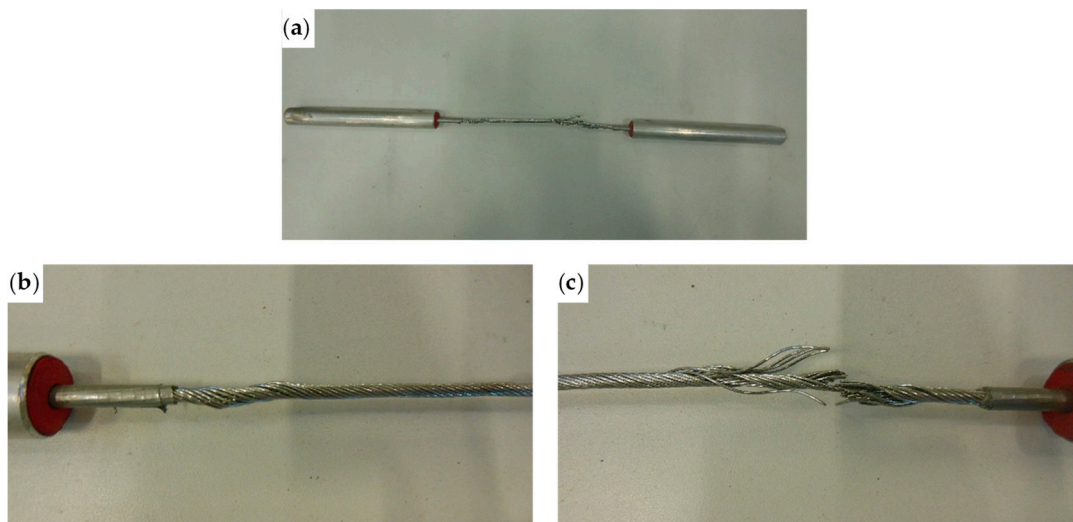
Figure 21. The spiral strand rope after the test: (a) general overview; (b) detail of wire twisting at the left end; and (c) detail of the failure due to fraying, at the right end.

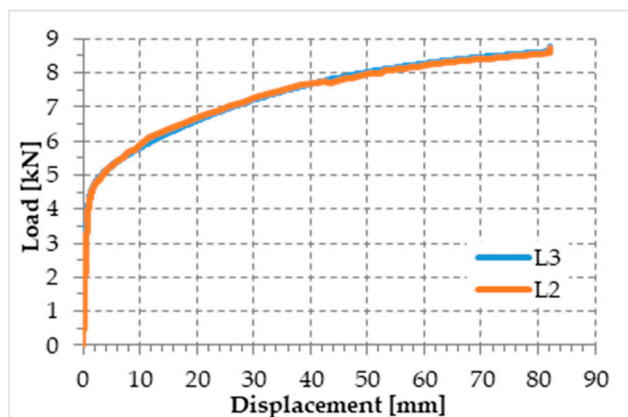
Figure 22. Load/displacement diagrams for the steel ribbons used in [1].

For comparison purposes, the selection criterion for the cross-section of the steel wire rope was to choose a steel wire rope with the same yield load as that of the steel ribbons used in the experimental program on the first combined technique [1]. The yield load in Figure 20 is actually comparable to the yield load of the steel ribbons of [1] (Figure 22). The specimen failure took place at the frayed end, with a final displacement equal to about 8.6% of the final displacement for the steel ribbons of [1] (Figure 22).

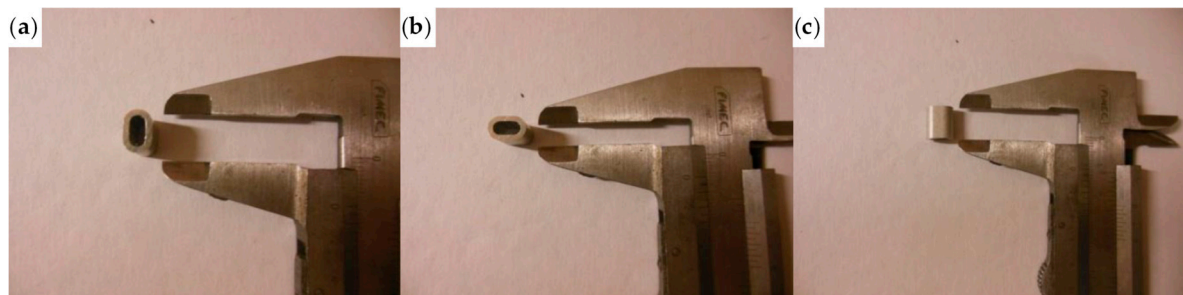
**Figure 23.** The ferrules of the experimentation: (a) longitudinal dimension; (b) transversal dimension; and (c) thickness.

As already mentioned in Section 2.2, the most common devices for fixing a Flemish eye are ferrules and clips. Ferrules—also often referred to as eyelets or grommets—are narrow circular clamps made from metal (Figure 23). They are useful to hold together and connect steel wires, generally by crimping, swaging, or otherwise deforming the ferrule to tighten it permanently on the parts it holds. A clip is a steel wire rope clamp consisting of a U-shaped bolt, a forged saddle with two holes to fit into the U-bolt, and two nuts to fix the arrangement in place (Figure 24).

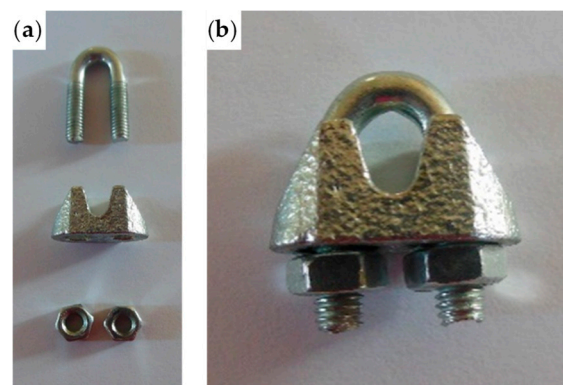
**Figure 24.** The clips of the experimentation: (a) constituent parts and (b) a clip after assembly.

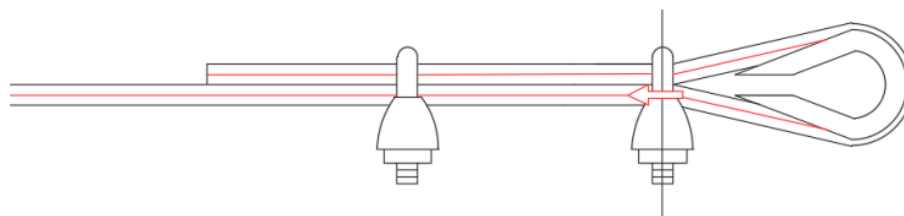
**Figure 25.** Eccentricity of the load provided by a clip to the steel wire rope, with respect to the Flemish eye.

The loose end and the steel wire rope on which to fix it pass in the space between the U-bolt and the saddle, placed one on the other on the saddle (Figure 25). By screwing the nuts, the U-bolt and the saddle approach each other, holding the two parts of the steel wire rope together.

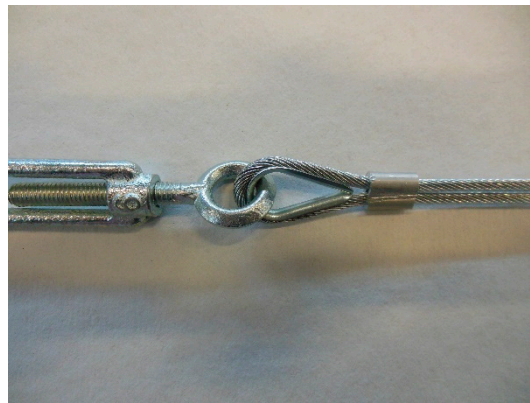
**Figure 26.** Specimen 1: Flemish eye closed by 1 ferrule.

Specimens 1 and 2 had a very bad behavior, because they failed for a load value much lower than the maximum load of the steel wire rope without a joint (Table 3). Moreover, both specimens showed an excessive deformation of the Flemish eyes, which squashed despite the use of the thimble. However, since the maximum load of Specimen 2 was more than double the maximum load of Specimen 1 (Table 3), the use of a second ferrule helps the joint to withstand higher loads.

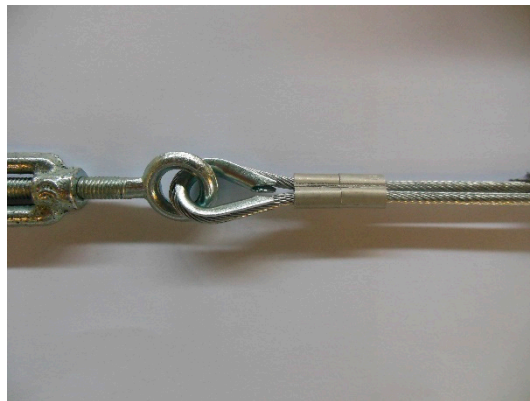
**Figure 27.** Specimen 2: Flemish eye closed by 2 ferrules.

- 2 ferrules in succession (Specimen 2, Figure 27);
- 1 clip (Specimen 3, Figure 28);
- 2 clips in succession (Specimen 4, Figure 29);
- 1 ferrule and 2 clips, in succession, starting from the Flemish eye (Specimen 5, Figure 30);
- 1 ferrule, 1 clip, a second ferrule, and a second clip, in succession, starting from the Flemish eye (Specimen 6, Figure 31);

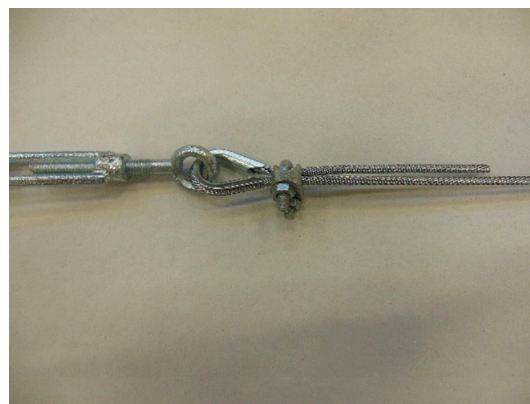
**Figure 28.** Specimen 3: Flemish eye closed by 1 clip.

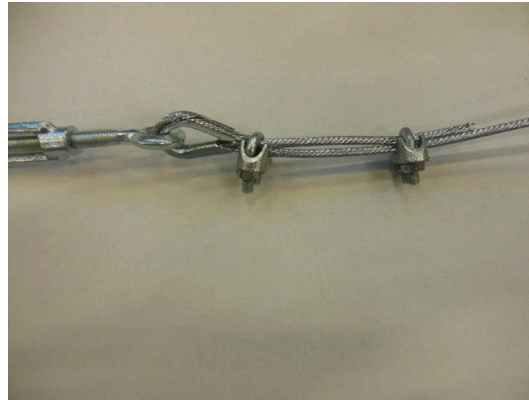
**Figure 29.** Specimen 4: Flemish eye closed by 2 clips.

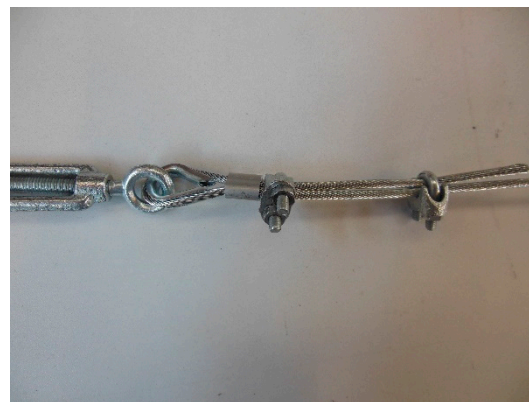
**Figure 30.** Specimen 5: Flemish eye closed by 1 ferrule and 2 clips, in succession.

- The purpose of the fifth fastening scheme was to eliminate the torsion of the first clip of the fourth fastening scheme, that is, the clip closest to the Flemish eye. In other words, the function of the ferrule was to center the load on the two clips (Figure 36). Specimen 5 did not actually fray near the first clip (Figure 37): It frayed near the second clip. The improved load centering allowed the specimen to withstand a higher ultimate load, comparable to the ultimate load of the steel wire rope without a joint. However, the ferrule caused an excessive deformation of the Flemish eyes, as for Specimens 1 and 2. This greatly reduced the stiffness of the specimen.

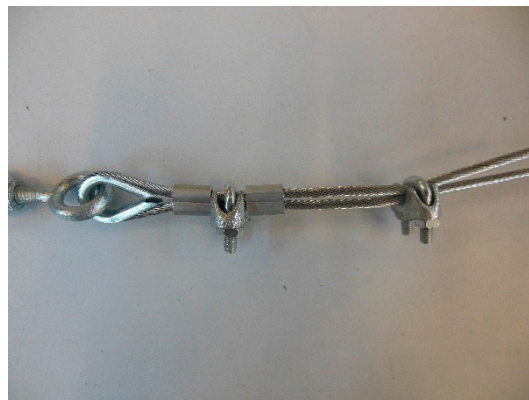
**Figure 31.** Specimen 6: Flemish eye closed by 1 ferrule, 1 clip, 1 ferrule, and 1 clip, in succession.

- The sixth fastening scheme introduces an additional ferrule between the two clips to eliminate even the rotation of the second clip, with the aim of preventing the specimen from fraying near both clips. The second ferrule actually further improved the load centering, eliminating fraying near both clips. However, this concentrated the deformation phenomena on the thimble that twisted, cutting off the steel wires (Figure 38). The twisting of the thimble occurred due to the excessive squashing of the Flemish eye. In fact, once the two ends of the thimble come into contact, the further squashing of the Flemish eye is possible only by forcing the two ends of the thimble to slide one over the other in the direction orthogonal to the load. This causes the twisting borders of the thimble to cut the steel wires. Even in Specimen 5 the excessive deformation of the Flemish eye caused a twist of the thimble (Figure 35), but this did not lead to damage to the steel wires. Lastly, the concentration of the deformations on the Flemish eyes greatly reduced the stiffness of Specimen 6, as for Specimen 5.

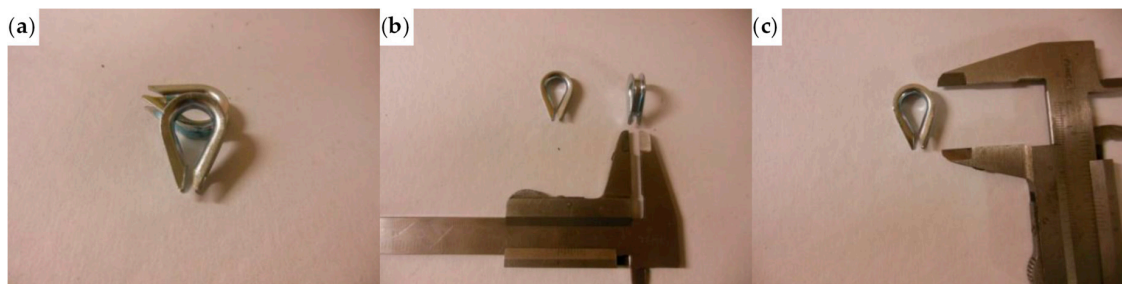
**Figure 32.** The thimbles of the experimentation: (a) overview; (b) thickness; and (c) longitudinal dimension.

The thimbles used to shape the Flemish eyes for the specimens listed above have the geometrical characteristics shown in [Figure 32](#).

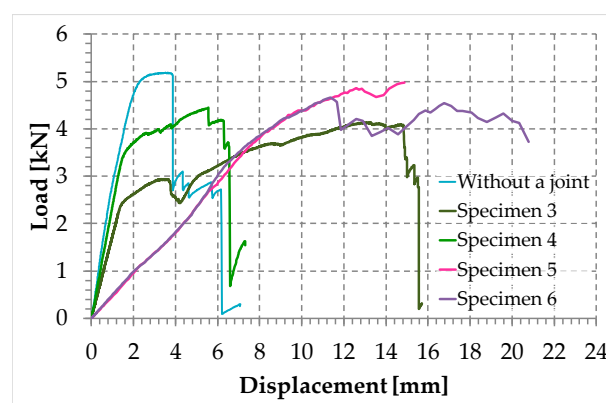
**Figure 33.** Load/displacement diagrams for 5 of the 7 specimens used for the mechanical characterization of the joints.

Figure 33 shows the comparison between the load/displacement diagrams of the steel wire rope without a joint and the four specimens with Flemish eyes closed by means of clips or combinations between clips and ferrules.

suffered a load drop due to the squashing of the Flemish eyes. Once the squashing of the Flemish eyes was over, the load started to rise again, up to its maximum value. Afterwards, the fraying of the steel wires quickly led the specimen to failure. It is worth noting that the fraying started from one of the two clips used to close the Flemish eyes (Figure 34). In fact, the eccentricity of the load supplied to the steel wire rope—due to the non-perfect coaxiality between the turnbuckle and the “live” side—caused the flat bearing seat of the clip to rotate, until its edge came into direct contact with the steel wires. This caused the pinching and abrading of the steel wires and, consequently, their failures in rapid succession.

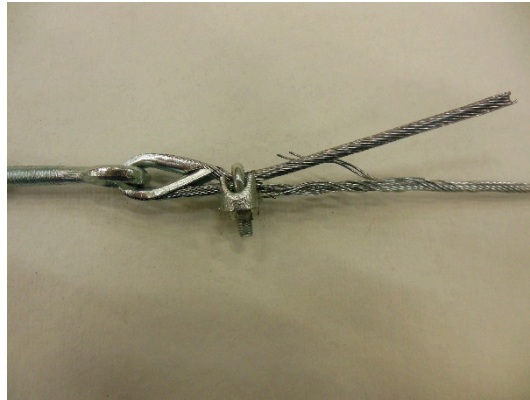
Figure 34. Failure mechanism of Specimen 3.

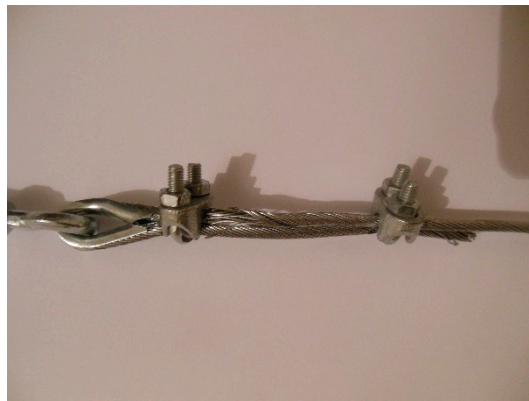
Figure 35. Failure mechanism of Specimen 4.

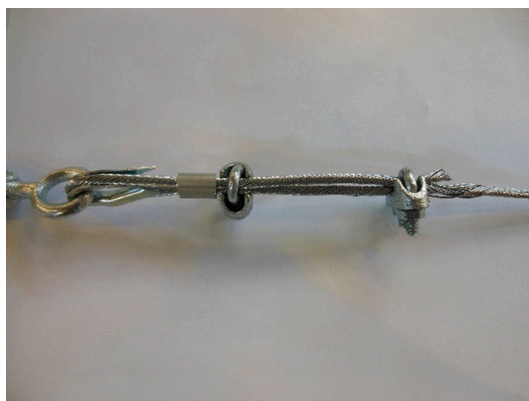
Figure 37. Failure mechanism of Specimen 5.

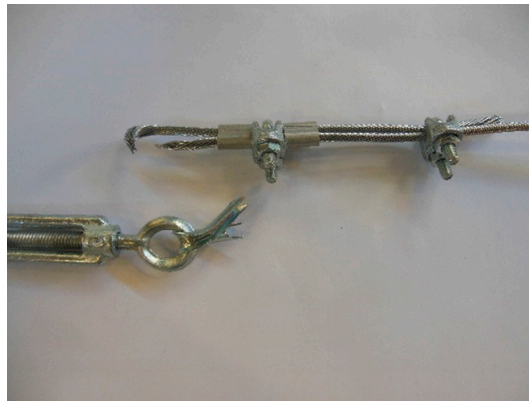
**Figure 38.** Failure mechanism of Specimen 6.

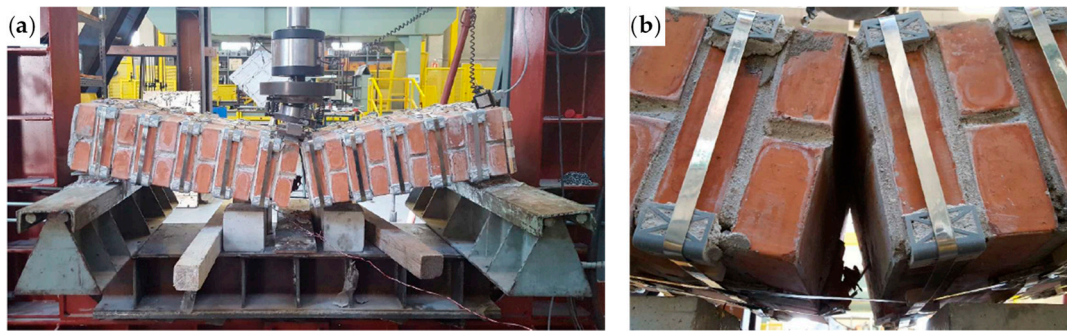
**Figure 39.** Specimen W1 shortly before the interruption of the test [1]: (a) disconnection mechanism and (b) detail of the disconnected cross-section (brick tear in the background).

During the three-point bending test on Specimen W1, an inner hinge opened near the middle cross-section (10th mortar bed joint from the right, in Figure 39a). The disconnection along the failed mortar bed joint led the two parts of the specimen to rotate around the inner hinge in a controlled manner, because the high ductility of the steel ribbons (Figure 22) allowed the disconnection to open up considerably (Figure 39), without ever causing loss of equilibrium. No straps broke during the opening of the disconnection. However, of the two longitudinal straps that crossed the disconnection, the one that passed through the hole closest to the inner hinge broke the protective funnel-shaped element and ripped off the thin layer of brick located between the disconnection and the cavity for the passage of the straps (Figure 39b).

- Removal of the specimen from the testing machine;
- Removal of all the straps from the specimen;
- Cleaning of the disconnected mortar bed joint (10th mortar bed joint from the right, in Figure 39a), where the crack propagated in Mode I [47–49] (Figure 40);

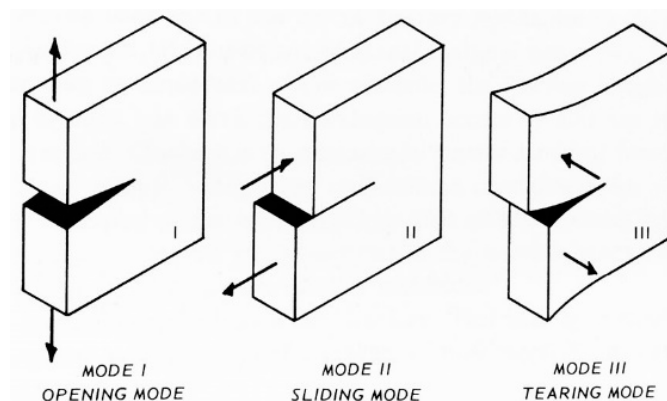
**Figure 40.** Modes of fracture.

Since the delamination of the upper CFRP strip occurs due to buckling, the detachment of the upper CFRP strip was in Mode I (Figure 40), near the disconnected cross-section. As usual for detachments in Mode I between CFRP strips and masonry [55], delamination caused the tearing of a thin layer composed by brick and mortar (Figure 51b), since the substrate is the element with the lower tensile strength in the system consisting of CFRP, resin, and masonry.

Even on the lower side, the delamination caused the tearing of a thin layer of substrate (Figure 48b), although the failure mode on the lower face of a bended specimen occurs in Mode II (Figure 40). Actually, the substrate is the weakest element also for shear sliding on mortar bed joints reinforced with CFRP strips [56–58], since the substrate is the component with the lower shear strength in the CFRP/resin/masonry system.

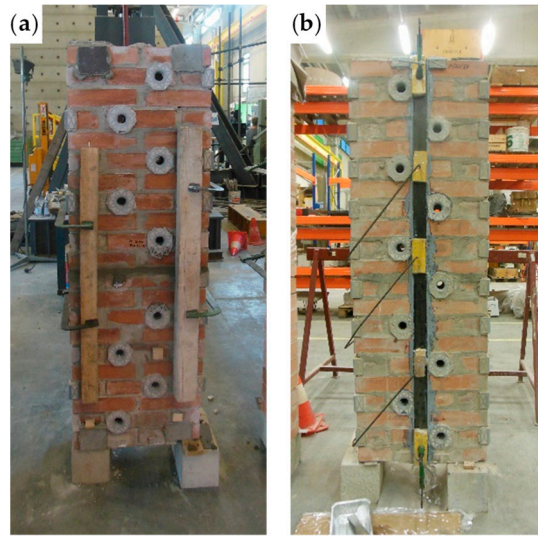
**Figure 41.** Preparation of the specimen: (a) restoration of the 10th mortar bed joint from below (front view) and (b) application of the CFRP strips after the maturing period (back view).

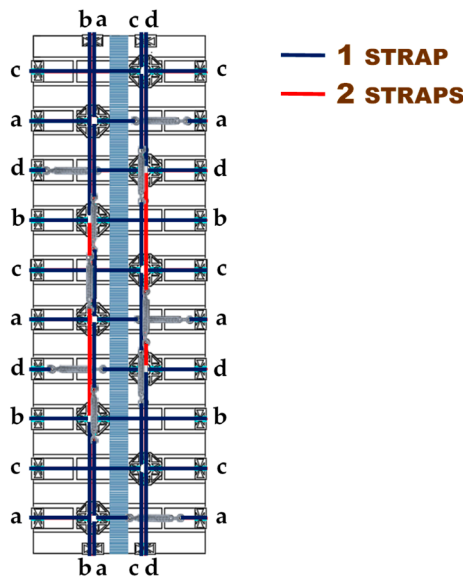
**Figure 42.** The four staggered meshes to strap the restored specimen (Specimen W5).

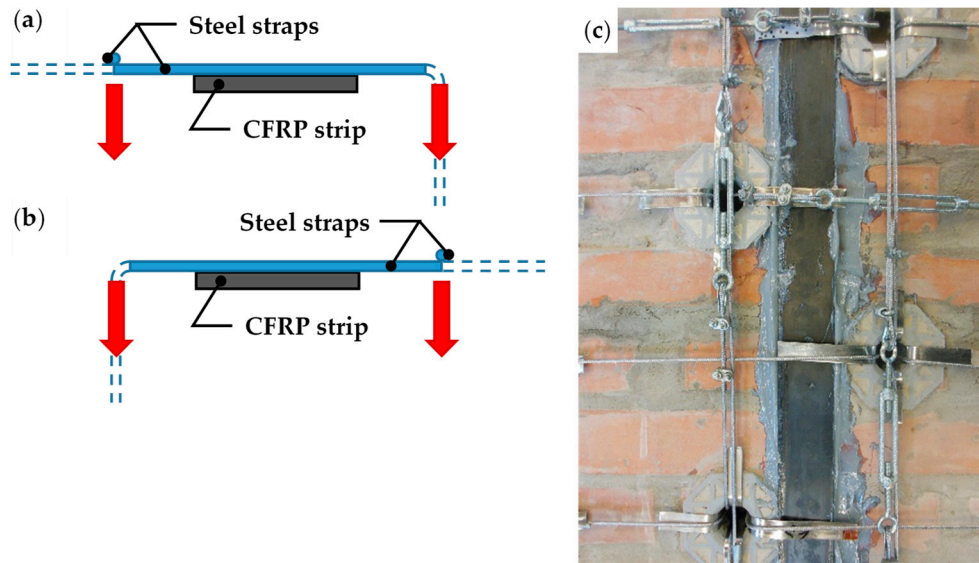
**Figure 43.** Load patterns of the CFRP strips: (a) cross-section view of the longitudinal strap on the left of the CFRP strip (not to scale); (b) cross-section view of the longitudinal strap on the right of the CFRP strip (not to scale); and (c) scheme sequence a, b, a, b on the strapped specimen.

As already done for the first combined technique, the strapping took place in two phases, arranging the transverse straps (parallel to the shorter sides), first, and the longitudinal straps (parallel to the longer sides), subsequently. As a result, the longitudinal straps pass over and press the transverse straps against the wall (Figure 43). This gives rise to the alternate patterns (a) and (b) of Figure 43, which allow the transverse straps to act on the CFRP strips with symmetric loads. The frictional forces caused by contact then couple the transverse straps and the CFRP strips mechanically, establishing the I-beam behavior described in Section 1.

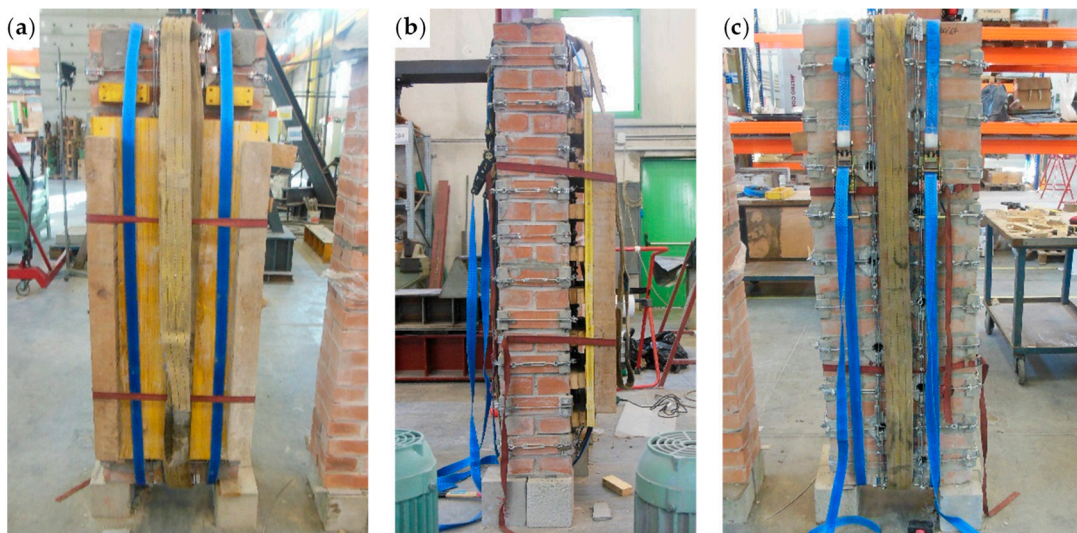
**Figure 44.** Slinging of Specimen W5, used to allow handling and overturning of the specimen by means of the girder crane: (a) front view; (b) viewed from the left; and (c) back view.

The slings also had the function of tying a wooden “stretcher” on the front side of the masonry wall (Figure 44a), to avoid damage to the specimen during the subsequent handling phase. Some wooden spacers between the wooden “stretcher” and the masonry wall (Figure 44b) prevented the wooden “stretcher” from touching the straps. In the absence of spacers, the wooden “stretcher” could have crushed the straps when the slings pushed it against the wall, damaging the tying system.

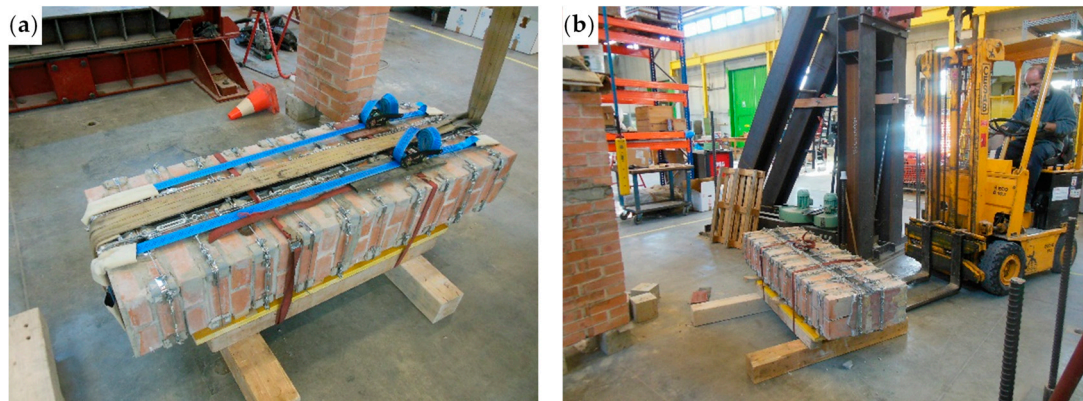
**Figure 45.** Handling of Specimen W5: (a) overturning of the specimen on the wooden beams, with the wooden “stretcher” placed below and (b) positioning the forklift forks to lift the specimen.

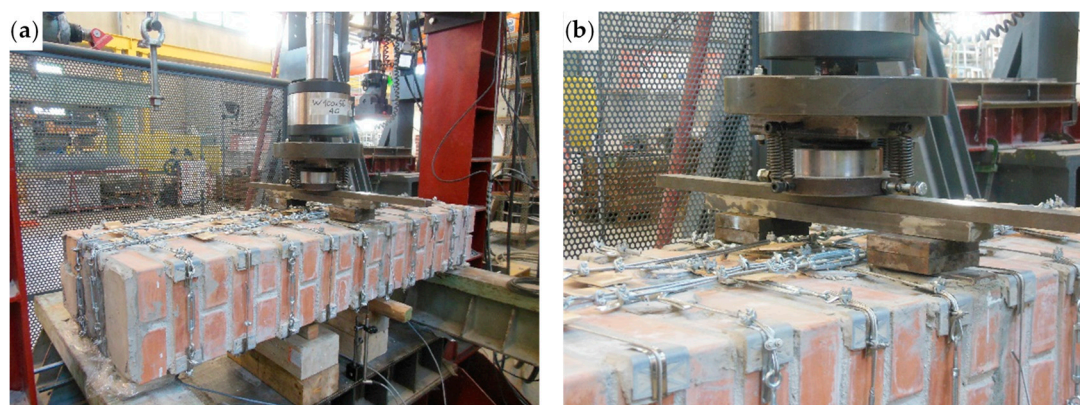
**Figure 46.** The flat steel bars for load distribution on the middle cross-section: (a) overview of the loading system and (b) detail of the passage of the steel wire ropes under the loading piston.

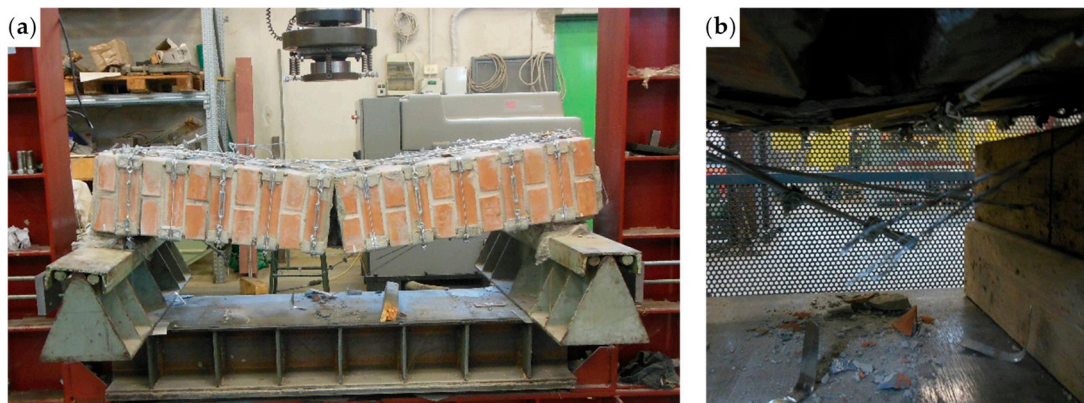
**Figure 47.** The specimen on the testing machine after the test: (a) front view and (b) detail of the broken straps under the middle cross-section (back view).

The bending test took place under displacement control. The behavior of the specimen was highly ductile, as for the specimens strengthened with the first combined technique (Sections 2.1 and 3.5.1). In fact, even in this latter case the specimen did not undergo an actual collapse because the steel wire ropes allowed the inner hinge to provide relative rotations in a controlled manner, preventing the specimen from falling (Figure 47a). However, contrary to what happened with the first combined technique (Section 3.5.1), several longitudinal straps suffered fraying and failure during the test, in particular those positioned on the middle cross-section (Figure 47b). This occurred due to the lower ductility of the steel wire ropes compared to the steel ribbons of the first combined technique (Section 3.3). In addition, one of the two threaded eyebolts of a defective turnbuckle positioned near the middle cross-section opened, due to the high load supplied by the steel wire rope. This led the Flemish eye to come out of the threaded eyebolt, interrupting the continuity of the strap (Figures 47b and 48b).

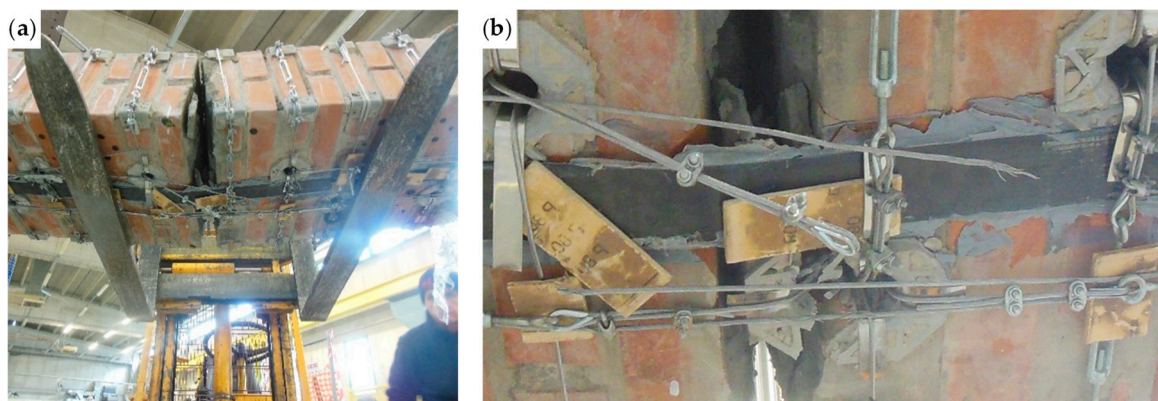
**Figure 48.** The specimen on the forklift after the test: (a) bottom/back view (the vertical white marks indicate the middle cross-section) and (b) detail of the disconnected cross-section viewed from below, with the Flemish eye that came out of the threaded eyebolt in the foreground.

The view from below in Figure 48b also shows a broken funnel-shaped plate near the middle cross-section. Since the internal disconnection of Specimen W5 opened in the same position as for Specimen W1 (Specimen W5 before the restoration), for Specimen W1 the funnel-shaped plate near the middle cross-section also broke into two parts. In Specimen W5, however, the failure of the funnel-shaped plate did not entail the interruption of the chain made by the longitudinal straps

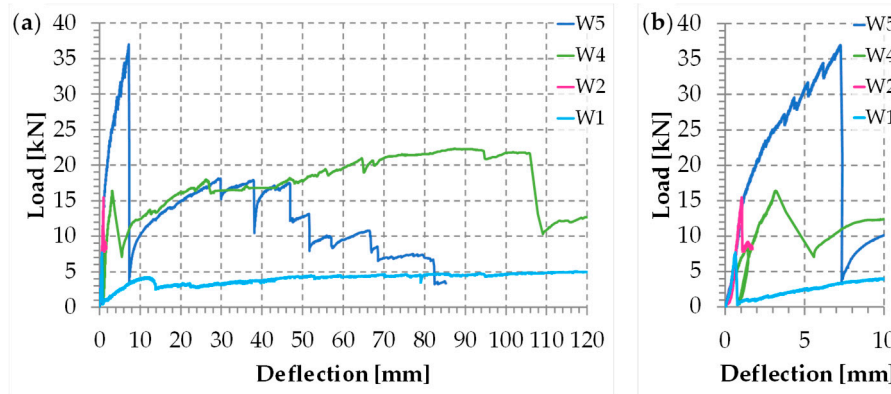
**Figure 49.** Load/deflection diagrams of the specimens reinforced with CAM-like ribbons (Specimen W1), CFRP strips (Specimen W2), first combined technique (Specimen W4), and second combined technique (Specimen W5): (a) complete diagrams up to the end of the tests and (b) detail of the peak of delamination of Specimen W5.

The internal disconnection occurred for a load value of about 23 kN. This disconnection did not result in any appreciable load drop in the load/deflection diagram of Specimen W5, but led to a slight decrease in the slope of the diagram (Figure 49). Moreover, the disconnection was not appreciable to the naked eye at first, since the straps took up the load no longer supported by the failed mortar, not allowing the disconnection to open. This increased the load on the longitudinal straps positioned above the disconnected cross-section. As a result, some steel wire ropes began to fray. The four load drops for the load values of about 27.122, 29.520, 31.698, and 34.444 kN (Figure 49b) occurred precisely because of the fraying. After each of these load drops, the load started to rise again, exceeding the load reached before fraying. Furthermore, the first load drop made the disconnection visible along the mortar bed joint (Figure 50).

At the load value of 36.992 kN (maximum load), a fifth load drop occurred (Figure 49). This additional load drop has a different cause than the previous ones, as it is the consequence of the delamination of both CFRP strips. It is worth noting that the load of delamination of Specimen W5 is about 239% of the delamination load with only the CFRP strips (Specimen W2 of [1], see Figure 49). This is a significant improvement compared to the first combined technique (Specimen W4 of [1], see Figure 49), which provided a delamination load equal to 106% of the delamination load of Specimen W2. The improvement also concerned the ductility up to delamination of the specimen reinforced with the second combined technique: The delamination deflection of Specimen W5 is approximately 242% of the delamination deflection of Specimen W4 and 743% of the delamination deflection of Specimen W2.

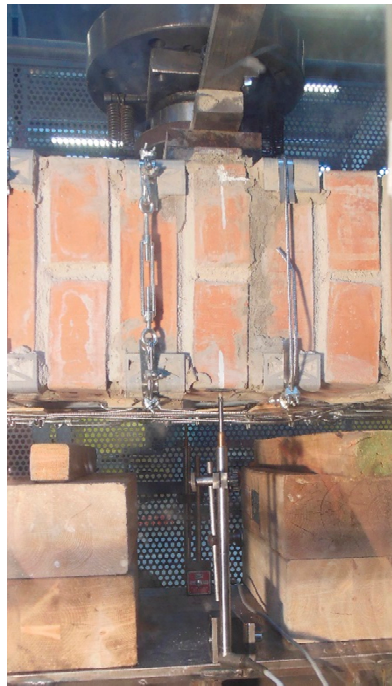
**Figure 50.** A snapshot of when the disconnection became visible for the first time (load value of about 27.122 kN), on the right of the middle cross-section: the stiffness of the longitudinal straps does not allow free rotation around the inner hinge (back view, the vertical white marks indicate the middle cross-section).
