# Wire Ropes and CFRP Strips to Provide Masonry Walls with Out-Of-Plane Strengthening

Elena Ferretti

**Abstract:** The present paper deals with an improvement of the strengthening technique consisting in the combined use of straps—made of stainless steel ribbons—and CFRP (Carbon Fiber Reinforced Polymer) strips, to increase the out-of-plane ultimate load of masonry walls. The straps of both the previous and the new combined technique pass from one face to the opposite face of the masonry wall through some holes made along the thickness, giving rise to a three-dimensional net of loop-shaped straps, closed on themselves. The new technique replaces the stainless steel ribbons with steel wire ropes, which form closed loops around the masonry units and the CFRP strips as in the previous technique. A turnbuckle for each steel wire rope allows the closure of the loops and provides the desired pre-tension to the straps. The mechanical coupling—given by the frictional forces—between the straps and the CFRP strips on the two faces of the masonry wall gives rise to an I-beam behavior that forces the CFRP strips to resist the load as if they were the two flanges of the same I-beam. Even the

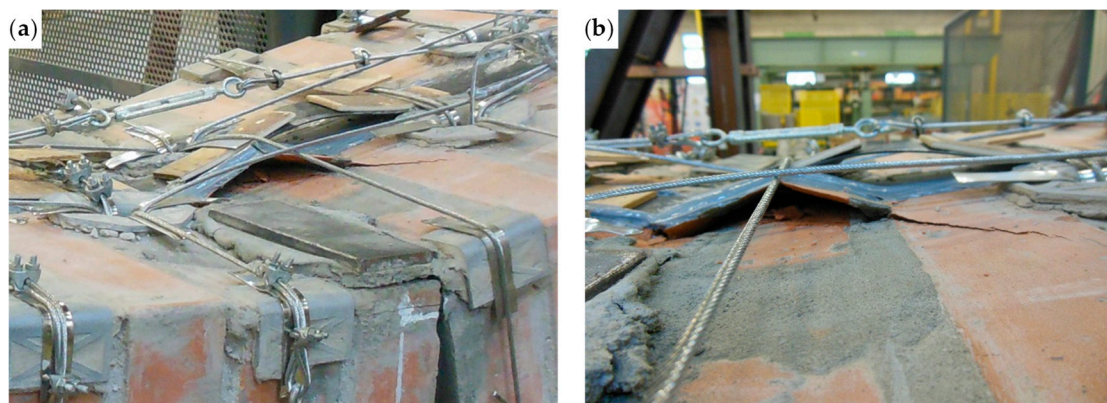
**Figure 51.** Buckling of the upper CFRP strip: (a) how the transverse and longitudinal steel wire ropes hold back the upper CFRP strip, counteracting delamination on the middle cross-section and (b) detail of the brick peeling caused by delamination.

Since the delamination of the upper CFRP strip occurs due to buckling, the detachment of the upper CFRP strip was in Mode I (Figure 40), near the disconnected cross-section. As usual for detachments in Mode I between CFRP strips and masonry [55], delamination caused the tearing of a thin layer composed by brick and mortar (Figure 51b), since the substrate is the element with the lower tensile strength in the system consisting of CFRP, resin, and masonry.
