# **In-plane shear behavior of stone masonry panels strengthened through grout injection and Fiber Reinforced Cementitious Matrices**

Keywords: stone masonry, diagonal compression tests, shear behavior, FRCM strengthening system, grout injection.

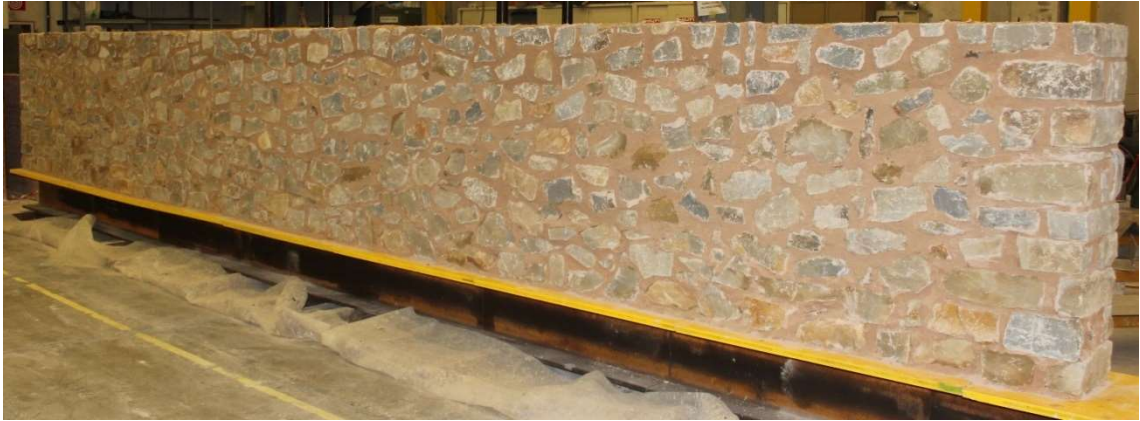
Figure 1. Stone masonry wall.

In the present experimental campaign, seven stone masonry panels were built by using rubble sandstones and natural hydraulic lime-based mortar. In more details, a unique continuous masonry wall, with dimensions  $7700 \times 1100 \times 300 \text{ mm}^3$ , was initially built and cured in laboratory conditions (Figure 1). The masonry pattern was arranged with two outer leaves and a chaotic internal filling, containing smaller stones and mortar and characterized by an average thickness of approximately 80 mm, depending on the dimensions of the stones. After 28 days of aging, the wall was cut to obtain seven square samples, having dimensions of  $1100 \times 1100 \times 300 \text{ mm}^3$ .

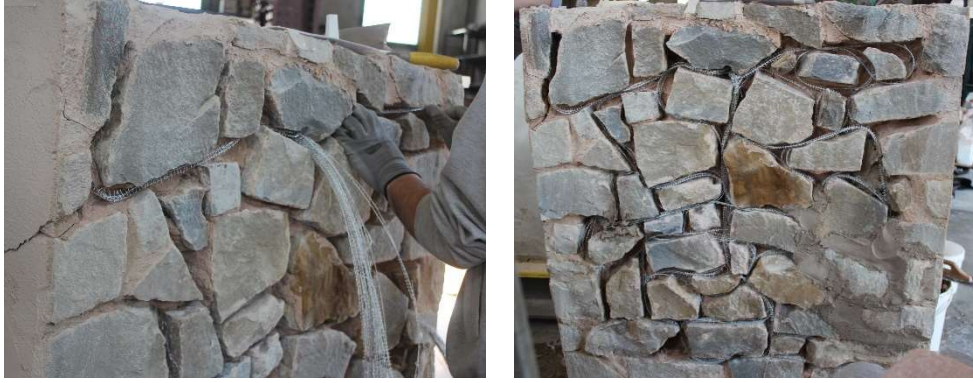
Figure 4. Reinforcing procedure for the sample S\_I-MA\_B200-S600, *Reticolatus* technique.

For the stone masonry panel strengthened with an asymmetric layout, the reported procedure is still valid, except for the fact that the continuous bidirectional grid was applied only on one side of the sample. On the other side, steel fibers cords (S600), anchored inside the drilled holes, were spread along the mortar joints according to the structural repointing scheme (*Reticolatus*), as shown in Figure 4.

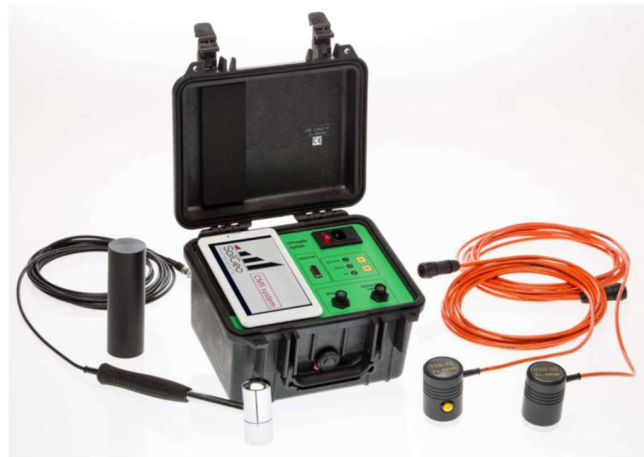
Figure 5. Sonic tests: (a) testing grid over the lateral surface of the samples; (b) test instrumentation.

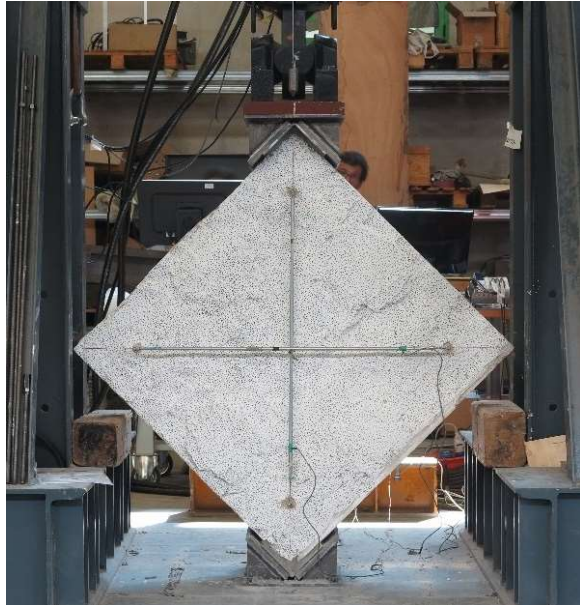
Figure 6. Diagonal compression test setup.

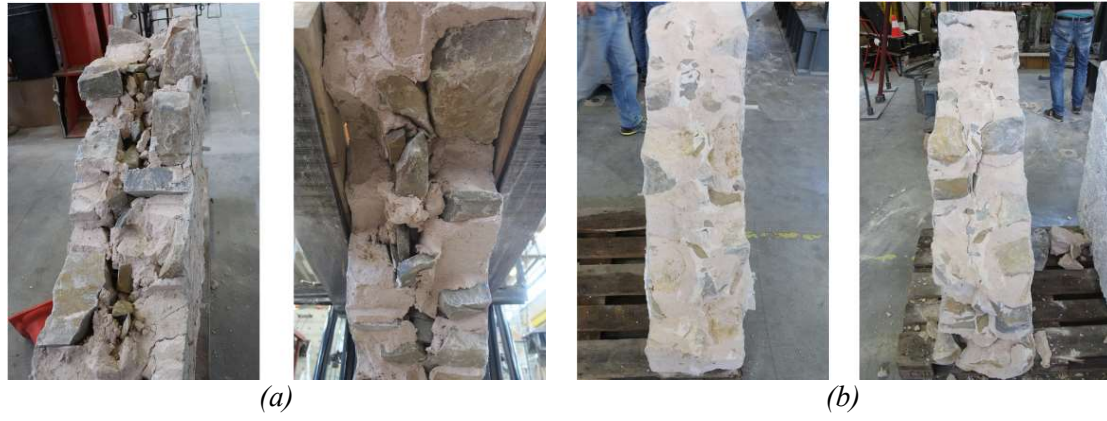
Figure 13. Detail of the cross section of the samples after the tests: (a) sample S\_I; (b) sample S\_I-MA.

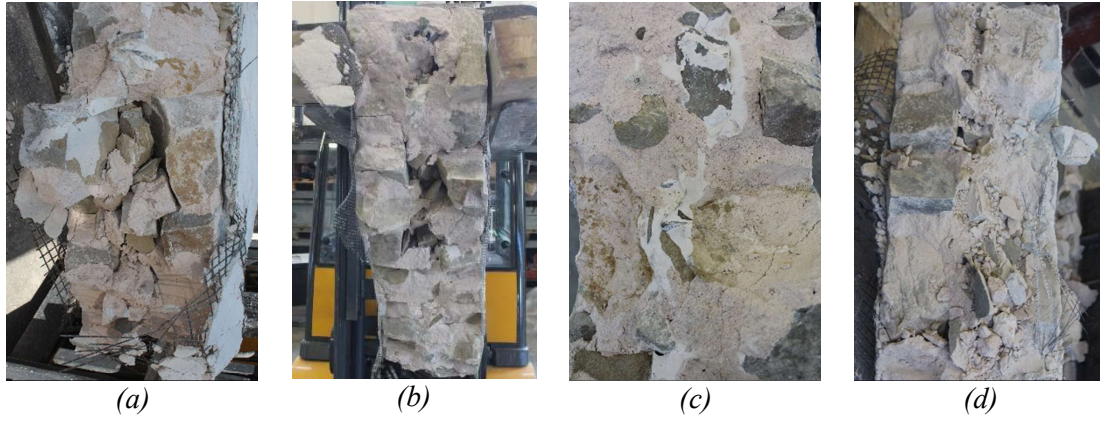
Figure 14. Detail of the cross section of the samples after the tests: (a) sample S\_I-MA\_B200; (b) sample S\_I-MA\_B400, (c) sample S\_I-MA\_S600, (d) sample S\_I-MA\_B200-S600.

The shear behavior of the panel strengthened with an asymmetric layout (S\_I-MA\_B200-S600) was characterized by a plateau in correspondence of the peak load, which can be associated to the growing effectiveness of the structural repointing after the onset of cracking, with the steel cords gaining force during the crack opening. The values of the peak load and of the shear modulus, significantly lower with respect to the other strengthened samples, were influenced both by the poor-quality of the injection (Figure 14*d*) and by the asymmetry of the reinforcement layout.
