Seismic-induced damage in historical masonry vaults: A case-study in the 2012 Emilia earthquake-stricken area

# Seismic-induced damage in historical masonry vaults: a case-study in the 2012 Emilia earthquake-stricken area

*Keywords:* Historical masonry vaults, Seismic damage, FE nonlinear analysis, Architectural Heritage, Laser scanner

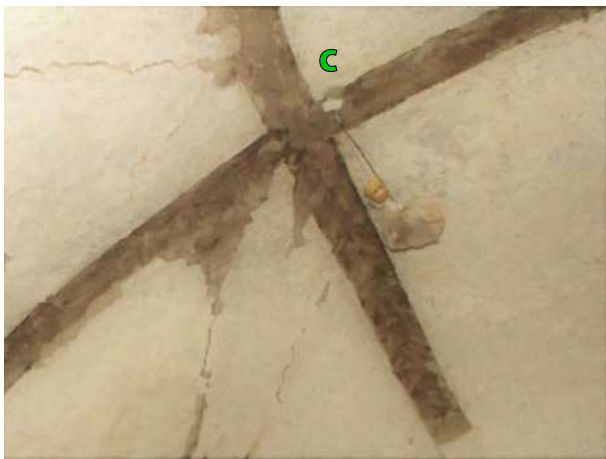
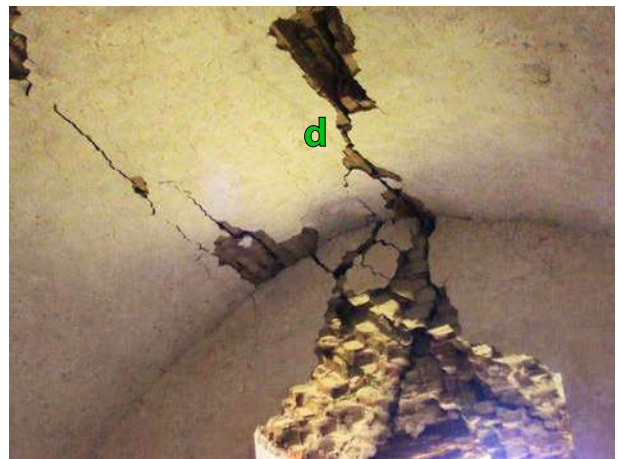
Figure 5: Giulio II Hall's vault major failures. The letters a, b, c and d are referred to Figure 4.

- 157 (a) a collapse of a part of the vault near the flue chimney (West side), see Figure 5(a);
- 158 (b) a main and very severe crack which substantially cut in two parts the Giulio II Hall,  
 159 highlighted by blue arrows in Figure 4, see details in Figure 5(b);
- 160 (c) the detachment and collapse of the ribs, see Figure 5(c);
- 161 (d) a deep crack which starts from the upper extremity of the South-side-window, passes  
 162 near the vault's keystone and ends in the opposite side, see Figure 5(d).

- 182 • the crack (d) starts from the window in the South side of the tower (Figure 5(d)).  
183 Such an opening was obtained by demolishing a portion of the wall, as said before.  
184 This fact, as well as the absence of an adequate lintel over the opening, could have  
185 weakened this part of the structure.

186 Summing up, it emerges that the damages experienced by the vaulted structure during  
187 the earthquake are strictly linked to its historical evolution phases (e.g. failures (a), (c)  
188 and (d) in Figures 4 and 5) and to the seismic-induced damage experienced by the masonry  
189 tower, i.e. the vault's bearing structure (e.g. failure (b) in Figures 4 and 5).

- 229 (i) absence of ribs, since they appear to have only a decorative function, see Figure 5(c);
- 230 (ii) vault without any hole, to model the vault condition before the earthquake;
- 231 (iii) equivalent masses have been applied on the vault in order to take into account the infill  
 232 weight, made up of a heterogeneous material, and the pavement.

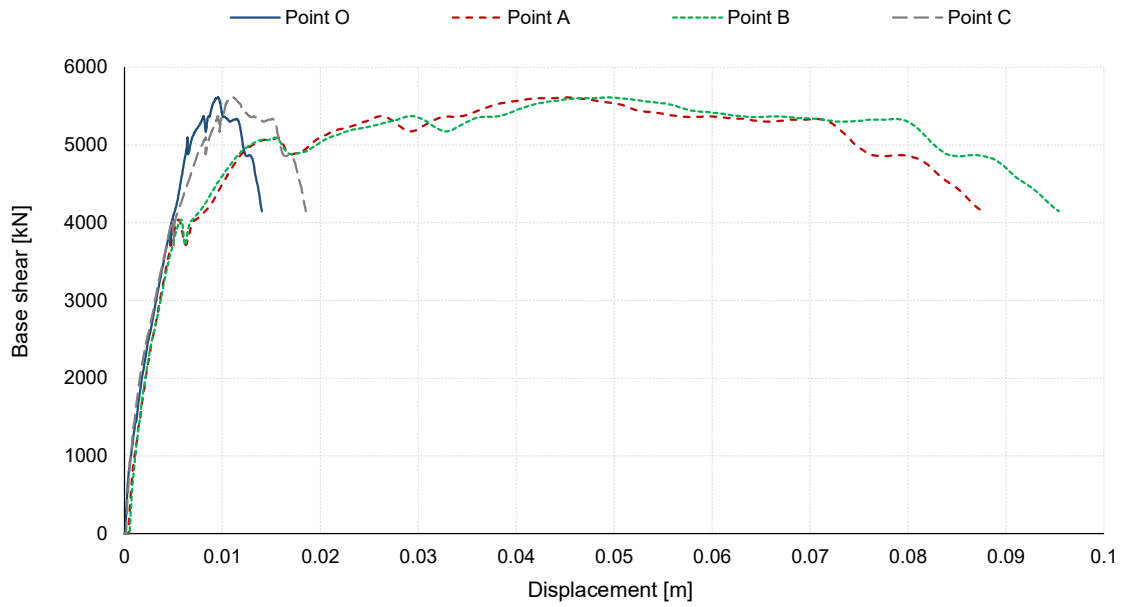
Figure 10: Base shear-displacement of the vault's abutments curve of the points depicted in Figure 9(c), East directed force.

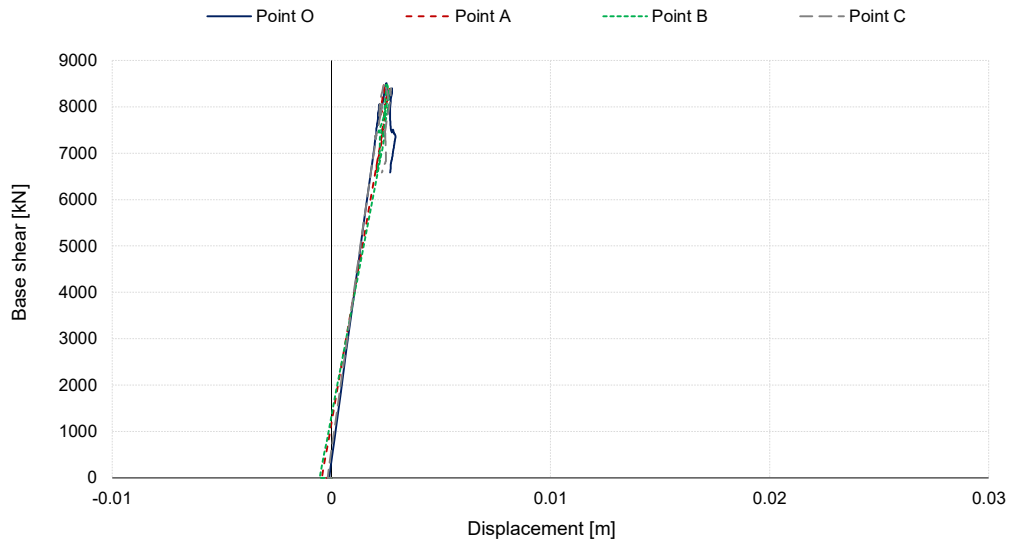
Figure 11: Base shear-displacement of the vault's abutments curve of the points depicted in Figure 9(c), West directed force.

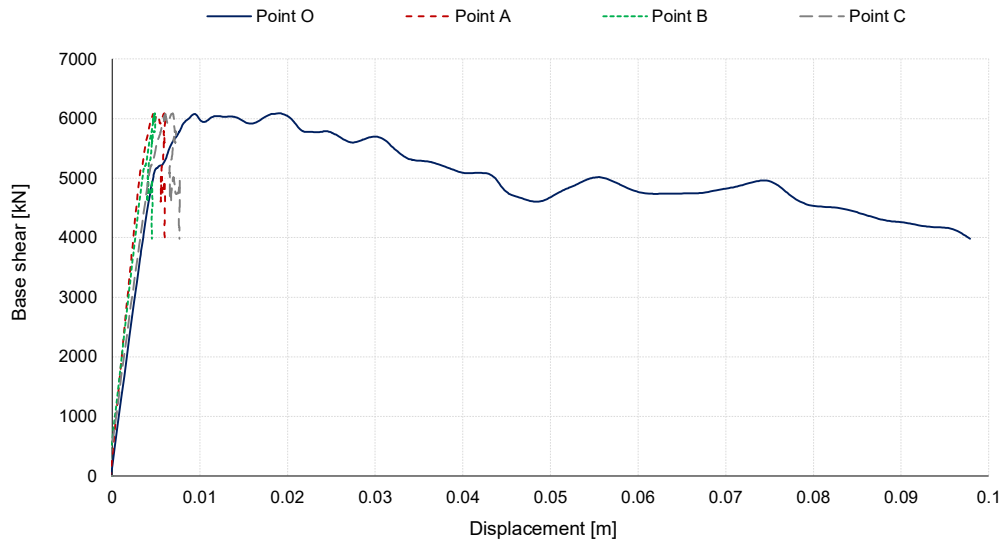
Figure 13: Base shear-displacement of the vault's abutments curve of the points depicted in Figure 9(c), North directed force.

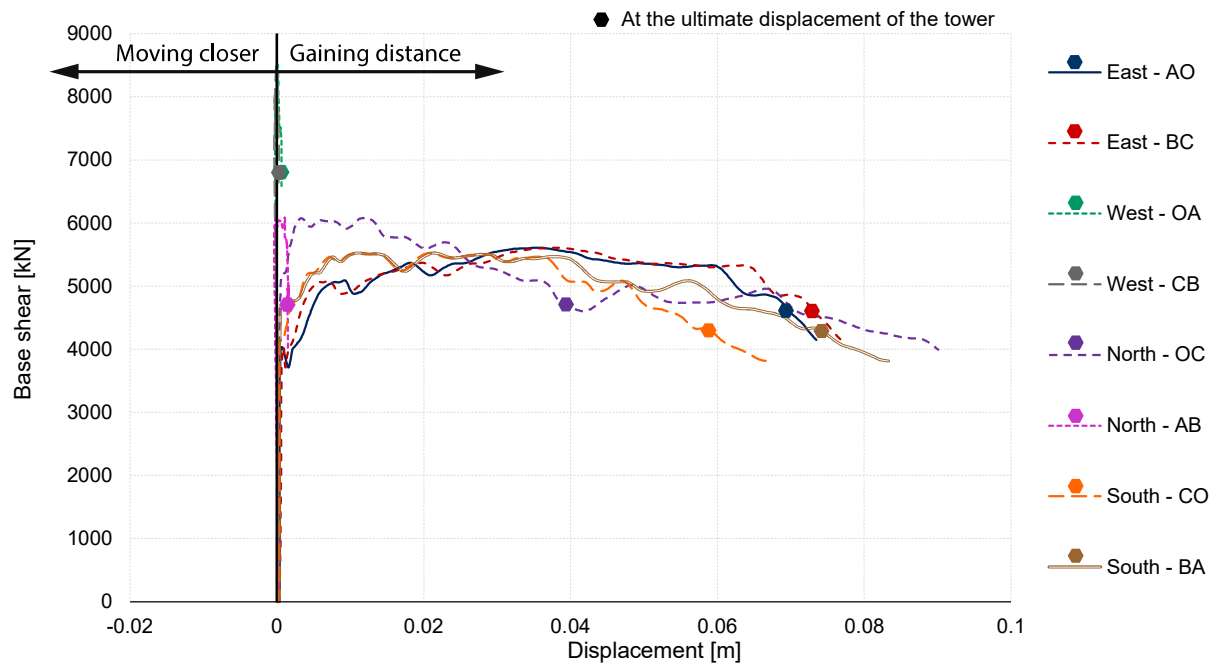
347 Table 3 collects the relative displacements of the vault's abutments at the ultimate  
348 displacement of the tower, i.e. when the base shear shows a drop of 20%. Such displacements  
349 are also highlighted on the curves of Figure 14 through a hexagon. As can be noted, the East  
350 and South load cases show greater relative displacements at the ultimate condition than the  
351 other load cases (included between 5.8 and 7.4 cm). This fact could also be addressed to  
352 the presence of adjacent structural elements in the other directions.

Figure 14: Base shear-relative displacement of the vault's abutments curves between the points depicted in Figure 9(c).

372 For what concern the South load case, as already noted in Figure 14, the points of the  
373 sides parallel to the force direction tend to distance themselves in a similar way. This is also  
374 confirmed by the damage contour plots of Figure 17 which show the progressive development  
375 of a crack in the intrados perpendicular to the South direction.

376 Concerning the North load case, due to the strong interaction with the curtain wall, the  
377 torsion of the tower is recorded (as reported in Figure 14) and the damage pattern of the  
378 vault (Figure 18) is conditioned by this effect. Indeed, in the vault intrados it emerges a  
379 crack which approximately tends to link the contact point with the curtain wall and the  
380 point C (Figure 9(c)) of the vault, see the progression of such a crack in Figure 18. This  
381 crack is in agreement with the actual crack specular to the failure (d) in Figure 4.
