Research Article

Structural Characterization of an Historical Building by Means of Experimental Tests on Full-Scale Elements

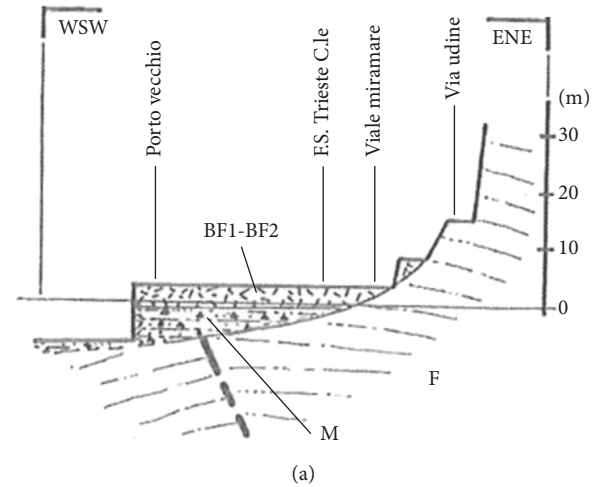
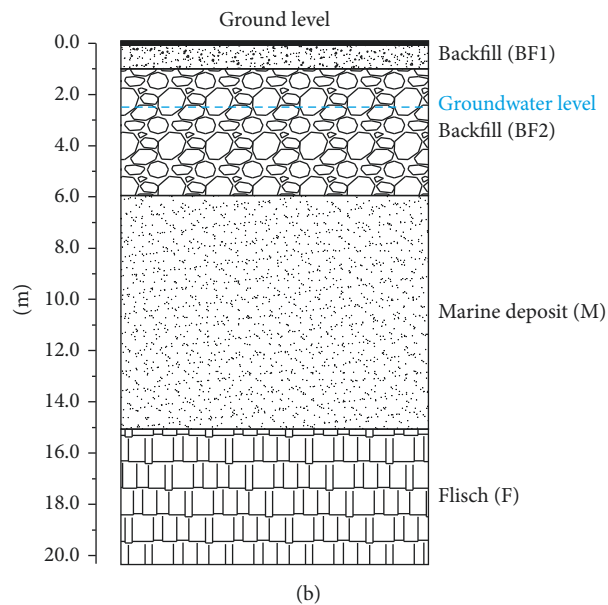
FIGURE 3: Geological characterization of the ground: (a) vertical section; (b) geotechnical interpretation of one of the probings executed; (c) the building foundations of the storehouses as depicted on the original 1850 drawings.

In order to investigate the soil stratigraphy and the geological characteristics of the site, standard penetration test (SPT) in six probing, up to about 20 meters below the ground level, was conducted in the area. The probing showed the presence of four principal layers of soils (from the ground level to depth) exhibited in Figure 3:

- (i) BF1: backfill soil of recent transportation of sand matrix mixed with cobbles and demolition debris
- (ii) BF2: backfill soil of ancient transportation
- (iii) M: littoral marine deposits like wave-formed terrace, composed of fat clay and lens of silt with sand, with low consistency and stiffness
- (iv) F: coastal rockstone flysch bank of Cenozoic era (more precisely, Eocene period), with high compactness

These outcomes are confirmed by the Geolithological Chart [20]. A vertical section of the soil stratification of the Trieste's coastal area is shown in Figure 3(a), together with the results of one of the six probings executed (Figure 3(b)).

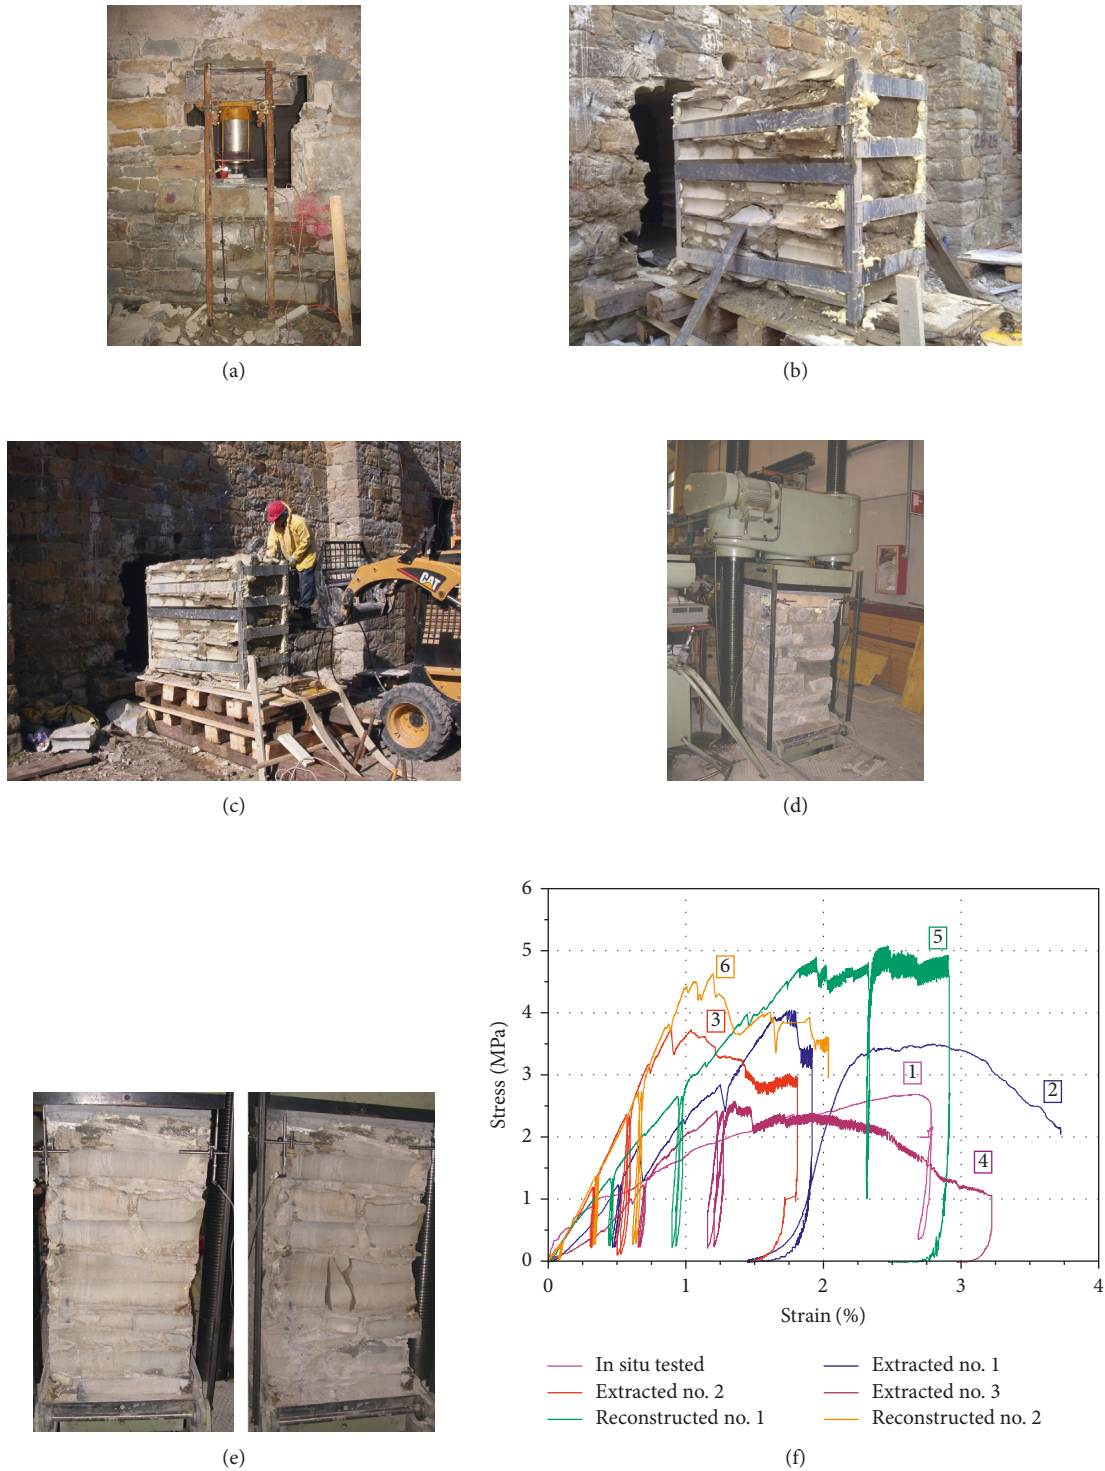
FIGURE 4: Compression tests on stonework specimens: (a) experimental setup for in situ compression test on specimen no. 1; (b) extraction of wall specimens; (c) transportation to the laboratory for testing; (d) experimental setup for laboratory compression test; (e) specimen no. 4 before (left) and after (right) compression test; (f) experimental stress-strain curves obtained from the in situ tests and laboratory tests on extracted and reconstructed specimens.

Geotechnical Engineering Laboratory of the University of Bologna. One smaller specimen was tested in situ (Figure 4(a)), while three specimens were extracted from perimeter walls and tested in the laboratory (Figures 4(b)–4(e)). Two

more specimens were reconstructed in the laboratory using stones extracted from damaged walls and new mortar with composition similar to that found in situ. The in situ test on the wall specimen has been performed by means of

a compression force assigned by a hydraulic jack until the crushing of the panel. Between the hydraulic jack and wall specimen was inserted a thick steel plate so to transmit a more uniform state of stress at the stonework panel, thanks to the plan surface of the steel plate. Instead, for the

specimens tested in laboratory (both reconstructed and extracted), a plan surface for the application of a uniform state of stress on the stonework wall has been obtained by introducing a horizontal layer of high-strength mortar having thickness variable from 3 to 4 cm.

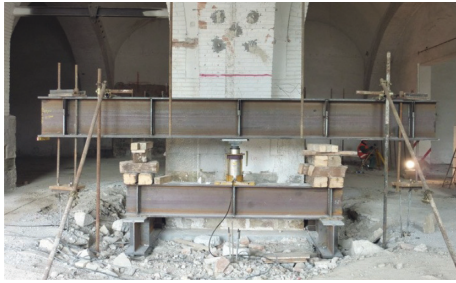
FIGURE 5: Loading system realized for the tests on foundation plinths.

In order to estimate the load-carrying capacity and vertical settlement of the foundation system, four typical plinths (indicated with a blue color in Figure 2(a)) were tested with an increasing static vertical load. The loading system was composed of a double metallic frame, the lower one transferring the load to the plinths and the upper one providing for the reaction system by means of four steel wire ropes anchored to the ground. The load was then applied by two hydraulic jacks placed between the two frames (Figure 5). For each test, the vertical displacements of four points on the pillar faces were measured by means of two optical levels with 0.01 millimeters of sensitivity, and the mean vertical displacement of the pillar was calculated as the mean value of the four displacements.

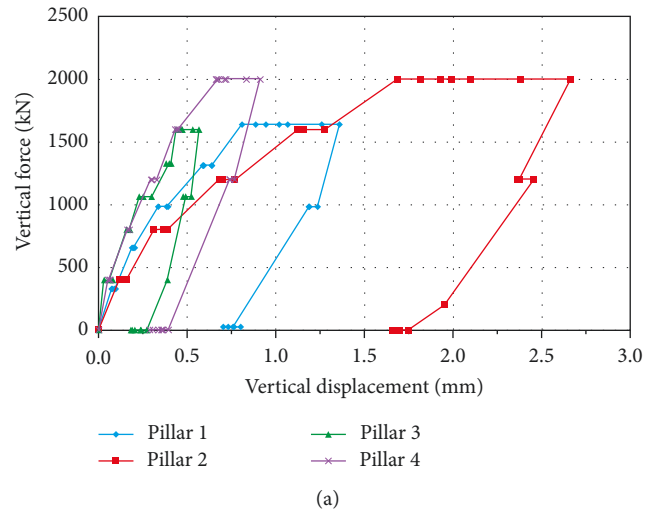
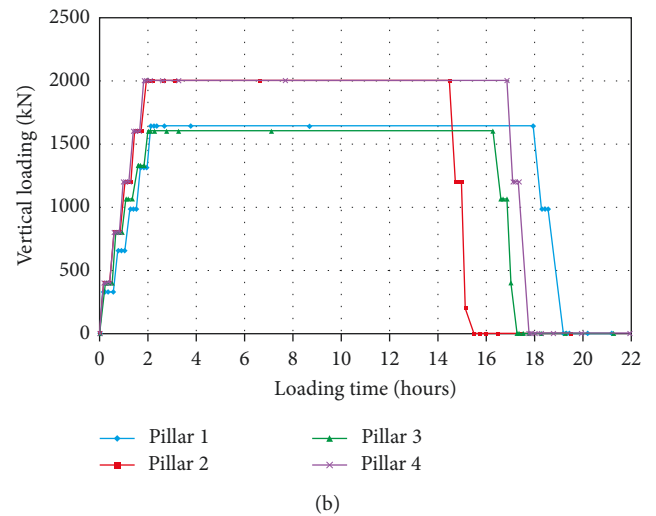
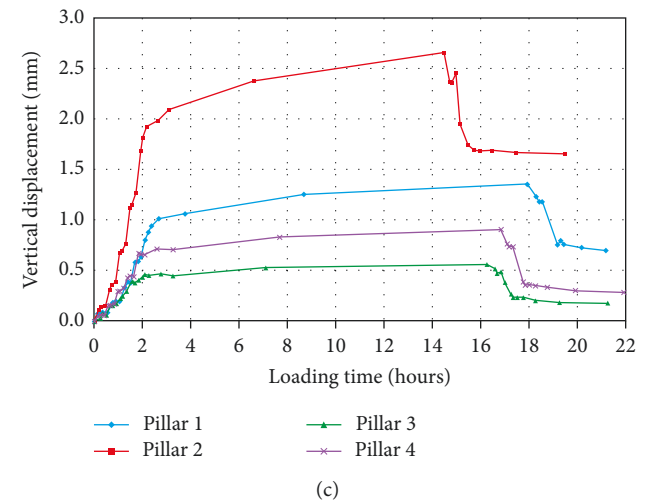
FIGURE 6: Experimental results on pillar foundations plinths: (a) vertical force versus vertical displacement curves; (b) vertical loading versus time; (c) vertical displacement versus loading time.

The force-displacement curves obtained for each of the four tested plinths are reported in Figure 6(a). The maximum applied force corresponds to the loading increase estimated by the designers. For each step, the loading was kept constant for 15–20 minutes. The maximum loading was reached after 2–4 hours of test and then kept constant for 14–16 hours before unloading (Figure 6(b)).

Looking at the general trend of the four graphs, the behavior of the soil-foundation system seems to be non-linear even for low levels of applied force, but values of the vertical displacements of the foundation remain very limited even at the maximum loading level. The loads were increased very slowly during the test in order to allow the dissipation of pore water pressure in the soil and to include possible viscous soil deformation (Figure 6(c)). It is interesting to remark that, at the maximum loading level, the foundation exhibited most of the viscous displacements (varying from 25 to 60% of the instantaneous displacements). Furthermore, after the complete loading removal, a significant permanent displacement of the foundations was recorded.

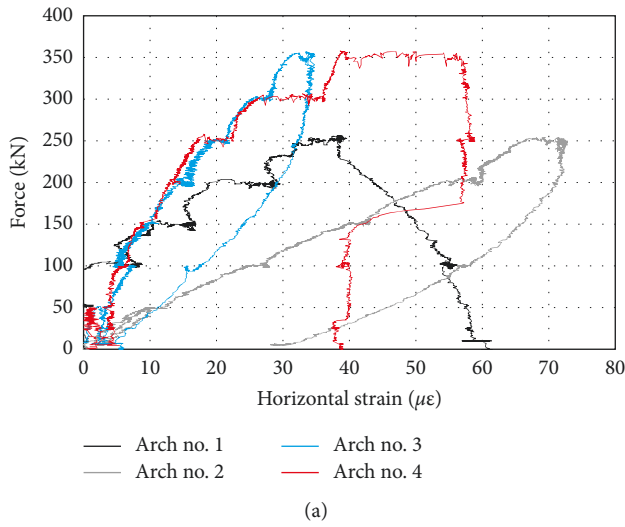
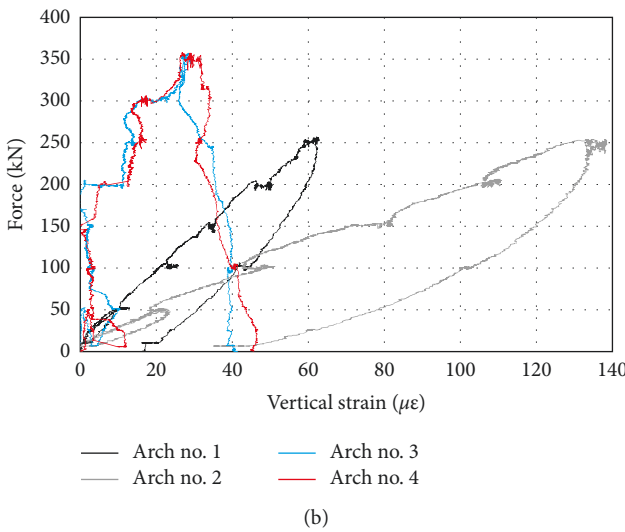
FIGURE 10: Test on arches subject to static symmetric loading (Figure 8(a)): (a) horizontal average strain measured at key brick; (b) vertical average strain measured at the quarters on the upper portion on the arch.

Figures 10(a) and 10(b) show the evolution of horizontal mean strain at the key brick position (calculated from LVDT3 and LVDT4 measures at the two sides of the arch) and the vertical average strain in the upper small wall belonging to the arch and originally supporting the wood deck, calculated from LVDT5–6 displacements at the quarters, just below the vertical loading application. As far as the arches subject to asymmetric static loadings are concerned, vertical displacements are reported in Figures 11(a)–11(c). Also in this case, the maximum value of the vertical displacement was obtained for arch no. 3, equal to 1.97 cm under the maximum applied load of 350 kN.

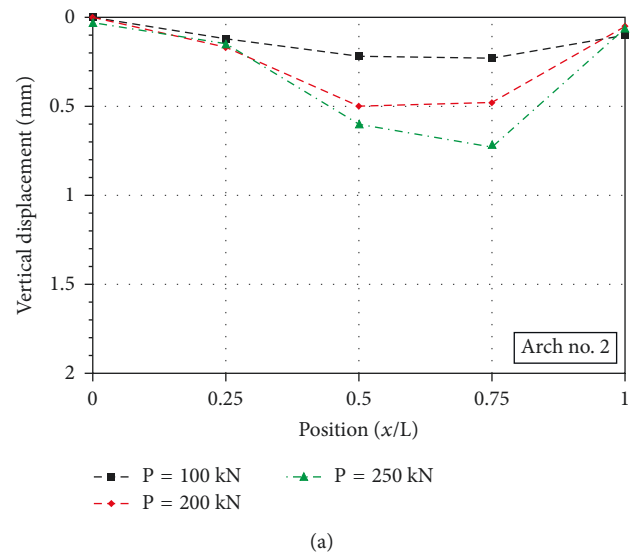
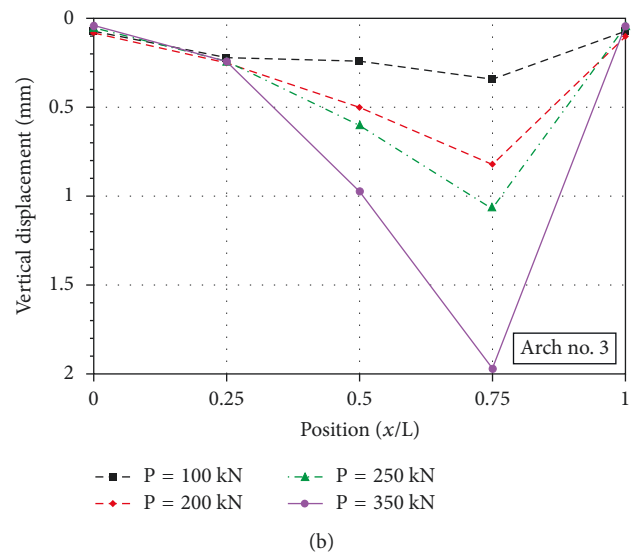
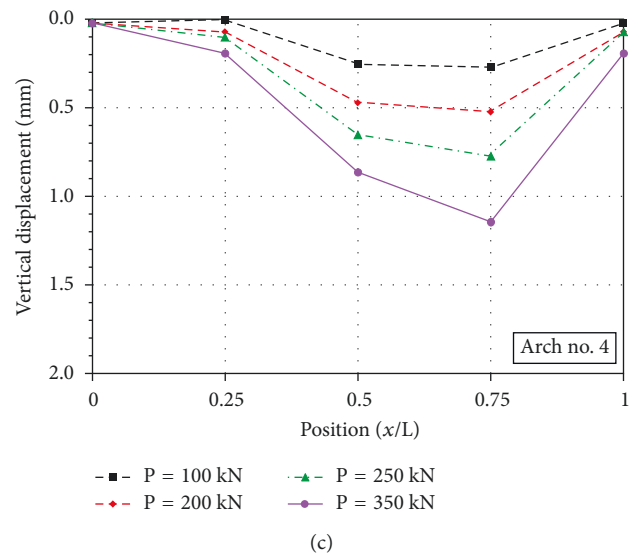
FIGURE 11: Test on arches subject to static asymmetric loading: (a)–(c) vertical displacements obtained by optical level for the three arches tested.
