The effects of in-plane shear displacements at the springings of Gothic cross vaults

Carfagnini, C., Baraccani, S., Silvestri, S., Theodossopoulos, D. (2018). The effects of in-plane shear displacements at the springings of Gothic cross vaults. *CONSTRUCTION AND BUILDING MATERIALS*, 186, 219-232 [10.1016/j.conbuildmat.2018.07.055].

9 **Abstract**

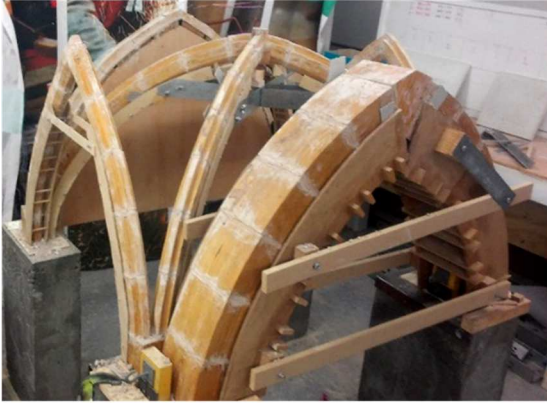
7 **Fig. 3:** (a) Construction of the vault arches. (b) Timber blocks for the webs.

21 for the construction of the webs (Figure 3a).

1 Secondly, the webs were filled with timber blocks of uniform thickness. The blocks were cut and
2 arranged to reproduce the masonry bond pattern and particular attention was paid to fit them along
3 the ribs by forming a dihedral section specific for the end block of each row (Figure 3b).

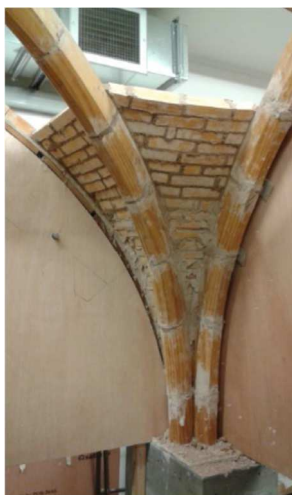
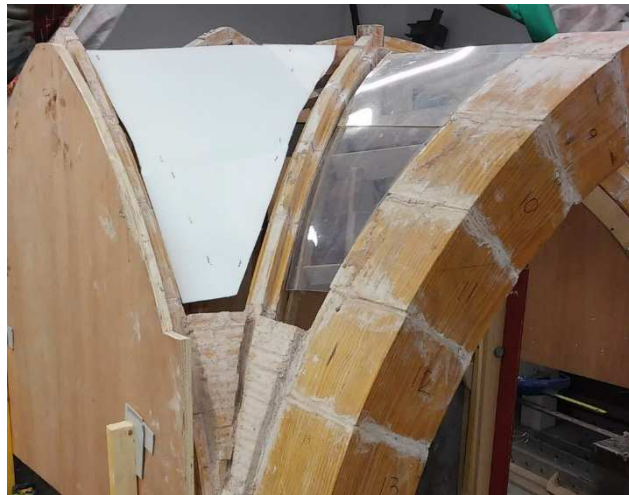
16 **Fig. 4:** (a) Springing built without falsework. (b) Plastic panels falsework for the subsequent courses.

9 The units were laid in rows for each web and were bonded with lime mortar. The construction
10 started from the supports and each corner was built without falsework as the rows were quite
11 vertical (Figure 4a), but a falsework was required when the row span and the web curvature
12 increased (Figure 4b).

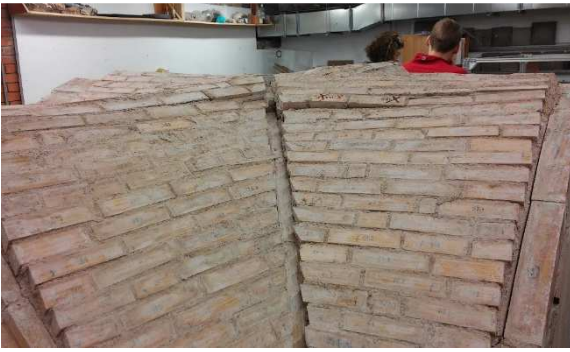
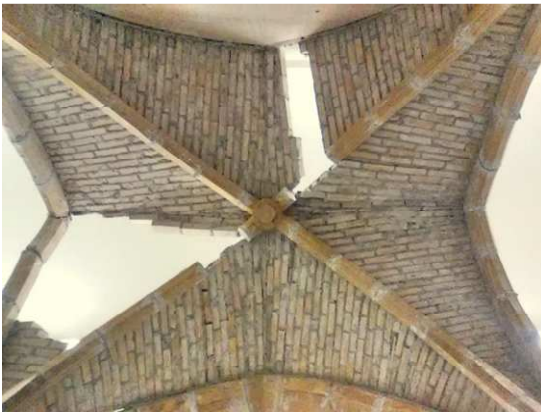
Fig. 8: (a) The crack pattern at the shear displacement of 30mm, (b) Collapses at a shear displacement of 35mm, (c) Partial collapse at the 50 mm stage, (d) Hinges on the nave arch at 45mm.

- 12 - during the 35 mm stage, partial failure of web F occurred (orange area in Figures 7 and 8b).
13 The bigger crack at the 30 mm stage detached the voussoir on the rib 1-3 and this caused a
14 rotation of the cracked web around the nave arch. A new long “sliding” crack also
15 developed along the same rib on the intrados of the entire web C;
16 - during the last stages more damage occurred. At the shear displacement stage of 40 mm, the
17 cracks along the ribs (webs C and E) and along the nave arch extended to the whole length
18 on the extrados. New cracks developed at the intrados of web A and E close to the keystone;
19 - further increasing of the shear displacement up to 45 mm caused a partial collapse in web C
20 (yellow area in Figures 7 and 8c). The nave arch looked very deformed and hinges are
21 clearly recognizable (Figure 8d);
22 - the shear displacement stage of 55 mm caused the failure of the whole web B and the

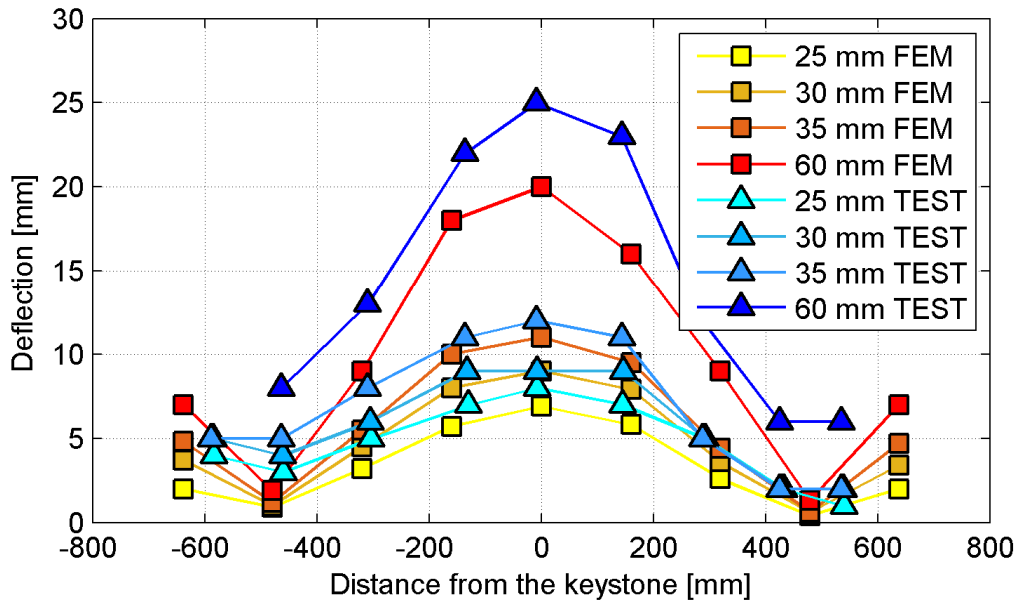
Fig. 15: Vertical displacement of the longitudinal ridge – Numerical and experimental results

11 The validation of the vertical displacements of the longitudinal ridge (Figure 15) shows that the
12 non-linear simulation is capable of well reproducing the experimental responses at all stages of
13 loading both qualitatively and quantitatively. In particular, contrary to the linear analysis, the
14 vertical uplift is well captured by the non-linear simulations.

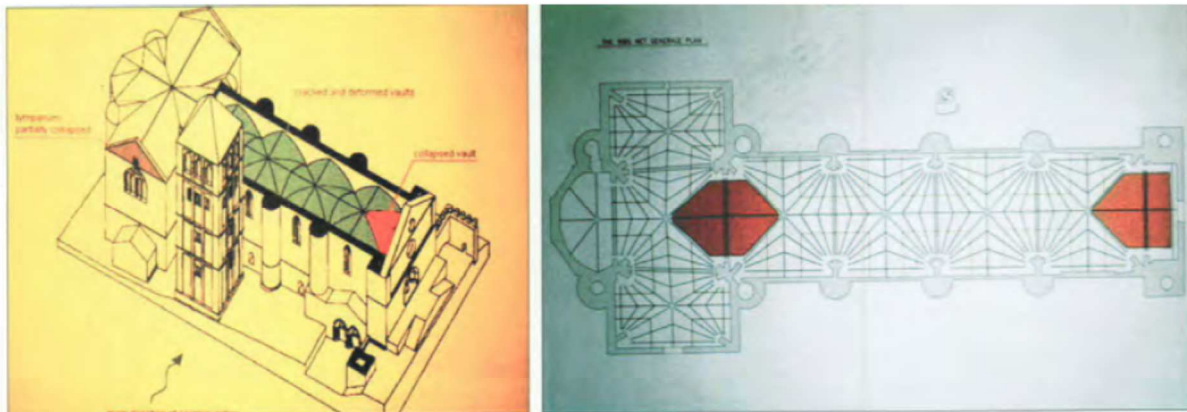
Fig. 19: Damages incurred during the 1997 earthquake in the San Francesco church in Assisi [51].

Finally, it is worth pointing out that a similar structural response caused the collapse of two vaults in Saint Francis Basilica in Assisi (1997 Umbria earthquake), being these two vaults in the same boundary conditions as the tested one. The first was connected to the façade, the second to the rigid zone of the transept/apses [51].
