Article

Improving the Corrosion Resistance of Wrought ZM21 Magnesium Alloys by Plasma Electrolytic Oxidation and Powder Coating

Citation: Ballam, L.R.; Arab, H.; Bestetti, M.; Franz, S.; Masi, G.; Sola, R.; Donati, L.; Martini, C. Improving the Corrosion Resistance of Wrought ZM21 Magnesium Alloys by Plasma Electrolytic Oxidation and Powder Coating. *Materials* 2021, 14, 2268. https://doi.org/10.3390/ma14092268

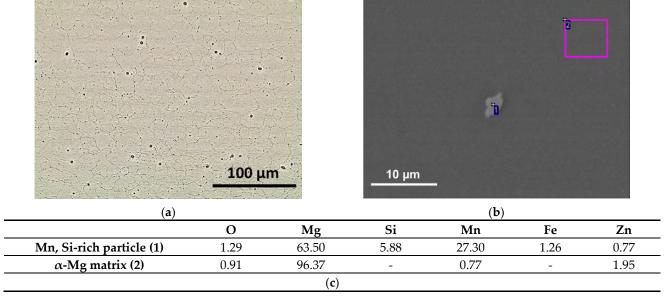
Optical and SEM images showing the microstructure of the ZM21 alloy are shown in Figure 1a,b: a fully recrystallized microstructure was observed in the plane perpendicular to the extrusion direction. Equiaxed grains displayed an average size of 9 \pm 5 μm and a bimodal grain size distribution was observed, consisting of both relatively coarse grains (15 \pm 4 μm) and fine grains (3 \pm 1 μm), as already reported by other authors for ZM21 after extrusion [26]. Relatively small Mn,Si-rich particles (<5 μm , as shown by high magnification SEM image in Figure 1b, accompanied by localized EDS analysis results, Figure 1c) were also detected in the α -Mg matrix (with Zn and Mn in solid solution, as indicated by EDS data in Figure 1c). Mn,Si-rich particles also contained Fe, a common impurity in Mg alloys. Similar observations were reported for the same alloy in the extruded condition, also by Bian et al. [6]. The formation of the Zn-rich β phase was not observed, due to the balance between Zn and Mn in the alloy [27].

Figure 1. Microstructure of the ZM21 substrate: (a) optical image and (b) higher magnification SEM image with (c) EDS analysis (wt.%) of the unetched alloy.

The small Mn,Si-rich particles described in Section 3.1 (Figure 1b) do not appear to have any significant influence on the overall growth of the PEO layer at this scale, and the ZM21 alloy basically responds to oxidation as a single phase material. As for the elements from the electrolyte, elemental maps show that Na-rich species are mostly located in the outer areas of the coating, while Si and P are more homogeneously distributed throughout the whole layer. The distribution of these elements in PEO layers is influenced by ionic mobility of different species, as discussed by Monfort et al. and Matykina et al. in [30,31].

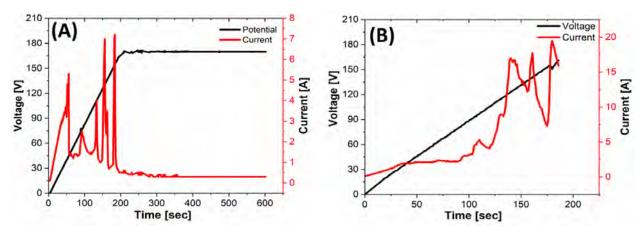
The chronopotentiometric and chronoamperometric curves recorded during the PEO of the sacrificial samples (Figure 2A) showed a typical current profile characterized by randomly distributed peaks corresponding to discharge avalanches on the anodic surface. The current peaks did not exceed 7 A during the PEO of the sacrificial samples (Figure 2A). This induced lower energy dissipation and a better temperature control. During PEO of the extruded profiles (Figure 2B), the current peaked at 20 A, probably because of the higher anodic surface area. Correspondingly, a more intense sparking and gas evolution was observed, with significant electrolyte temperature increase, inducing the operator to interrupt the treatment at the beginning of the potential plateau. The discrepancy on the chronoamperometric profiles reported in Figure 2A,B can be ascribed to the different ratio of anodic to cathodic exposed area. This issue would deserve a dedicated development stage, which was out of the scope of this work.

Figure 2. Potential (black) and current (red) curves as a function of the PEO processing time for the ZM21 sacrificial specimen (**A**) and for the ZM21 extruded profile (**B**).

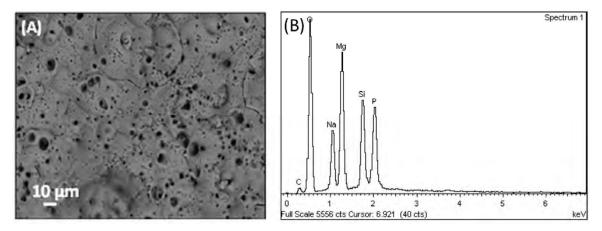
After anodizing, the surface of sacrificial samples exhibited a micrometric and submicrometric porosity; however, the typical cracks often resulting from PEO of Mg alloys [16] were not observed (Figure 4A). The EDS analysis of the surface (Figure 4B) revealed that the PEO layer contained O, Zn, Na, Mg, Si and P, with Zn and Mg from the ZM21 alloy and Na, Si and P incorporated from the electrolyte.

Figure 4. PEO-treated surface: **(A)** SEM image and **(B)** EDS surface spectrum of the oxide layer obtained onto a ZM21 sacrificial sample at 170 V, 188 s, 30 °C in 100g/L Na₃PO₄·12H₂O), 20 g/L Na₂SiO₃, 25 g/L Na₂B₄O₇·10H₂O.

The surface morphology of PEO-treated profile and the corresponding cross-section image are shown in Figures 4A, 7 and 8, respectively. The surface morphology appeared rough and porous with typical craters generated by local discharge events occurring during the growth of the anodic oxide layer [15,29]. A few microcracks, derived from thermal stresses, and a pancake morphology, formed by molten oxide erupted from discharge channel and rapidly cooled by the electrolyte at the room temperature, were also observed

The corroded surface as well as the polished cross section of the bare and PEO-treated ZM21 were also analyzed by SEM/EDS at the end of the NSS test (120 h). Figure 13 shows the morphology of corroded surfaces and further demonstrates that the PEO layer contributed to limit the formation of corrosion products on ZM21: a more extensive formation of Cl- and O-rich crystalline corrosion products was observed on bare ZM21 (Figure 13a) than on the PEO-treated surface (Figure 13b). However, some localized corrosion attacks are also visible on the PEO-treated surface (areas 2 and 3 in Figure 13b), with increased amounts of elements from the aggressive environment (namely Cl and O) by comparison to the less corroded areas of the anodic oxide (area 1 in Figure 13b), which still retains its typical surface morphology with volcano-like features (as shown before corrosion by Figure 4A).

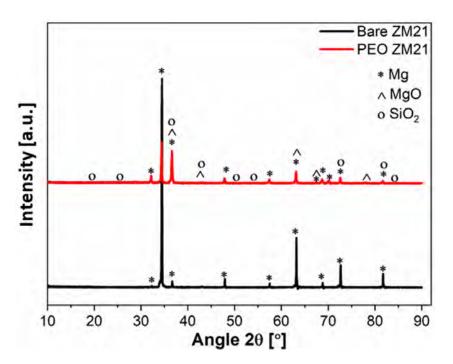
XRD patterns shown in Figure 5 demonstrate that the PEO film consisted of a mixture of MgO and SiO_2 .

Figure 5. XRD pattern of the bare ZM21 alloy (black) and of the anodic film (red) obtained onto ZM21 at 170 V, 188 s, 30 $^{\circ}$ C in 100g/L Na₃PO₄·12H₂O), 20 g/L Na₂SiO₃, 25 g/L Na₂B₄O₇·10H₂O.

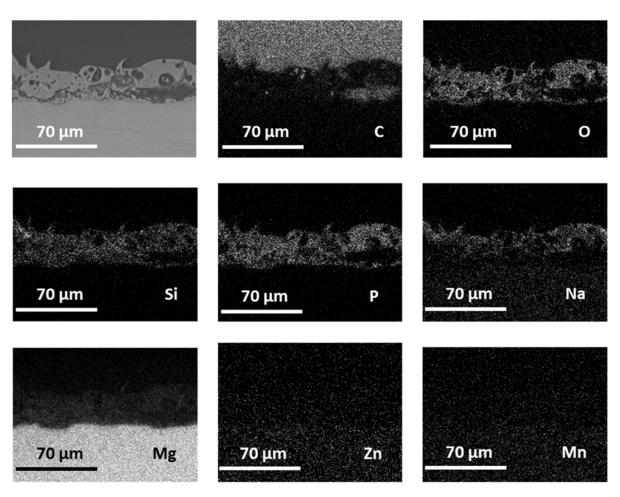
Figure 8. BSE image (top left) and X-ray EDS elemental maps of the PEO-treated ZM21 extruded profile (polished cross section; the presence of C is due to the mounting resin).

Elemental X-ray maps recorded by EDS on polished cross sections of PEO-treated samples (Figure 8) showed a homogeneous distribution of alloy elements (Mg, Zn, Mn) as well as of elements incorporated from the electrolyte (O, Si, P).

The cross-section images (Figures 7 and 8) showed that the PEO layer/substrate interface is slightly undulated, due to local thickening of the anodic oxide following breakdown events [11]. The pores are unevenly distributed throughout the specimen crosssection and the average thickness of the film is about 30 µm. Typical discharge channels, pores and cracks, bigger and larger in the outermost region, were also observed. The characteristic anodic oxide morphology afforded mechanical interlocking of the powder coating top layer (Figure 7a), an important prerequisite for satisfactory bonding strength. Additionally, the deposition of the powder coating top layer allowed to obtain a smoother surface (as shown also by surface roughness data in Table 2), levelling out the rough PEO surface. The average thickness of the PEO layer was $39 \pm 4 \mu m$, while the powder coating top layer was $118 \pm 9 \,\mu m$ thick (Figure 7a,b), regardless the presence of the PEO interlayer (as expected, since the powder coating was applied in a single painting session). The coating thickness was fairly uniform in both cases (PEO layer alone and PEO with powder coating top layer). EDS analysis of bright spots in the BSE cross-section images of the powder coating showed the presence of Ba-and Ca-based compounds, typical inorganic fillers added to the powder coating top layer (such as BaSO₄ and CaCO₃).

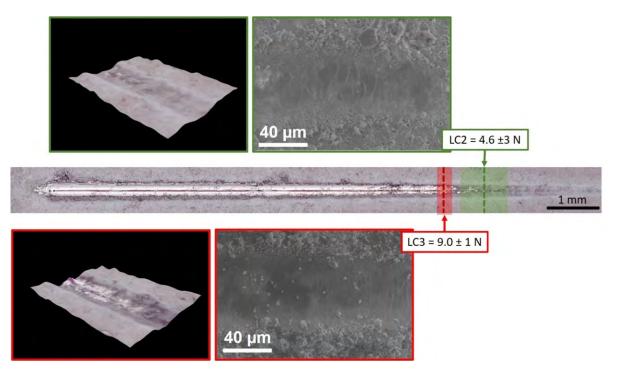
Representative images of scratch tracks with indication of critical loads Lc2 and Lc3 for adhesive failure of PEO layer, estimated according to ISO 20502:2016 [32] are reported in Figure 9.

Figure 9. Overview of a representative scratch track on PEO-treated ZM21 extruded profiles (optical image), with indication of critical loads Lc2 (first coating detachment) and Lc3 (full delamination). Each critical load for adhesive failure of the PEO layer is accompanied by the corresponding SEM image (SE) and 3D-digital microscopy image of the scratch track (black background).

The measured average value of Lc2, indicating when the coating detachment begins, and Lc3, corresponding to penetration of the coating to the substrate at the center of the track, were 4.6 ± 3 N and 9.0 ± 1 N respectively, comparable to those measured in a previous work on PEO-treated EV31A Mg alloy, where scratching was carried out in the same conditions [29]. Substrate and coating properties influence the failure mode during scratch testing [33]: PEO-treated Mg alloys can be considered as hard coating on soft substrate even though the hardness difference may not be notably high. Therefore, PEO layers were bent into the track as a consequence of substrate plastic deformation. The SEM image corresponding to Lc2 in Figure 9 (top right) shows buckling failures (cracks and patches of coating detachment) appearing in the scratch track, in the areas where the indenter movement generates pile-up deformation. After full delamination of the PEO layer, only substrate plastic deformation was observed, together with scattered micro-fragments from the anodic oxide (bottom right SEM image in Figure 9).

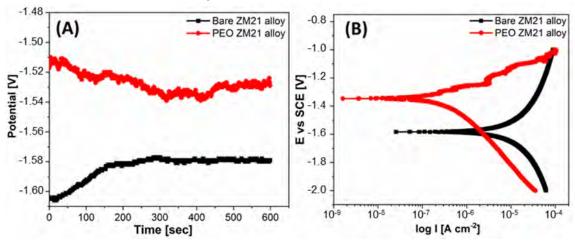
Corrosion tests were carried out on sacrificial specimens. Open circuit measurements in 3.5% NaCl solutions (Figure 10A) showed that the immersion potential of the anodized

According to the potentiodynamic tests (Figure 10B), after anodization the corrosion current density decreased by one order of magnitude, i.e., from $2.5 \cdot 10^{-8}$ A cm⁻² to $1.5 \cdot 10^{-9}$ A cm⁻² and the corrosion potential increased by about 300 mV, i.e., from -1.6 V vs. SCE (untreated ZM21 alloy) to -1.3 V vs. SCE (anodized alloy). Correspondingly, the polarization resistance of the alloy increased by two orders of magnitude after the PEO treatment, rising from about 9837 Ω cm² to about 145,848 Ω cm².

Figure 10. Open circuit voltage as a function of immersion time (**A**) and potentiodynamic curves (**B**) of ZM21 before (black curve) and after (red curve) PEO. Tests carried out in 3.5% NaCl aqueous solutions.

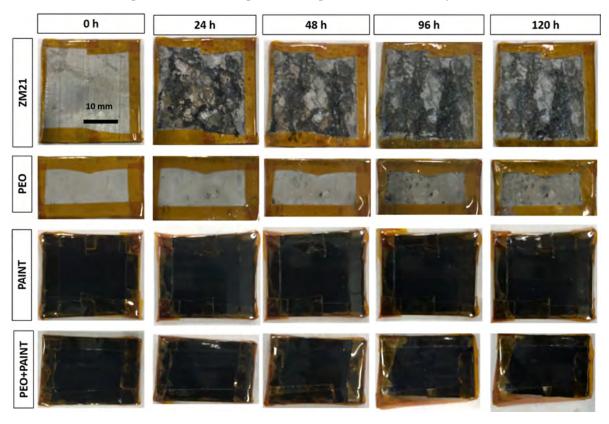
The results of the visual inspection of the samples during and at the end of NSS test are reported in Figure 11. Already after a few hours of exposure (>6 h), ZM21 alloy exhibited corrosion products on the surfaces, indicating the high reactivity of this material in NaCl solution. At the end of the exposure, the reference ZM21 samples showed a strongly damaged surfaces characterized by the precipitation of uniformly distributed corrosion products, as highlighted in micrographs of Figure 12. The PEO-treated samples showed localized corrosion attacks for short exposure time (>6 h) that are clearly visible after 24 h. However, these corrosion attacks on PEO surfaces did not significantly evolve with time. This is probably due to the initiation of the localized corrosion attacks in correspondence with PEO treatment defects (e.g., porosity). In addition, corrosion products continuously precipitated inside the localized corrosion sites, mitigating the corrosion rate of the process. However, at a longer exposure time (>96 h), a localized acceleration of the corrosion process was observed with a consequently leaching of the corrosion products, as shown in Figure 12. Conversely, for both the painted samples, no corrosion attacks and/or painting damages were observed within the 120 h NSS test, indicating an increased performance for both the

Figure 11. Visual observation of the samples before and during the NSS test.

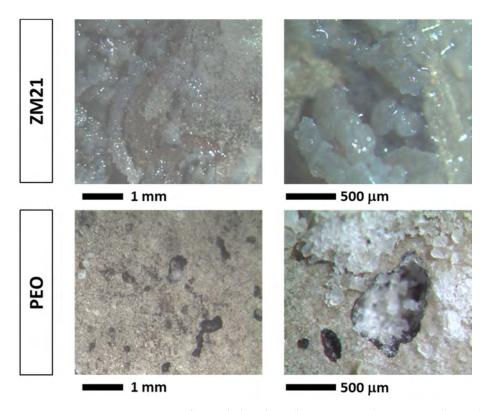
Figure 12. Macroscopic images of corroded surfaces (bare ZM21 and PEO-treated ZM21) at the end of the NSS test (120 h).

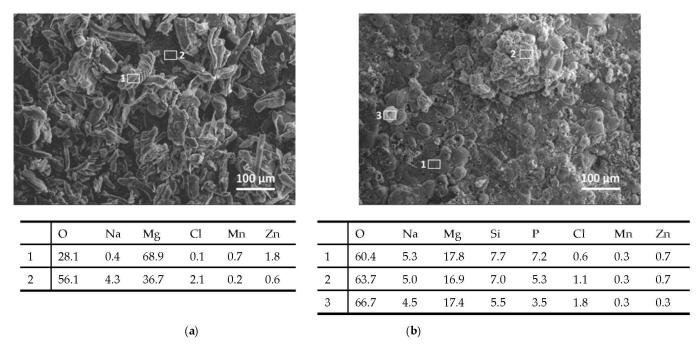
Figure 13. SEM images (secondary electrons) and localized EDS analyses (wt.%) of corroded surfaces (bare ZM21 (a) and PEO-treated ZM21 (b)) at the end of the NSS test (120 h).

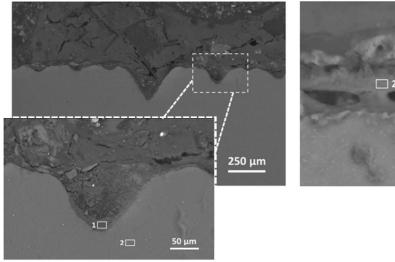
Figure 14 compares the polished cross section of the bare and PEO-treated ZM21, showing that while the bare alloy underwent remarkable localized corrosion, with the formation of several craters (Figure 14a), the PEO-treated samples still showed the presence of the anodic oxide layer, even though with a slight increase of defects (cracks and pores), which favored the previously mentioned localized corrosion phenomena. Cl from the aggressive environment was always detected at the interface between the corrosion products and the alloy, as expected.

О	Mg	Si	C1	Mn	Zn
1-crater	63.1	33.4	1.5	1.0	0.3	0.7
bottom	05.1	33.4	1.5	1.0	0.5	0.7
2-ZM21	1.8	95.3	0.1	100	1.8	1.0

О	Na	Mg	Si	P	Cl	Mn	Zn
1-PEO	45.8	4.1	19.4	21.1	9.1	-	-	0.5
(top)								
2-PEO	24.8	0.4	42.2	26.8	0.7	=1	0.9	4.2
(centre)								
3-PEO	25.6	0.5	63.0	4.6	3.3	0.3	0.7	2.0
(interface)								
4-ZM21	3.9	=	91.6	1.0	-	=)	1.2	2.3
	(b)						·

Figure 14. SEM images (backscattered electrons) and localized EDS analyses (wt.%) of polished cross sections through corroded samples (bare ZM21, with general view and high magnification detail (a) and PEO-treated ZM21, high magnification detail (b)) at the end of the NSS test (120 h).
