THE COMPLEX OF SANTA CROCE IN RAVENNA AS A CASE STUDY: INTEGRATION OF 3D TECHNIQUES FOR SURVEYING AND MONITORING OF A HISTORICAL SITE

Gabriele Bitelli^{a,b,*}, Ester Barbieri^b, Valentina Alena Girelli^{a,b}, Alessandro Lambertini^a, Emanuele Mandanici^a, Eleonora Melandri^b, Domenico Simone Roggio^b, Angela Santangelo^{b,c}, Maria Alessandra Tini^a, Simona Tondelli^{b,c}, Andrea Ugolini^{b,c}

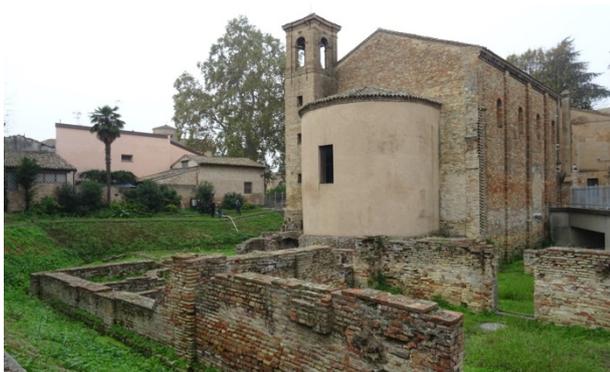
Figure 1: General outer view of the complex of Santa Croce: the Church and the archaeological area.

The Santa Croce complex (Fig. 1), located in the historic area of Ravenna, is characterized by the coexistence of different architectures that over time have been layering in the area: the early 17th century Church, the remains of the late-antique Placidian Church and the structures of a Roman *domus* with part of its mosaics. The Roman remains were attributed to a luxurious residence, coherently with others identified in the surroundings. The studies were undertaken in the area date the *domus* back to the turn of the 3rd and 4th century AD (Sericola, Agostinelli, & Ugolini, 2019).

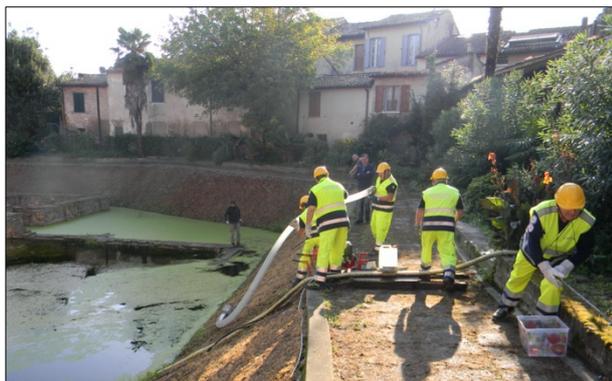
Figure 2: Draining operations of the area after the flooding event in August 2019.

The flooding hazard is even more relevant as, seen the configuration of the archaeological area, also rainwater and stagnant water constitute a relevant potential risk for the site. Currently, the presence of water is only managed with manually controlled pumps conveying the groundwater into the city sewerage system. However, no early warning system is active in the area, a situation that hinders an immediate response when anomalous situations occur. As happened both in 2016 and 2019, a malfunction of the water pumping system caused sudden flooding of the archaeological area (Fig. 2).

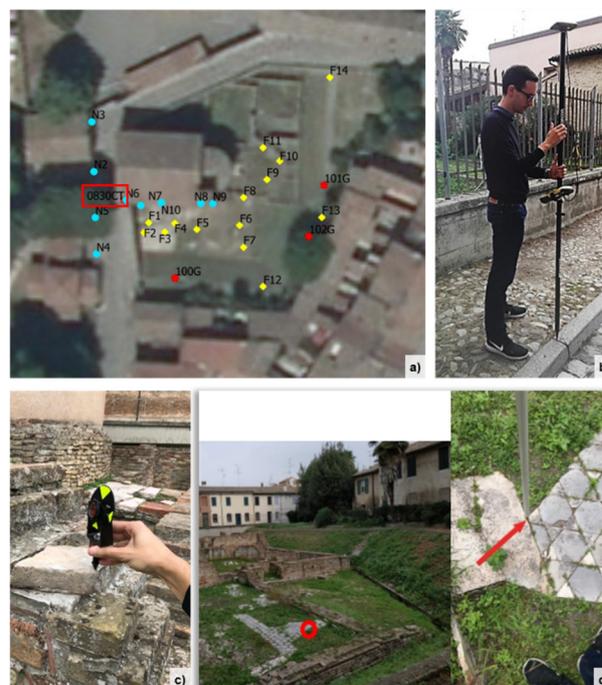
Figure 3: Surveying operations: a) Topographic network; the red stars indicate the GNSS stations, with in the red box the benchmark of the municipal levelling network; cyan and yellow squares indicate respectively targets and natural points used for geo-referencing laser scanning and photogrammetric data; b) a phase of the GNSS survey; in c) and d) two natural control points in the archaeological area.

The surveying operations involved the integration of different techniques: GNSS observations, classical topography with Total Station, Terrestrial Laser Scanning, aerial (by UAV) and close-range digital photogrammetry, thermal images analysis. A careful planning of all the activities allowed the design and the realization of a network for the absolute geo-localization of the acquired data (Fig. 3).

GNSS observations in NRTK mode were performed for the planimetric network absolute georeferencing, through the survey of three vertices in the area (red stars in Fig. 3). The GRS-1 receiver by Topcon, with PGA-1 antenna, was used and it was connected to NetGEO, the NRTK commercial service provided by the manufacturer. For the altimetric network referencing, the orthometric height of a benchmark of the existing municipal levelling network was used. The position of the benchmark is indicated in Figure 3 by a red rectangle.

The topographic network was surveyed using the first-class motorized Leica TS30 Total Station ($\pm 0,5''$ angular error, $\pm (0,6 \text{ mm} + 1\text{ppm})$ distance error). Overall, 25 points were measured, both targets and natural points, used as ground control points for geo-referencing laser scanning and photogrammetric data (respectively cyan and yellow squares in Figure 3). The target coordinates were obtained by a least-square adjustment with minimal constraints.

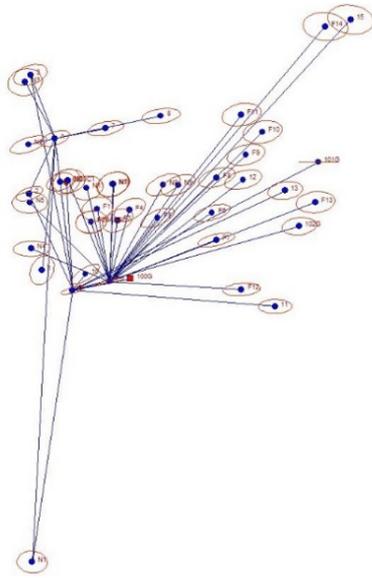
Figure 4: Topographic network drawing; the error ellipses, in red, show uncertainty of 2-3 mm on the calculated positions (exaggeration factor of 500).

Figure 4 shows the planimetric drawing of the topographic network. The error ellipses evidenced an uncertainty of 2-3 mm on the calculated positions.

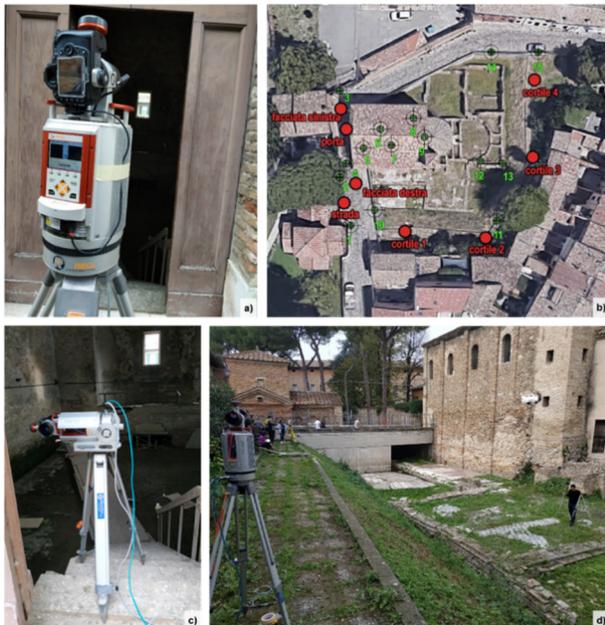
Figure 5: Laser scanning surveys: a) Riegl TOF system; b) scheme of the scan-positions performed for the exterior survey (red circles); c) acquisition of the church ceiling, with the laser tilted horizontally; d) acquisition of the south wall.

The laser scanner survey of the complex was realized using the time-of-flight (TOF) Riegl VZ400 (declared accuracy 5 mm, precision 3 mm, measurement speed 122000 points/sec) coupled with a Nikon D90 reflex camera. The acquisitions were performed by 15 scan-positions, 7 for the interior, 8 for the exterior (Fig. 5). The number of the measured points is significant: more than 410 million points overall.

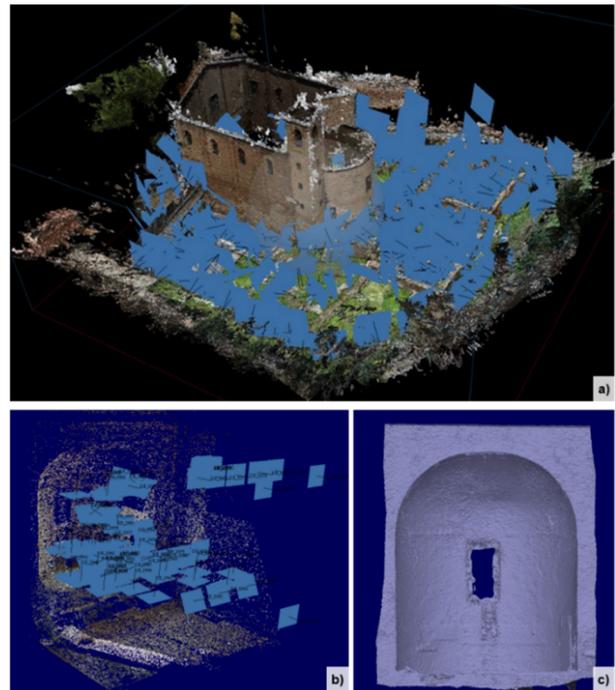
Figure 6: Photogrammetric surveys: a) close-range in the exterior; b) and c) by drone in the interior; c) the detailed 3D model of the church apse.

scanning due to the fence, were acquired by a close-range photogrammetric survey, whereas in the interior of the church, especially for the apse and the upper part of the truss in the ceiling, an aerial photogrammetric flight by UAV was performed.

In the first case, more than 600 images were acquired using a full-frame DSLR camera, then processed by Multi-View Structure-from-Motion approach. The achieved average error was in the order of 1-2 pixel and the obtained point cloud consists of 3.5 million points. Inside the church, two flights with UAV were realized to obtain a detailed model of the apse and a point cloud of the whole interior, especially of the ceiling (Fig. 6). The UAV was a DJI Spark, equipped with FC1102 camera (sensor size 6.17 × 4.56 mm, resolution 3968 × 2976 pixel, pixel size 1.57 μm, focal length 4.4 mm).

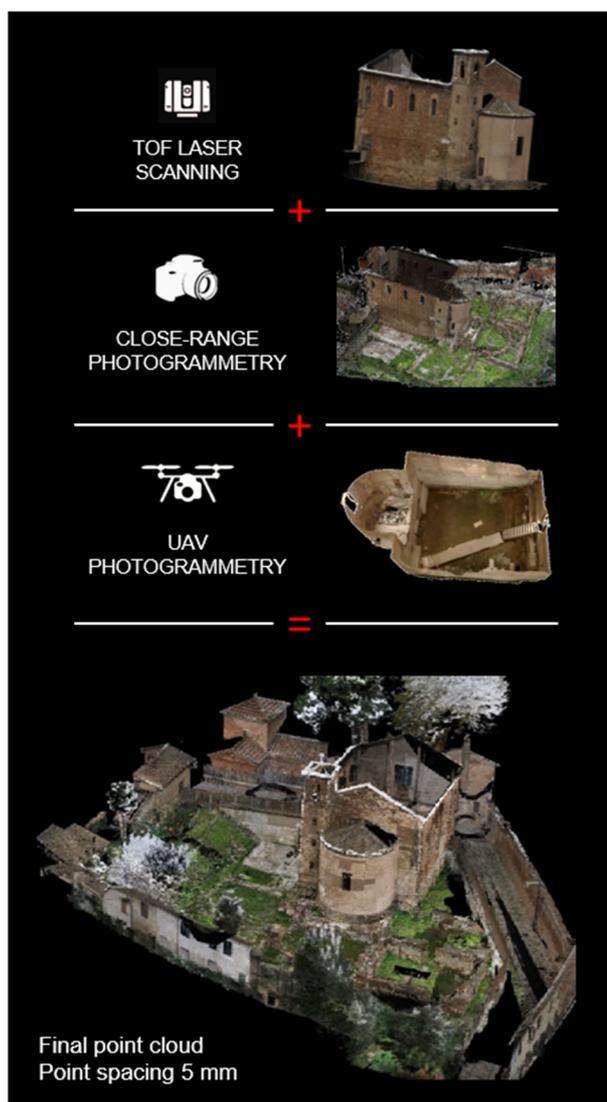
Figure 7: The final point cloud of the complex, obtained fusing together all the acquired data.

All the point clouds obtained by the different techniques were aligned in the absolute reference system established by GNSS and topographic surveys. In particular, the alignment of each TLS point clouds to the reference system adopted, performed by means of the 3D targets, always provided root means square of less than 5 mm. The clouds were then cleaned, fused and filtered. The processing, due to the area complexity and the huge amount of data, required an accurate manual intervention. The alignment between photogrammetric and TLS clouds was realized in two steps: firstly, a coarse registration using manually collimated homologous points and then a fine registration by ICP procedure. The filtering of the outliers was done mostly manually. The TLS model was integrated with data by photogrammetry only where it was lacking, trying to limit the overlapping areas. After the fusion, an automatic resampling was applied, by imposing an average point spacing of 5 mm (Fig. 7). Considering the integration with the photogrammetric data, the overall reliability of the final model can be evaluated at about 1 cm.

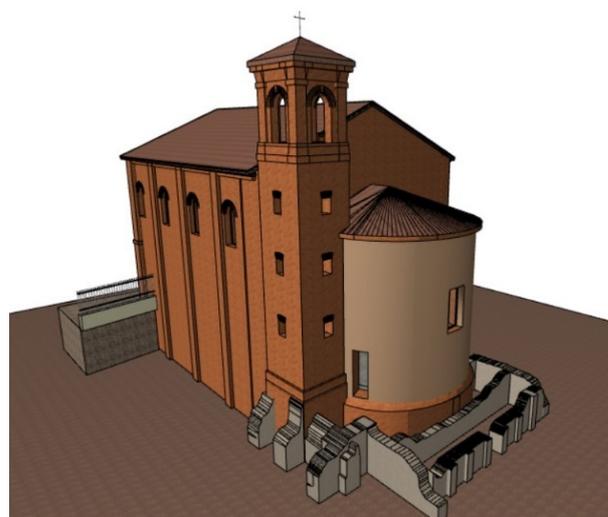
Figure 8: Simplified model of the Church obtained by the HBIM approach.

Starting from the final point cloud, a simplified BIM model of the Church of Santa Croce was produced (Fig. 8). The BIM model, generated according to an HBIM approach, can represent further support for the knowledge of the current state and its preservation and conservation (Brumana et al., 2020).

By the final point cloud, a simplified model of the church was created using an HBIM approach. The main purpose of this model is not linked to the production of a 3D model strictly reflecting the geometric characteristics of the building but is oriented to integrate the geometric component, with a series of information indispensable for

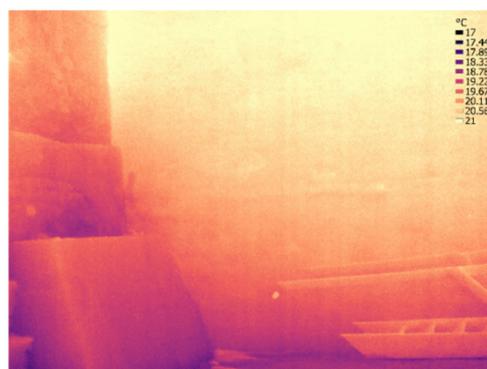
Figure 9: Thermal image of the interior south wall.

As said before, also a diagnostic analysis by thermal imaging (Adamopoulos, Bovero, & Rinaudo, 2020) was experimented in the interior. The used thermal camera was a FLIR P620, which has a spectral range between 7.5 μm and 13 μm , 640 x 800 resolution; the camera was equipped with the standard 24° lens. During the survey, 56 thermal images were acquired. In order to facilitate the focus of the camera and to identify points during post-processing phase, artificial targets were placed on the masonry. The images were later processed with FLIR software, producing 32-bit tiff files without loss of quality. Thermal images were then edited for easier reading by using a false-colour, to highlight small temperature differences between 17 and 21 °C. Figure 9 shows an example of the acquired thermal images.
