Constraints of the durability of inorganic and organic consolidants for marble

Johanna Menningen¹ · Enrico Sassoni² · Robert Sobott³ · Siegfried Siegesmund¹

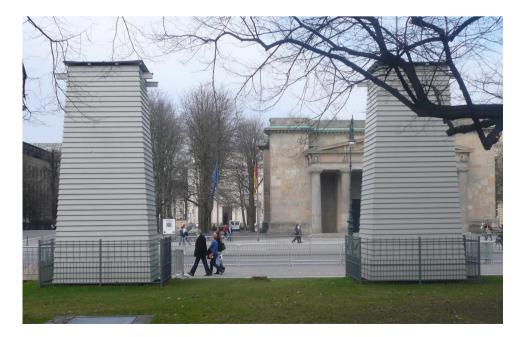
Fig. 2 Monuments of General von Bülow and General von Scharnhorst, sheltering of both monuments at their current location during the winter time to avoid extreme climate condition and its effect on the progressing decay (after Menningen et al. 2020)

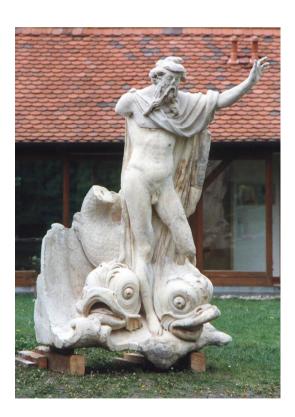
Fig. 16 The sculpture of Neptune after conservation by ATI on the premises of IbachGmbH. The ATI conservation process allows a badly damaged sculpture to return to its original site instead of final in-door storage somewhere in the cellar
