Phosphate treatments for stone conservation: 3-year field study in the Royal Palace of Versailles (France)

Abstract Phosphate treatments for conservation of stone have provided so far encouraging results in laboratory studies, as they exhibit good effectiveness, compatibility and durability to accelerated weathering tests. However, limited data are available about their long-term performance in real environment. Here, a systematic evaluation of phosphate consolidants after prolonged exposure in the field is reported for the first time. Naturally weathered marble specimens and a XVII century marble sculpture located in the Park of the Royal Palace in Versailles were treated by various

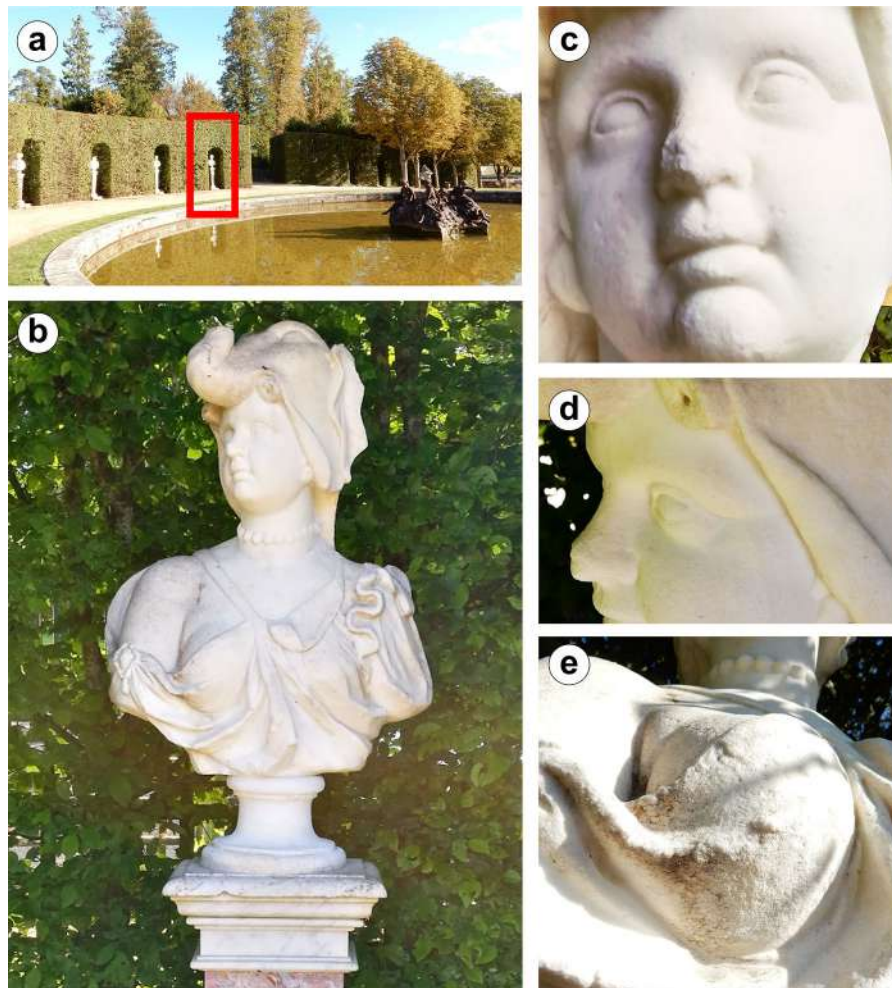
Fig. 3 Sculpture of *L'Afrique*: **a** location in the park of the Grand Trianon; **b** general view of the bust; details of grain loss affecting the face **c**, the nose **d** and the right breast **e** of the bust

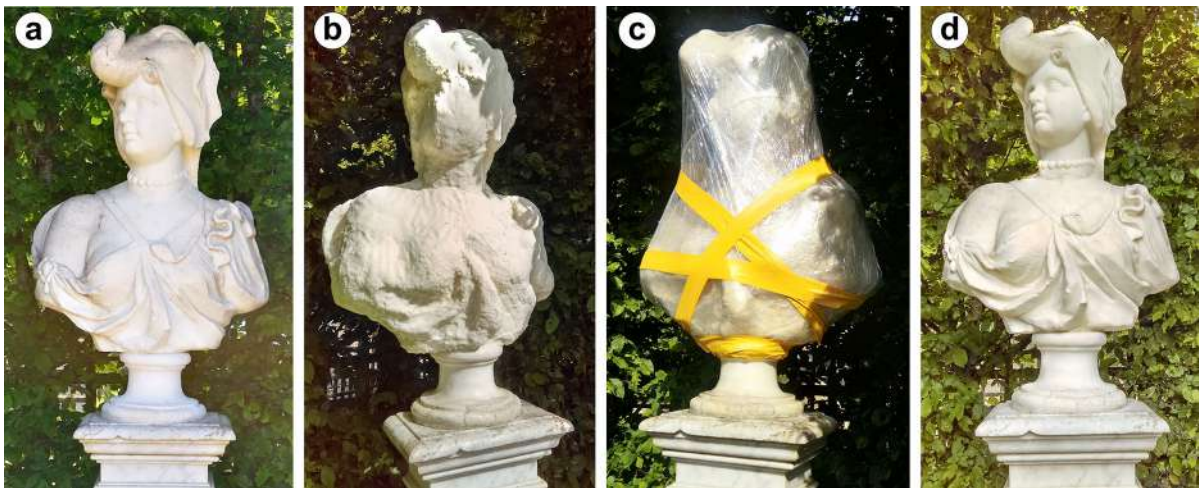
Fig. 4 Phases of bust consolidation: **a** before treatment; **b** after poultice application; **c** after wrapping with a plastic film; **d** after treatment

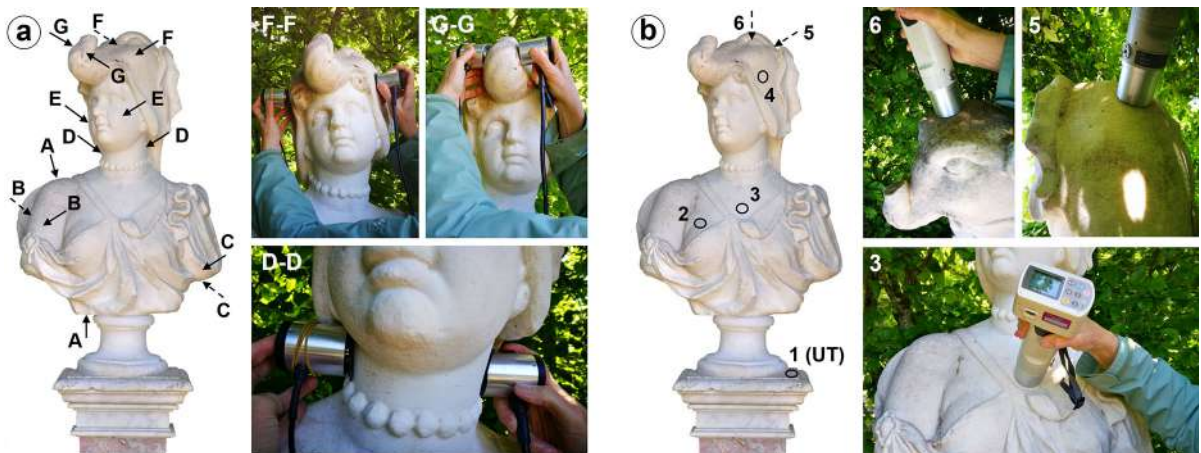
Fig. 5 Schemes and photos illustrating the field measurements on the bust: **a** ultrasonic tests; **b** water absorption and color change (point 1 was left untreated, UT, and used as reference). Dotted arrows indicate measurement points in the rear part of the bust

To evaluate the effectiveness and the compatibility of the treatment, UPV was measured in the points illustrated in Fig. 5a, while WA and $L^*a^*b^*$ color parameters were determined in the positions illustrated in Fig. 5b, in all cases repeating the tests before and after treatment. The same instruments and techniques described in Sect. 2.1.4 were used. All the measurements performed in the field (before and after

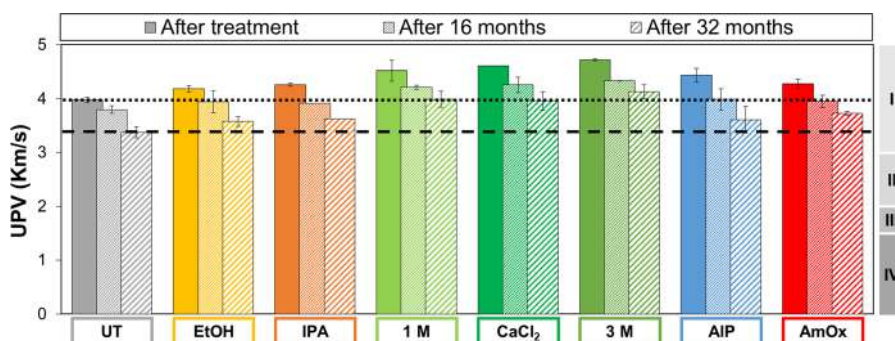
Fig. 6 UPV values of untreated and treated specimens after consolidation (solid bars) and after field exposure for 16 months (densely hatched bars) and 32 months (sparsely hatched bars). Dotted and dashed lines indicate the values of the untreated references after treatment and after 32 months, respectively.

Bars on the right indicate the categories (I–IV) of marble deterioration according to the classification proposed by Köhler [45]. Values are averages for 2 replicates (bars indicate the difference between the average and the maximum/minimum values)

The increase in UPV after treatment (before exposure in the Park) can be seen in Fig. 6 (solid bars). The untreated specimens exhibited the lowest UPV (4.0 km/s), which corresponds to a condition of “increasing porosity” according to the classification proposed by Köhler [45]. All the treated specimens exhibited higher UPV, increasing in the order: “UT” < “EtOH” < “IPA” \approx “AmOx” < “AIP” < “1 M” < “CaCl₂” < “3 M”. Starting from the least effective treatments, “EtOH” and “IPA” caused modest increases in UPV (+ 5% and + 7%, respectively), actually lower than in previous studies [13, 16]. This is likely due to the very limited formation of new CaP phases, as revealed by SEM (only isolated clusters of new CaP were visible, Fig. 7) and FT-IR (no clear bands ascribable to new CaP were detected, Fig. 8). Such limited formation of new CaP may be a consequence of the different conditions of this study compared to previous studies, in terms of application technique (poulticing, instead of immersion [16] or brushing [13]) and/or initial marble condition (naturally weathered specimens, instead of artificially weathered but uncontaminated specimens [13, 16]). The influence of these parameters may be strong when low DAP and CaCl₂ concentrations are used, whereas their influence seems lower in the case of more concentrated DAP formulations.

UPV improvements by + 14 and + 19% were achieved after consolidation by “1 M” and “CaCl₂”, respectively, in agreement with previous studies highlighting the effectiveness of both formulations [1, 16, 35, 47]. The benefit of adding CaCl₂ as a calcium source, originally pointed out in [21], is here confirmed, both in terms of mechanical effectiveness (Fig. 6) and continuity of the new CaP phases (Fig. 7). In fact, while the new CaP layer formed over the marble surface exhibits some gap in the case of the “1 M” treatment, no evident uncovered zones were present in the “CaCl₂” sample. FT-IR results (Fig. 8) suggest formation of HAP (having bands at 1031–1032, 602–604 and 561–563 cm⁻¹ [48, 49]), consistently with previous findings [21]. In the case of the “CaCl₂” treatment, a shift in the FT-IR band from

The highest UPV increase was registered for the “3 M” formulation ($\Delta\text{UPV} = +19\%$), consistently with previous results [13, 15, 27, 39]. This high strengthening ability is due to the abundant formation of new CaP phases, as indicated by SEM (Fig. 7) and FT-IR (Fig. 8). These new phases effectively bond calcite grains, even though pores and cracks have been reported in the new CaP phases [3].

After 16 months, all the specimens exhibited a reduction in UPV by 5–10% (Fig. 6, densely hatched bars). These UPV reductions can be ascribed to natural weathering processes occurring in the field, in particular: (i) freezing–thawing cycles, leading to microcrack formation (the analysis of environmental data pointed out that, during the exposure period, on at least 63 days conditions for freezing–thawing cycles occurred, but the total number of cycles was likely higher as freezing–thawing might have taken place more than once in a day); (ii) heating–cooling cycles during summertime, leading to microcrack formation, especially if moisture is present in the pores [52]; (iii) rainfall, leading to dissolution of uncoated areas and

However, a further UPV decrease was experienced passing from 16 to 32 months (Fig. 6, sparsely hatched bars). Pre-conditioning was performed in the same way in these two occasions and re-heating at the same temperature is not expected to cause additional thermal damage [54]. In fact, when marble is heated to a certain temperature, calcite crystals undergo anisotropic thermal deformation and stress arises at grain boundaries, resulting in the formation of new intergranular fissures. When marble is cooled down and then re-heated at the same temperature, the voids formed after the first heating are able to accommodate calcite crystals deformation without significant new stress and without formation of additional new cracks [54], thus exerting a sort of “buffering effect” [55]. Therefore, in the present case the further UPV decrease passing from 16 to 32 months can be mainly ascribed to natural weathering, because pre-conditioning at the same temperature should not cause formation of additional cracks.

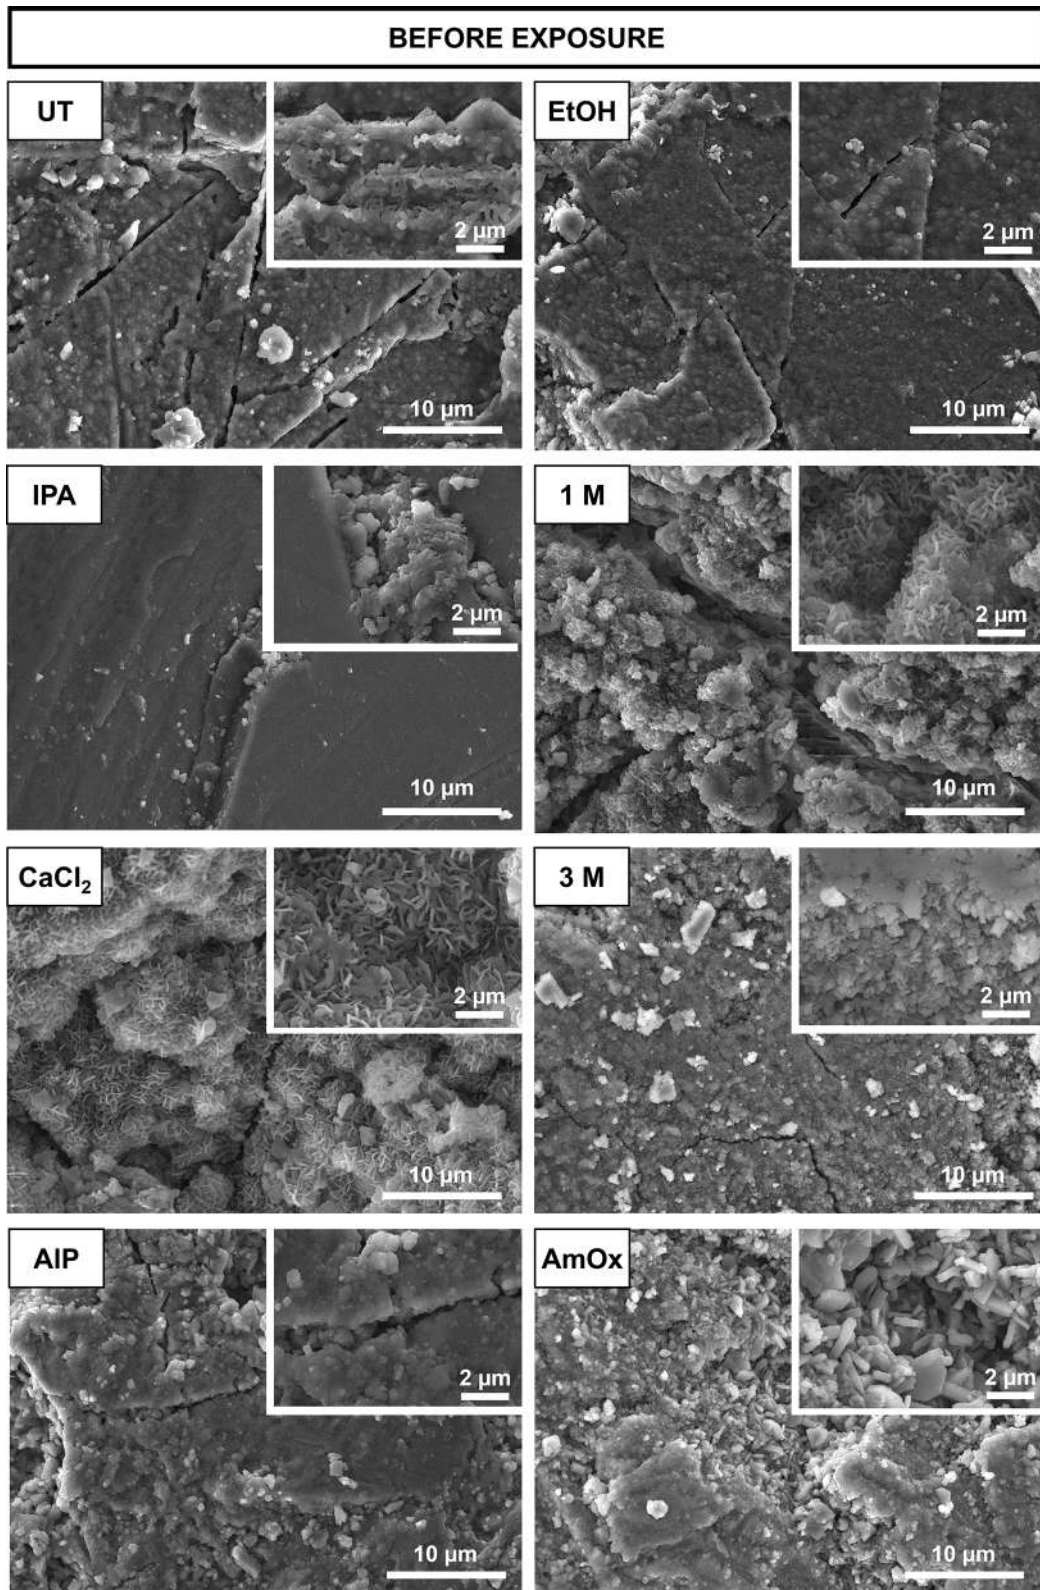
◀ **Fig. 7** SEM images of untreated and treated specimens, before field exposure

“AmOx” caused an UPV increase (+ 8%) comparable to “IPA” (+ 7%), thanks to the formation of whewellite, as revealed by SEM (Fig. 7) and confirmed by FT-IR (bands at 1618, 1323, 781, 517 cm⁻¹ [46], Fig. 8). The limited consolidation caused by “AmOx” treatment is consistent with some previous results [13, 15], although a higher effectiveness has also been reported [16, 41].

“AIP” was a little more effective than “AmOx”, reaching Δ UPV = + 11%. However, no clear evidence of aluminum phosphate formation was obtained by either SEM (Fig. 7) or FT-IR (Fig. 8), differently from a previous study [39]. Again, this may be a consequence of the different application technique and/or the different condition of the marble substrate in the present case, compared to the previous study [39].

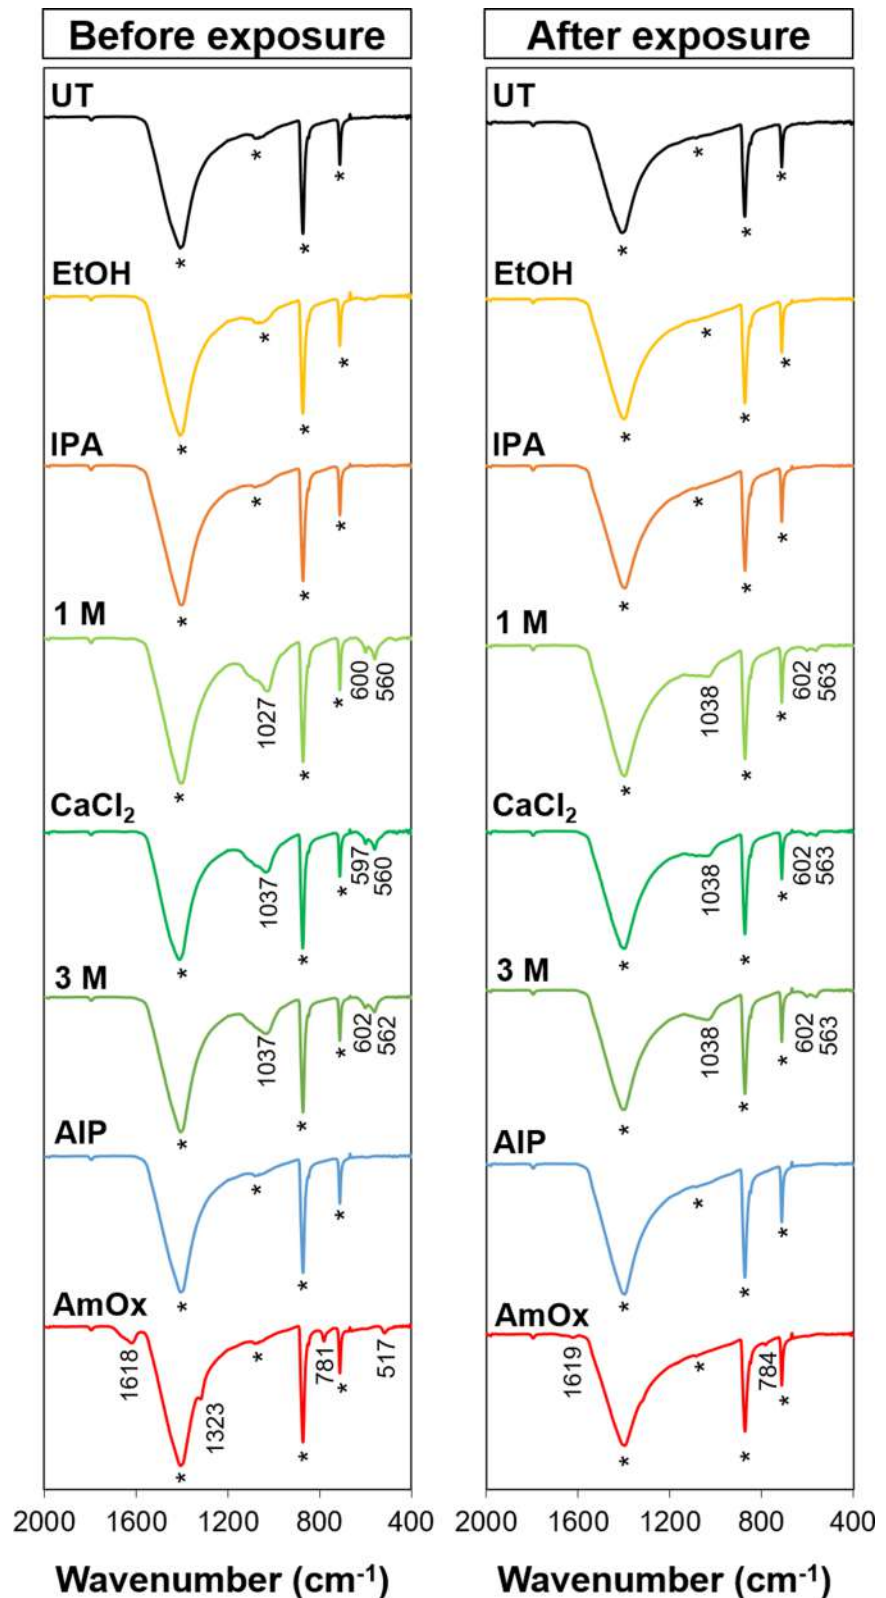
Fig. 8 FT-IR spectra of untreated and treated specimens, before and after field exposure. Bands owing to the marble substrate are marked by a star while the position of bands owing to newly formed phases is specified. Bands in the “1 M” sample can be ascribed to hydroxyapatite (HAP, having bands at 1031–1032, 602–604 and 561–563 cm^{-1} [48, 49]). Bands in the “ CaCl_2 ” sample can be ascribed to octacalcium phosphate (OCP, having bands at 1023–1026, 1036–1038, 602–603 and 560 cm^{-1} [48, 49]). Bands in the “3 M” sample are likely to be ascribed to OCP. Bands in the “AmOx” sample can be ascribed to whewellite (having bands at 1618, 1323, 781, 517 cm^{-1} [46])

After 32 months, the only treatments for which the new CaP phases were still clearly distinguishable by SEM (Fig. 12) and FT-IR (Fig. 8) were “CaCl₂” and, even more, “3 M”. Although cracks and uncoated areas appeared and FT-IR bands decreased in intensity, clear signs of the consolidating phases were detected. Consistently, after 32 months the “3 M”, “CaCl₂” and “1 M” specimens still exhibited a residual UPV (4.0–4.1 km/s) similar to the “UT” reference before field exposure (4.0 km/s) and sensibly higher than the “UT” reference after 32 months (3.4 km/s) (Fig. 6). Therefore, application of these formulations was not sufficient to completely prevent marble damage, but still was able to mitigate damage, leading to a significant residual benefit after 32 months.

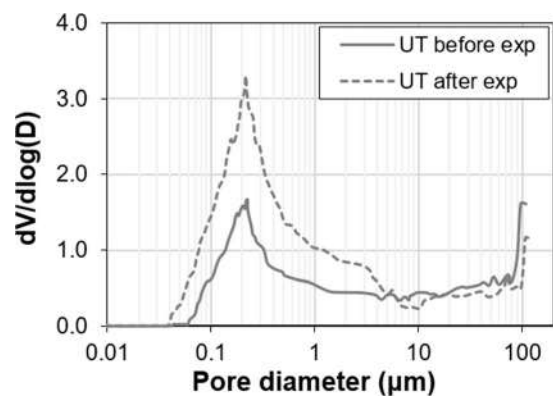
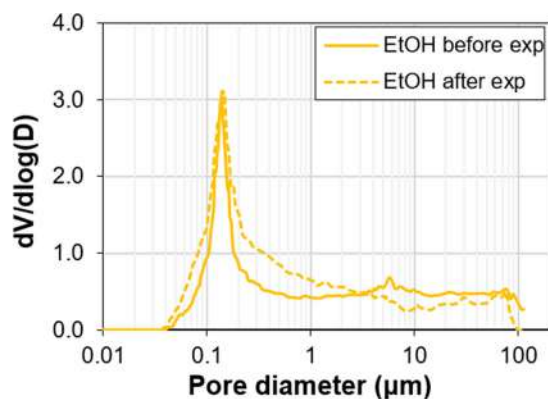
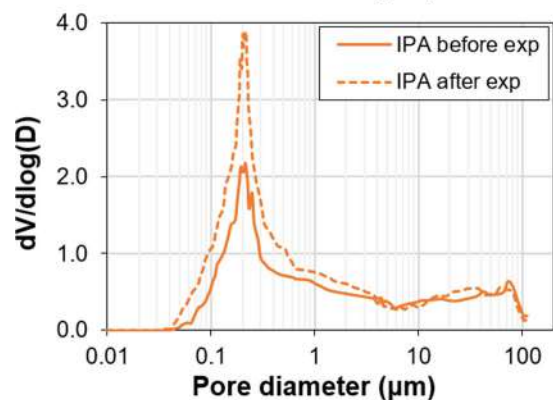
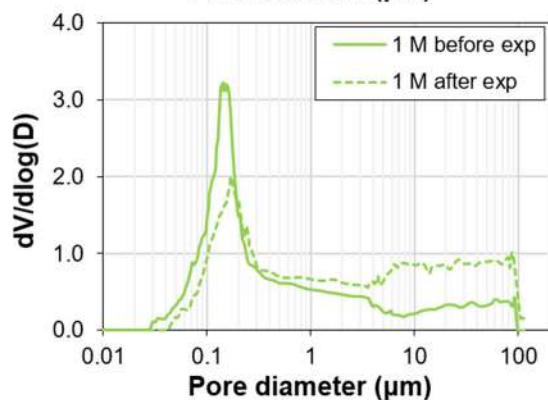
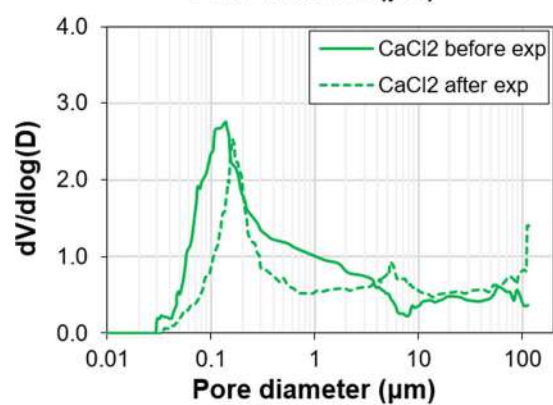
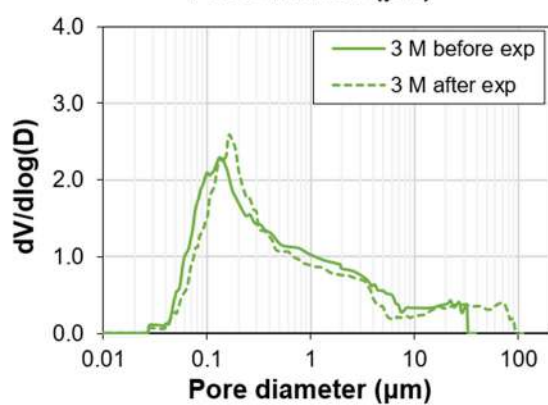
◀ **Fig. 9** Pore size distribution of untreated and treated specimens, before (solid lines) and after (dotted lines) field exposure for 32 months

As a consequence of CaP formation, variations in pore size distribution (Fig. 9) and water absorption (Fig. 10) were registered. All the treatments caused some alteration in the pore system, especially a reduction in the amount of bigger pores, but in no case was marble porosity completely occluded (Fig. 9). The lack of significant pore occlusion is important as it ensures the possibility for calcite grains to deform upon temperature variations, without stress arising at the grain boundaries [13]. Consistently, some reduction in water absorption was registered, however without any dramatic decrease (Fig. 10). The alterations in WA were mostly consistent with the increases in UPV. “IPA” and “AIP” led to modest consolidation, as a consequence of limited formation of new phases, and also limited WA reductions by 10–12% (Fig. 10). “EtOH” is apparently an exception, because an average WA reduction by 42% was registered. However, a strong difference exists between the two replicates (reductions by 10% and by 74% for the two specimens). Most likely the latter

A similar trend was found by MIP (Fig. 9) and WA (Fig. 10). After 16 and 32 months, all the specimens underwent a progressive increase in WA, which is a sign of progressive formation of new cracks, also responsible for the progressive decrease in UPV. For “UT”, the WA increase was higher between 16 and 32 months, compared to the first 16 months, which suggests that the weathering effect of field exposure was predominant over damage possibly occurred during pre-conditioning. In “UT”, a substantial alteration in pore size distribution and open porosity (increased from 0.59 to 0.93%) was assessed by MIP. Notably, after 32 months the “CaCl₂”, “1 M” and “3 M” specimens exhibited lower WA than the “UT” reference, in accordance with the UPV results. This mitigating effect is sensibly more effective than in the case of alternative treatments, including “AmOx”.

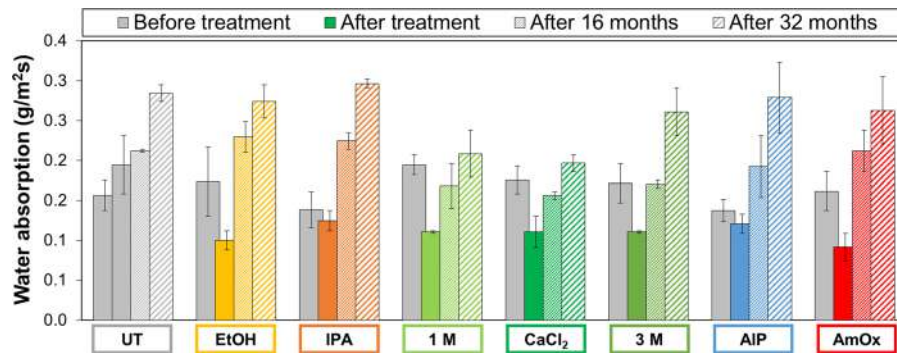
Fig. 10 Water absorption of untreated and treated specimens, before consolidation (solid gray bars), after consolidation (solid colored bars) and after field exposure for 16 months (densely hatched bars) and 32 months (sparsely hatched bars). Values are

averages for 2 replicates (bars indicate the difference between the average and the maximum/minimum values). (Color figure online)

measurement was biased, so the former result (in line with the “IPA” and “AIP” specimens) is likely more reliable. The “1 M”, “ CaCl_2 ” and “3 M” treatments, which caused the highest UPV increases (Fig. 6) and the most abundant CaP formation (Figs. 7 and 8), also exhibited the highest WA reductions by 36–43% (Fig. 10). A similar WA reduction (–43%) was shown also by “AmOx”, which however exhibited lower consolidating effectiveness (Fig. 6). The WA variations assessed in the present study are in good agreement with the values reported for the same formulations in previous studies [1, 39].

However, when evaluating these WA alterations, it should be considered that a not negligible *increase* in WA (+25%, Fig. 10) was found also for the untreated reference (re-tested only to check the measurement repeatability). This increase was attributed to the different amounts of moisture present in the specimen when the WA measurements were taken, before and after consolidation. The possible influence of hygroscopic salts was excluded, because ion chromatography did not reveal any significant amount of ions ascribable to soluble salts. To prevent uncontrolled amounts of moisture in the pores from altering the measurements, when WA was assessed during field exposure the specimens were pre-conditioned as described in Sect. 2.1.5.

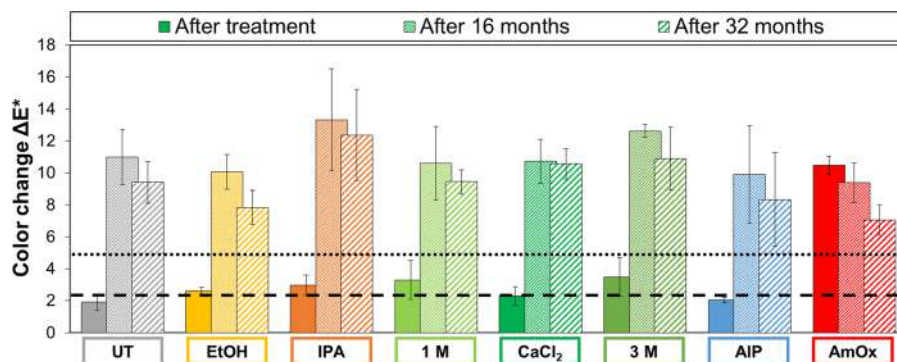
Fig. 11 Color change of untreated and treated specimens after consolidation (solid bars) and after field exposure for 16 months (densely hatched bars) and 32 months (sparsely hatched bars). The dashed line ($\Delta E^* = 2.3$) indicates the threshold of

detectability by the human eye [50], while the dotted line ($\Delta E^* = 5$) indicates the common acceptability threshold [51]. Values are averages for 2 replicates (bars indicate the difference between the average and the maximum/minimum values)

After treatment, the specimens also exhibited some alterations in the color parameters (Table S2), resulting in the overall color change reported in Fig. 11. Also the untreated reference exhibited $\Delta E^* = 1.9$, mostly due to an increase in lightness $\Delta L^* = 1.8$ (Table S2). Although below the human eye detection limit ($\Delta E^* = 2.3$ [50]), this color change was still unexpected and likely due to a different moisture content when the measurements were taken. Except for “AmOx”, all the treatments caused modest color changes ($\Delta E^* = 2.0$ – 3.5), in all cases below the threshold commonly accepted for conservation treatments ($\Delta E^* = 5$ [51]). In particular, the phosphate treatments involving low DAP concentrations (“EtOH”, “IPA” and also “AIP”) caused some increase in lightness (ΔL^* ranging from 1.9 to 2.8, Table S2) and minor decreases in the a^* and b^* parameters (ranging from –0.3 to –0.6, Table S2). On the contrary, the formulations involving higher DAP concentrations (“1 M”, “ CaCl_2 ” and “3 M”) caused some *decreases* in lightness (ΔL^* ranging from –1.8 to –3.3, Table S2) and some *increases* in

Unlike UPV and WA, the color measurements during field exposure did not show a clear progressive trend (Fig. 11). After 16 months, all the specimens exhibited a strong *increase* in L^* (whitening), while after 32 months L^* strongly *decreased* (darkening), thus inverting the previous trend. Such unintuitive behavior is likely due to specimen pre-conditioning before the measurement, rather than to field exposure. In fact, the first pre-conditioning in oven likely caused some microcrack formation, with a consequent change in the scattering of light and apparent whitening. When the measurement was repeated after 32 months, pre-conditioning at the same temperature did not cause

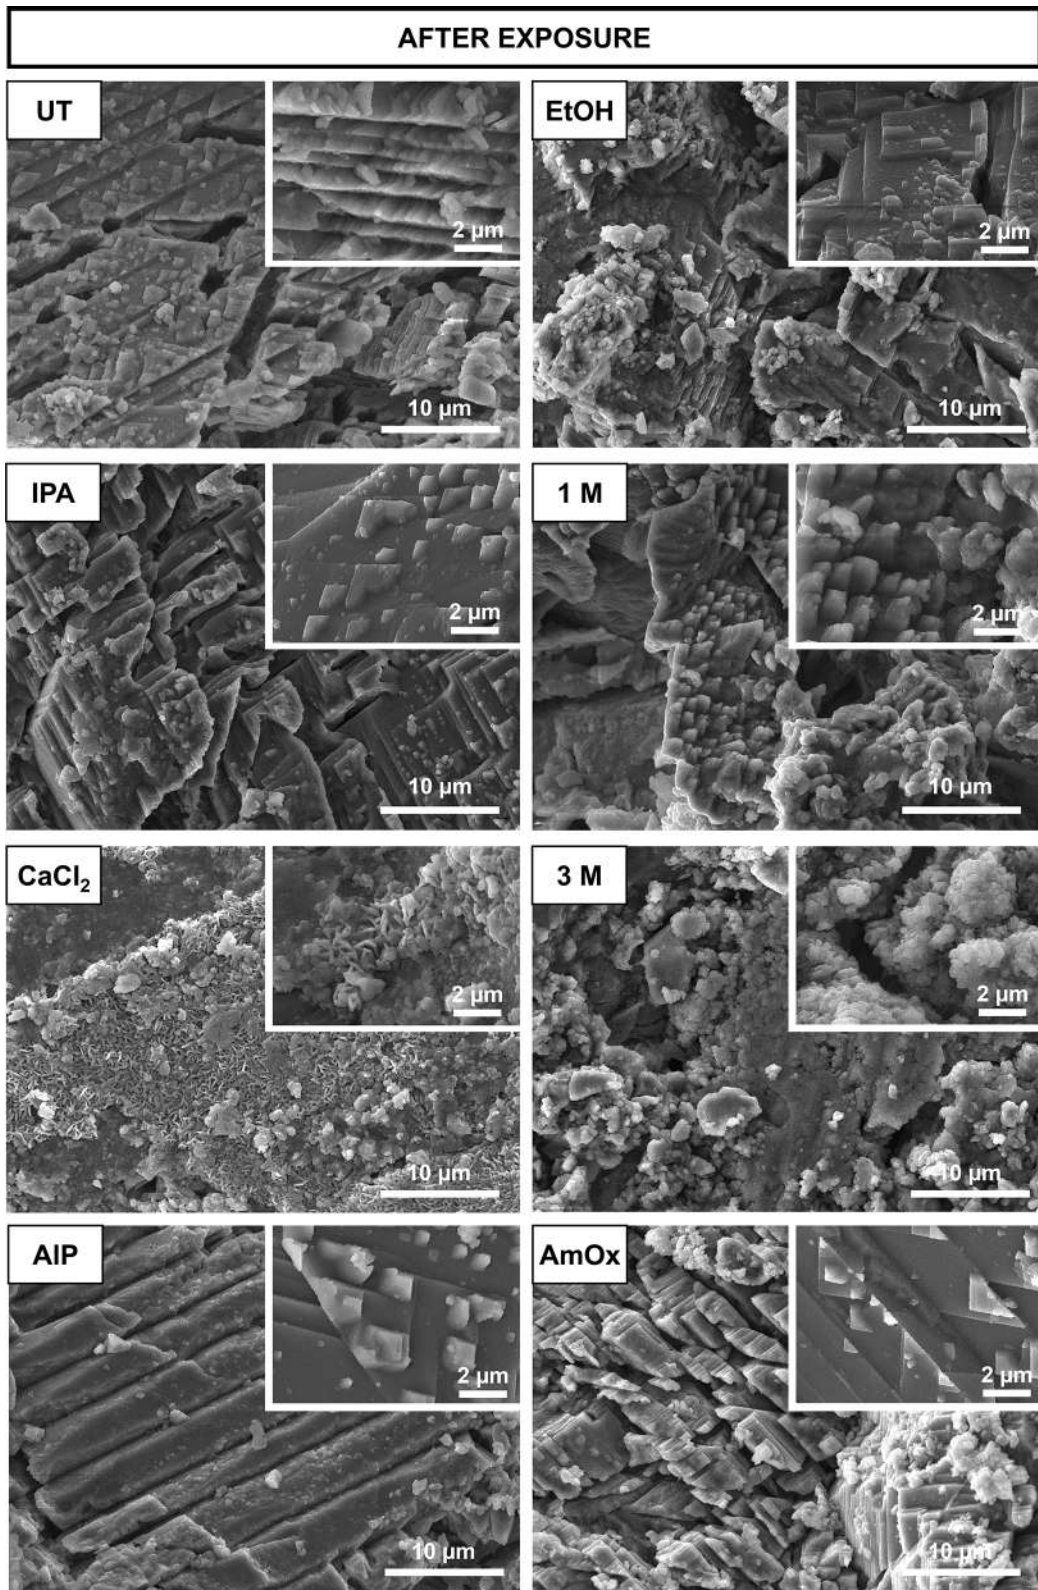
◀ **Fig. 12** SEM images of untreated and treated specimens, after field exposure

According to UPV measurements, SEM observations performed after 32 months (Fig. 12) revealed etching of the marble surface not only in the untreated reference, but also in the “EtOH”, “IPA”, “1 M”, “AIP” and “AmOx” specimens, which indicates significant damage and removal of the new consolidating phases in these specimens. The detachment of the consolidating phases was likely triggered by some discontinuity in the new coatings covering the calcite grains, as a consequence of some defect originally present in the coating and/or the action of environmental weathering processes. Once the detachment of the coatings had started from these weak areas, the combined action of rainwater and thermal stress likely led to the removal of the consolidating phases. Consistently, FT-IR analysis of the “EtOH”, “IPA”

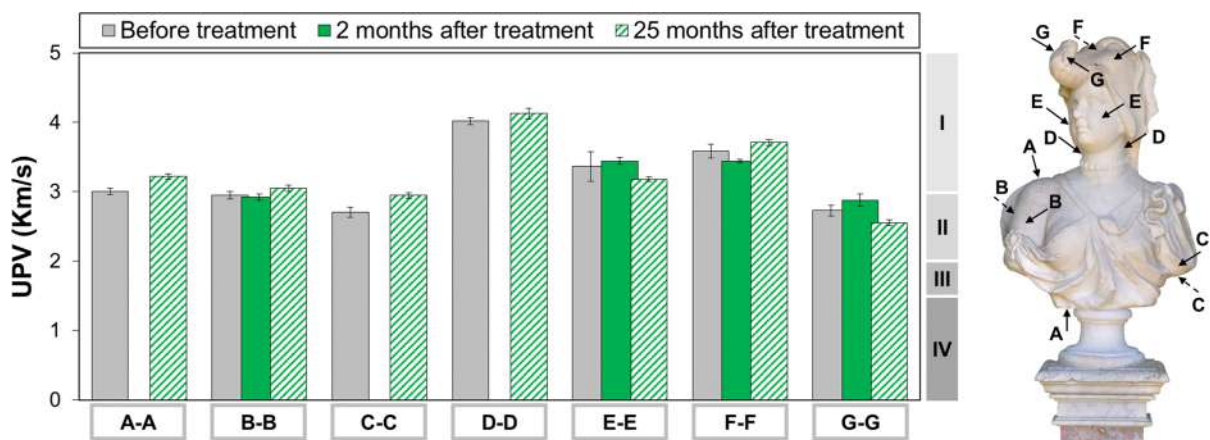
Fig. 13 UPV values measured on the bust in the positions indicated on the right, before (solid gray bars), 2 months after treatment (solid green bars) and 25 months after treatment (hatched bars). Bars on the right indicate the categories (I–IV) of

marble deterioration according to the classification proposed by Köhler [45]. Values are averages for 2 measurements (bars indicate the difference between the average and the maximum/minimum values). (Color figure online)

Before treatment, UPV ranged between 2.7 and 4 km/s (Fig. 13, solid gray bars), thus between the conditions of “increasing porosity” and “crumbling surface” proposed by Köhler [45]. Such low UPV values are not surprising, considering that the sculpture has been exposed outdoors for more than three centuries. The lowest values were measured in the left arm (point C–C) and in the elephant nose (point G–G), hence in thin elements that are usually more prone to thermal

Two months after application of the “CaCl₂” treatment, the UPV increases (Fig. 13, solid green bars) were sensibly lower than those measured in the prismatic specimens after the same treatment. In fact, UPV improvements by + 19% were registered in the specimens (Fig. 6), whereas a maximum UPV increase of + 6% was found in the bust, specifically in the elephant nose (point G–G, Fig. 13). This difference is thought to be due to the treatment penetration depth, which based on previous studies can be estimated as 10–20 mm [15, 16]. In the specimens (30 mm thick), consolidation of the first 10–20 mm from the treated surface led to a high UPV increase, as the consolidated layer was about 1/3–2/3 of the path travelled by the ultrasonic pulse. In the sculpture, where the path of the ultrasonic pulse was generally much higher than 30 mm, an analogous 10–20 mm thick consolidated layer had a much lower influence on the measured UPV. A similar effect occurs when UPV is used to evaluate the weathering condition of marble elements in the field, as the shorter the travelling path of the ultrasonic pulse, the higher the reduction in UPV caused by surface damage [56]. In some of the measuring points (B–B and F–F), slight UPV decreases by 1–4% were found, which seems likely due to the measurement reproducibility in the field, rather than to actual deterioration occurred after just 2 months of field exposure.

After 25 months, the UPV values reported in Fig. 13 (sparsely hatched bars) were registered. All the points that could not be measured right after treatment but were measured after 25 months exhibited slightly higher UPV than before treatment, with increases between $+3$ and $+9\%$ (the maximum being registered in the most decayed part, point C–C). In the points already characterized after treatment, some UPV increases (points B–B and F–F) and some UPV decreases (points E–E and G–G) were registered. Considering all the tested points, it can be concluded that after 25 months the phosphate treatment generally

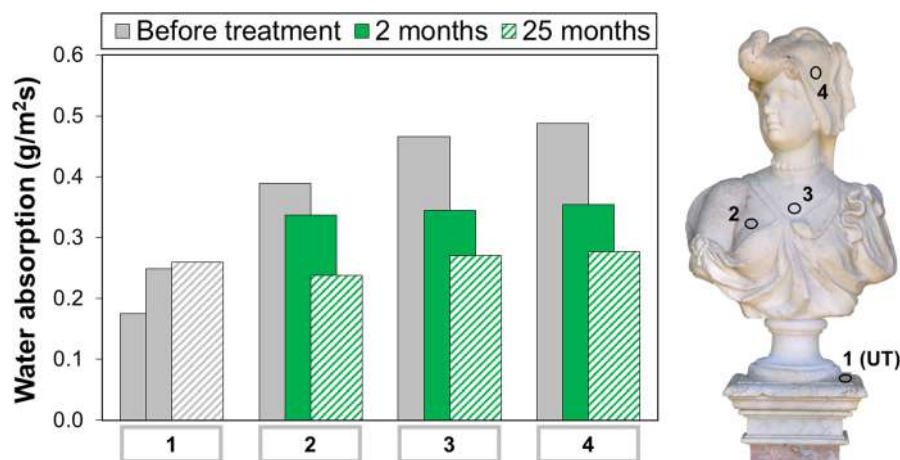
Fig. 14 Water absorption measured on the bust in the positions indicated on the right, before (solid gray bars), 2 months after treatment (solid colored bars) and 25 months after treatment (hatched bars). The position 1 was left untreated and used as reference. (Color figure online)

After treatment, water absorption reductions ranging from -13 to -27% were registered in all the measuring points (Fig. 14), in line with the WA reduction found in the specimens after the same treatment (-37% , Fig. 10). This confirms the compatibility of the “CaCl₂” treatment, which causes some reduction in WA without complete pore occlusion. Point 1 in the pedestal (Fig. 14), which was left untreated and used as reference, actually exhibited a slight *increase* in WA, likely because cleaning of this area right before the WA and color measurements exposed the stone surface.

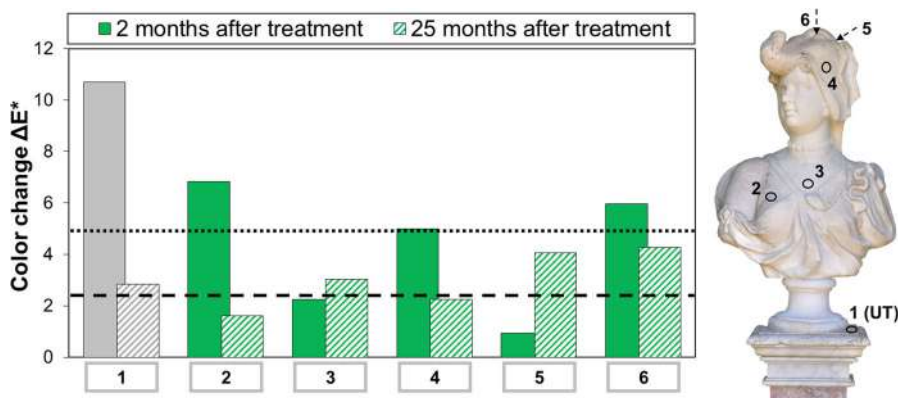
Fig. 15 Color change measured on the bust in the positions indicated on the right, 2 months (solid bars) and 25 months after treatment (hatched bars). The dashed line ($\Delta E^* = 2.3$) indicates the threshold of detectability by the human eye [50], while the

dotted line ($\Delta E^* = 5$) indicates the common acceptability threshold [51]. The position 1 was left untreated and used as reference
