An experimental study of the bond behavior of twisted steel bars embedded in mortar cylinders and in the joints of masonry wallettes

An experimental study of the bond behavior of twisted steel bars embedded in mortar cylinders and in the joints of masonry wallettes / Gentilini C.; Finelli F.; Carloni C.. - In: CONSTRUCTION AND BUILDING MATERIALS. - ISSN 0950-0618. - ELETTRONICO. - 316:(2022), pp. 125795.1-125795.17. [10.1016/j.conbuildmat.2021.125795]

AN EXPERIMENTAL STUDY OF THE BOND BEHAVIOR OF TWISTED STEEL BARS EMBEDDED IN MORTAR CYLINDERS AND IN THE JOINTS OF MASONRY WALLETTES

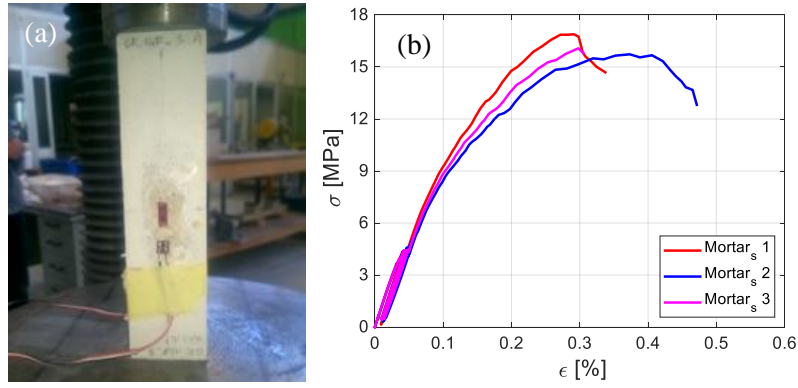
Figure 1. Mechanical characterization of mortar_s: (a) compression test to determine the elastic modulus, and (b) stress-strain curves.

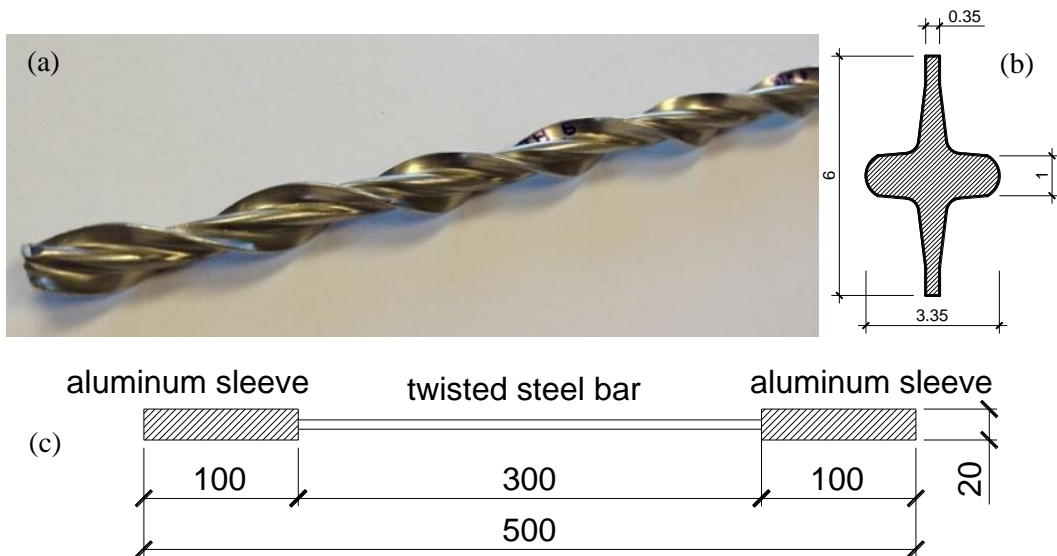
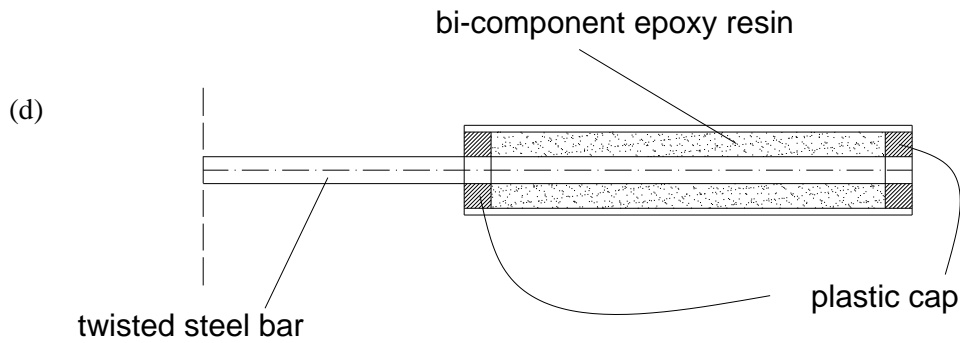
Figure 2. a) Photo of the twisted steel bar, b) cross-section of the helical-shape bar, c) specimen dimensions for the tensile test, and d) detail of the anchoring system for the tensile test. (Dimensions in mm).

The bars used for repointing were made of high-strength steel (AISI 316) and had a helical shape to improve adhesion (Figure 2a). The bars were formed from a circular steel wire, which was cold worked to obtain the cross-sectional shape shown in Figure 2b. Afterwards, the bars were twisted while applying a tension force to reach the final helical shape. Nominal diameter, ϕ , and cross-sectional area, A , were equal to 6 mm and 8 mm², respectively. Steel bars were tested to determine Young's modulus, E , and tensile strength, f_t .

Preliminary tests indicated that direct gripping of the helical bars would have damaged the bars and compromised the tension test results. Thus, to avoid undesired failure modes of the bars tested in tension, aluminum hollow cylinders were epoxy-glued at each end of the bars. The length of the cylinders (or sleeves) were determined through preliminary tests, and it was found that a length of 100 mm was sufficient to run the tension tests of the bars up to failure (Figure 2c). The bars were inserted into the sleeves, which were filled with a thixotropic bi-component epoxy resin and left to cure for at least 24 hours. The bars were placed concentrically in the pipes, plastic caps with a hole to insert the bar were applied at both end of each sleeve (Figure 2d). The total length of the bars was 500 mm, with a free length of 300 mm. A 100 kN universal testing machine was used for the tests and the load was applied at a constant stroke rate of 2 mm/min until failure of the specimen occurred. Three specimens, out of eleven bars tested, were equipped with a 100 mm-gauge length extensometer placed in the central portion of the bar to measure the elongation and determine Young's modulus (Figure 3a). To check if the gripping system (aluminum cylinders) could affect the test results, the location along the bar where rupture occurred was observed and reported (Figure 3b). The average tensile strength resulted equal to 1226 MPa (CoV=2%), while the average elastic modulus based on three tests was equal to 143 GPa (CoV=7%). Figure 3c shows the stress-strain curves for the three bars equipped with extensometer. After an initial linear-elastic branch, the bars exhibited a nonlinear behaviour followed by an almost-horizontal branch until tensile failure occurred.

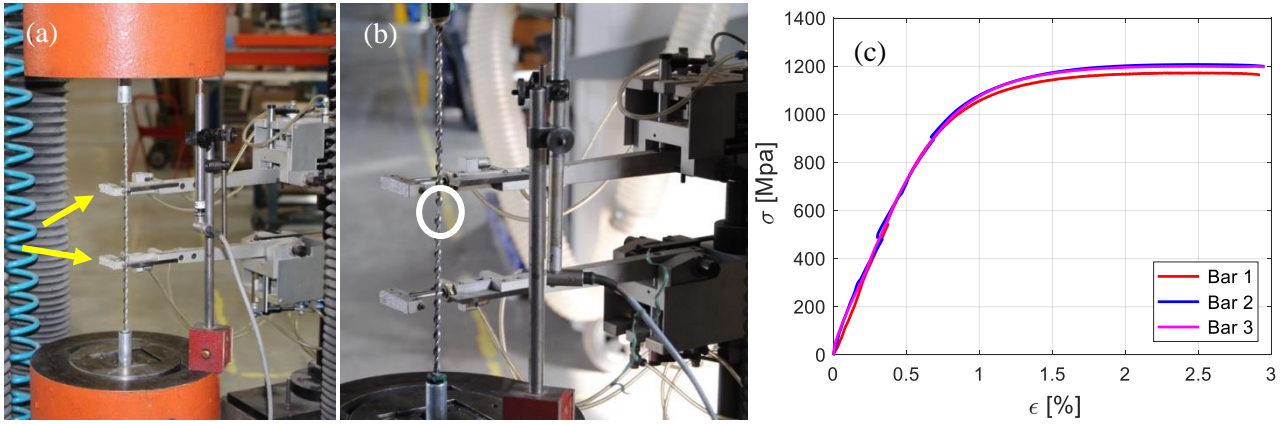
Figure 3. Mechanical characterization of twisted (helical shaped) steel bars: a) bar at the beginning of the tensile test (the extensometer employed to measure the bar length variation is indicated with yellow arrows), b) bar at the end (failure) of the test, and c) stress-strain curves.

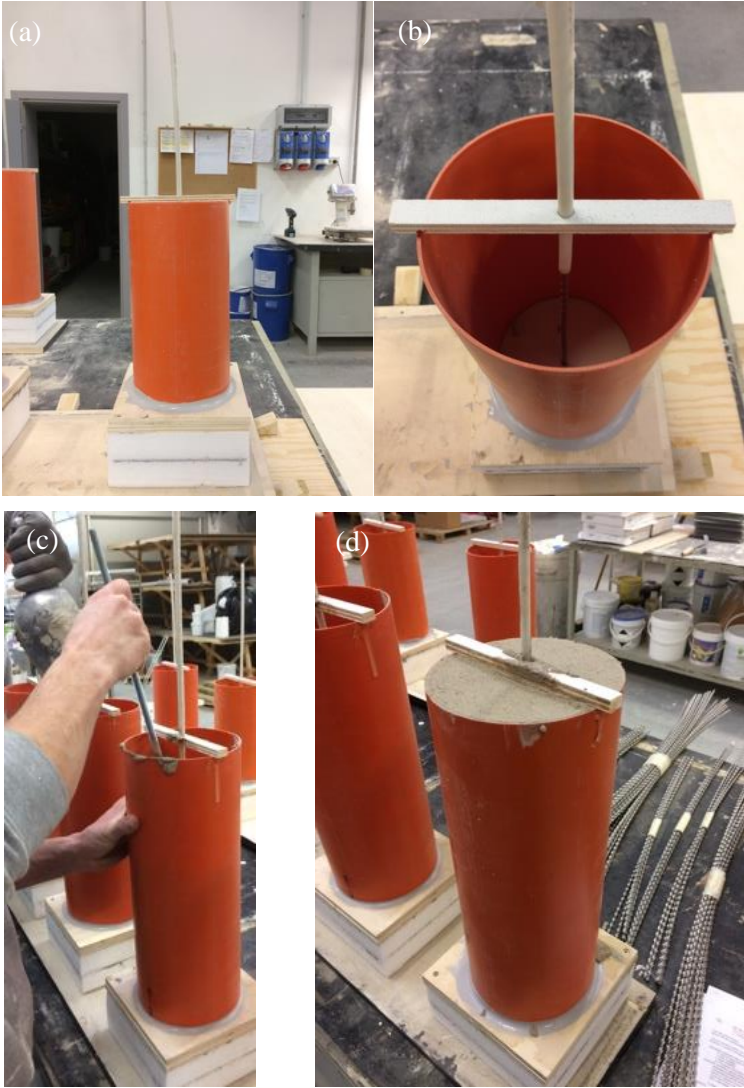
Figure 4. Construction phases of the cylindrical specimens: a) and b) the bar is positioned concentrically in the cylinder mold, a plastic tube is used to create a bond break of length equal to 50 mm from the top face of cylinder, c) mortar_s is manually rodded in order to avoid the formation of large voids, and d) the cylinders are left to cure in lab conditions.

Mortar cylinders of nominal diameter equal to 150 mm were cast with mortar_s and twisted steel bars of different lengths were embedded concentrically. PVC tubes were used as molds (Figure 4a). A length of 50 mm from the top of the cylinder was left unbonded, such that during the pull-out, failure was given to the bar pull-out and not to an incorrect tensile failure of the mortar cylinder [33, 34]. Plastic pipes were used to create the bond break (Figure 4b) and in order to avoid the formation of voids, the compaction of the fresh mortar was carried out manually with a rod (Figure 4c). The bonded length of the bar is named L_B in the remainder of the paper. The bar extended 300 mm and 100 mm from the top and bottom ends of the cylinders, respectively. Cylindrical specimens with different bonded lengths L_B , namely 150, 250, 350, 450, and 700 mm, were cast. The total height of those cylinders was 50 mm longer than the corresponding bonded length because of the additional unbonded length. Three specimens for each bonded length were constructed, which correspond to 15 cylinders in total (Figure 4d). Specimens were cured in laboratory conditions for two months under a polyethylene sheet. At the end of the two months, prior to testing an aluminum sleeve was installed at the end of the bar to improve gripping by the machine jaws. The sleeves were the same as the ones used in the direct tensile tests. They were 100 mm long, 2 mm thick, and were filled with epoxy. Specimens were named C-X-Z, where C stands for cylindrical, X is the bonded length L_B , and Z is the specimen number. A sketch of the geometry of cylindrical specimens C- L_B with a generic bonded length L_B is shown in Figure 5.

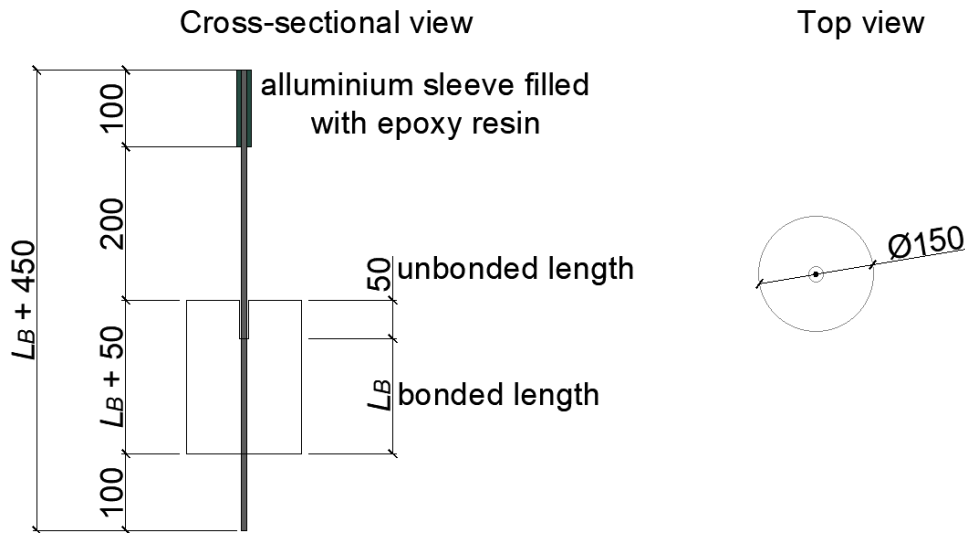
Figure 5. Sketch of a cylinder with a bar embedded for a length L_B : on the left, longitudinal section and on the right, top view. (Dimensions in mm).

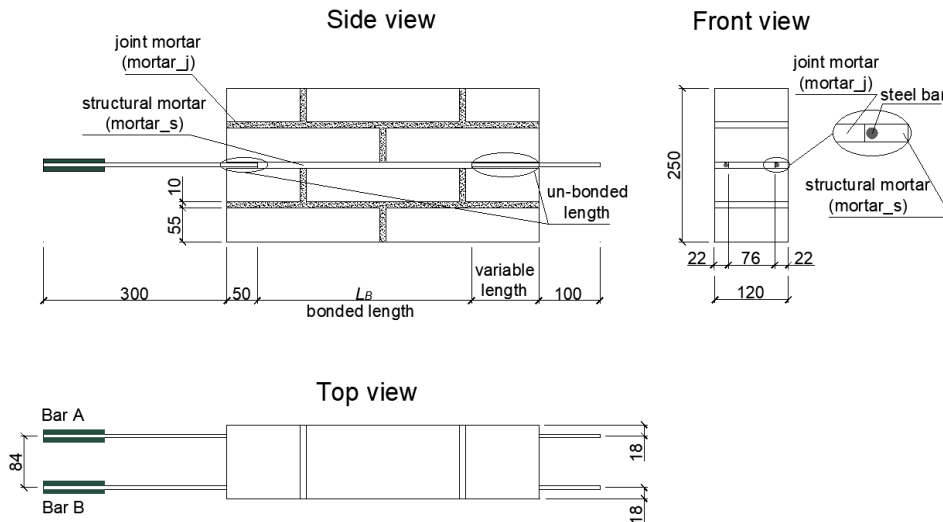
Figure 7. Sketch of a masonry wallette with two bars embedded for a length L_B in central bed joint.
(Dimensions in mm).

1
2 installed at the end of each bar. Masonry specimens were named W-X-ZY, where W stands for masonry
3
4 wallette, X is the bonded length L_B , Z is the specimen number, and Y stands for A or B depending on which
5
6 of the two bars inserted in the specimen was tested. Figure 7 shows a sketch of a masonry specimen (W- L_B)
7
8 with two bars bonded for a length L_B in the central bed joint.
9
10

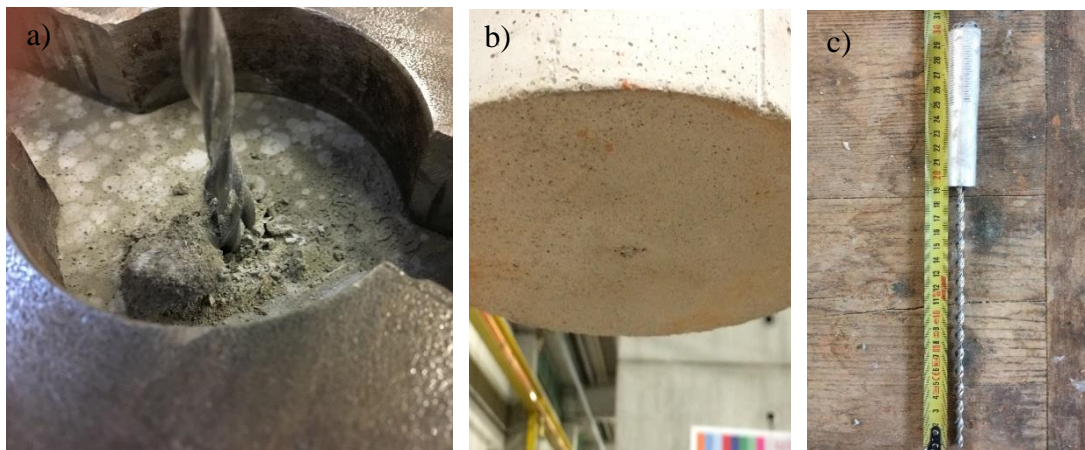
25
26
27
28
29
30
31
32
33
34
35
36
37
38
39
40
41 Figure 10. (a) Top; (b) bottom view of a representative cylindrical specimen at the end of the test; (c) tensile
42 rupture of the bar that attained for cylinders with $L_B = 700$ mm.
43
44
45

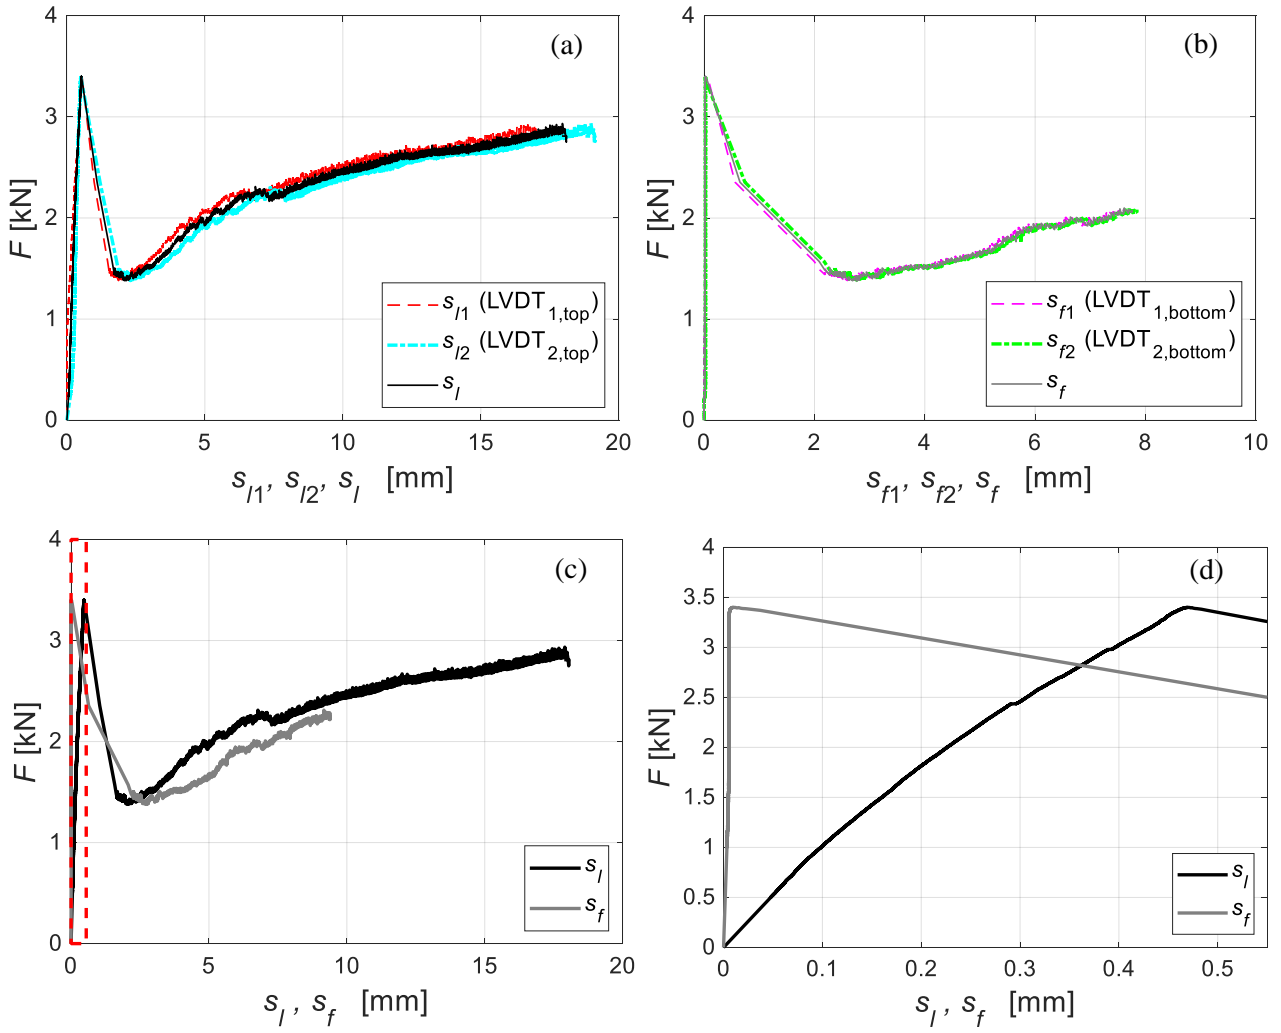
Figure 11. Load-slip curves of a representative cylindrical specimen (C-150-1, $L_B = 150$ mm): (a) $F - s_l$, $F - s_{l1}$ and $F - s_{l2}$ curves, (b) $F - s_f$, $F - s_{f1}$ and $F - s_{f2}$ curves, (c) $F - s_l$ and $F - s_f$ curves and (d) call-out of the $F - s_l$ and $F - s_f$ curves at the beginning of the test.

11 pulled out without any significant bending. In Figure 11c, the two average curves $F-s_l$ and $F-s_f$ are compared.
12
13
14
15
16
17
18
19
20
21
22
23
24

46 Referring to Figure 11c, three main branches can be distinguished in the $F - s_l$ curve: 1) an initial pseudo-
47 linear portion for low load values followed by a non-linear branch until the peak load F_m is reached; 2) a load
48 drop branch; and 3) an ascending almost-linear branch until the end of the test. In the first branch, the free-end
49 slip is different from zero, although the values are very small, for the majority of the branch, as shown in the
50 call-out (Figure 11d). In the third branch, the free-end slip increases almost linearly like s_l but with a lower
51 rate.
52
53
54
55
56
57
58
59
60
61
62
63
64
65

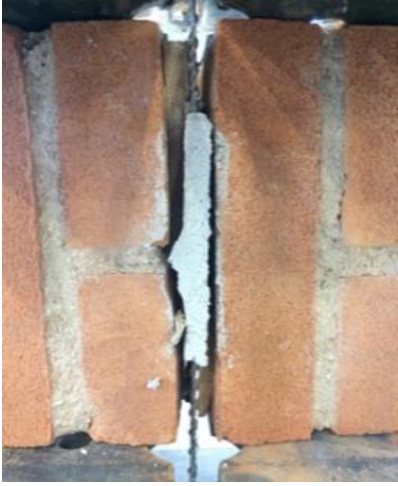
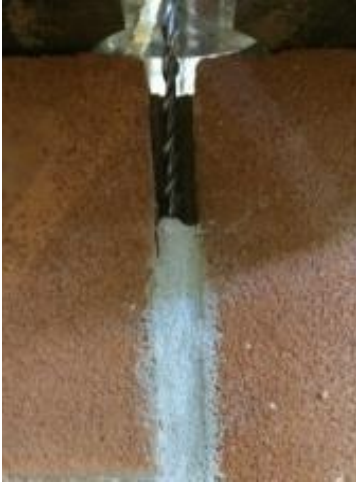
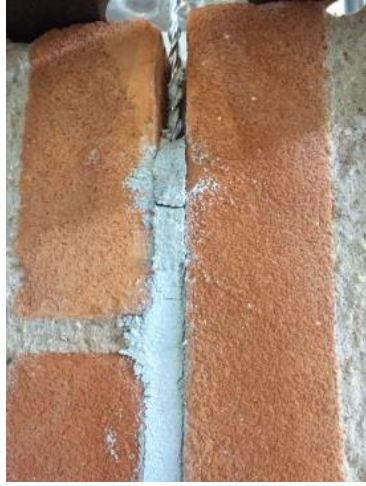
Failure mode A:
splitting of the masonry
wallette

Failure mode B:
bar pull-out

Failure mode B*:
bar pull-out with local
fracture of the mortar

Figure 13. Failure modes of the masonry specimens.

Two main different failure modes were observed during the tests on the masonry wallettes and are reported in Figure 13. In 8 tests, the mortar joint, where the bar was embedded, detached from the bricks as the bar was pulled out (Type A in Figure 13), which resulted in the splitting of the masonry wallette. The detachment of the mortar from the bricks occurred at the actual interfacial surface between mortar and brick with no mortar left attached to the brick. For those 8 specimens, it was not possible to test the second bar. Pull-out of the bar without detachment of the mortar joints occurred in the remaining 11 specimens (Type B in Figure 13). However, it should be noted that fracture of the mortar in the transversal direction near the loaded end (regardless of whether the mortar joint detached from the brick) was observed in 13 tests. This additional phenomenon was accounted for by adding an asterisk next to the failure mode, i.e. A* or B* depending on whether it occurred prior to failure A or B. Figure 13 reports, as an example, a B* failure. Only in two cases, the splitting of the specimen occurred with transversal fracture of the mortar (A* failure mode) at the loaded end. The bonded length seems to have small influence on the failure mode of the specimens, since failures A, A*, B, and B* were observed for both short and long bonded lengths and a no clear trend could be pointed out,

1 although it should be noted that failure modes B and B* occurred more frequently for the longest bonded
2 lengths.
