Review Article

Fracture of Ceramic Bearing Surfaces following Total Hip Replacement: A Systematic Review

Francesco Traina,¹ Marcello De Fine,¹ Alberto Di Martino,^{1,2} and Cesare Faldini¹

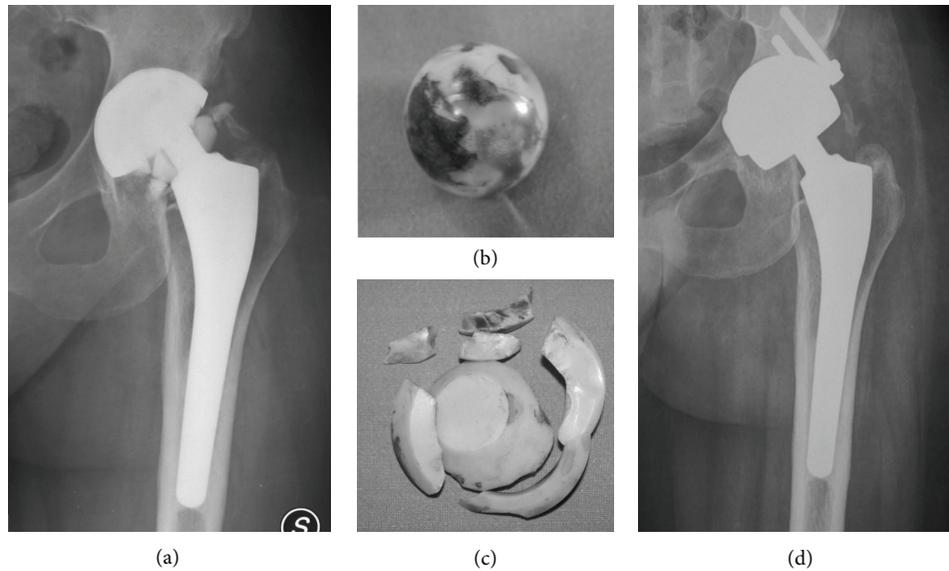
FIGURE 1: (a) Preoperative radiograph showing catastrophic failure of a ceramic liner. (b) The retrieved ceramic head grossly damaged because of contact with metal back. (c) The retrieved ceramic liner. (d) Postoperative radiograph after cup revision and bearing surfaces exchange to metal on metal coupling.

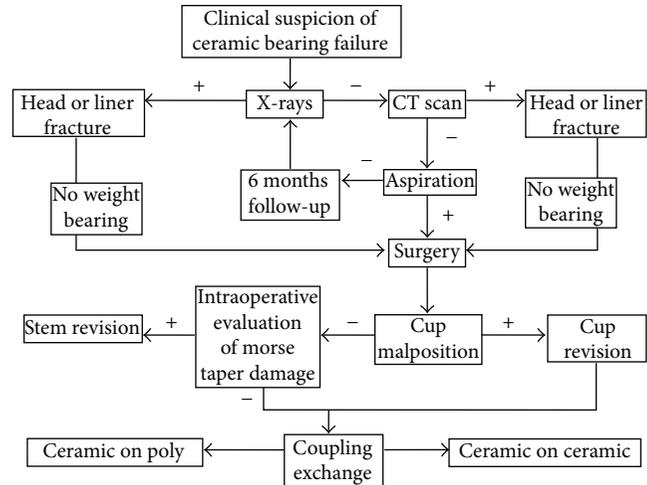
FIGURE 3: Algorithm with guidelines for the diagnosis and treatment of fractured ceramic bearings following THR.

When addressing the suspicion of a rupture of ceramic components of hip arthroplasty (Figure 3), the first diagnostic step is as usual the performance of standard X-rays; in most cases an adjunctive CT scan is required to refine the diagnosis and better characterize the mutual relationship between the cup and the stem. Current knowledge consider the use of short neck 28 mm heads as the only factor that significantly affects the risk of ceramic head fracture, and malposition of the cup on the axial plane and misalignment of the liner during insertion as the only two relevant factors affecting the risk of liner fractures. Synovial fluid microanalysis seems to be a valuable tool for early diagnosis of ceramic liner fracture and the presence of a noisy hip following THR should raise the suspicion of liner fractures; however, data

on synovial fluid aspiration reliability should be confirmed on larger cohorts of patients. Once the diagnosis of ceramic component fracture is done, revision surgery is required. It is not possible to draw definitive conclusions about the best treatment strategy, however during revision surgery an extensive synovectomy and thorough irrigation of the articular space are mandatory, while COC or COP couplings are both considered as viable options to reduce the risk of third body wear of revised implants.
