Effects of rising damp and salt crystallization cycles in FRCM-masonry interfacial debonding: Towards an accelerated laboratory test method

Franzoni, E., Gentilini, C., Santandrea, M., Carloni, C. (2018). Effects of rising damp and salt crystallization cycles in FRCM-masonry interfacial debonding: Towards an accelerated laboratory test method. CONSTRUCTION AND BUILDING MATERIALS, 175, 225-238 [10.1016/j.conbuildmat.2018.04.164].

Effects of rising damp and salt crystallization cycles in FRCM-masonry interfacial debonding: towards an accelerated laboratory test method

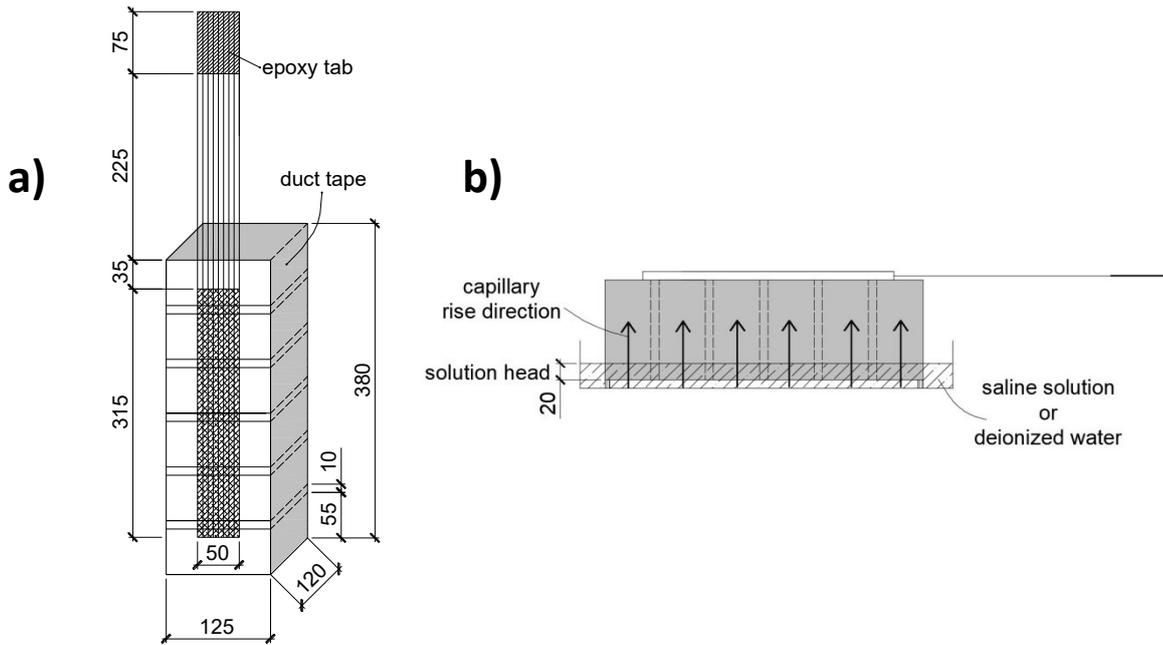
Fig. 1. a) Geometry of the steel FRCM-masonry joints and b) capillary rise direction of the saline solution (mixture of sodium chloride and sodium sulfate) or deionized water. Dimensions in mm.

Nineteen masonry blocks were manufactured with six half-bricks joined by five 10 mm-thick mortar layers (Fig. 1a). The nominal dimensions of the blocks were 125 mm × 120 mm × 380 mm.

The final configuration of the steel FRCM-masonry joints is reported in Fig. 1a.

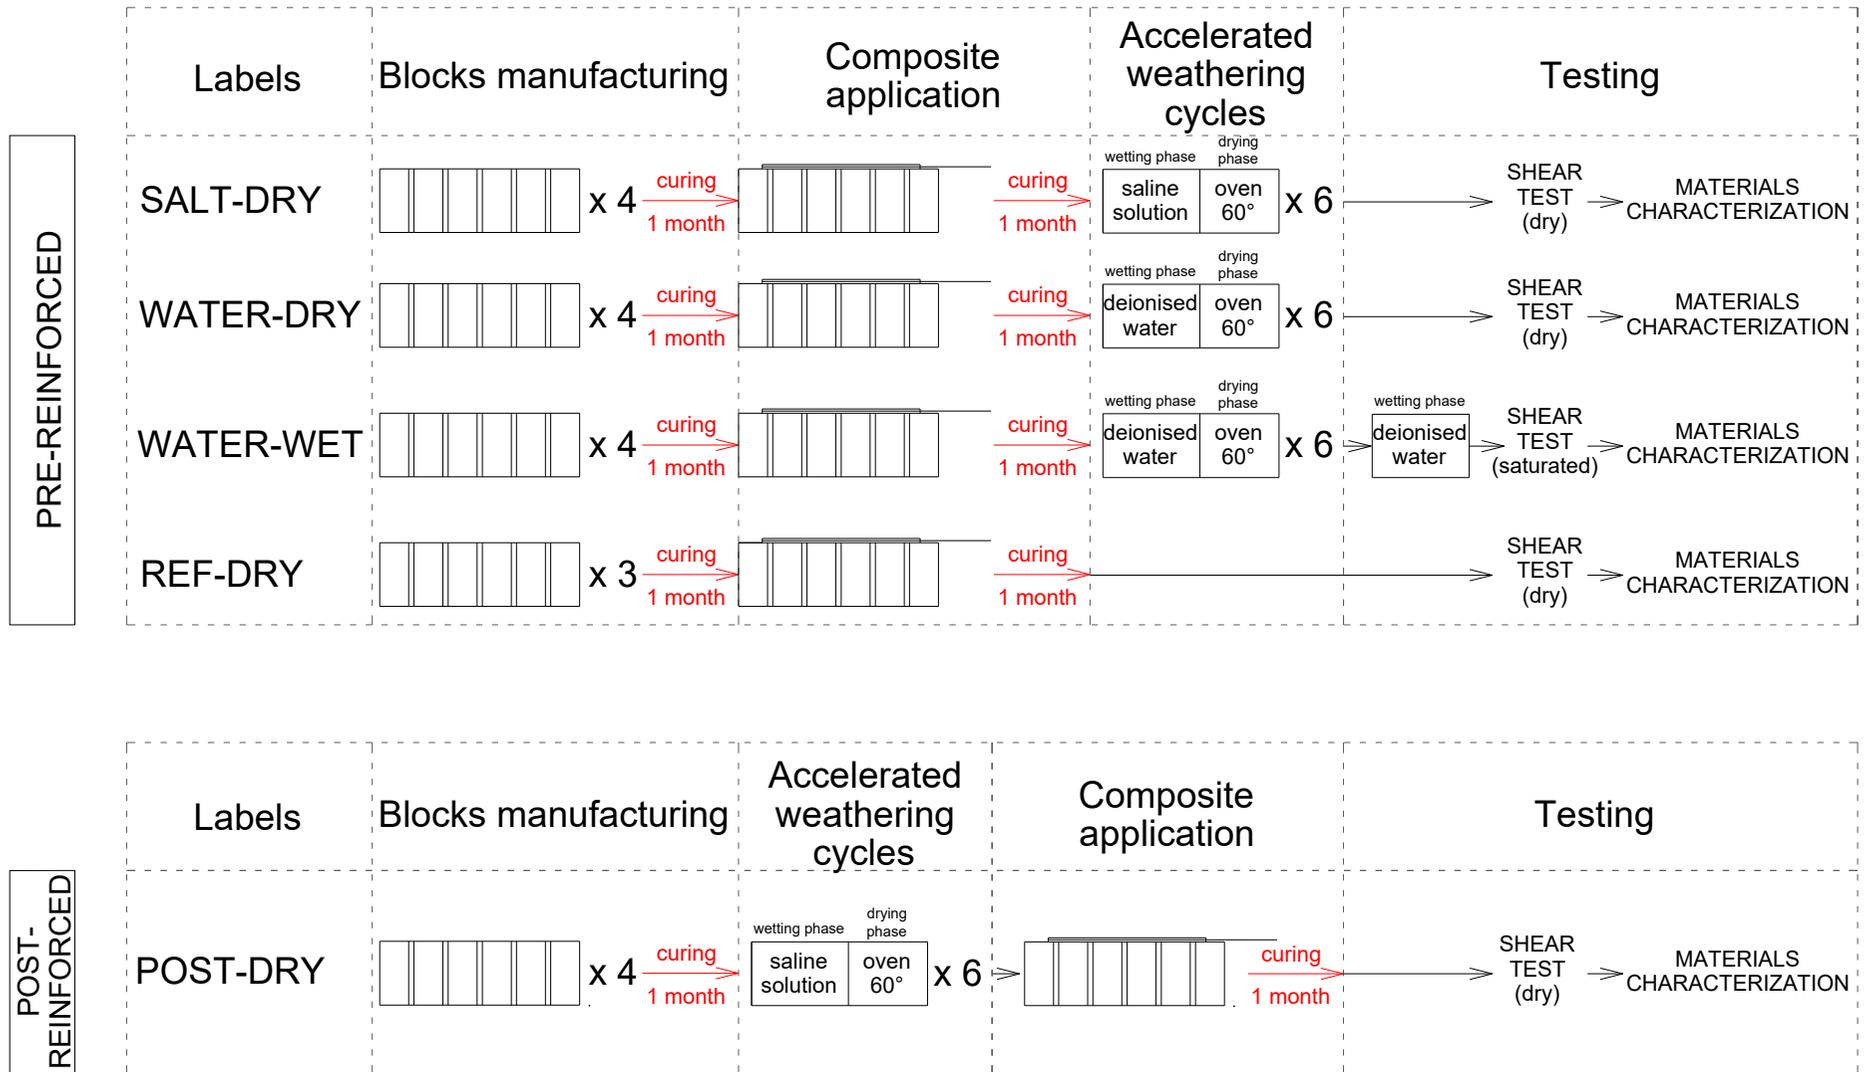
Fig. 2. Scheme of the FRCM-masonry joint labels, construction, composite application, weathering cycles, and material testing.

Figure 2 shows a scheme of the specimen labels, construction, composite application, conditioning procedures, as well all testing conditions.

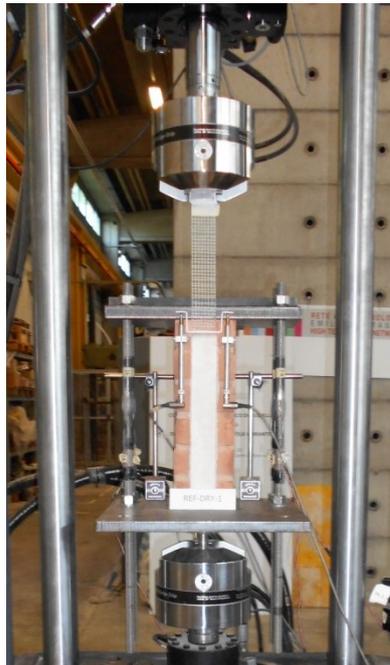
Fig. 3. Experimental test set-up: FRCM-masonry joint at the beginning of the direct shear test. Two vertical LVDTs are employed to measure the relative displacement between the composite strip and the adjacent masonry surface.

the adjacent masonry surface. The displacements measured by the LVDTs are indicated as g_a and g_b . The global slip g is the average of these two measurements;

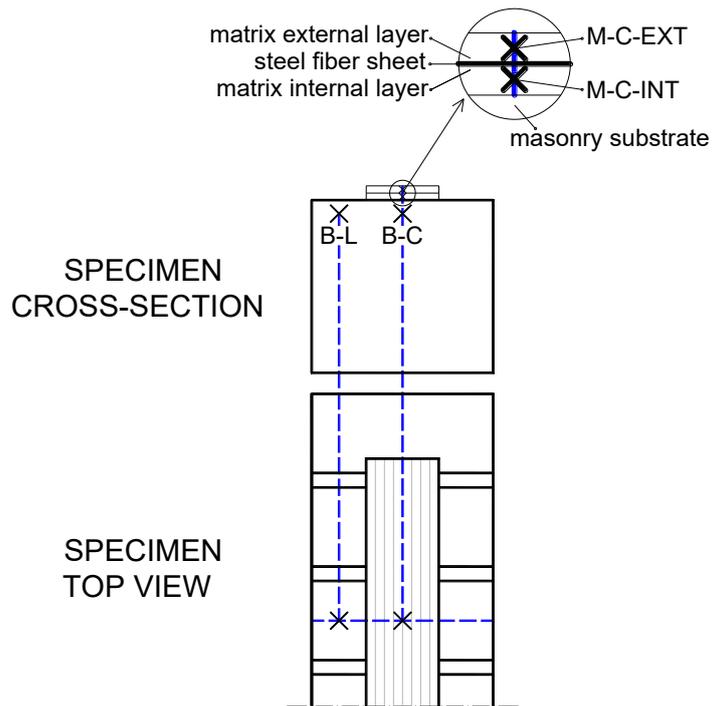
Fig. 4. Sampling location for material characterization (M = matrix, B = brick, L = lateral sampling location, C = central sampling location, EXT = external layer, INT = internal layer).

correspond, respectively, to the center and edge of the FRCM strip. The locations were chosen to investigate if the composite might have caused an undesired accumulation of salts in the brick region beneath the composite itself, which could possibly lead to the composite detachment. Moreover, samples of the composite matrix were collected from the internal layer of the matrix, i.e. underneath the fibers (M-C-INT), and from the external layer, i.e. above the fibers (M-C-EXT), in order to check if the steel fiber sheet itself created a barrier to the capillary flow of the saline solution. All the fragments were collected far from the edges. Particular care was used to remove the surface efflorescence, when present.

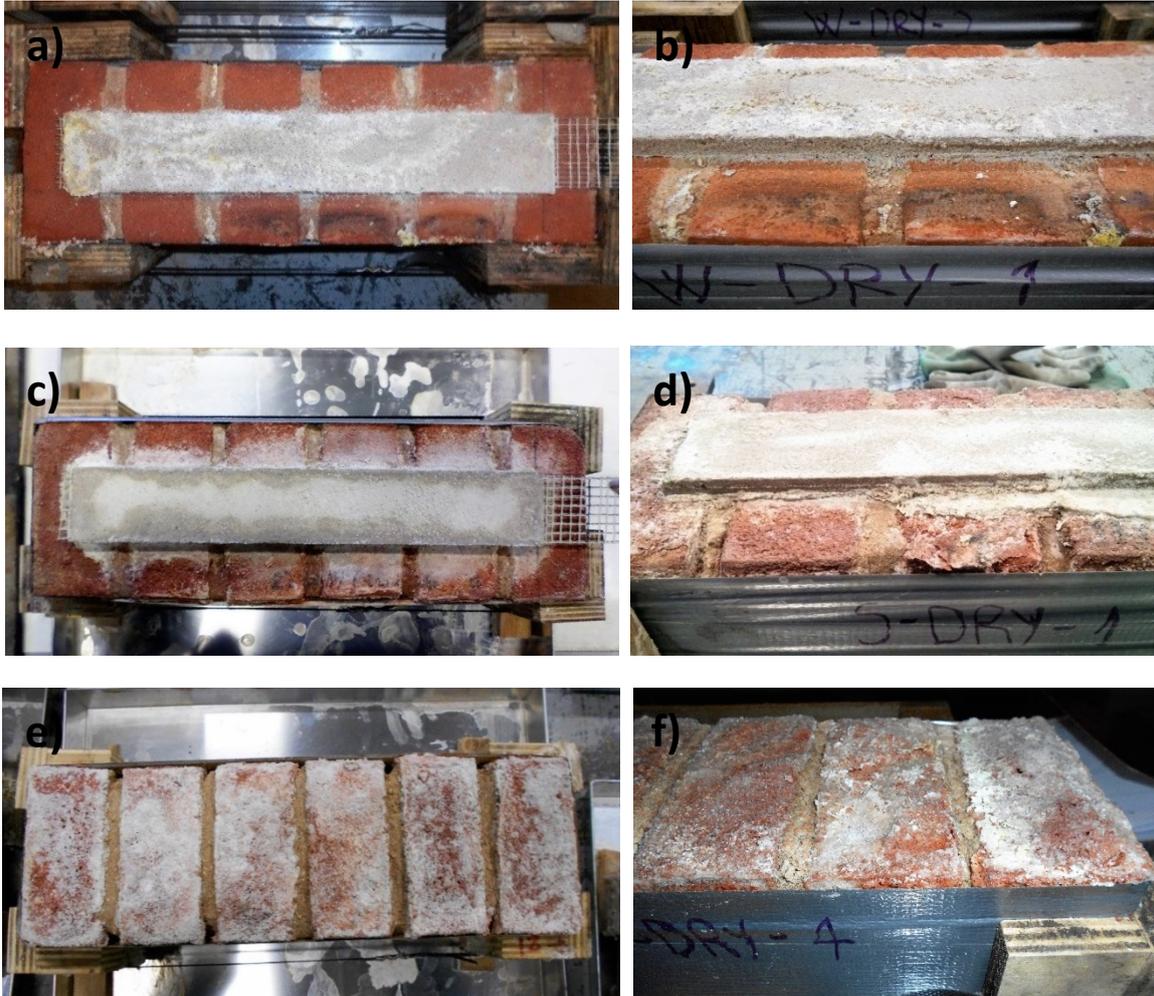
Fig. 5. Photos of selected WATER-DRY (a,b), SALT-DRY (c,d), and POST-DRY (e,f) specimens at the end of the conditioning procedure (6th cycle) and before the shear test was performed.

Figure 5 shows some selected specimens at the end of the conditioning procedure (6th cycle). Images of the WATER-WET specimens are not reported, for the sake of brevity, since they were subjected to the same cycles of the WATER-DRY specimens. WATER-DRY specimens, Fig. 5a and b, exhibit a slight formation of whitish efflorescence on the surface of the composite, while no efflorescence is visible on the bricks and a negligible amount on the mortar joints. The formation of such efflorescence has to be ascribed to salts that were already present in the original materials of the blocks and of the composite matrix, solubilized by water and transported by the capillary flow up to the top surface of the specimens.

uniform due to the presence of the strip. This phenomenon is confirmed by the efflorescence observed on the POST-DRY specimens at the end of the 6th cycle, before the composite was applied (Fig. 5e and f). When the composite is not present, efflorescence is clearly distributed over the entire top surface of the block and no preferential paths were followed by the capillary rise, hence evaporation and salt precipitation occurred uniformly over the surface. In Fig. 6a, the POST-DRY specimens after the removal of the superficial efflorescence with a steel brush and before the application of the composite are shown.

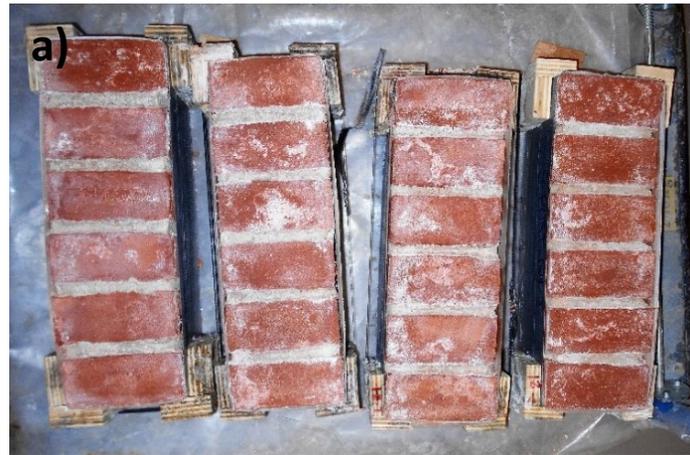
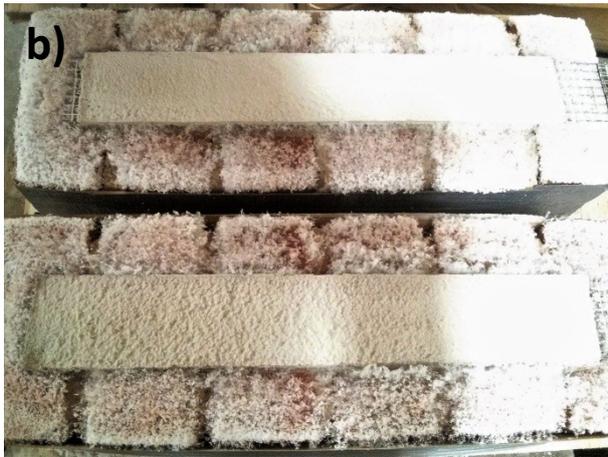
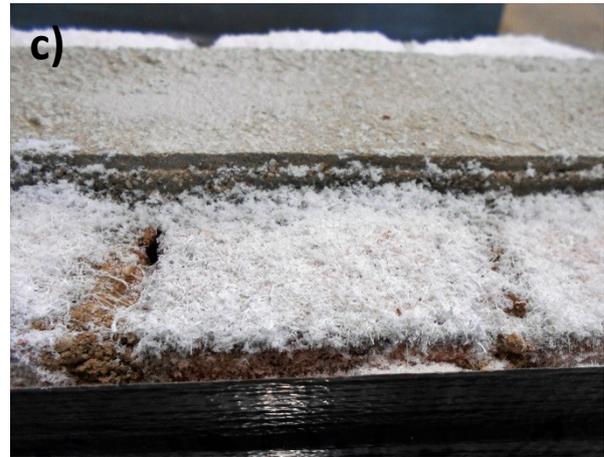
Fig. 6. Photos of selected POST-DRY specimens: a) at the end of the conditioning procedure and after removal of the superficial efflorescence with a metal brush; b) and c) after curing of the composite and before the shear test.

A completely different efflorescence distribution with respect to SALT-DRY specimens was observed in the POST-DRY specimens (Fig. 6b and c) in which the cycles were performed, then the composite was applied and cured for one month, and finally the shear test was carried out. In fact, efflorescence is distributed over the entire top surface, hence not only in the central part near and on top of the composite as in the SALT-DRY specimens (Fig. 5c and d). The curing of the composite in moist conditions (under a wet cloth), which was necessary to achieve the development of the mortar strength, seems to have caused the dissolution of the salts in the masonry blocks and their transport towards the top surface during the final drying; in this way also the composite exhibited a marked salts accumulation.

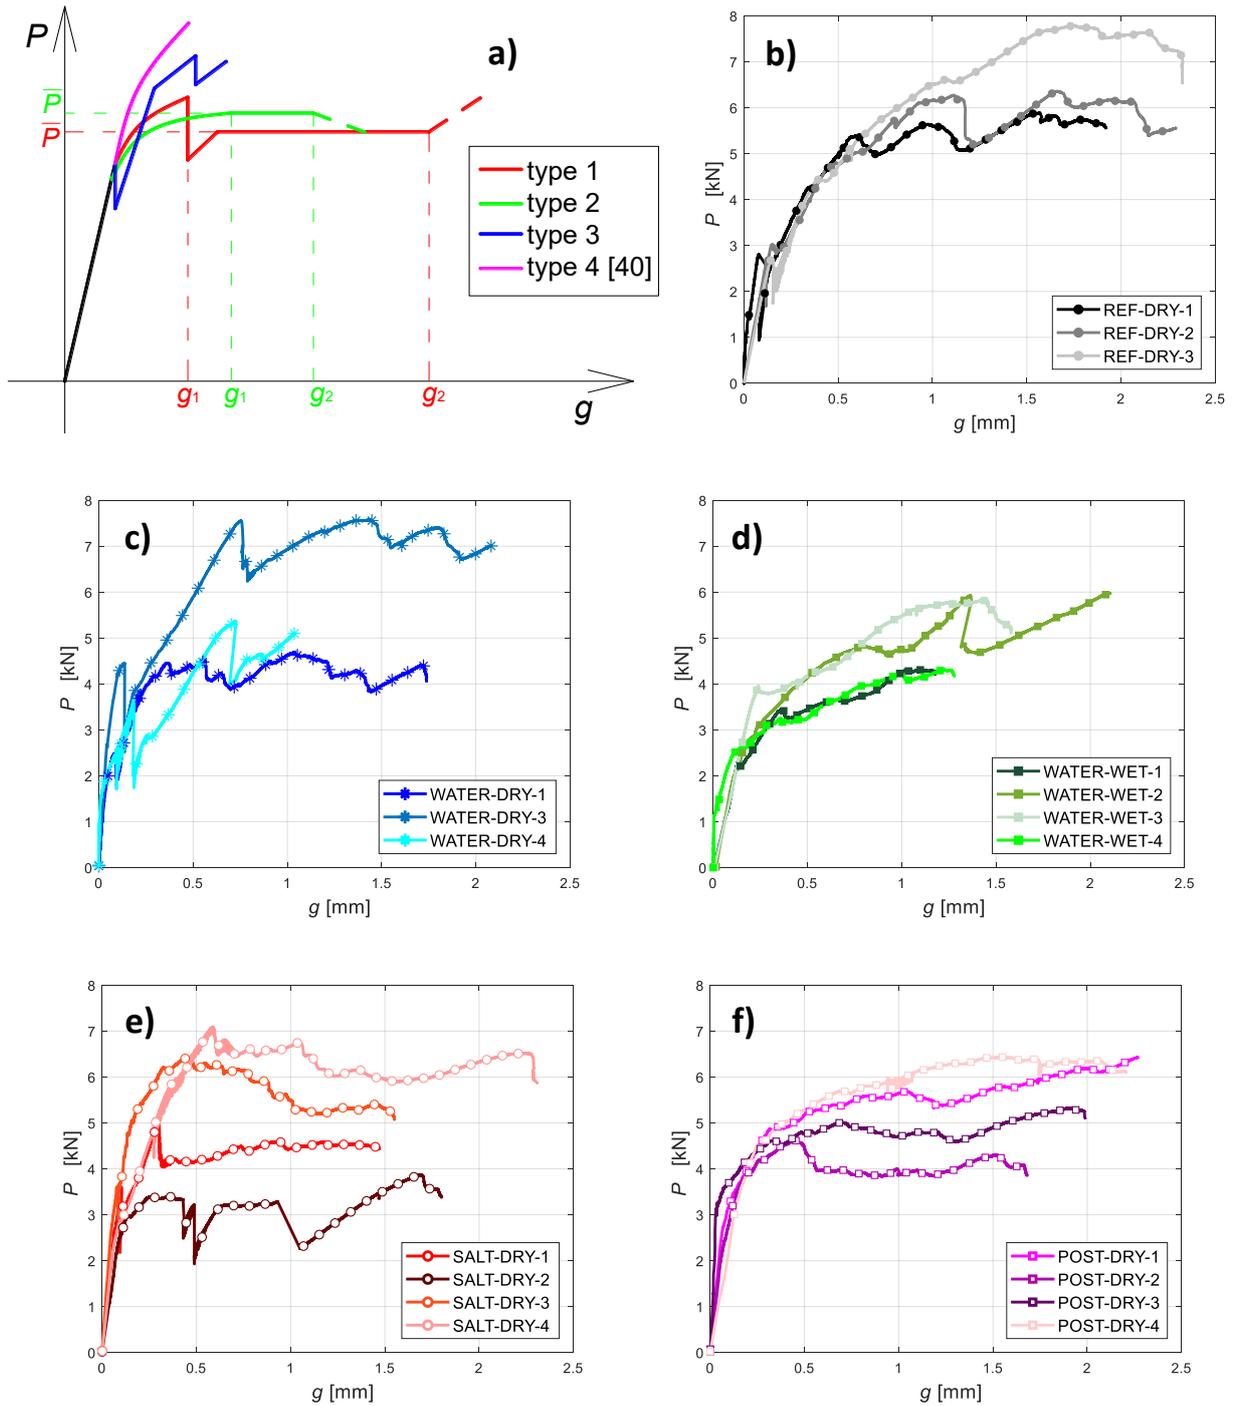
Fig. 7. a) Idealized applied load-global slip responses for FRCM-masonry joints, b) applied load-global slip curves of REF-DRY, c) applied load-global slip curves of WATER-DRY, d) applied load-global slip curves of WATER-WET, e) applied load-global slip curves of SALT-DRY, and f) applied load-global slip curves of POST-DRY specimens.

All curves show an almost linear behavior at low load values. For increasing load values, a non-linear behavior follows, which corresponds to the formation of micro-cracks in the matrix (Fig. 7a). After the linear part, the behavior of the specimens depends on several factors as described below.

The first type of curve (type 1 in Fig. 7a) is characterized by a load drop followed by an almost-horizontal branch until the end of the test. The load drop corresponds to the coalescence of the micro-cracks into a macro-crack at the interface between the two layers of matrix. The propagation of the macro-crack at the interface occurred at an almost constant load. This behavior can be identified for specimens REF-DRY-1, REF-DRY-2 (Fig. 7b), WATER-DRY-1, WATER-DRY-3, all SALT-DRY specimens, and POST-DRY-2 specimen. The global slip range (g_1, g_2) that defines the horizontal part of the curve, corresponds to the progression of the interfacial macro-crack towards the free-end of the composite (i.e., the end of the bonded area opposite to where the load was applied). The constant load, which is calculated as the average load between g_1 and g_2 , is indicated as \bar{P} and represents the debonding load, bond capacity, or load-carrying capacity. \bar{P} is reported in Table 1 for each specimen together with its average \bar{P}_{avg} for each group. Type 1 curve might feature an

A second type of curve (type 2 in Fig. 7a) is the one where the load drop is not detectable, since the load reaches smoothly an almost constant value after the linear part, i.e. without any significant drop. Specimen REF-DRY-3, all WATER-WET specimens, and specimens POST-DRY-1, POST-DRY-3, and POST-DRY-4 are characterized by this type of curve. These specimens exhibited either an interlaminar failure mode or a mixed one (failure modes A or B). In this case, the selection of the interval $g_1 - g_2$ to define \bar{P} is done by identifying the almost-horizontal part on the curve.

The type 3 curve in Fig. 7a is characterized by one or more load drops, but no nominally constant load branch (plateau) can be identified. Specimen WATER-DRY-4, for which the failure is characterized by a sudden detachment at the composite-to-substrate interface (failure mode C), exhibited a type 3 response. In this case, the debonding load \bar{P} is not defined since the $g_1 - g_2$ interval where the load is constant cannot be identified.

The last type of curve (type 4 in Fig. 7a) is characterized by an initial linear portion followed by an always ascending non-linear branch until failure that occurs when the fibers rupture. As stated before, this failure mode was not observed in any of the specimens tested.

The results of the direct shear test for the FRCM-masonry joints that cycled in water and were tested in dry conditions (WATER-DRY) are collected in Fig. 7c. Only three curves are reported: the curve relative to WATER-DRY-2 specimen was disregarded since an anomalous rotation of the specimen was noted during the test. In general, the responses show a behavior similar to the control specimens (REF-DRY). A comparison between the results of REF-DRY and WATER-DRY specimens in Table 1, indicates that the average peak load P_{avg}^* and average bond load \bar{P}_{avg} of WATER-DRY specimens show a decrease with respect to REF-DRY values (about 12% and 22%, respectively). These values appear to confirm past experimental results [24]. The wetting/drying cycles in deionized water/oven did not cause any increment in the load-carrying capacity of the WATER-DRY specimens. In fact, the FRCM-masonry joints were left to cure under a wet cloth for one month, which assured an almost complete hydration of the hydraulic fraction of the binder, hence no additional mechanical benefit was achieved by the cycles in water. The slight decrease exhibited by WATER-DRY specimens with respect to REF-DRY specimens might be ascribed to some limited spots of corrosion detected in the steel cords (see Section 4.3). However, a high coefficient of variation characterizes the results of the WATER-DRY specimens, since only the results of two specimens were used to compute the average of the load-carrying capacity. Additional tests are necessary to confirm the present results.

In Fig. 7d, the P - g curves related to the specimens that cycled in water and were tested in saturated conditions (WATER-WET) are represented. It is well known that the presence of water inside the pores of the materials causes additional pressures, which is detrimental for the mechanical properties [38]. In fact, considering the average peak load P_{avg}^* and parameter Δ^* in Table 1, WATER-WET specimens exhibit the

lowest average peak load. In particular, a 23% decrease is observed with respect to REF-DRY specimens. In addition, the average debonding load \bar{P}_{avg} was 30% lower than the average capacity of REF-DRY specimens. Figure 7e reports the response of specimens that cycled in saline solution and were tested in dry conditions (SALT-DRY). The average peak load P_{avg}^* and bond capacity \bar{P}_{avg} show a decrease with respect to the average values of REF-DRY specimens of 16% (Δ^*) and 27% ($\bar{\Delta}$), respectively.

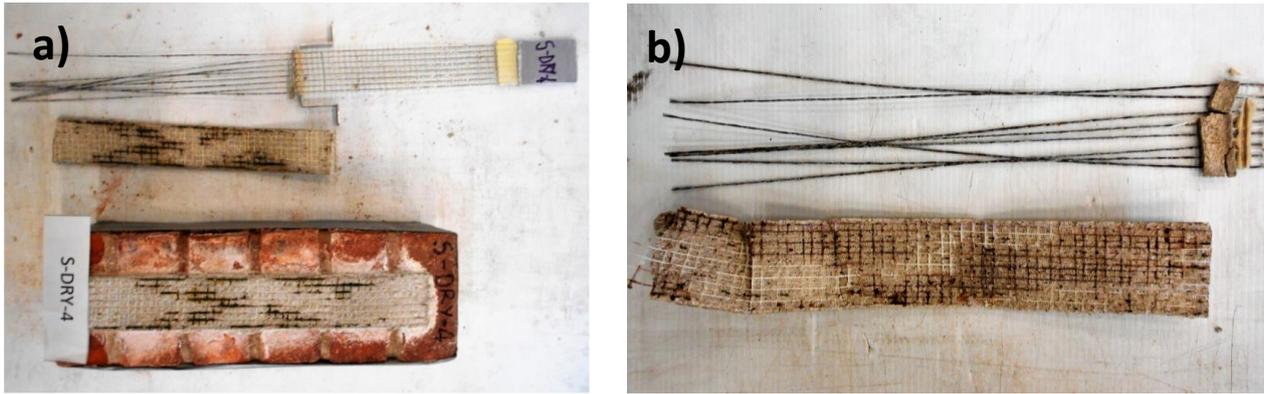
Fig. 9. Presence of corrosion in a) SALT-DRY and b) POST-DRY specimens after the single-lap shear test was performed.

The visual observation of the SALT-DRY and POST-DRY specimens after the single-lap test was performed (Fig. 9a and b, respectively) revealed that some corrosion occurred on the surface of the galvanized steel cords. The corrosion is related to the presence of sodium chloride in the solution employed in the wetting cycles, as no corrosion was observed when only sodium sulfate was used [24]. Some spots of corrosion were observed also in the WATER-series specimens, although very limited.
