Elisa Franzoni, Cristina Gentilini, Mattia Santandrea, Christian Carloni, *Effects of rising damp and salt crystallization cycles in FRCM-masonry interfacial debonding: Towards an accelerated laboratory test method*, Construction and Building Materials, Volume 175, 2018, Pages 225-238

Effects of rising damp and salt crystallization cycles in FRCM-masonry interfacial debonding: towards an accelerated laboratory test method

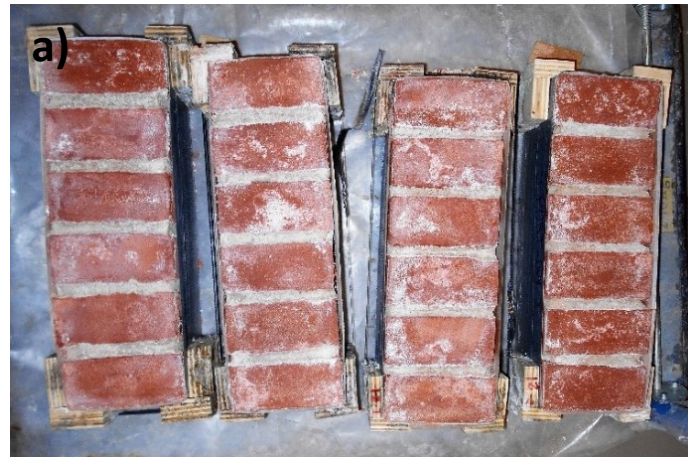
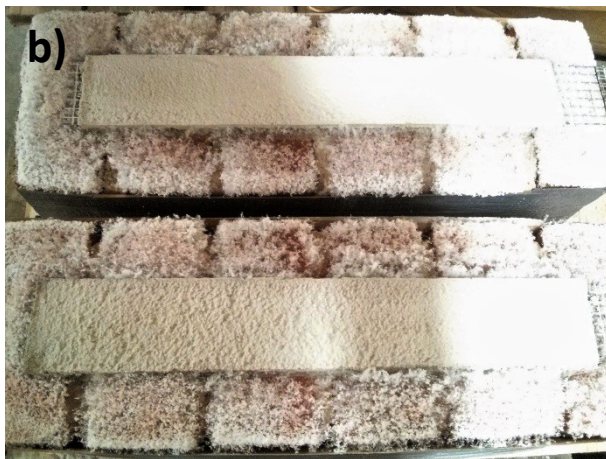
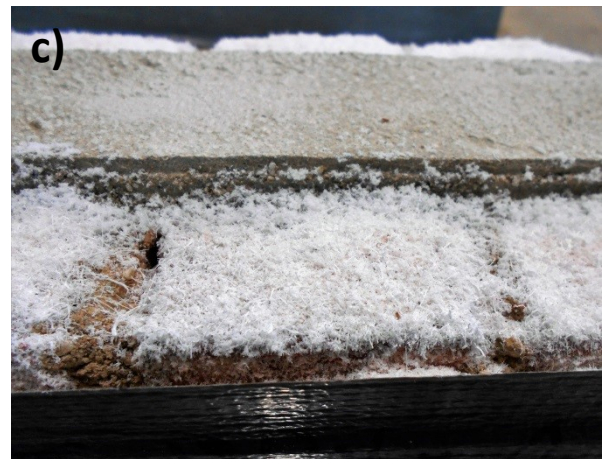
Fig. 6. Photos of selected POST-DRY specimens: a) at the end of the conditioning procedure and after removal of the superficial efflorescence with a metal brush; b) and c) after curing of the composite and before the shear test.

A completely different efflorescence distribution with respect to SALT-DRY specimens was observed in the POST-DRY specimens (Fig. 6b and c) in which the cycles were performed, then the composite was applied and cured for one month, and finally the shear test was carried out. In fact, efflorescence is distributed over the entire top surface, hence not only in the central part near and on top of the composite as in the SALT-DRY specimens (Fig. 5c and d). The curing of the composite in moist conditions (under a wet cloth), which was necessary to achieve the development of the mortar strength, seems to have caused the dissolution of the salts in the masonry blocks and their transport towards the top surface during the final drying; in this way also the composite exhibited a marked salts accumulation.
