## THE MONUMENTAL GATE AT TOL-E AJORI, PERSEPOLIS (FARS): NEW ARCHAEOLOGICAL DATA

**Abstract:** Thanks to new evidence brought to light in 2015 at Tol-e Ajori, Persepolis (Fars), further information has been acquired on two fundamental architectural aspects, the technique of construction on one hand, and the plan of the inner room on the other. A third important objective, the topographic context of the Gate, has also benefited from new information, which is however insufficient to complete the picture. Finally, interpretation of the destruction phase of the Gate has also been further advanced.

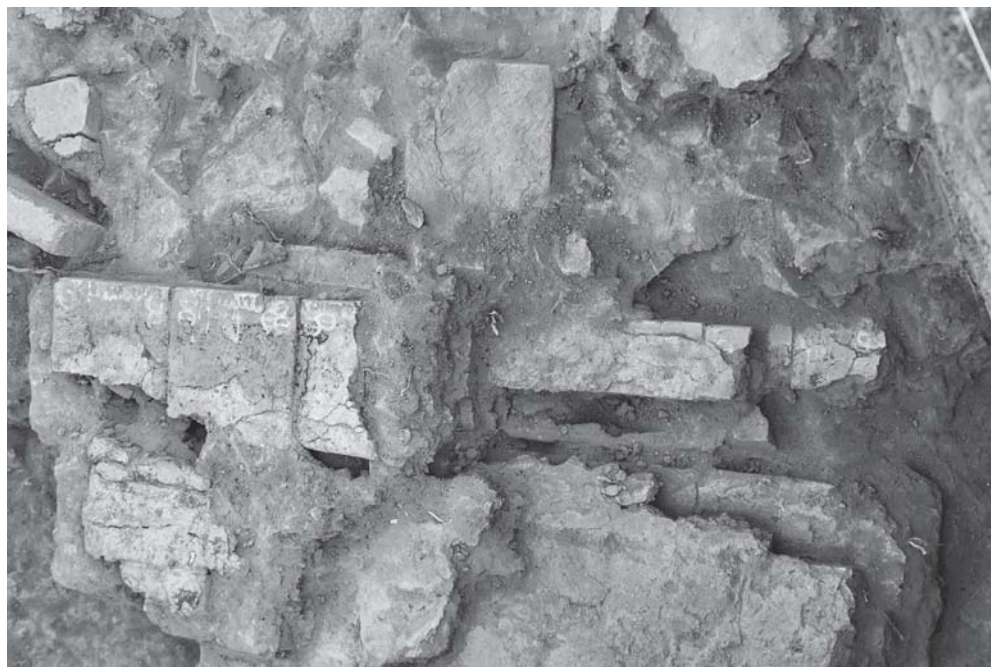
Pl. 7a. Firuzi 5: general plan (©Iranian-Italian Joint Archaeological Mission, drawing S. Tilia);  
Pl. 7b. Tol-e Ajori: Trench Tr. 11, wall SSU1120 with fracture NSU1134 of possible seismic origin  
(©Iranian-Italian Joint Archaeological Mission).

The lower courses of the wall elevation were damaged by this disastrous event, while the portion above is perfectly vertical and still shows its well-preserved glazed decoration, although horizontally shifted by 0.10 m to NE (Pl. 7b). This situation prevented excavation of the whole portion below the shift, which, in order to prevent the preserved part above it from crumbling, was only investigated in a 0.50 m-long stretch: this short stretch shows in the brick courses from the second to the fifth from the bottom the effects of a strong compression and horizontal movement of the further portion of the wall. Above this damaged portion, the glazed brick courses are, by contrast, well-preserved; they were described in the preceding pages.

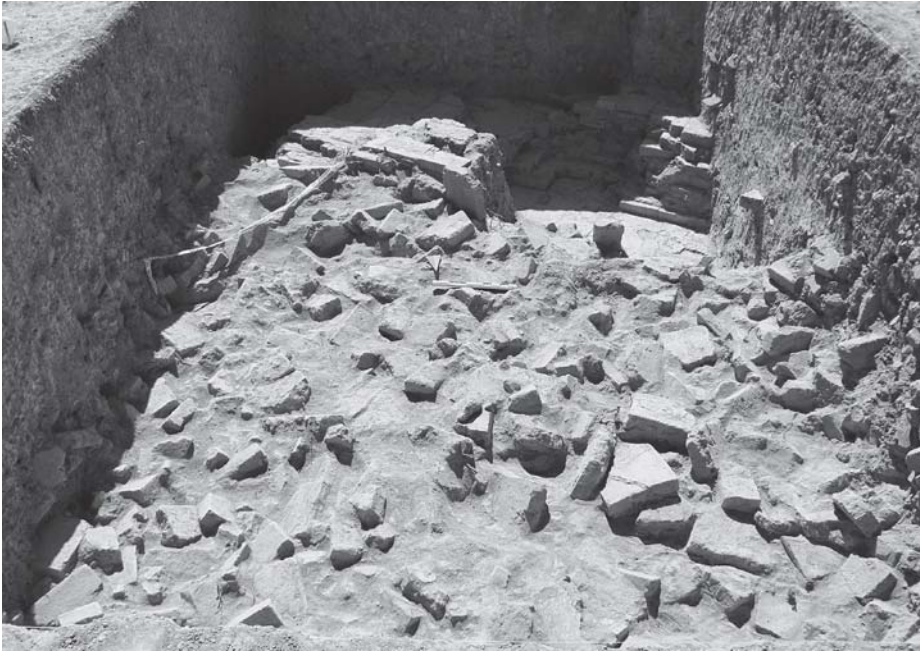
Pl. 8a. Tol-e Ajori: Trench Tr. 11, collapse layer SU1124  
(©Iranian-Italian Joint Archaeological Mission);  
Pl. 8b. Tol-e Ajori: a flat polychrome glazed brick fragment, Reg. No. GB00695  
(©Iranian-Italian Joint Archaeological Mission, photo N. Ibnoerrida).

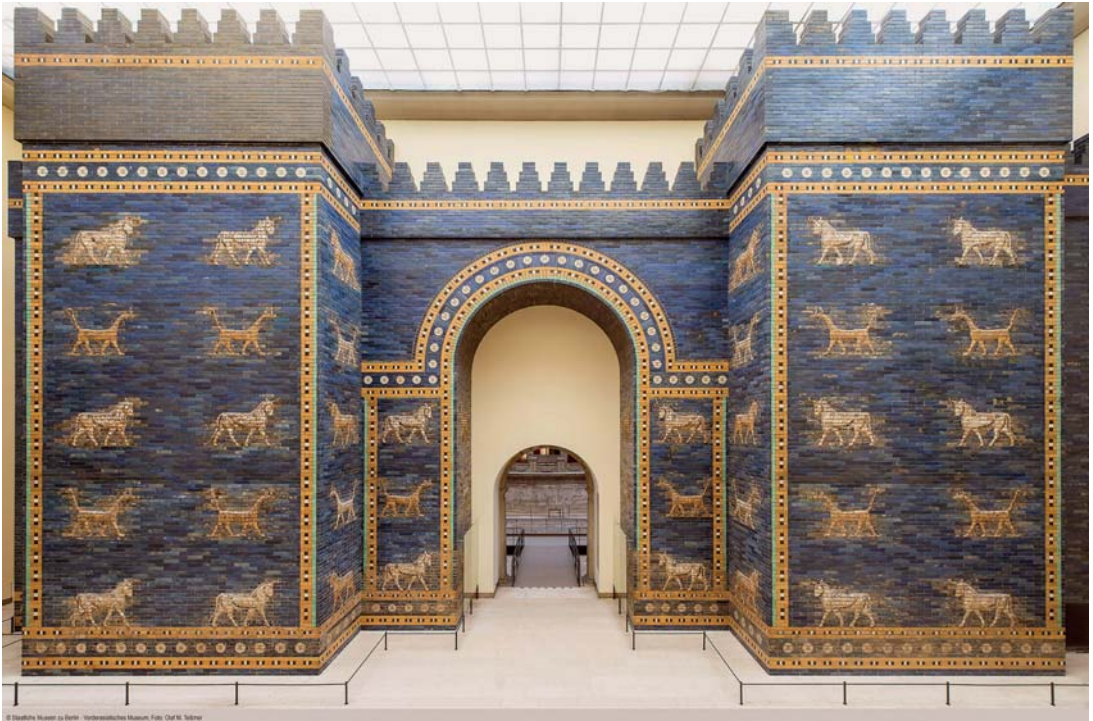
Pl. 9. Berlin, Vorderasiatisches Museum: reconstruction of the Ishtar Gate  
(©Staatliche Museen zu Berlin-Vorderasiatisches Museum, photo O.M. Teßmer).

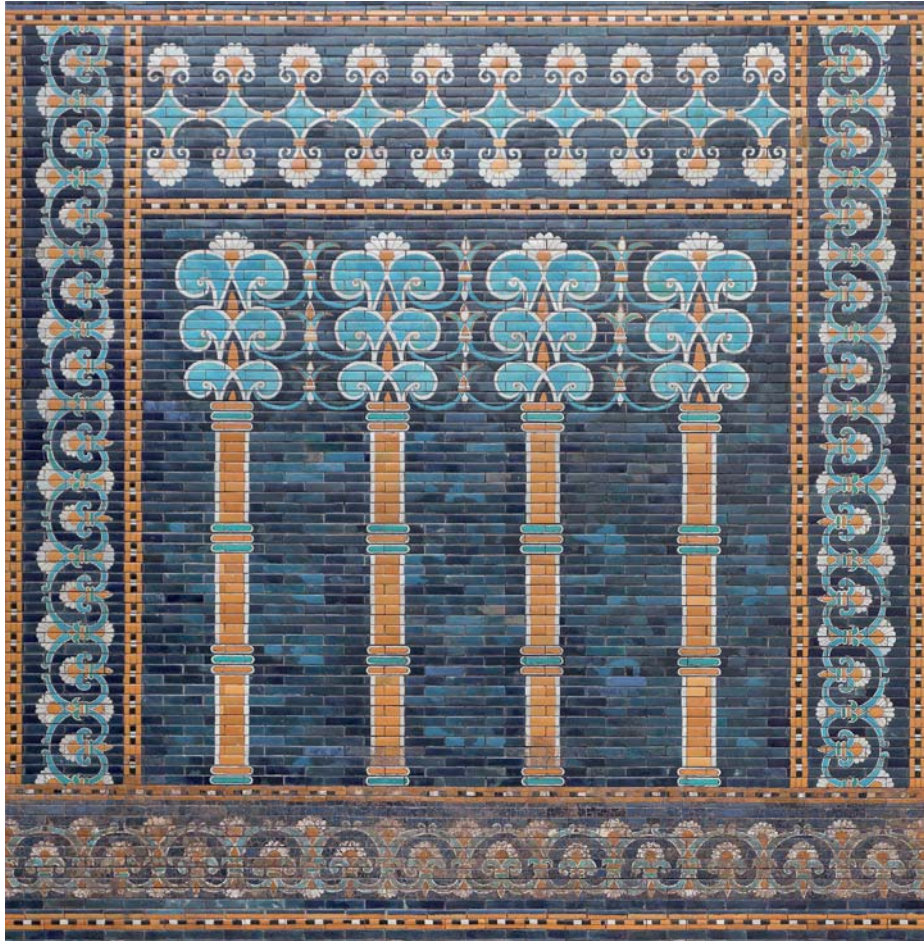
Pl. 11. Berlin, Vorderasiatisches Museum: part of reconstruction of the façade of Southern Throne (©Staatliche Museen zu Berlin-Vorderasiatisches Museum, photo O.M. Teßmer).

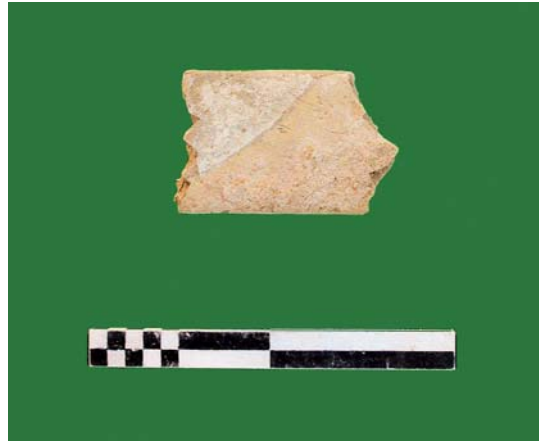
- Pl. 12a. Tol-e Ajori: a flat polychrome glazed brick fragment, Reg. No. GB00838  
(©Iranian-Italian Joint Archaeological Mission, photo N. Ibnoerrida);  
Pl. 12b. Tol-e Ajori: a flat polychrome glazed brick fragment, Reg. No. GB00796  
(©Iranian-Italian Joint Archaeological Mission, photo N. Ibnoerrida).

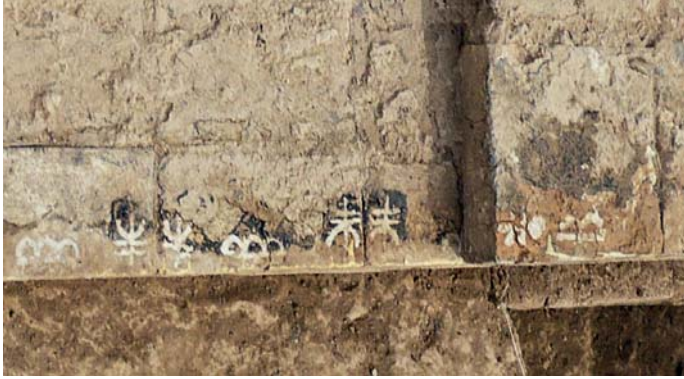
Pl. 14a. Tol-e Ajori, Trench Tr. 1: part of the monument wall found *in situ*.

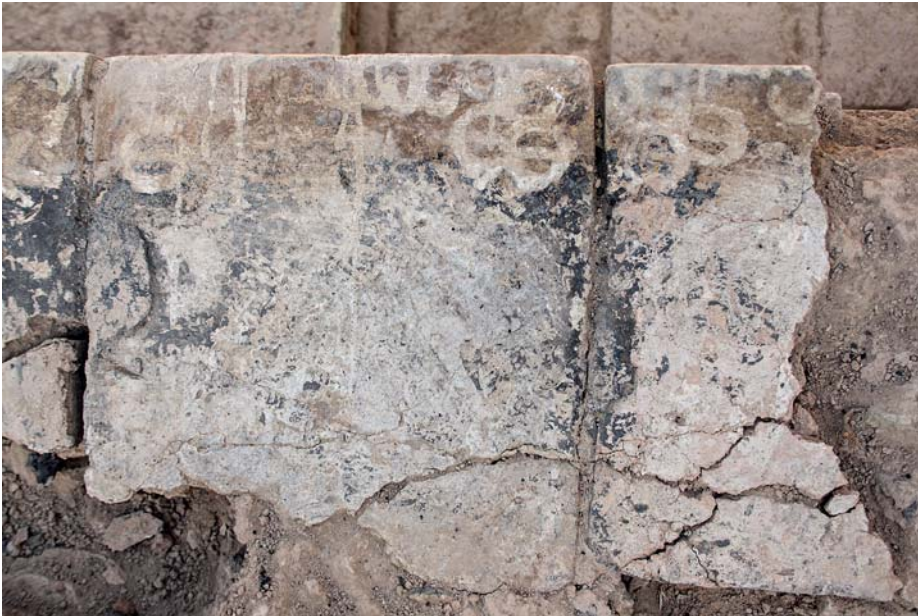
Pl. 14b. Tol-e Ajori, Trench Tr. 11: part of the monument wall found *in situ*.

The central fitters' marks is visible on upper surface of the brick

In the 2015 season in Trench Tr. 11 a stretch of the elevation of the wall of the inner room was found preserved from the subsequent pillage, in a reasonably good state of conservation. The wall as usual consisted of a baked-brick section<sup>45</sup> (Block D) and a mud-brick section<sup>46</sup> (Block C): the outermost part for a thickness of 2.50 m had an elevation entirely constructed in baked bricks, while the mud-brick sections lay on some courses of baked bricks section, with no uniform number of courses. The outermost three-four rows of baked bricks of Block D used bitumen as mortar, as visible from what was left by the wall robbery trench. The NE face of Block D, above the course of unglazed bricks set back by 0.035 m, was built with glazed bricks, of which eleven courses are preserved for a 2.70 m long stretch. The lower ones were damaged by a disastrous event while the portion above still shows its well-preserved glazed decoration, even though it was horizontally shifted by 0.10 m to NE. In view of this situation, to avoid the risk of collapse it was decided not to excavate the whole portion below the shift, which was only investigated in a 0.50 m long “window”, showing in the courses from the second to the fifth from the bottom the effects of strong compression and horizontal movement, possibly caused by an earthquake (see “Destruction of the Gate Process”). Above this damaged portion, the glazed-brick courses are well-preserved and show from the bottom upwards: a band composed by a course with alternating yellow, white and dark squares between two courses of monochrome yellow bricks and two courses belonging to a band of open rosettes in dark ground above a monochrome dark course (Pl. 5b). This is the same composition as the one discovered in Trench Tr. 9, and corresponds exactly to that of the Ishtar Gate, with a difference in the present preservation of the blue glaze. Another interesting feature of this portion of wall consists in the fitters’ marks, well preserved on the upper face of the glazed bricks under the bitumen mortar: here the meaning of the central fitters’ mark could be effectively understood in relation to the course position.

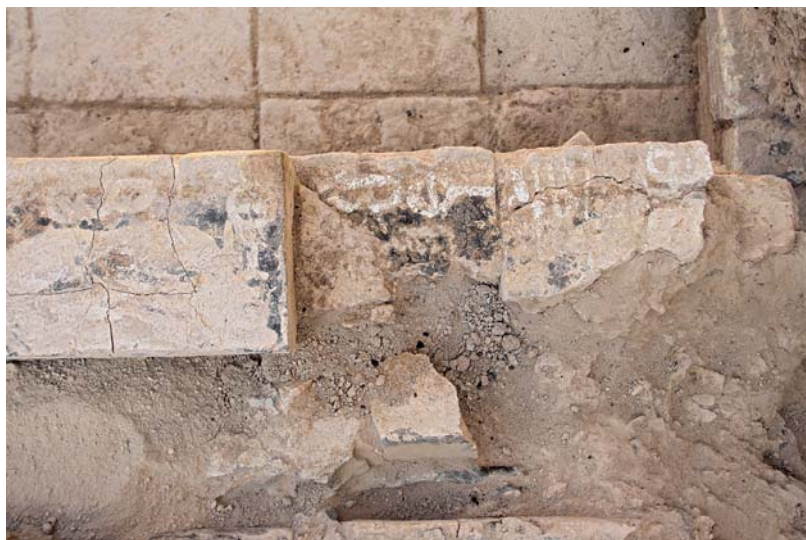
Pl. 15a. Tol-e Ajori, Trench Tr. 11: part of the monument wall found *in situ*. The fitters' marks are visible on upper surface of the bricks (©Iranian-Italian Joint Archaeological Mission, photo D.M. Meucci);

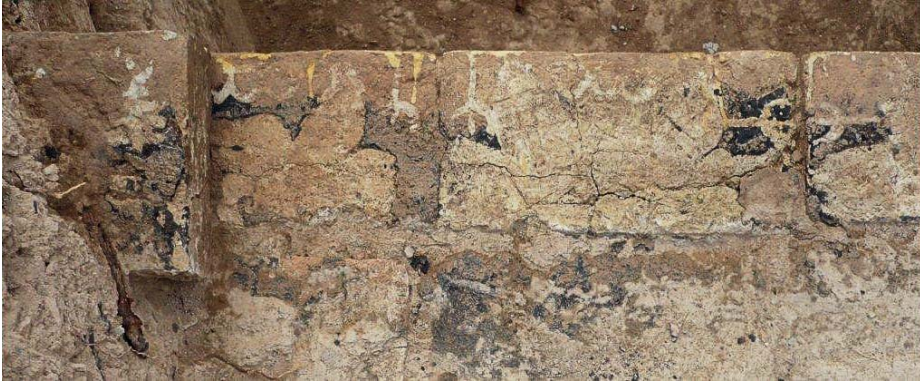
Pl. 16a. Tol-e Ajori, Trench Tr. 1: part of the monument wall found *in situ*. The fitters' marks are visible on upper surface of the bricks (©Iranian-Italian Joint Archaeological Mission, photo A. Mercuriali);

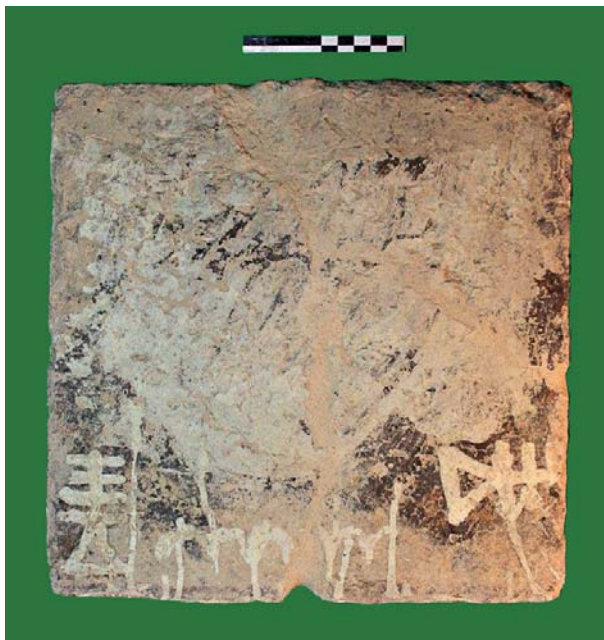
Pl. 16b. Tol-e Ajori: the upper surface of a flat polychrome brick fragment with fitters' marks, Reg. No. GB01743 (©Iranian-Italian Joint Archaeological Mission, photo P. Severi).

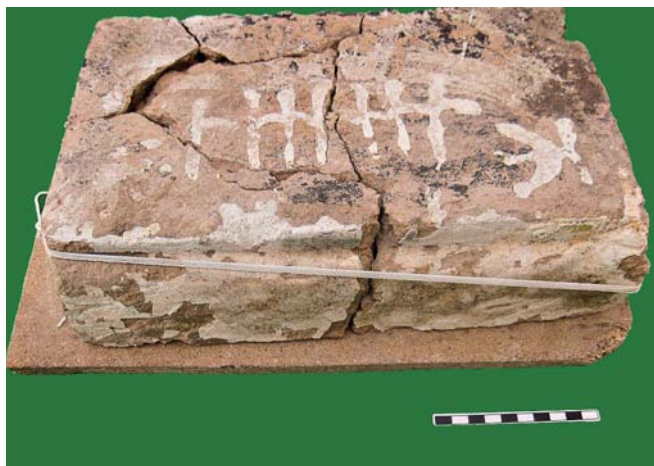
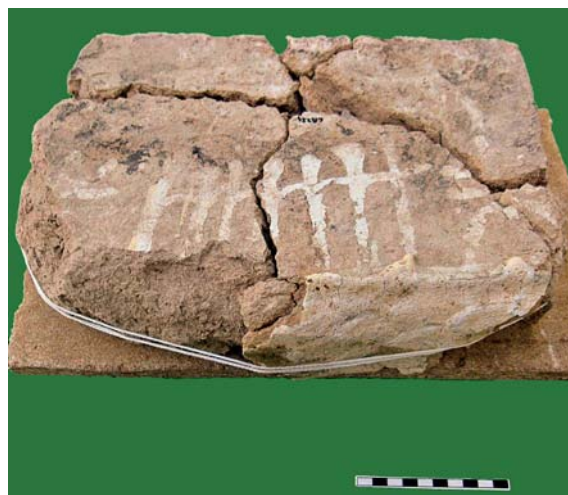
Pl. 17a. Tol-e Ajori: a relief glazed brick fragment showing fitters' marks, Reg. No. GB00273 (©Iranian-Italian Joint Archaeological Mission, photo L. Tortella);  
 Pl. 17b. Tol-e Ajori: a relief glazed brick fragment showing fitters' marks, Reg. No. GB00274 (©Iranian-Italian Joint Archaeological Mission, photo L. Tortella).
