QUASI-STATIC INDENTATION BEHAVIOR OF GFRP WITH MILLED GLASS FIBER FILLER MONITORED BY ACOUSTIC EMISSION

Abstract. *This paper aims at investigating the influence of the addition of milled glass fibers upon quasi-static indentation (QSI) properties of glass/epoxy composite laminates. The QSI behavior was experimentally studied by evaluating indentation force, residual dent depth, energy absorbed and size of the damaged area for different indentation depths. Following the QSI tests, the filler-loaded glass/epoxy samples were subjected to three-point bending tests in order to measure residual flexural strength, and the results were compared with the baseline glass/epoxy samples. Both tests were performed with online acoustic emission monitoring in order to observe damage progression and characterize different fracture mechanisms associated with loading. The results show that the filler-loaded laminates exhibit a substantial improvement in the peak force and contact stiffness, with a reduced permanent damage both in terms of depth and of area, in comparison with the baseline ones. It is found that the filler presence offers greater stiffness and higher energy dissipation through tough

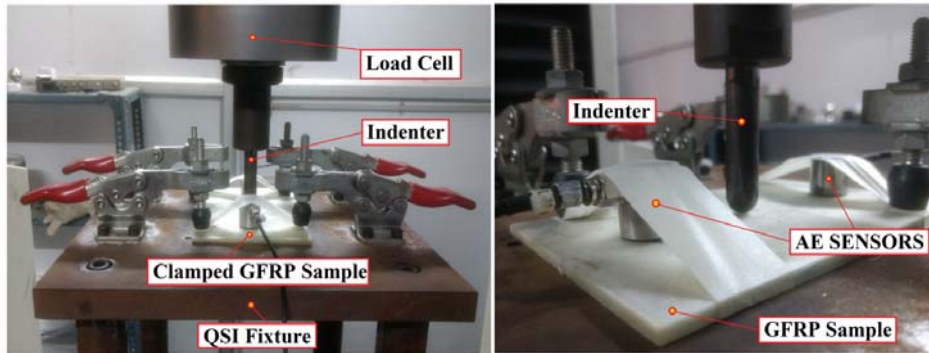
Fig. 1 Quasi-Static Indentation test fixture

Quasi-static indentation tests were performed on the Tinius Olsen 100kN Universal Testing Machine at crosshead speed of 1 mm/min. The test was carried out with the indentation fixture as per ASTM D6264/D6264M-17 standard [30], hence with a hemispherical indenter. The glass/epoxy samples with dimensions of 150 x 100 mm rested on the fixture and were clamped at both sides, as shown in Fig. 1. Later, the indentation test was performed directly on the center of the samples. The specimen was indented with a 12.7 mm diameter hemispherical end steel tup. Load-displacement data were recorded *via* the digital data acquisition system from the universal testing machine. Four specimens were tested in all the cases, and the average results were considered. QSI tests were carried out at a predetermined indentation depth of 1, 2, 3, 4, 5 and 6 mm, respectively. Quasi-static indentation behavior and test parameters, such as indentation force, residual dent depth, energy absorbed, contact stiffness and damaged area at different indentation depths were evaluated. The evolution of damage and damage mechanism associated with indentation were monitored with online AE monitoring.

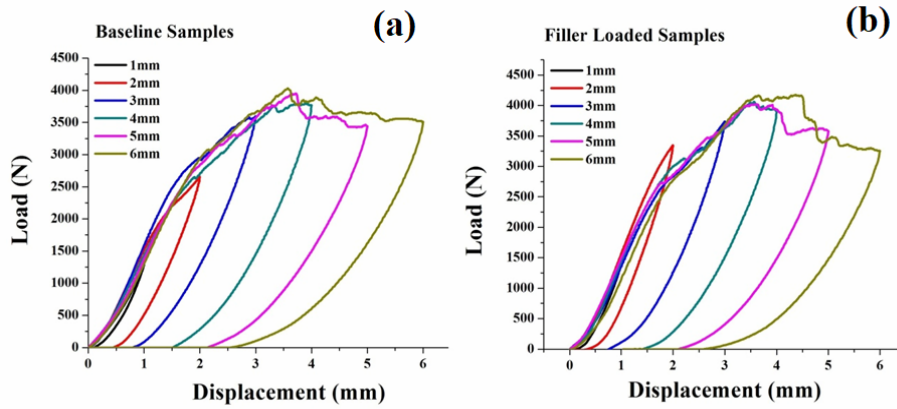
Fig. 2 Load-Displacement curve for different indentation depth: (a) Baseline samples (b) Filler-loaded samples

Figure 2 shows a typical load-displacement curve for the quasi-static indentation test on both baseline and filler-loaded glass/epoxy samples, tested at different indentation depths. The curve profile was initially quasi-linear, which suggested a prevalently elastic behavior: this was followed by the onset of some permanent plastic deformation with increasing indentation displacement. The resistance offered by the samples was observed to increase with indentation depth. Thus, the peak force increases consistently with indentation depth accompanied by a sequence of load drops associated with the occurrence of a significant damage, such as delamination and fiber failure. At a higher indentation depth, the onset of the process leading from fiber disruption to perforation through the appearance of back damage reduces the resistance of the samples through load drops to be ascribed to the indenter producing shear failure and local crushing of fibers during local bending [34]. These load drops are followed by the appearance of a plateau region in the curve, which can be attributed to frictional sliding between the indenter and the sample. In particular, it can be observed that beyond 4 mm no longer any major increase in the peak load is revealed: this was associated with the predominant fiber damage, leading to the appearance of back face damage. Also, the results show that irrespective of indentation depth, the filler-loaded samples exhibited higher load carrying capacity (peak force) than the baseline samples.

The slope of the load-displacement curve during quasi-elastic phase, preceding the first load drop, defines the initial contact stiffness of the glass/epoxy. Further, as the indentation depth increases, non-linear behavior was observed associated with damage accumulation and progression through matrix cracking, while the onset of delamination at a higher delamination depth corresponds to stiffness degradation. More specifically, it was found that the filler-loaded samples exhibit initial contact stiffness of 2181 ± 75 N/mm and delaminated contact stiffness of 955 ± 72 N/mm, against 1902 ± 58 N/mm and 832 ± 75 N/mm for the baseline samples, respectively. In other words, it was observed that the filler-loaded samples exhibited approximately 15% improvement in initial and delaminated contact stiffness, compared to the baseline samples.

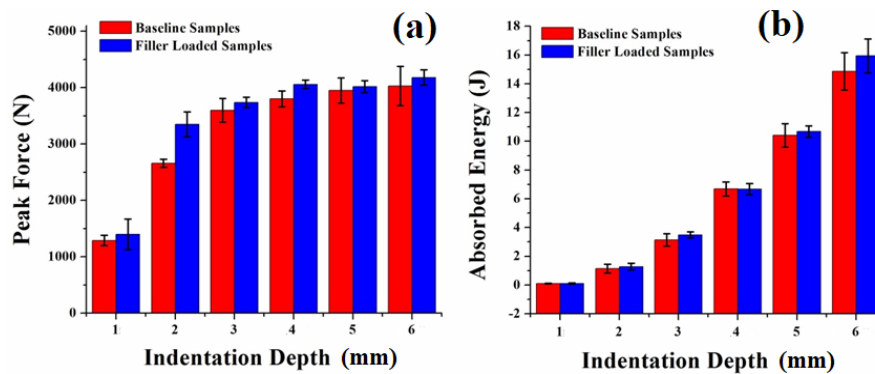
Fig. 3 Comparison of: (a) Peak force (b) Absorbed energy between baseline and filler-loaded samples for different indentation depths

Figures 3 (a) and (b) indicate peak force and absorbed energy variation with respect to indentation depth: both peak force and absorbed energy are slightly higher for the filler-loaded samples; though given the standard deviation, differences are minimal. It can also be observed that while the former shows an abrupt increase at a given indentation depth, particularly between 1 and 2 mm, the latter grows quasi-linearly with it. In general terms, this behavior depends on the fact that the peak force suddenly increases after the contact area overcomes the limit that is related to the dimension of the indenting tip, an evidence which is basically related to its hemispherical geometry [35].

However, at a higher indentation depth, beyond 4 mm, some failure of load-bearing fibers due to induced tensile stress resulted in some reduction in the peak load, which means that the peak loads for both the filler-loaded and the baseline samples were similar. In other words, the influence of the filler on absorbed energy was prominent at a lower indentation depth, while as the indentation depth increases, the contribution of the filler to energy dissipation deteriorates. This was attributed to the damage gradually extending from the matrix to the reinforcement through the intermediate occurrence of some debonding.

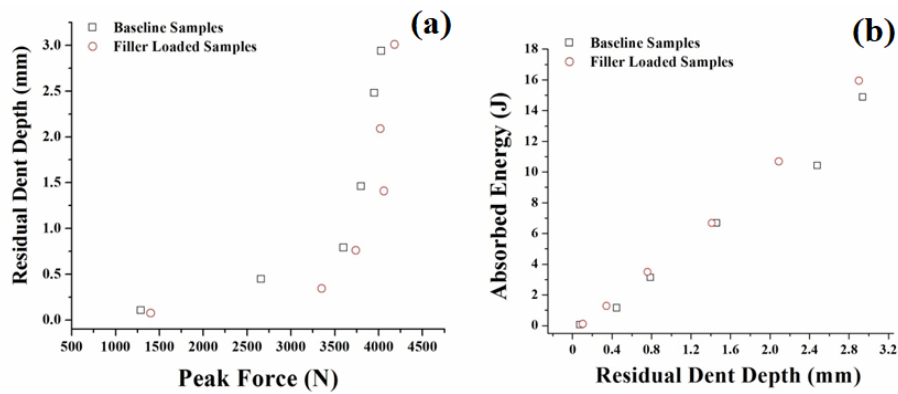
Fig. 4 (a) Peak force vs. Residual dent (b) Absorbed energy vs. Residual dent: comparison between baseline and filler-loaded samples for different indentation depths

What was expected was that the filler-loaded samples would exhibit a reduced damaged area and a smaller residual dent at respective indentation depths in comparison with the baseline ones. The relationship between the peak force and the absorbed energy with a residual (permanent) dent, i.e. the plastic deformation of the samples remaining after unloading for both the baseline and the filler-loaded samples is reported in Fig. 4. In general, both the absorbed energy and the residual dent are increasing with the indentation force. The relation between the peak force and the residual dent indicates that the accumulation of damage is dependent on indentation displacement. The change in the slope was observed to be small/gradual at a lower indentation depth below 3 mm corresponding to matrix cracking and some delamination damage. As the indentation depth increases, the slope of the curve changes rapidly while the peak force remains almost unchanged. The occurrence of fiber breakage with matrix cracking and delamination contributes to an increase in the residual dent depth and with no raise in the peak force, suggesting at this point the transition of failure mechanism from gradual to severe, substantially indicating the occurrence of fiber failure, basically signifying

that no resistance is offered by the broken fibers. It is observed that the filler-loaded samples exhibit a lower permanent depth by an average of 25% than the baseline samples. The filler presence offers improved stiffness and also higher energy dissipation through plastic deformation.

Figure 4 (b) shows the relationship between the permanent dent depth and the absorbed energy for the baseline and the filler-loaded samples. It is well known that the energy absorbed by the samples is utilized for investigating damage development. Thus, the responses of the absorbed energy and the residual dent are dependent and the results show that the trend of the absorbed energy and the residual dent was almost linear till an indentation depth below 4 mm. However, as the indentation depth increases further, the damage is close to saturation in the laminate, which causes marked non-linear behavior. Irrespective of indentation depth, the residual dent depth induced on the filler-loaded samples was consistent and depended upon the absorbed energy, which, in its turn, was higher with the reduced residual dent comparing to the baseline samples. It was observed that the fillers presence enhanced the energy dissipation capacity of the laminates, which was attributed to the toughening mechanism, such as filler debonding/pullout, filler interlocking/bridging of cracks, as will be seen in Fig. 12.

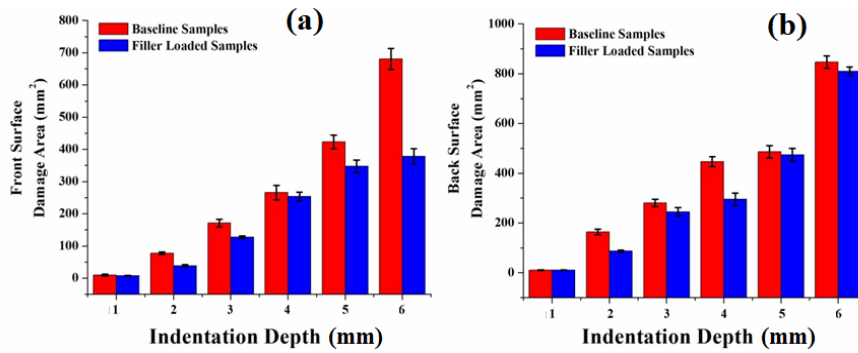
Fig. 5 Damage area at different indentation depth for baseline and filler-loaded samples: (a) Front surface (b) Back Surface

More indications were expected to come from the measurement of the extent of the damaged, hence delaminated, areas, by non-destructive backlight imaging of the damaged samples with ImageJ software for post-processing: these are reported in Fig. 5 for various indentation depths. The delaminated area had irregular shape and perimeter, despite being centered on the point of indentation. The damage area at the back surface was observed to be greater comparing to the front surface, suggesting a larger disruption if the fiber layers with indenter progress in the laminate, significant for the reduction of flexural performance [36]. The damage area was found to be reduced in the filler-loaded samples for an average of 25% less than for the baseline samples. This is due to the higher rigidity/stiffness offered by the filler-loaded samples resulting in energy dissipation through toughening mechanism such as filler debonding/pullout, filler bridging/interlocking, as will be seen in SEM images. This proves that the filler inclusion resulted in higher energy absorption with a reduced damage area, contributing to enhanced crashworthiness properties of the laminates.

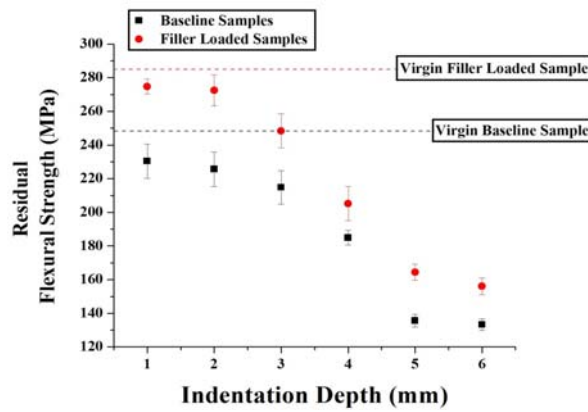
Fig. 6 Residual flexural strength for baseline and filler-loaded samples at different indentation depths

In particular, the effect of the filler introduction on the residual flexural strength after indentation allowed observing that the filler-loaded samples exhibited an average of 18% higher load carrying capacity than the baseline samples (Fig. 6). In particular, three-point bending strength of non-indented laminates was 249 ± 6.5 MPa for baseline ones and 284.5 ± 8.3 MPa for filler-loaded ones. Bending effects are the cause of shear forces leading to delamination propagation toward a free edge during the three-point bending test. This propagation expands from the former delamination damage developed during quasi-static indentation, followed by a newly generated damage. The damage evolution was observed to be gradual on the samples subjected to a low indentation depth showing matrix cracking, and debonding damage followed up by the ultimate failure by fiber breakage at compression or tension side of the samples. The residual flexural strength was observed to reduce gradually by an average of 15% for an indentation depth above 3 mm. In addition, the samples subjected to higher indentation exhibit penetration/perforation damage leading to a large delamination area and intensive fiber breakage.

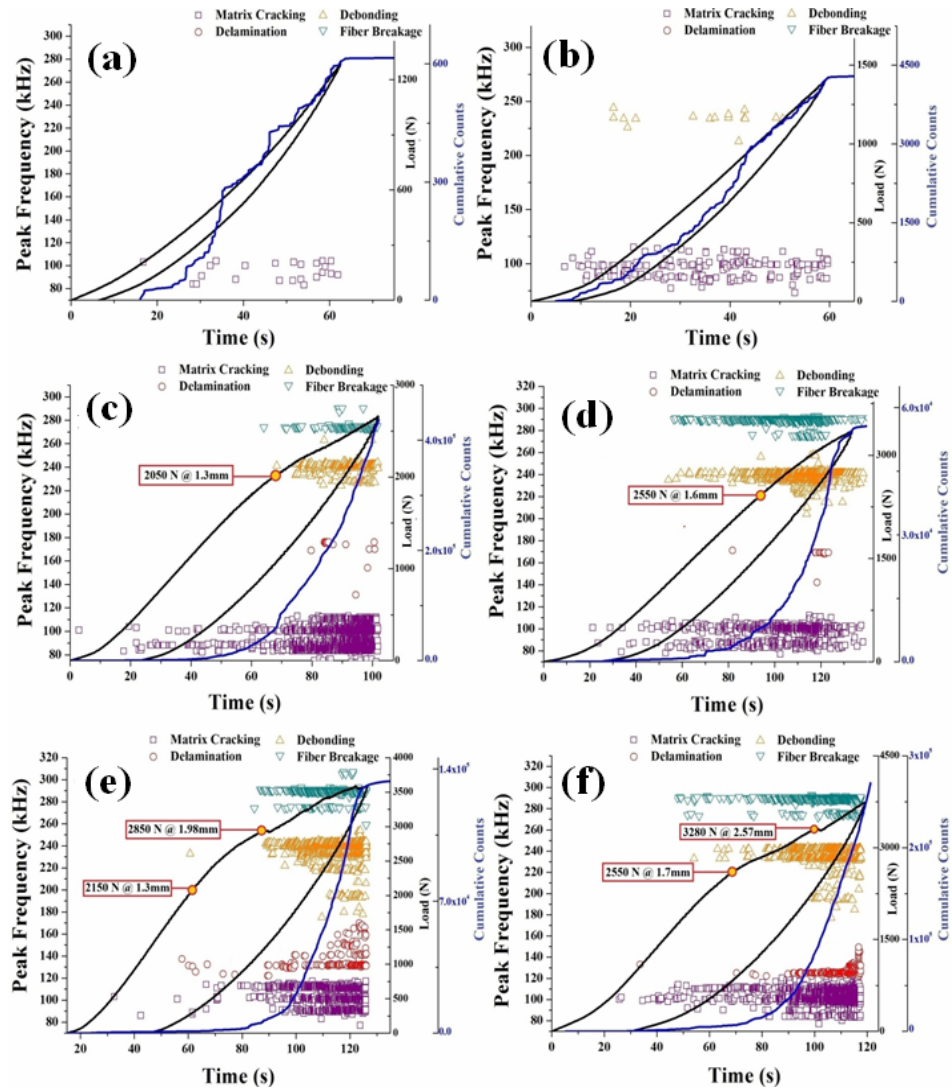
Fig. 7 Peak frequency & Cumulative Counts vs. Time plot of corresponding load-displacement behavior for indentation depth. Baseline samples: (a) 1mm (c) 2mm (e) 3mm & Filler-loaded samples: (b) 1mm (d) 2mm (f) 3mm

The load-displacement behavior of the glass/epoxy samples subjected to quasi-static indentation test with acoustic emission monitoring will be discussed in detail, as follows. In general, the AE events initiate after the occurrence of local plastic deformation in the samples. Figures 7 and 8 show Peak frequency & Cumulative Counts vs. time plot of corresponding load-displacement behavior for each indentation depth. The curve profile of the AE cumulative counts – time plot signifies the evolution of damage initiation and progression during loading, as previously discussed, e.g. in [24]. It was observed that the profile of the AE cumulative counts curve changes significantly with subsequent damage as loading progresses. Initially, the damage starts with lower count rates, so that the AE cumulative counts curve is almost flat while the AE signals can be mostly attributed to matrix cracking. Further loading intensifies the progression of matrix cracking within the ply at faster rates, promoting fiber/matrix debonding and fiber breakage, as will be shown in Figs. 10 and 11. Damage accumulation was indicated by a sudden and abrupt increase in the cumulative counts with a change in the slope associated with a major failure such as delamination. Finally, a sharp increase in the cumulative counts with a steep slope corresponds to unstable crack growth, resulting in the ultimate failure of the laminates. Also, the AE signals associated with different failure mechanisms were identified sequentially during the damage evolution from the peak frequency vs. time plots. It is suggested from previous literature that the peak frequency ranges in the GFRP correspond to different damage mechanisms: with some accuracy, these can be defined as 70-120 kHz for matrix cracking, 120-190 kHz for delamination, 190-260 kHz for debonding and 260-320 kHz for fiber failure.

In particular, Figs. 7 (a) and (b) show the results for a lower indentation depth of 1 mm. Both in the baseline and the filler-loaded laminates, the damage initiates in the form of matrix cracking, while fiber/matrix debonding was observed only in the case of the filler-loaded samples; delamination was not yet evident at this indentation depth. This can suggest that the filler-loaded laminates may provide higher energy dissipation through an additional toughening mechanism such as filler/matrix debonding offered by the presence of milled glass fibers. In practical terms, at 1 mm indentation depth, no significant damage was visible in both the baseline and the filler-loaded samples, except minor local indentation at the contact of the indenter. This will be confirmed in Fig. 9, with no delamination/debonding visible for 1 mm indentation depth in the baseline samples.

Figures 7(c) and (d) show the results for an indentation depth of 2 mm, where the damage onset load (or) delamination threshold load was indicated from the incipient point during quasi-static indentation. Typically, the incipient point defines the initial change in the slope or a drop in the load where delamination occurs during testing. The baseline samples show a change in the slope during 2050N and 1.3mm indentation depth, while the filler-loaded samples indicate a change in the slope only during 2550N and 1.6mm indentation depth. Correspondingly to this load/indentation, damage

accumulation was observed attributed to a sudden and abrupt increase in the AE cumulative counts with a change in the slope associated with a major failure, such as debonding/delamination, as observable from the peak frequency-time plot. These failure modes were nominal at 2 mm indentation depth and consequently exhibit a smaller damage area, as seen in Fig. 9. The size of the damaged area, the intensity of damage and relevant damage mechanism were observed to increase with indentation depth.

The indentation response of the glass/epoxy samples subjected to 3 mm indentation depth can be seen in Figs. 7(e) and (f). In this case, the change of the slope of the load-displacement curve indicates reduced contact stiffness of the material due to the initiation of damage mechanisms, such as matrix cracking, debonding and delamination, as can be seen in Figs. 10 and 11. As previously discussed, the flat region of the curve of the AE cumulative counts indicates the damage initiation stage attributed to low-frequency failure mode matrix cracking, whereas the initiation of delamination in the baseline samples occurred at 2150N and 1.3mm, followed by a sudden load drop at 2850N and 1.98mm, corresponding to the fiber failure, as seen in Figs. 10 and 11.

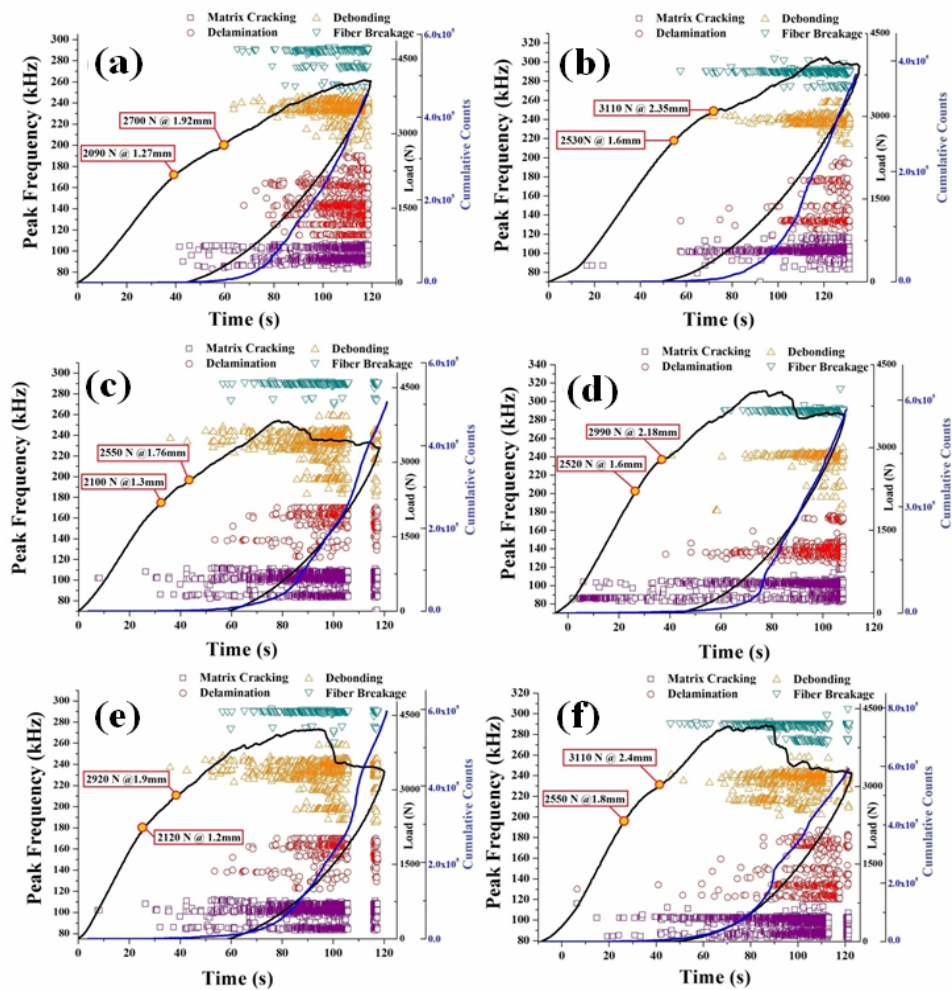
Fig. 8 Peak frequency & Cumulative Counts vs. Time plot of corresponding load-displacement behavior for indentation depth. Baseline samples: (a) 4mm (c) 5mm (e) 6mm & Filler-loaded Samples: (b) 4mm (d) 5mm (f) 6mm

Figures 8 (a) to (f) show the load-displacement behavior of the baseline and the filler-loaded samples indented at 4, 5 and 6mm. The same trend was observed with a flat profile of the AE cumulative counts indicating the damage initiation stage and a steep rise in the slope of the curve showing the damage accumulation. It was observed that the damage onset load in the baseline samples occurred at an average of 2100 N at 1.2mm followed by a sudden load drop at 2700N and 1.8mm corresponding to the fiber failure. In contrast, the filler-loaded samples exhibited delamination damage load and a load drop related to fiber damage at 2500N and 1.6mm, and 3100N and 2.1mm, respectively. It is significant to observe that the damage onset load and the fiber breakage load exhibited by the filler-loaded samples were for about 20% and 15% higher than the baseline samples, respectively. This is due to enhanced energy dissipation through toughening mechanism such as filler/matrix debonding, filler interlocking/bridging which contributes to higher load-bearing capacity.

At a higher indentation depth, a fiber failure occurs during penetration/perforation of the samples which reduces the load resistance capability. Beyond 4 mm indentation depth, all the samples show the same trend in peak load and absorbed energy, while no significant increase was observed due to a more intense fiber failure. The failure occurred through matrix shear cracking, and fiber micro-buckling at the local contact of the indenter, followed by delamination between the adjacent plies and intra-laminar cracking (or) axial fiber splitting through penetration/perforation of the indenter. It is clearly seen that the delamination onset load was almost similar for all the samples while the improvement in the fiber breakage load reduces drastically with an increasing indentation depth due to the perforation/penetration of the samples.

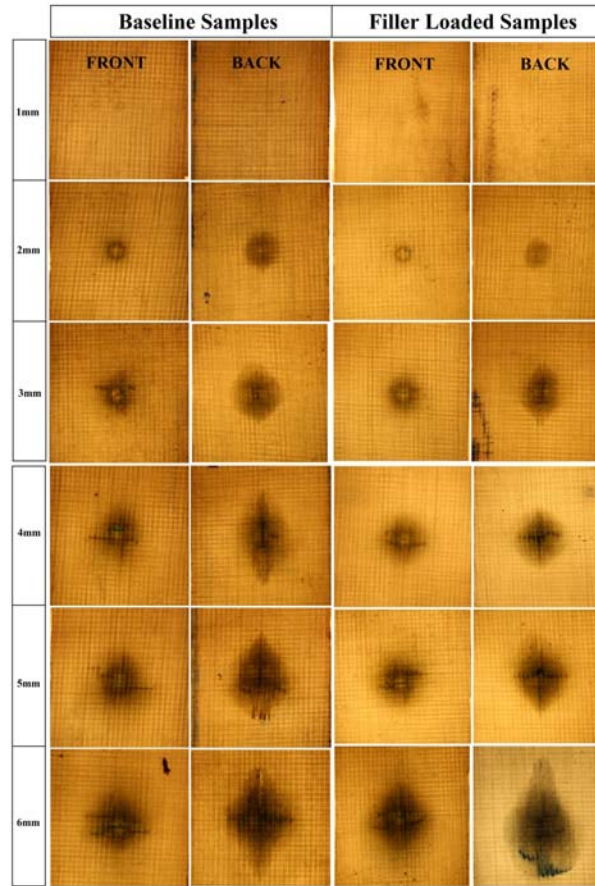
Fig. 9 Images of projected indentation damaged area at different indentation depth

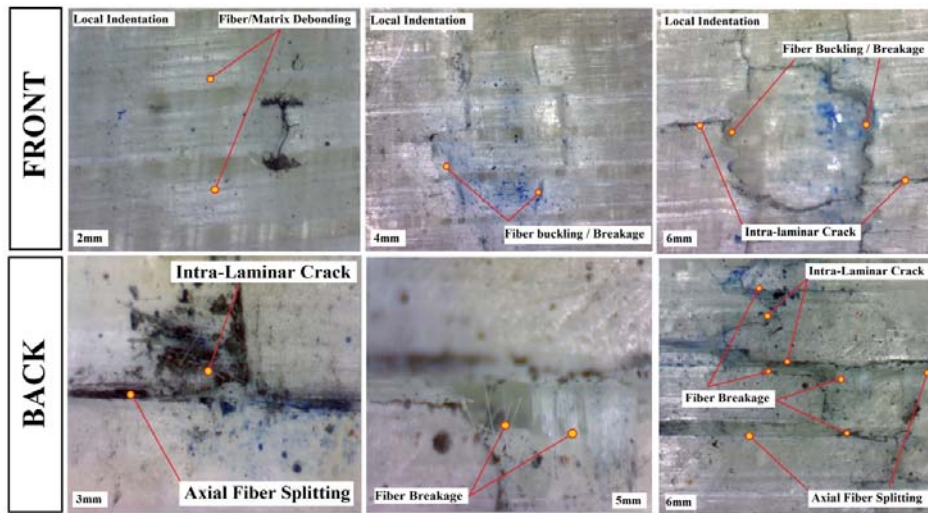
Fig. 10 Optical microscopic images of the fractured surfaces observed during quasi-static indentation test for baseline samples

Figures 10 and 11 show optical microscope images of the fractured surfaces observed during the quasi-static indentation test in the baseline and the filler-loaded samples. At a lower indentation depth, matrix fracture damage occurs, which decreases the localized stiffness of the laminate, but does not result in any catastrophic failure. However, further increasing the indentation displacement can cause the matrix cracking to progress into delamination and fiber breakage, due to the tensile stress caused by the indenter contact. In general, the transverse matrix cracking develops into delamination between the adjacent plies, and finally, prevalent intra-laminar crack and in-plane fiber buckling/breakage cause penetration and perforation damage at a higher indentation depth (4 to 6 mm). Figures 9, 10 and 11 show that the intensity of damage in the baseline samples was predominant comparing to the filler-loaded samples, especially at a higher indentation depth.

In contrast, the damage exhibited by the filler-loaded samples was minor and delayed, due to the improved load carrying capacity and energy absorption characteristics offered by the presence of fillers. Figures 12 (a) and (b) show scanning

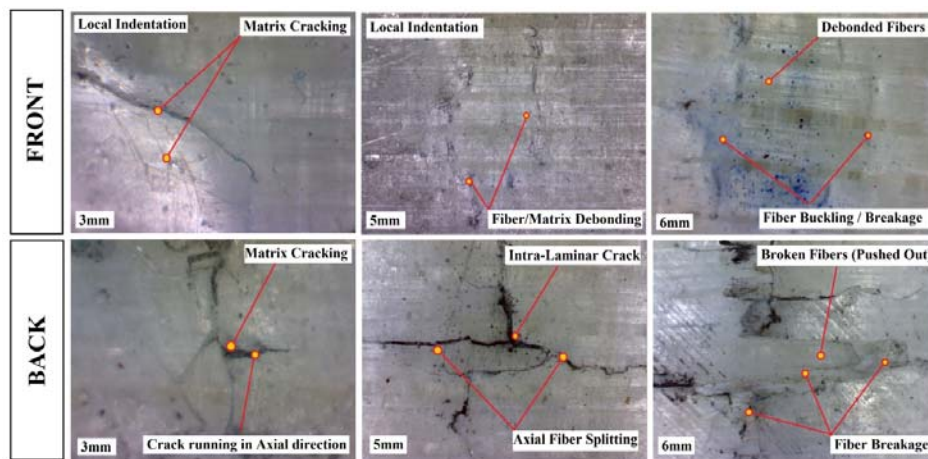
Fig. 11 Optical microscopic images of the fractured surfaces observed during quasi static indentation test for filler-loaded samples

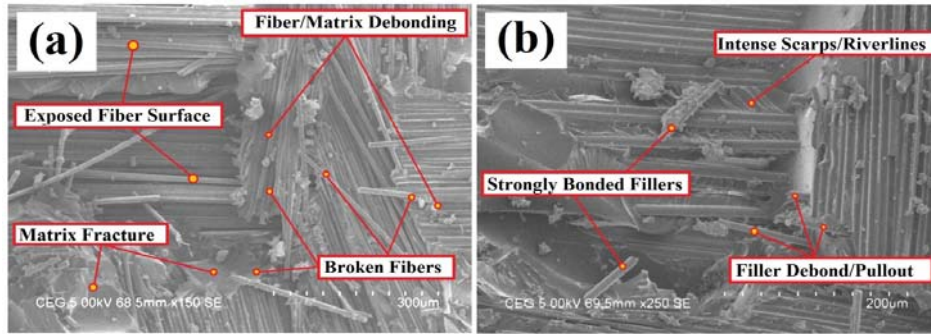
Fig. 12 SEM micrograph of the fractured surfaces showing: (a) Baseline samples (b) Filler-loaded samples

electron microscope images of the fractured surfaces of the baseline and the filler-loaded samples. The baseline samples exhibit smooth and brittle fracture surface associated with no plastic deformation corresponding to low fracture toughness of epoxy matrix. However, the fracture surface of the filler-loaded samples indicates rough surface with intense scarps/river lines. The intense scarps/river lines indicate hindrance of crack growth. Figure 12 (b) shows the fillers strongly bonded to the matrix and filler debonding/pullout, which can be attributed to the additional energy dissipation mechanisms.

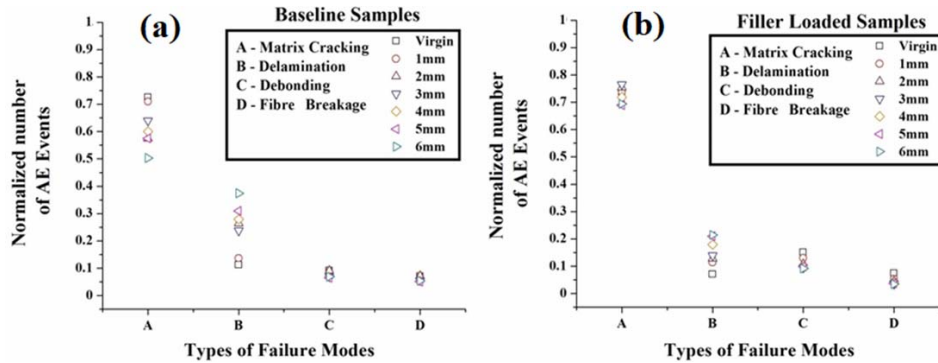
Fig. 13 Types of failure modes versus normalized number of AE events for Flexural After Indentation test: (a) Baseline Samples (b) Filler-loaded Samples

Figure 13 shows the normalized number of AE events exhibited during flexural after indentation test associated with types of failure modes for baseline and filler-loaded samples. The damage mechanisms associated with flexural after indentation test were characterized from frequency ranges, as discussed above. It can be observed that the delamination signals intensity in the baseline samples are more intense and greater than the filler-loaded samples which validate the correlation between these data and those of the damage areas. It can be observed that the matrix cracking signals associated during the test were found to be concentrated and more intense since they start almost from the beginning of loading; this triggers the other failure modes in both the baseline and filler-loaded samples. The number of the AE events associated with the delamination signals for the baseline samples was found to be more intense comparing to the filler-loaded samples: this trend was observed to be prominent at a higher indentation depth (beyond 4 mm). It can be suggested that, at this point, quasi-static indentation on the glass/epoxy samples has caused sufficient delamination damage, which might progress during post-indentation flexural testing. Correspondingly, the number of the AE signals attributed to matrix cracking decreases, while those related to delamination increase for the samples indented beyond 4 mm. This evidences that during flexural loading, the damage initiates as matrix cracking in the non-indented samples and samples indented below 4 mm. In contrast, in the samples indented beyond 4 mm, the failure starts/develops from the former damage mode (usually delamination / debonding). Consequently, the debonding and fiber breakage signals observed in all other cases were almost similar, and no significant changes in the intensity of AE signals were observed as seen in Fig. 13(a).

Similarly, Fig. 13 (b) shows the normalized number of the AE events with corresponding types of failure modes exhibited by the filler-loaded samples during flexural after indentation test. It can be observed that the normalized number of the AE events corresponding to the matrix cracking was highly predominant for the filler-loaded samples in all the cases (virgin and all indented samples). In contrast, the number of the AE events corresponding to delamination signals was observed to be lower for the filler-loaded samples than the baseline samples, even for the samples subjected to a higher indentation depth. However, the corresponding debonding signals associated with the test in the filler-loaded samples were greater than the baseline samples. This is due to the filler presence in the interlaminar domain introducing toughening mechanism, such as filler debonding/pullout resulting in more intense debonding AE events. Subsequently, the number of the AE events related to the fiber breakage was almost similar in both the baseline and the filler-loaded samples for all the cases of flexural after indentation.
