Franzoni E., Santandrea M., Gentilini C., Fregni A., Carloni C. (2019). The role of mortar matrix in the bond behavior and salt crystallization resistance of FRCM applied to masonry. CONSTRUCTION AND BUILDING MATERIALS, 209, 592-605 [10.1016/j.conbuildmat.2019.03.059].

The role of mortar matrix in the bond behavior and salt crystallization resistance of FRCM applied to masonry

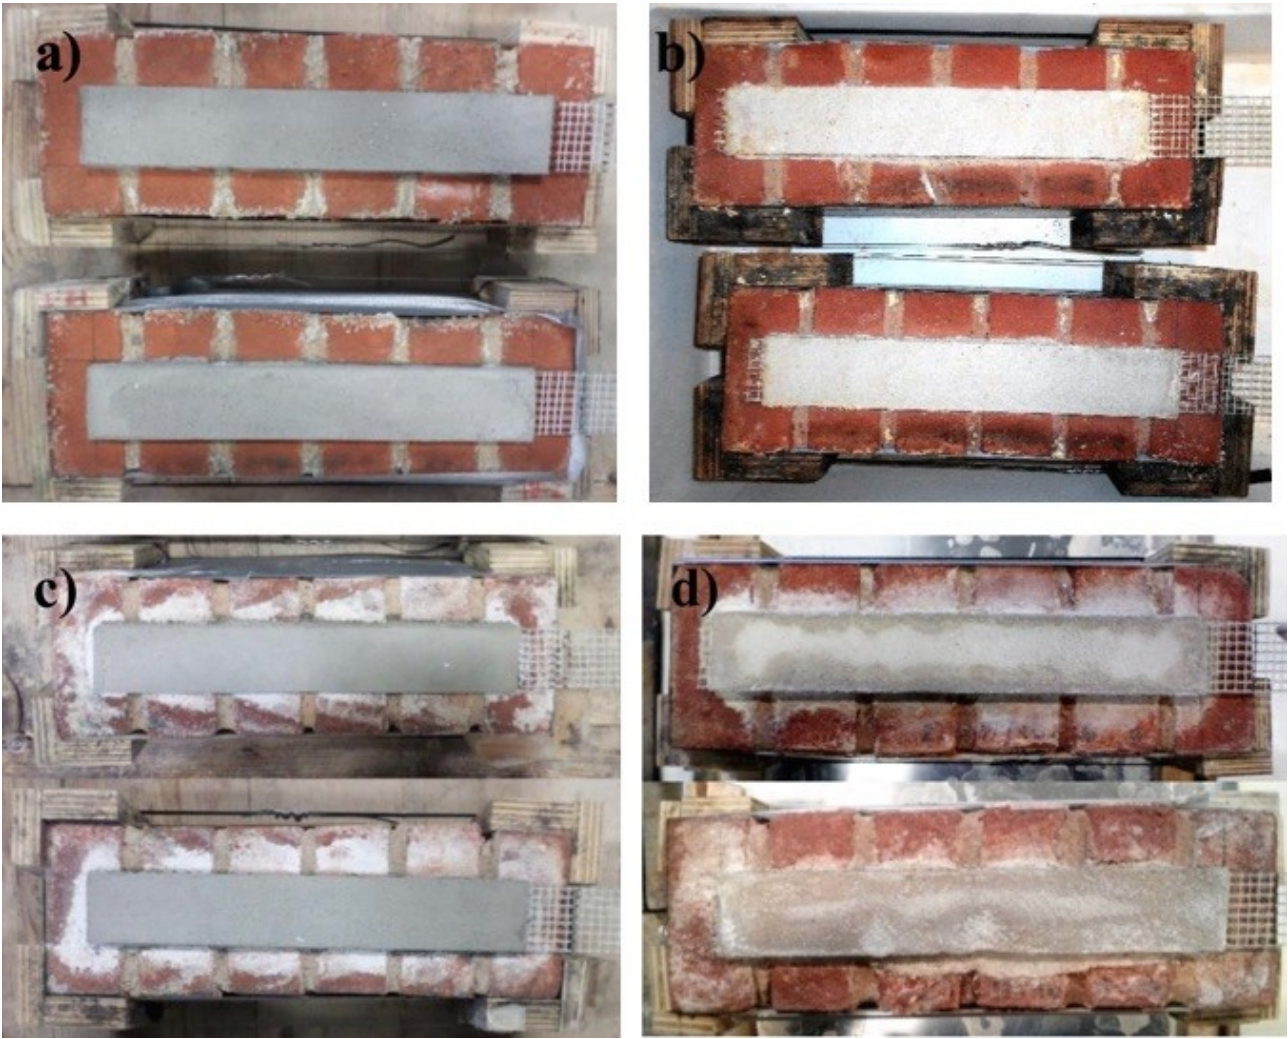
Figure 2. Photos of representative: a) CEM-WAT, b) NHL-WAT, c) CEM-SALT and d) NHL-SALT specimens at the end of the 6th cycle.

After 6 wetting-drying cycles in deionized water, for both groups of specimens CEM-WAT and NHL-WAT, a slight efflorescence formation was observed on the top masonry surface, near the edges, where water evaporation rate was higher (Fig. 2a and b, respectively). In fact, although the duct tape hindered the evaporation through the side surfaces, its sealing action along the edges was not perfect, as the oven drying cycles made the tape detach slightly from the edges. These slight efflorescence were due to some salt impurities originally present in the materials (see Section 3.4).

After 6 cycles in saline solution, for the CEM-SALT specimens, the top surface of masonry on each side of the composite was almost entirely covered by salts, while the composite was efflorescence free (Fig. 2c). Conversely, the accumulation of salt crystals on the top surface was evident for NHL-SALT specimens (Fig. 2d), where efflorescence was present on the composite and masonry (especially near the composite) surfaces. These very different salt accumulation patterns suggest that the migration paths of the saline solution through the FRCM-masonry joints depend on the type of composite (as it will be explained in Section 3.4).

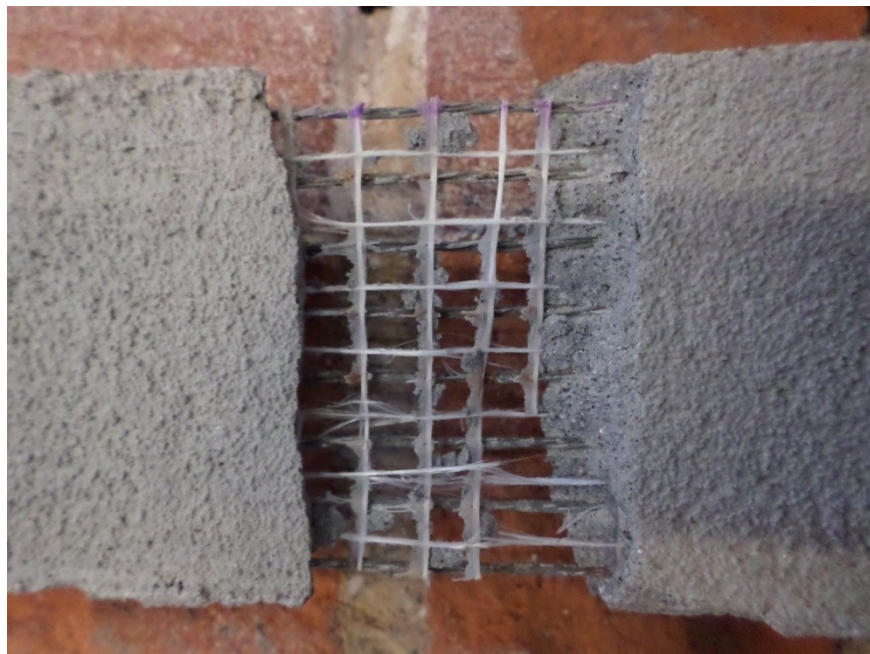
Figure 9. Details of the steel fibers in the composite after the shear test in a CEM-SALT specimens where no surface alterations and/or corrosion are visible.

further investigated in Section 3.4, where the solution flow patterns and salt concentration within the specimens are presented. NHL-SALT specimens show a lower bond quality than NHL-REF specimens (Fig. 8b and Fig. 6), since the weathering cycles with the saline solution caused some corrosion on the steel cords, due to the presence of sodium chloride, as observed in [16]. Due to the steel corrosion, the fiber-matrix interface resulted weaker and a lower amount of energy was needed to initiate and propagate the interfacial crack. For CEM-SALT specimens no corrosion was observed in the steel fibers (Fig. 9).

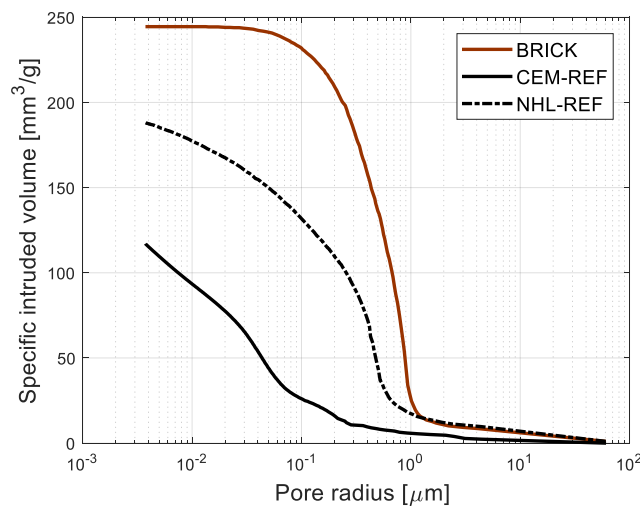
Figure 11. MIP curves of the brick and matrices (samples collected from CEM-REF and NHL-REF specimens).

The results highlight a strong difference between brick, NHL matrix, and CEM matrix in terms of porosity and water transport properties. The brick exhibits the highest porosity (43%), mean pore radius equal to 0.848 μm (Table 2) and a unimodal pore size distribution curve, which is typical for this type of material that exhibits the majority of pores with $\approx 1 \mu m$ radius (Fig. 11). Consistently, the capillary absorption curve of brick (Fig. 10) is first linear and then quickly reaches a plateau, which corresponds to the saturation of the pores, which is again typical for fired-clay bricks. NHL and CEM matrices exhibit a much lower porosity (26.6% and 22.5%, respectively, Table 2) and a completely different pore size distribution with respect to fired-clay bricks. NHL has a smaller R_{mean} (0.491 μm) with respect to brick, and pores within the full range 0.0035-0.5 μm (Fig. 11). CEM

matrix exhibits much finer pores ($R_{mean} = 0.041 \mu\text{m}$, i.e. an order of magnitude smaller than NHL), with a prevalence of pores $< 0.1 \mu\text{m}$ (Fig. 11). Consistently, the two matrices display a slow initial water absorption (linear part of the curves in Fig. 10) and then a gradual saturation, due to the progressive filling of the fine pores. Given its lower porosity and smaller R_{mean} with respect to NHL, CEM obviously exhibits a smaller sorptivity value (less than half). It is important to note that the sorptivity of the two matrices resulted basically the same when determined on mortar prisms and fragments extracted from the composite, which confirms that wetting the masonry blocks before the application of the composite and during its curing process (under a wet cloth) were effective expedients to prevent the premature depletion of the water from the matrices.

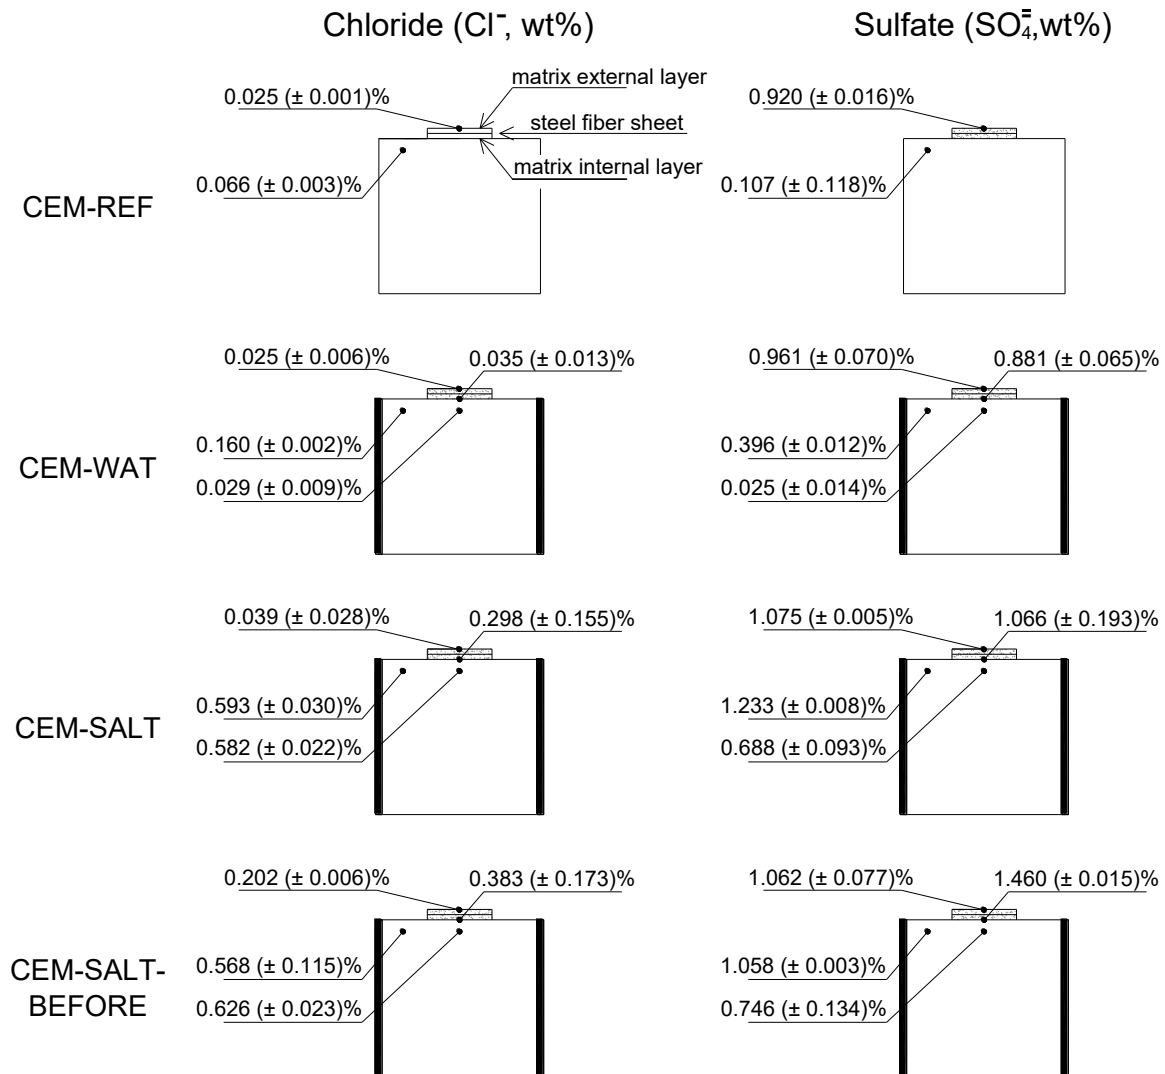
Figure 14. Anions amounts in selected locations of the CEM specimens.

The salt accumulation pattern in CEM specimens is completely different with respect to NHL (Fig. 14). In CEM-WAT, the amount of salts in the composite and in the brick beneath the strip is basically unaltered with respect to CEM-REF, while a slight increase is observed on each side of the FRCM strip, i.e. in the part of the brick outside the bonded area. The same pattern can be observed in CEM-SALT specimens, where the salt accumulation in the composite and in the brick beneath is limited, which confirms the low porosity alteration found in the matrix by MIP (curves almost overlap in Fig. 12a), while the highest increase of amount of salts is found in the portion of the brick outside the bonded area. A possible explanation is that the FRCM strip, due to its low porosity and thin pores (associated with a slow sorptivity), hinders the capillary flow and makes it deviate towards an easier path, i.e. through the brick. The result is that a limited amount of the saline solution flows through the composite and a low amount of salts is deposited in the matrix pores, without even forming efflorescence over the external surface (as shown in Fig. 3c and e). Conversely, the flow and the subsequent evaporation are concentrated in the brick outside the bonded area, where a higher salt accumulation is found. The fact that the presence of scarcely permeable mortars exacerbates the salt damage in the surrounding bricks is consistent with what

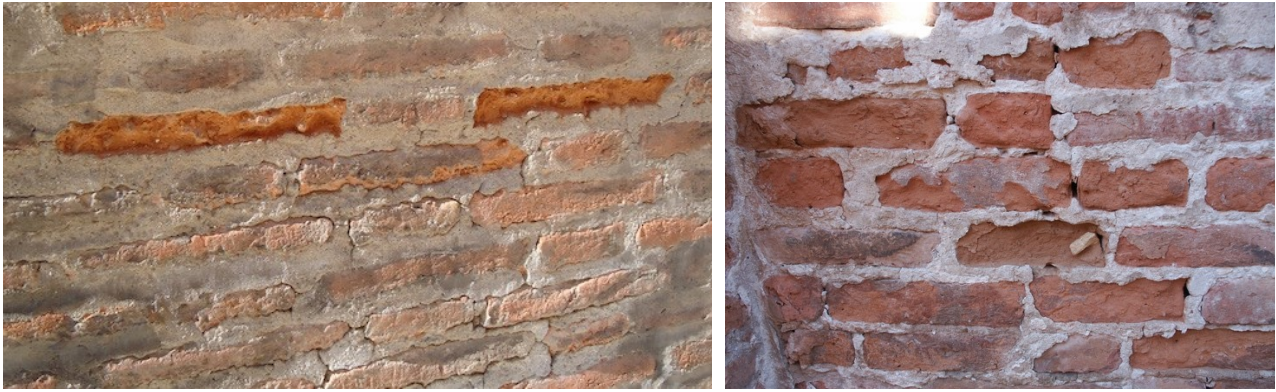
Figure 15. Increase of bricks deterioration in correspondence of scarcely permeable repointing mortars, boosting the water transport through the bricks (on the left: complex of the *Corpus Domini* church, Bologna, Italy; on the right: *S. Maria delle Consolazioni* church, Este, Italy).

frequently observed on-site, as discussed in [46] and shown in the examples of Fig. 15.
