In-plane shear behavior of stone masonry panels strengthened through grout injection and Fiber Reinforced Cementitious Matrices

Keywords: stone masonry, diagonal compression tests, shear behavior, FRCM strengthening system, grout injection.

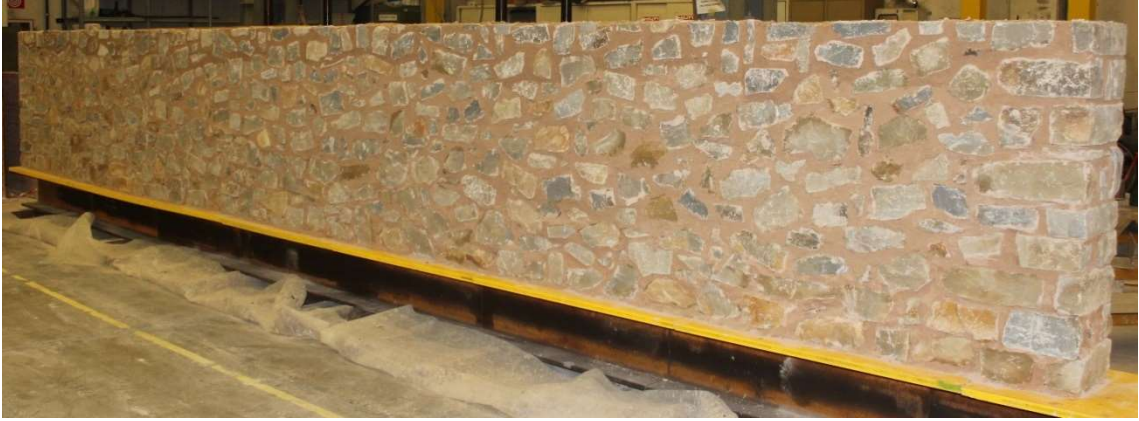
Figure 1. Stone masonry wall.

In the present experimental campaign, seven stone masonry panels were built by using rubble sandstones and natural hydraulic lime-based mortar. In more details, a unique continuous masonry wall, with dimensions $7700 \times 1100 \times 300 \text{ mm}^3$, was initially built and cured in laboratory conditions (Figure 1). The masonry pattern was arranged with two outer leaves and a chaotic internal filling, containing smaller stones and mortar and characterized by an average thickness of approximately 80 mm, depending on the dimensions of the stones. After 28 days of aging, the wall was cut to obtain seven square samples, having dimensions of $1100 \times 1100 \times 300 \text{ mm}^3$.

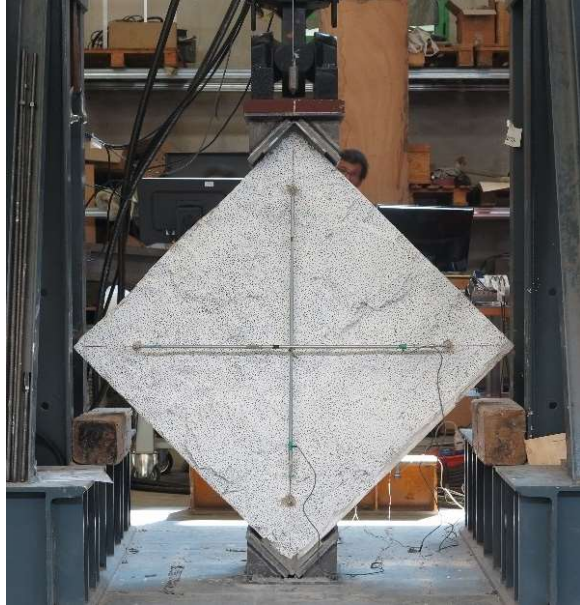
Figure 6. Diagonal compression test setup.

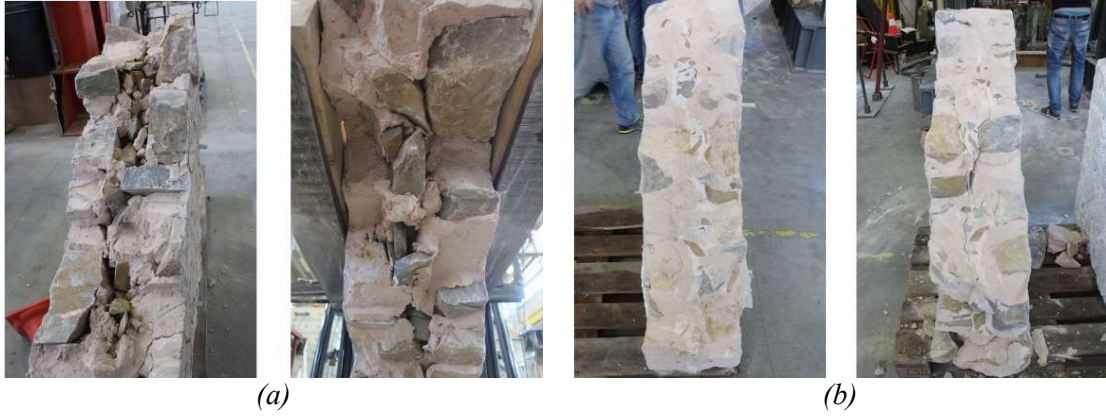
Figure 13. Detail of the cross section of the samples after the tests: (a) sample S_I; (b) sample S_I-MA.
