**GLI EFFETTI DELL'ACQUA
SUI BENI CULTURALI
VALUTAZIONI, CRITICHE
E MODALITA' DI VERIFICA**

Managing water risks in archaeological sites: the flooding of the complex of Santa Croce in Ravenna.

The paper deals with flooding-driven emergency situations and related managerial issues in archaeological contexts with a focus on the complex of Santa Croce, in Ravenna, encompassing a 5th century Church and the remains of a Roman *domus* and its mosaic floor. In August 2019, the archaeological area was flooded for reasons unknown at the time which led to the overgrowing of algae. Since 1993, the local Soprintendenza have been undertaking studies and surveys which enabled them to demonstrate that the water criticalities of the site are linkable to the phenomenon of subsidence and perhaps to the increasing pressure of the aquifers affecting the level of groundwater. The recent water emergency was solved thanks to the water pumping interventions carried out by the Municipality of Ravenna and Civil Protection volunteers, while the Soprintendenza took charge of the securing operations and cleaning of the site.

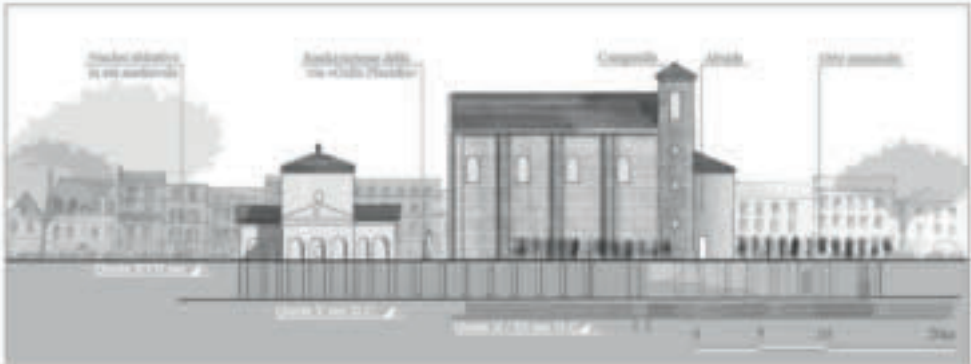
Figure 2. Representation of the historical stratification of the Area (elaborated from a drawing by J.P. Civiletti, DAVID 2013, p.125)

The Church of Santa Croce built between the 424 and the 432 AD, features a single Latin cross nave, completed by a narthex. In an immediately subsequent period, the South *sacellum*, now known as the Mausoleum of Galla Placidia, was added to the narthex, the perpendicular arms were lengthened, and two external mosaic-floored side porches were added to the central hall. This phase of the Santa Croce complex corresponds to its majesty, by virtue of its dimensions and the presence of decorated mosaic floors (DAVID 2013; VERDIER 2016). The first architectural evolution took place in the medieval age, when an oratory crypt was built under the nave. The last intervention on the Church it's datable at the beginning of the 17th century when the narthex was demolished, the roof renewed, the front entrance set back to build the street separating the façade from the South *sacellum*. After the demolition of the crosshead and the rectilinear apse, a church with a semi-circular apse and a bell tower was built. This was the last architectural configuration of the Church, up to the 19th and 20th century, when the first excavations and restoration works begun (DAVID *et al.* 2013).

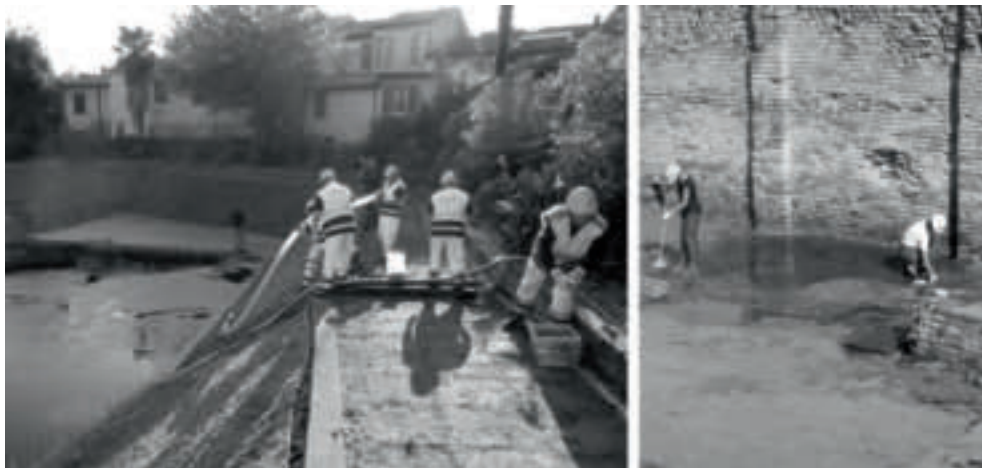
Figure 3. Management of the event and draining of the Area. (ph. SABAP, 2019)

The particular period in which the event took place, during summer holidays, meant that the activation of an intervention could only take place on August 19th. The draining operation was carried out by the Civil Protection volunteers using a self-priming centrifugal motor pump⁵ with low pumping intensity in order not to damage the archaeological structures. This was placed to avoid concentrated loads on the mosaic surfaces, both visible and not, on the basis of the graphic sheets and photographic documentation currently available.

Concomitantly with the water draining operations, a cautious removal with nets and rakes of algae, deposits of various kinds and especially aquatic plants (*Lemnia minor*, more commonly known as ‘water lentil’) that had settled on all floor and wall surfaces was undertaken. The specie is a small floating infesting plant with a very high rate of vegetative multiplication at high temperatures.

Damages related to the flooding event involved partially the vertical structures. While no specific degradation was detected on bricks and mortar, more significant were the consequences for the mosaic floor, especially the ones not involved in the conservation operations previously undertaken by the DBC. Surface deposit were removed cautiously by the conservators of SABAP in cooperation with some of the volunteers and right after a first washing the green shades lightly faded. Anyway, the need for further cleaning to remove all biological waste remains evident.
