Pull-out behavior of twisted steel connectors employed in masonry: The influence of the substrate

Gentilini C., Finelli F., Girelli V.A., Franzoni E. (2021). Pull-out behavior of twisted steel connectors employed in masonry: The influence of the substrate. CONSTRUCTION AND BUILDING MATERIALS, 274, 1-14 [10.1016/j.conbuildmat.2020.122115].

Pull-out behavior of twisted steel connectors employed in masonry: the influence of the substrate

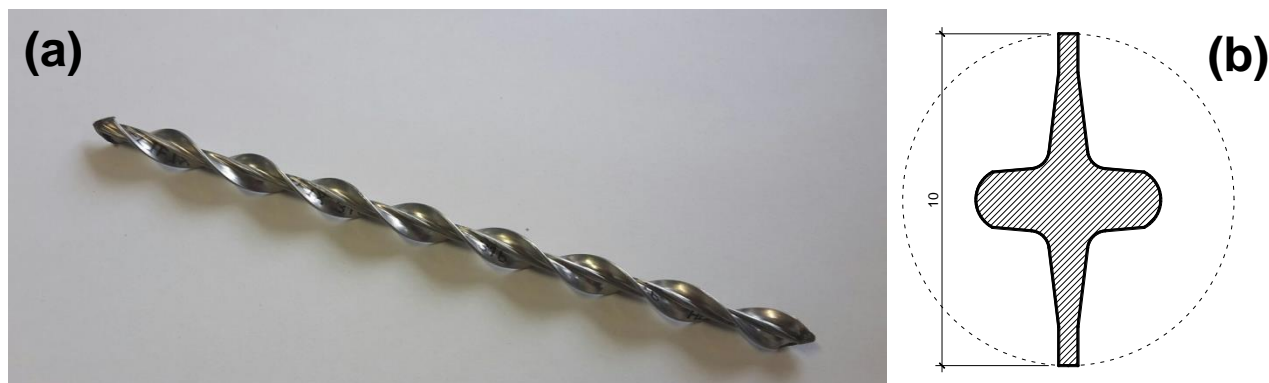
Fig. 1. a) Twisted bar and b) original cross-section of the bar before twisting (size in mm).

The most commonly used twisted connectors are characterized by a diameter equal to 10 mm, although 12 mm bars have been recently introduced in the market as well. In the present study, the 10 mm connectors were selected for the experimental campaign. A single size was selected, as the aim of the study was to investigate the role of different substrate materials, rather than the influence of the geometry of the connectors. The connectors are made of high-strength stainless steel (AISI 316) and exhibit nominal diameter, ϕ_{BAR} (defined as the diameter of the circle that circumscribes the cross-section of the bar), and cross-sectional area, A_{BAR} , equal to 10 mm and 14.5 mm², respectively, Fig. 1a. The bars were formed by cold working starting from a circular steel wire. The distance between the ribs is equal to 30 mm.

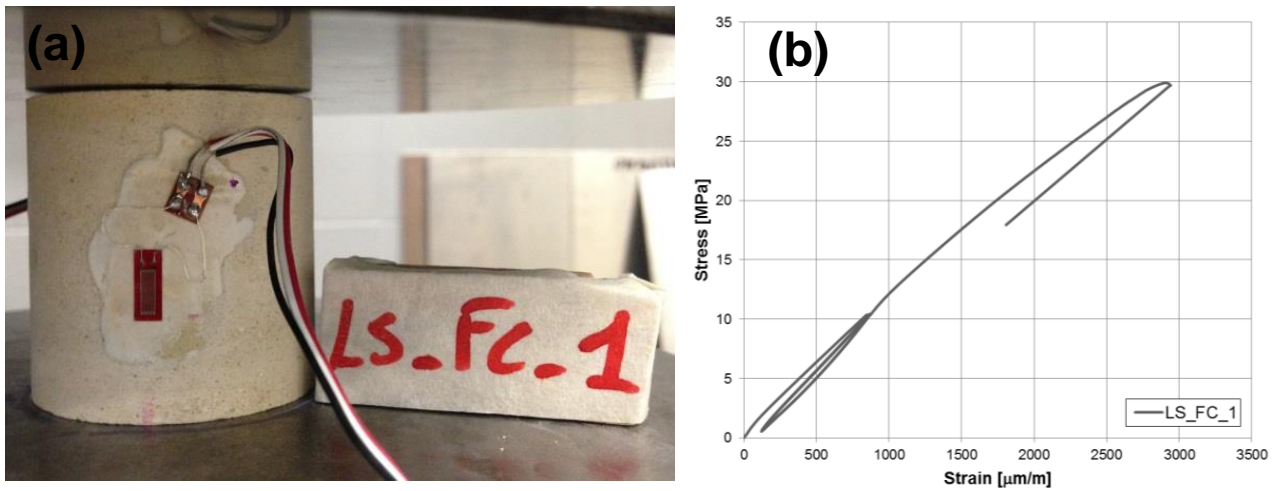
Fig. 3. Compression test on the substrate materials: a) a representative Lecce stone specimen before testing; b) its stress-strain curve.

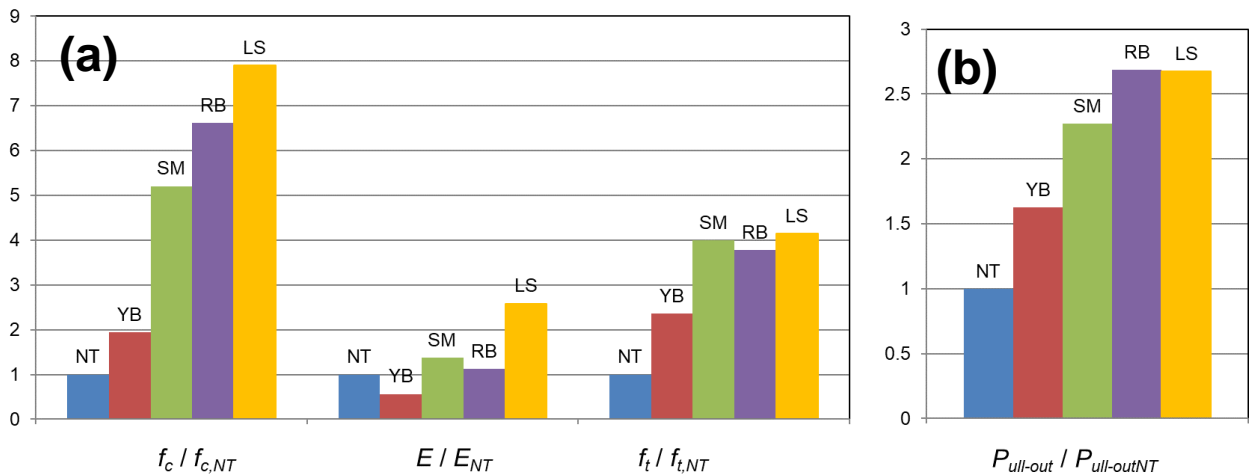
Fig. 10. Histograms of the: a) non-dimensional mechanical properties and b) non-dimensional pull-out loads for the different substrates with respect to those of Neapolitan tuff.

Analyzing the curves in Fig. 8 and the data in Table 3, it can be seen that the pull-out strength increases following the order $NT < YB < SM < LS < RB$ (being the difference between LS and RB within the dispersion of the results), i.e. following the order of increasing compressive strength of the substrates. This can be better observed in the histograms of Fig. 10, where the mechanical parameters (f_c , E and f_t) of the materials and the pull-out loads ($P_{pull-out}$) normalized with respect to the values of the NT series ($f_{c,NT}$, E_{NT} , $f_{t,NT}$ and $P_{pull-out,NT}$) are reported and compared. From this comparison, a clear correlation can be found between the pull-out load and the compressive strength of the materials. The material with the lowest compression strength is also the material with the lowest pull-out strength, and the same applies for the other substrates. It is clear that the compression strength plays a crucial role in the extraction of the bar, as the material in between the bar lugs during extraction is subjected to compression and shear. Additionally, from the weakest to the strongest material, the pull-out curves exhibit not only increasing maximum loads, but also larger and larger displacements at which the load drop occurred. In other words, the area under the curves increases. This is a very important aspect, as the area under the curves is correlated to the energy necessary for the bar extraction, so if the load drop is attained at higher slip/load values, more energy will be necessary to overcome the resistance to extraction for these materials. Interestingly, the last almost horizontal branch, in which the resistance to pull-out is just given only by friction, for all the substrate materials is basically overlapping.

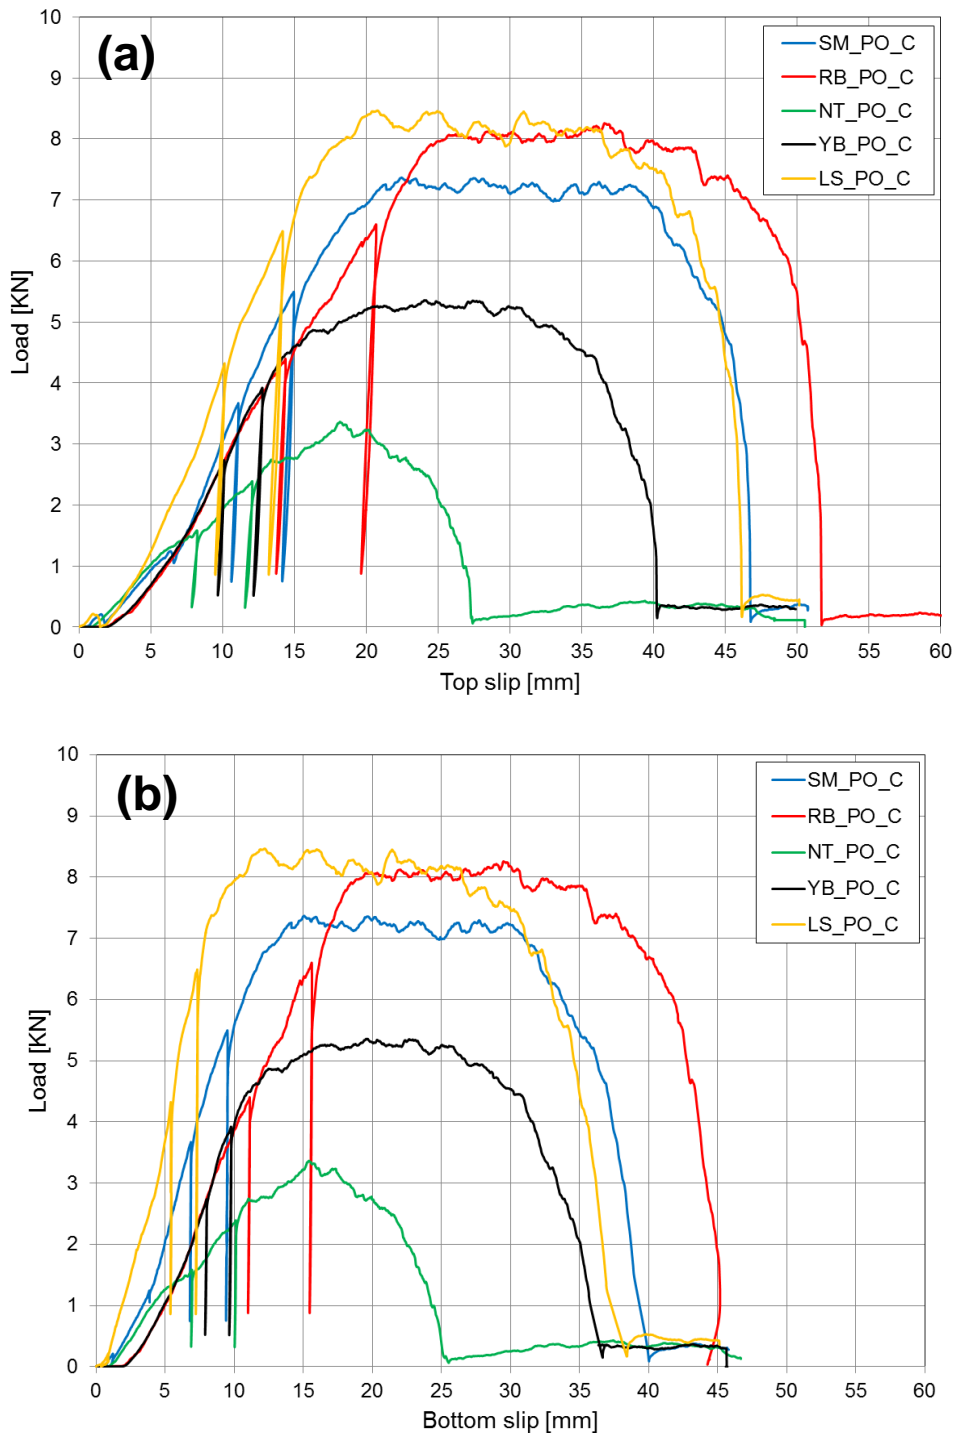
Fig. 11. a) Load-top slip curves and b) load-bottom slip curves for all the specimens which underwent two unloading and reloading cycles.

In Fig. 11a and Fig. 11b, the load - top and load - bottom slip curves of the specimens that underwent two unloading and reloading cycles are collected, respectively. The first unloading was performed at a load level equal to 50% of the expected pull-out load, and the second at 75%. Specimens were unloaded till the 10% of the average maximum load registered in the monotonic tests. The aim of considering such load pattern was to estimate its influence on the load bearing capacity of the connector, to get a preliminary insight on the bar performance in case of unloading and reloading cycles. A different behavior maybe observed when larger number of cycles are considered. Therefore, it should be noted that additional tests are necessary to mechanically characterize the bar behavior in presence of seismic actions, considering tensile-compression cyclic tests with a high number of repetitions.

Results are reported in Table 3, where it can be seen that the maximum load values of these specimens are consistent with the results of the monotonic tests. Both in the first and in the second cycle, when the load level reaches the level at which the unloading cycle has begun, the loading path is recovered and no modification on the load is registered, meaning that no degradation of pull-out strength due to the cyclic loadings is recorded. It should be noted that the unloading paths are almost perfectly vertical, highlighting an irreversible deformation of the bar and substrate as noticed in the monotonic tests due to the residual torsional strain and local crushing of the material substrate. As for the monotonic tests, all the specimens, except the NT one, exhibit a plateau section after the initial quasi-linear branch, followed by a sharp load decrease and final horizontal branch where the residual resistance to slip is given only by friction.

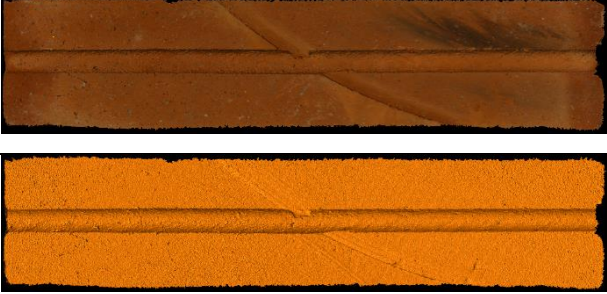
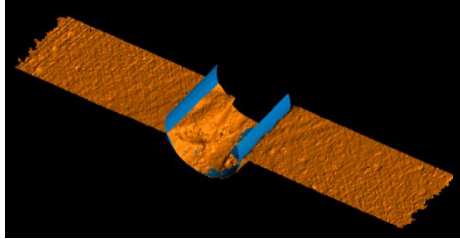
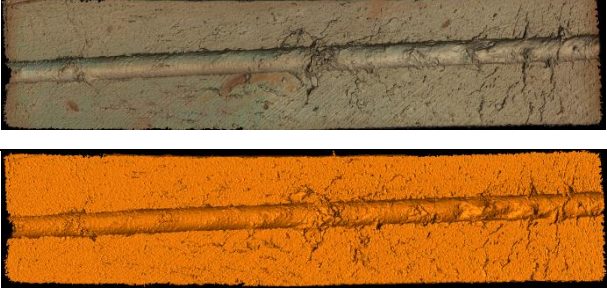
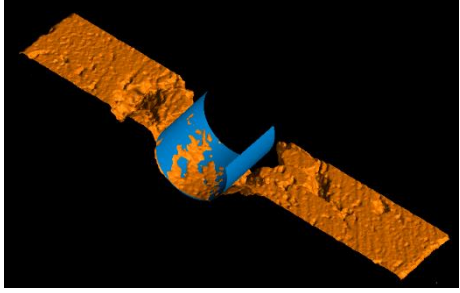
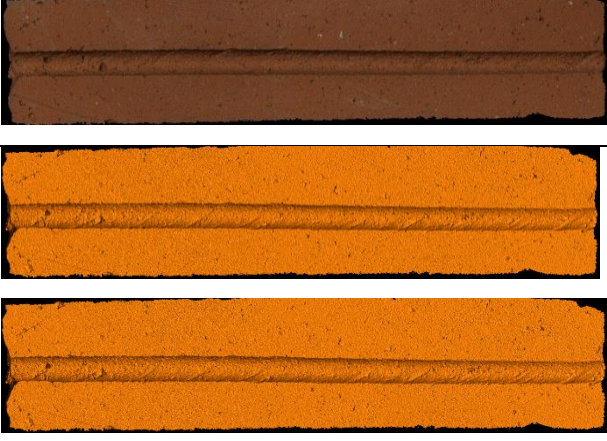
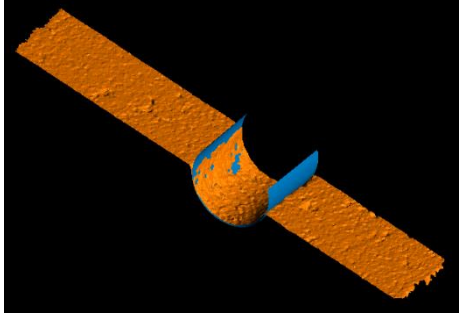
Fig. 12. Results of the 3D scanning analysis of the specimens.

average positive and negative values of the deviations (Avg^+ and Avg^- , respectively). In Fig. 12, the results obtained in terms of photo-textured 3D model, mesh in false colours and a portion of the mesh with the best-fit cylinder (represented in blue) are shown. It should be noted that the differences among the ideal cylinder diameters in the five substrates in Table 4 are limited, so these diameters can be considered basically comparable. The Avg^+ values, which may provide an indication about the depth of embedding of the ribs of the bar during its insertion (screwing) in the blocks, confirm that the penetration of the ribs in soft materials (YB and NT) is higher than in hard ones (especially LS), as expected. However, this deeper embedding in soft materials did not provide any additional pull-out resistance, as the low compressive strength of these materials was easily overcome during the bar extraction.
