Nanolime, nanosilica or ammonium phosphate? Laboratory and field study on consolidation of a byzantine marble sarcophagus

# NANOLIME, NANOSILICA OR AMMONIUM PHOSPHATE? LABORATORY AND FIELD STUDY ON CONSOLIDATION OF A BYZANTINE MARBLE SARCOPHAGUS

The present paper aims at comparing commercial nanolime and nanosilica dispersions with an aqueous solution of diammonium hydrogen phosphate (DAP) for consolidation of marble. The consolidants were first tested in the laboratory on artificially and naturally weathered marble specimens. The DAP-treatment applied by poulticing outperformed nanolime and nanosilica in terms of consolidating effectiveness, while showing good compatibility with the substrate. After preliminary testing of all the three consolidants on small areas of a byzantine marble sarcophagus, the DAP-treatment applied by poulticing was finally selected for application onto the whole sarcophagus. Field results confirmed the promising performance of the DAP-treatment.

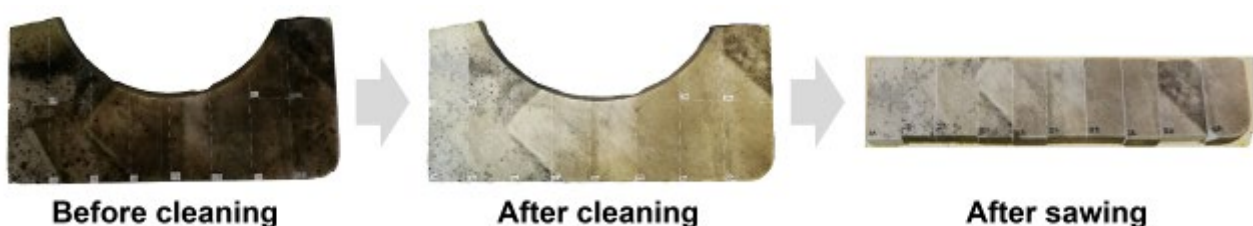
**Figure 3.** Naturally weathered slab, before and after cleaning, and “NAT” specimens.

In the case of the “NAT” specimens, visible color differences were present even before treatment (Figure 3), as a result of the different initial conditions and different cleaning methods applied in the various parts of the slab. Unfortunately, it was not possible to measure the color parameters of each specimen before and after consolidation, but the color difference could only be evaluated between untreated and treated specimens. However, evaluating the aesthetic effects of the consolidants by comparing specimens that originally had clearly visible differences would be scarcely significant. Therefore, the evaluation of the aesthetic compatibility of the treatments was based only on the results obtained on the “ART” specimens, which indicate that all the treatments can be considered as fairly compatible.

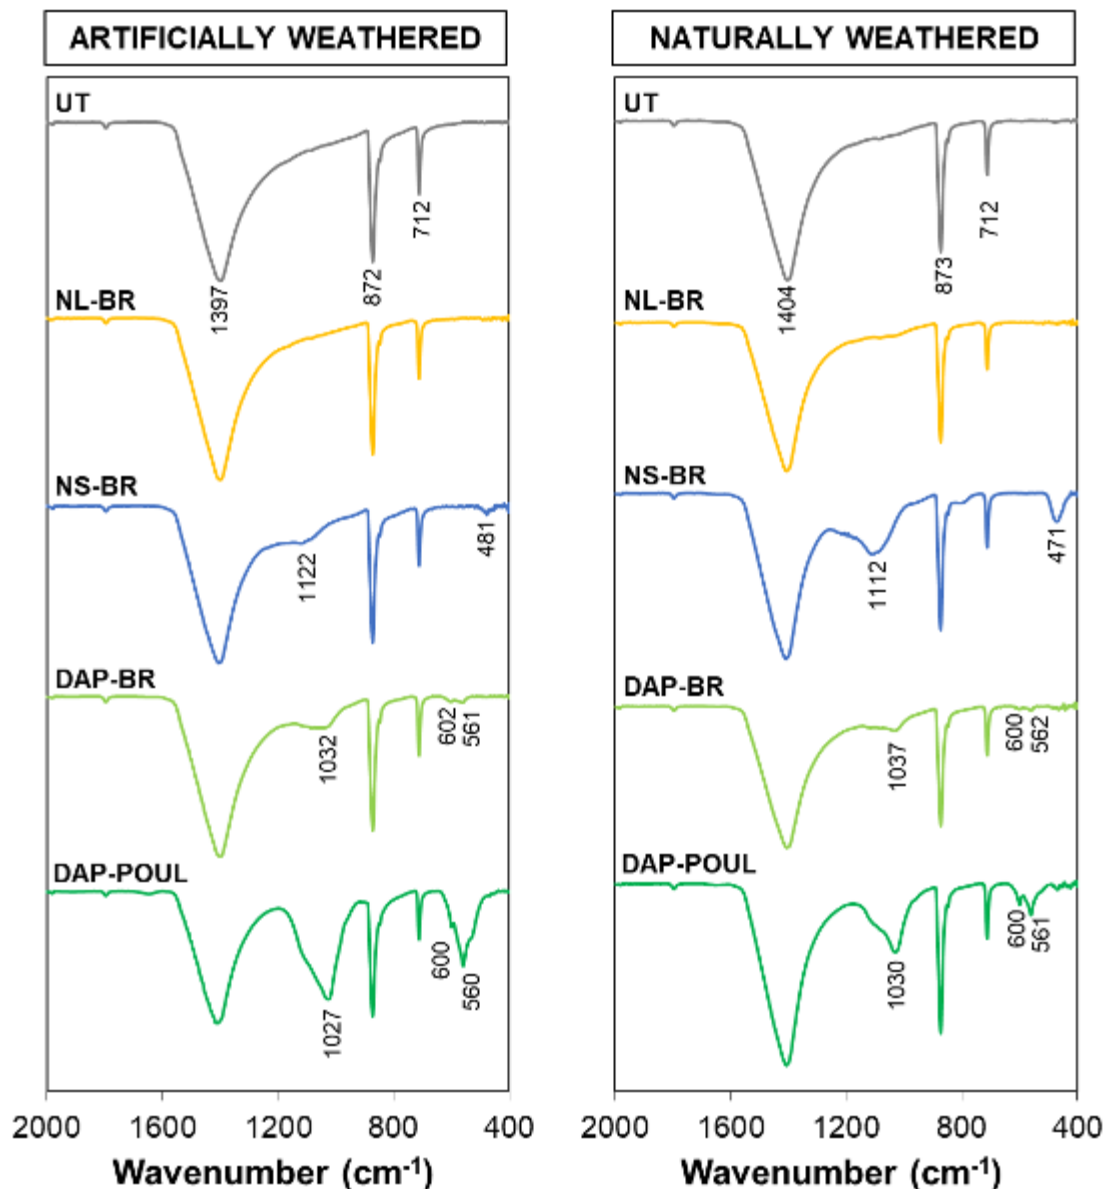
**Figure 6.** FT-IR spectra of untreated and treated specimens of artificially and naturally weathered marble (the position of bands owing to calcite is reported in the untreated reference and omitted in the treated samples for a better readability).

In the “UT” condition, the “NAT” samples exhibited visible surface etching (parallel grooves over the calcite surface) and presence of extraneous compounds (small acicular elements), which were not present in the “ART” samples, as expected. In both cases, calcite was the only phase detected by FT-IR, as indicated by bands at  $1397\text{-}1404\text{ cm}^{-1}$  ( $\text{CO}_3^{2-}$  asymmetric stretching [88]),  $872\text{-}873\text{ cm}^{-1}$  ( $\text{CO}_3^{2-}$  out-of-plane bending [88]) and  $712\text{ cm}^{-1}$  ( $\text{CO}_3^{2-}$  in-plane bending [88]).

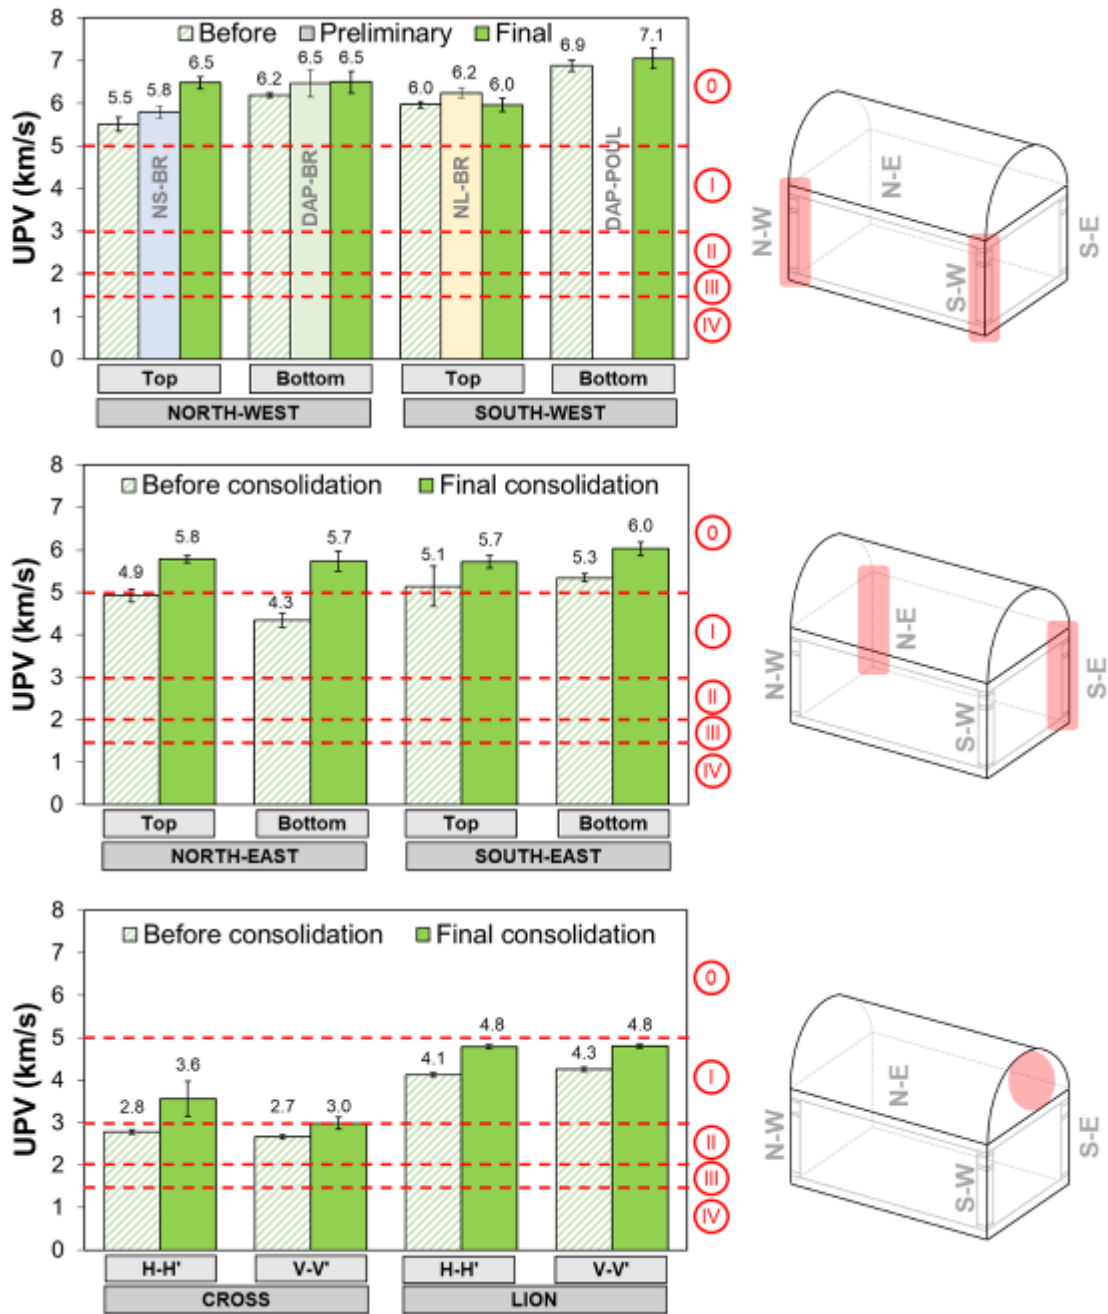
**Figure 13.** UPV of various parts of the sarcophagus (values are averages for 3 measurements, bars indicate the difference between the average and the maximum/minimum values): before consolidation (dashed bars); after preliminary consolidation by the various treatments (intermediate bars in the upper graph); after final consolidation by the “DAP-POUL” treatment (dark green bars).

The *UPV* values registered before consolidation in the different parts of the sarcophagus are reported in Figure 13 (dashed bars). Depending on the exposure, different conservation conditions were assessed in the different parts of the sarcophagus.

The west side (where preliminary field-testing was carried out) actually exhibited high *UPV* values (ranging from 5.5 to 6.9 km/s), corresponding to the “fresh marble” condition. In the east side, lower *UPV* values were registered, ranging from 4.3 to 5.3 km/s, hence close to the threshold of 5 km/s separating the “fresh marble” and the “marble with increasing porosity” conditions. In the south side, the lowest *UPV* values were registered (*UPV* ranging from 2.7 to 4.3 km/s), which is consistent with the greater solar radiation received by architectural elements facing south. The cross low relief exhibited *UPV* values of 2.7-2.8 km/s, indicating “marble with crumbling surface”. Such low *UPV* values can be explained considering that small carved elements are known to undergo more pronounced thermal weathering, as they follow temperature variations more closely than large massive elements [28]. Moreover, it should be noted that the cross low relief was tested by indirect surface method, which is strongly influenced by the damage condition of the most superficial layer of the tested element, although it is difficult to quantify the thickness of this layer. The lion head, tested by direct transmission method, gave *UPV* values of 4.1 to 4.3 km/s, corresponding to the condition of “marble with increasing porosity”.

The consolidating treatments were applied on small areas of the sarcophagus (cf. § 2.3.1), to evaluate the treatment performance in real conditions. The UPV increases in the tested areas are reported in the upper graph in Figure 13.

Nanolimes, nanosilica and DAP applied by brush all caused some increases in UPV, but in all cases the improvements were actually quite modest (maximum  $\Delta UPV = 0.3$  km/s). While nanolimes and nanosilica exhibited modest consolidating ability also in the

After consolidation by the “DAP-POUL” treatment, the *UPV* values measured in all the parts of the sarcophagus characterized before consolidation (i.e. the four edges, at two different heights, the cross low relief and the lion head) are illustrated in Figure 13 (dark green bars). In general, the “DAP-POUL” treatment caused significant *UPV* increases, the improvement varying as a function of the initial weathering condition.

In the west side, where marble was initially in a better conservation state than the other parts of the sarcophagus, the lowest *UPV* increases were registered ( $\Delta UPV = 0$  to 1 km/s). In the east side, where in some areas marble was in the “increasing porosity” condition, higher improvements were found, reaching  $\Delta UPV = 1.4$  km/s in the most damaged part. After consolidation, all the investigated areas in the east side reached the “fresh marble” condition. In the south side, the carved elements that initially exhibited the lowest *UPV* values underwent improvements up to  $\Delta UPV = 0.8$  km/s. In this way, even the most damaged area (the cross low relief) improved its condition from “crumbling surface” to “increasing porosity”.

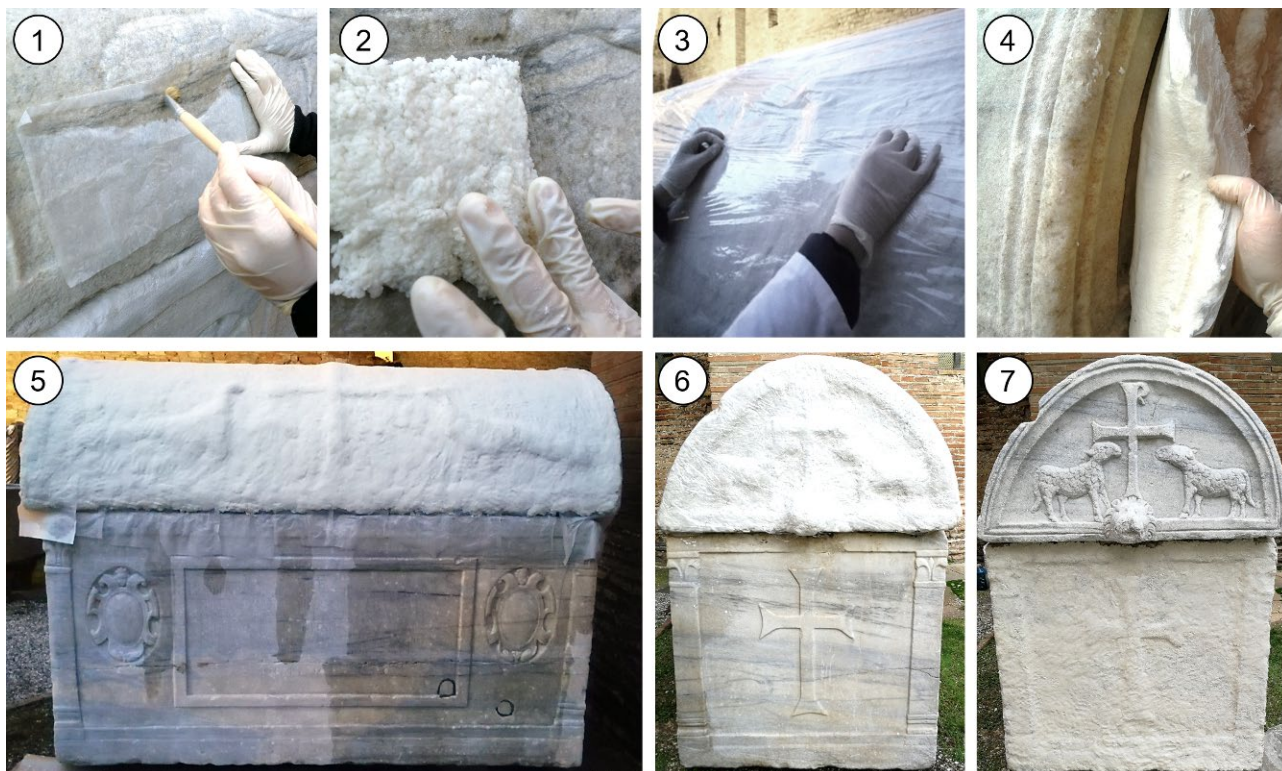
**Figure S1.** Consolidation of the sarcophagus by ammonium phosphate: (1) application of Japanese paper onto the marble surface by wetting with the DAP solution; (2) application of the poultice imbued with the DAP solution; (3) wrapping with a polyethylene film to prevent evaporation; (4) removal of the poultice after 24 hours; (5) view of the cover after application of the poultice; (6) view of the cover after wrapping with the polyethylene film; (7) application of the poultice onto the lower part of the sarcophagus.
