Identifying archaeological evidence of past earthquakes in a contemporary disaster scenario: case studies of damage, resilience and risk reduction from the 2015 Gorkha Earthquake and past seismic events within the Kathmandu Valley UNESCO World Heritage Property (Nepal)

Abstract The 2015 Gorkha Earthquake was a humanitarian disaster but also a cultural catastrophe that damaged and destroyed historic monuments across Nepal, including those within the Kathmandu Valley UNESCO World Heritage Property. In the rush to rebuild, traditionally constructed foundations are being removed and replaced with modern materials without assessments of whether these contributed to the collapse of a monument. Generally undertaken without scientific recording, these interventions have led to the irreversible destruction of earlier subsurface phases of cultural activity

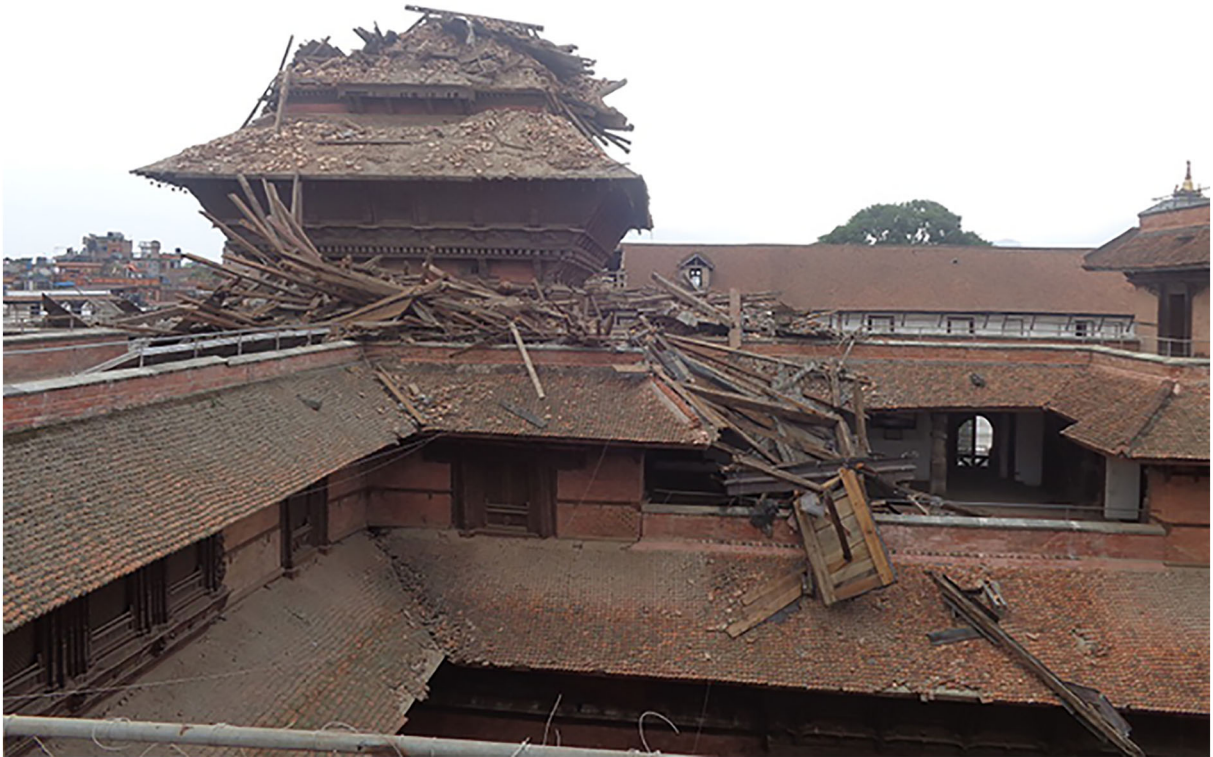
Fig. 2 Damage to the nine-storey palace in Hanuman Dhoka after the 2015 Gorkha Earthquake (image: Kai Weise)

As noted above, the 2015 Gorkha Earthquake damaged 691 historic buildings across Nepal, including monuments located within Kathmandu's UNESCO World Heritage Property, with many collapsing (Fig. 2). Initial damage assessment and salvage efforts were undertaken by the newly established Earthquake Response Coordination Office within the Department of Archaeology (Government of Nepal), which was followed by the preparation of a Post-Disaster Needs Assessment (Weise et al. 2017: 72). Completed on the 10th of June 2015 by the Department of Archaeology and UNESCO Kathmandu, the Post-Disaster Needs Assessment (PDNA 2015) estimated the damage to Nepal's cultural heritage at about US\$169 million, with an associated loss of US\$23 million from damage and impact on livelihoods (PDNA 2015: 1). As major visitor attractions, partially accounting for the 7.6% of GDP generated by tourism to Nepal's Gross Domestic Product, and as foci for veneration, community gatherings and local markets, damaged heritage sites were subject to a major programme of consultation, reconstruction and conservation.

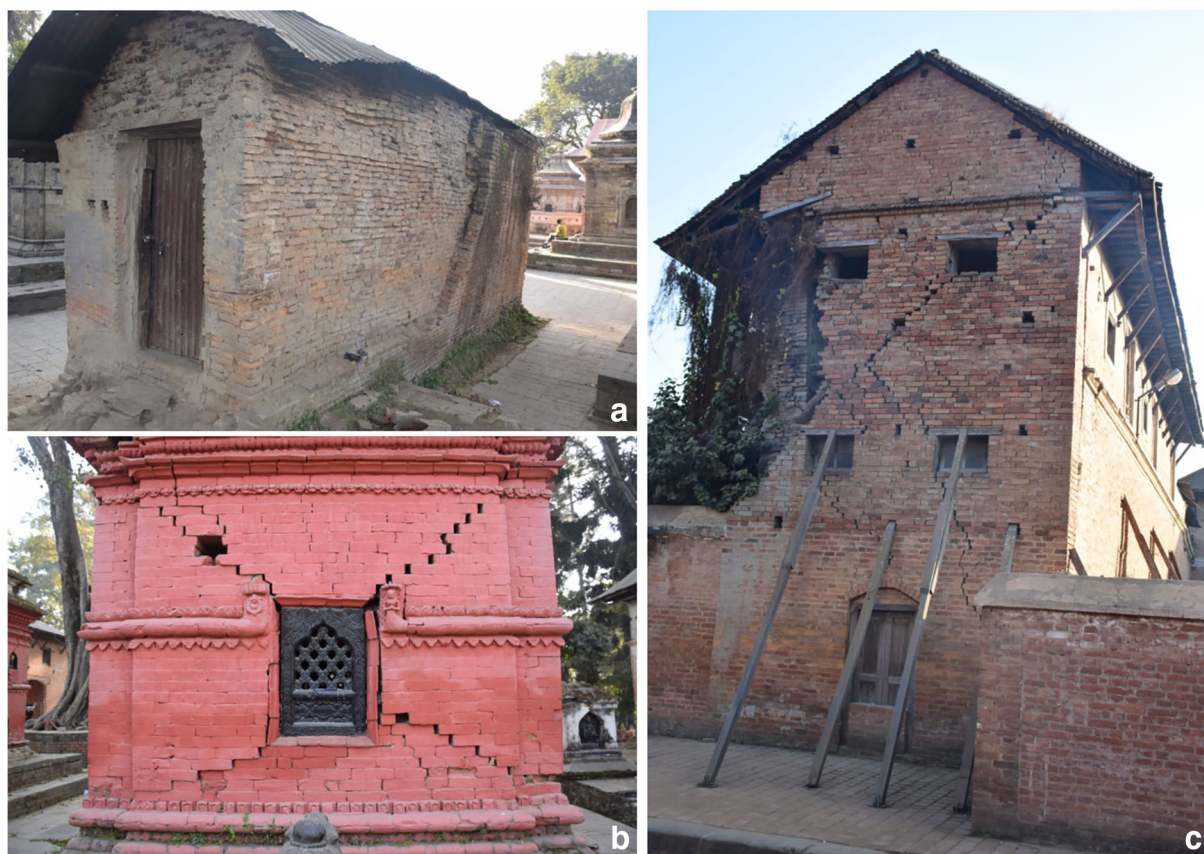
Fig. 3 Tilted wall at a structure at Mrigasthali in Pashupati (a); ‘X’ fracture through a brick built shrine at Mrigasthali in Pashupati (b); shear cracks through one of the walls within Bhaktapur Palace Complex (c)

Tilted walls, close to collapse, were found at several structures, including a clear example at a building within the Mrigasthali area of Pashupati (Fig. 3a). Of monuments where full collapse had not occurred, fractured walls, including shear cracks and 'X' fracture patterns through wall facades were common at stone and brick structures, particularly wood-framed buildings with brick infills. Occasionally, these cracks were caused by wall extrusions across the facades of structures. Examples of fracturing were found, but were not limited to, structures in Mrigasthali (Fig. 3b), the Jagannath temple in Hanuman Dhoka's Durbar, or palace, Square and at structures within Bhaktapur's palace complex (Fig. 3c). At Pashupati, in some instances, it was possible to identify vertical cracks linked to the displacement of walls. More complex patterns of cracks were identified at the Shiva temple located within Hanuman Dhoka Durbar Square. Here, there was evidence of composite shear cracks associated with the extrusion of a wall, with the wall profile also appearing to be folded. Such seismic damage patterns are caused by horizontal motion, but there was also a strong vertical component present, testified by sub-vertical fractures penetrating vertically. These EAEs were found at the base of the shrine, which is not entirely surprising due to

this being the location where architectural stresses would be higher. Extrusions and the shifting of masonry blocks was also identified, both at collapsed monuments such as the Vatsala Temple in Bhaktapur (Coningham et al. 2016b), but also within the lion statues that are located just within the western gateway of Bhaktapur’s Durbar Square, which now flank the entrance to the Shree Padma Secondary High School (Fig. 4).

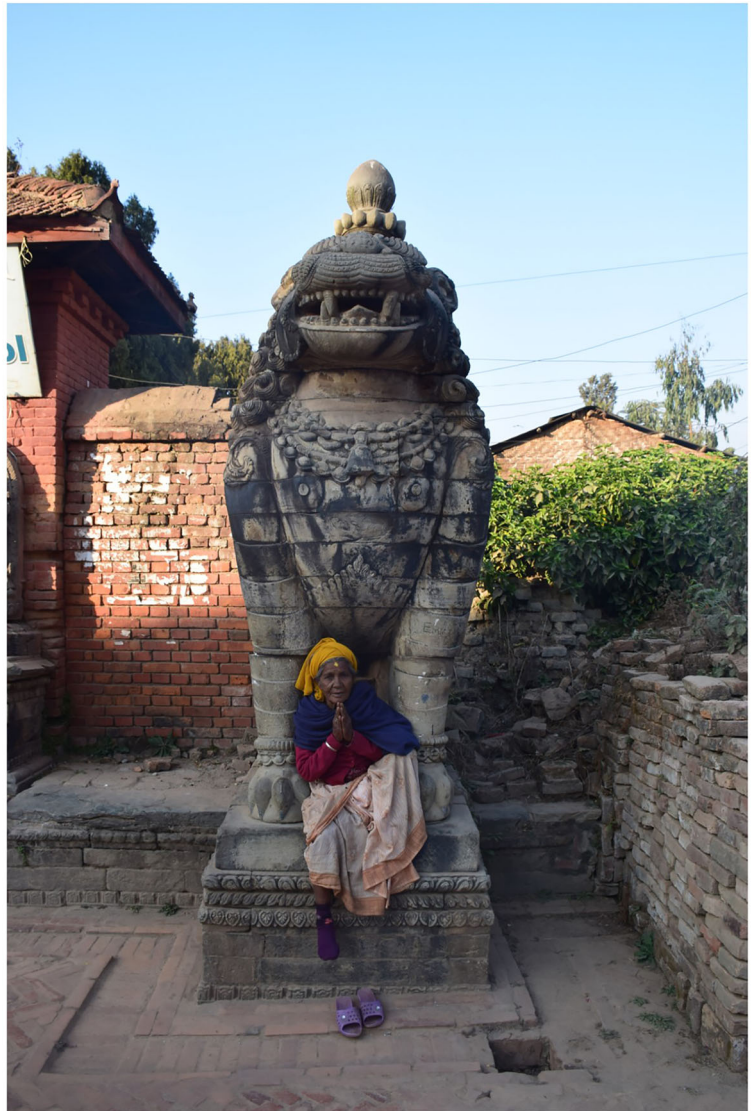
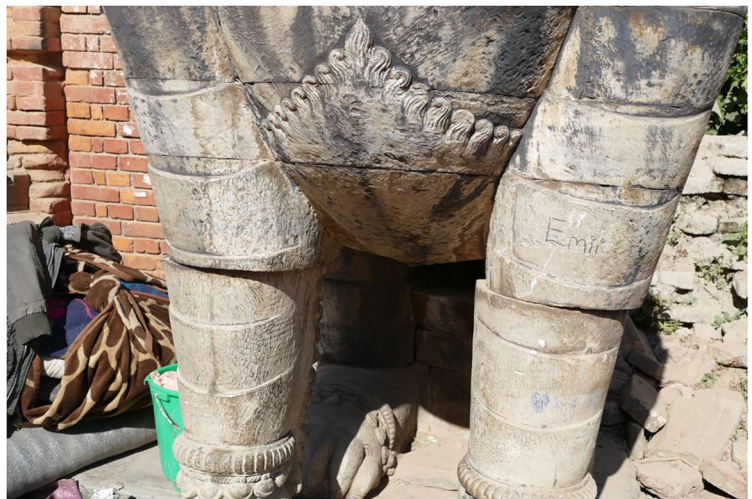
Fig. 4 Shifted and extruded stone blocks in a lion sculpture at Bhaktapur

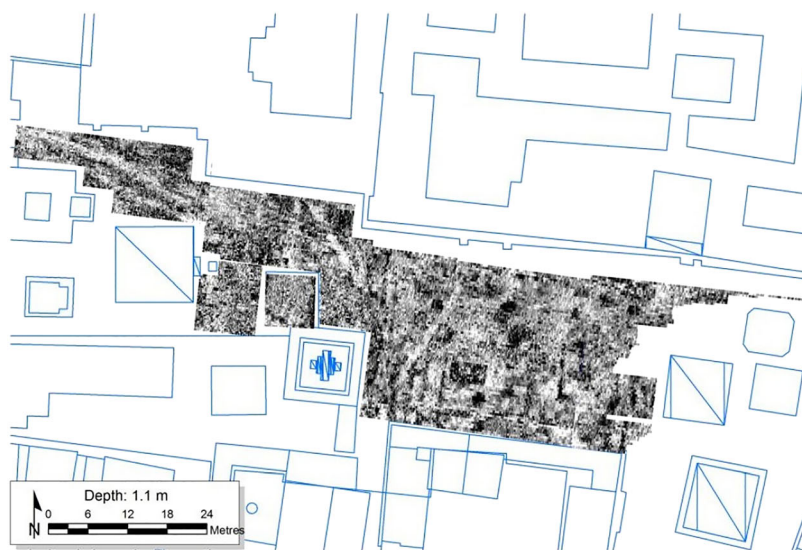
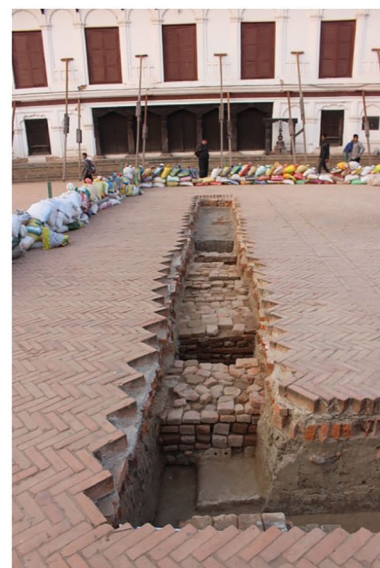
Fig. 5 GPR survey results at Bhaktapur Durbar Square at 1.1-m depth (left) and walls identified through excavation below the paved square (right)

This was clearest in Bhaktapur’s Durbar Square, where several rectilinear anomalies were identified. Their shape, size and overall layout suggest walls for a building that may have stood in this place. Excavations across the Durbar Square identified several east-west and north-south wall alignments, sealed below herringbone paving thought to be laid after the 1934 Bihar Earthquake (Fig. 5). The location and nature of these features suggest that these remains most likely represent the foundations of the Lamupati, a two-storey *sattal* (Coningham et al. 2016b). Known from early twentieth-century photographs as well as watercolours painted by Henry Ambrose Oldfield and drawings by Rajman Singh from the mid-nineteenth century, this structure with a postulated construction date of c. 1750 CE (Bajracharya et al. 2016: 82, 85) collapsed in the 1934 earthquake and was not rebuilt. The levelling of damaged structures, which were then sealed below what became open spaces, is not unique to the Kathmandu Valley and is a reaction to earthquakes that have been noted in medieval Europe. For example, in Padua, Italy, within the Piazza Duomo, damaged structures were levelled and overlaid with paving during a programme of redevelopment in response to an earthquake dated to 1117 CE (Forlin and Gerrard 2017: 99).

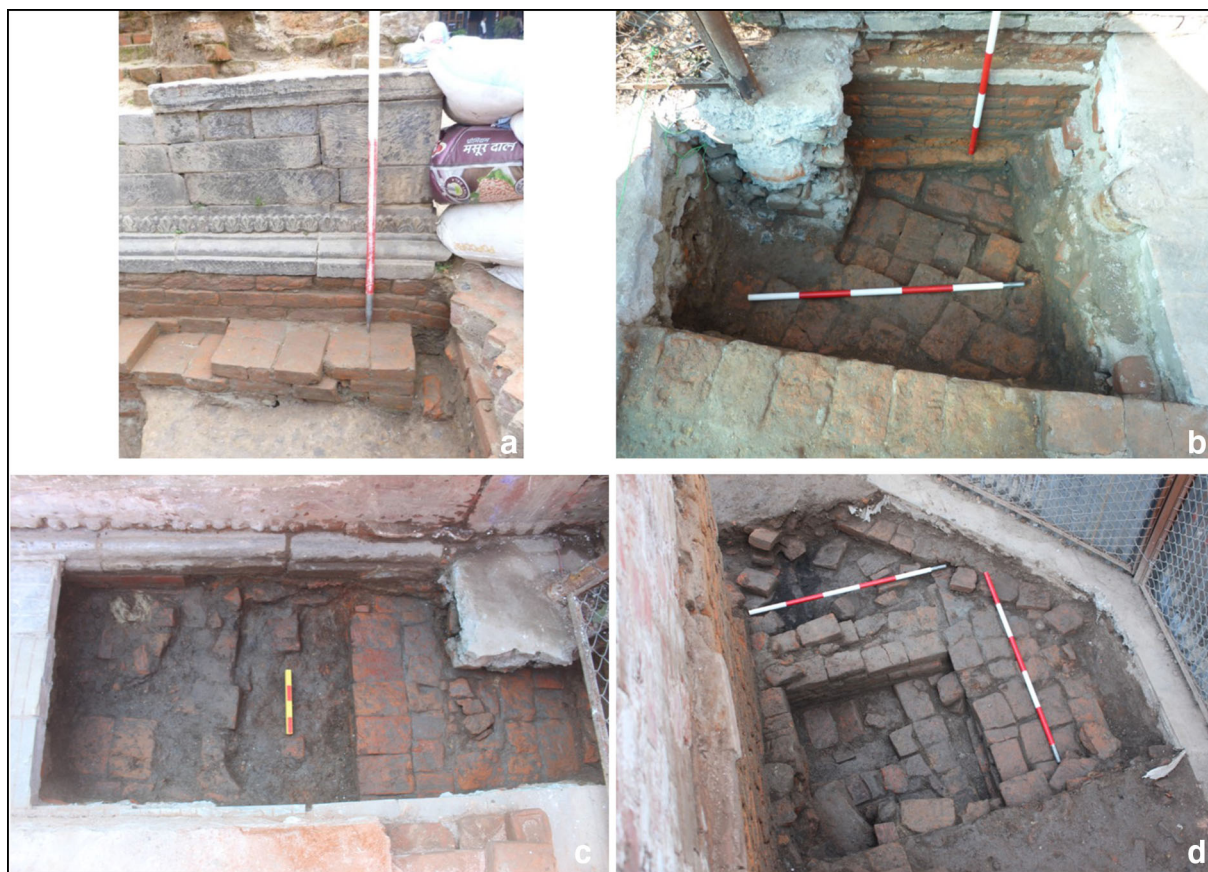
Fig. 6 The current footprint of the Vatsala Temple in Bhaktapur overlaying and overhanging an earlier brick foundation (a); a large brick wall on a differing alignment running under the plinths of the

Maju Dega Temple, Hanuman Dhoka (b); a structure located below the Trailokiya Mohan Temple to the east (c); and a further structure identified to the south (d)

Furthermore, our archaeological investigations have demonstrated that several current standing structures were erected directly on top of earlier phases. For instance, the footprint of the current stone-clad Vatsala temple within Bhaktapur's Durbar Square, thought to date to between the late seventeenth and early eighteenth century CE (Korn 2014: 29–33, 44, Basukala et al. 2014: 33), is off-set from the brick foundations below. These foundations step out to the west, whilst the superstructure overhangs this lower alignment to the south (Fig. 6a). This suggests the strong possibility of two quite separate phases of construction (Coningham et al. 2016b). Similarly, within Hanuman Dhoka's Durbar Square, we found that the current monumental plinths of the Maju Dega (Fig. 6b) and Trailokiya

Mohan Temples (Fig. 6c, d) had been built directly over earlier phases of construction (Coningham et al. 2018: 165). The scientific date for a structure identified running under the west of the Trailokiya Mohan temple, extracted from an Optically Stimulated Luminescence sample of the soil forming the wall's construction surface, was 1040 ± 120 CE. This is around 600 years prior to the traditional date of 1679 CE for the monument constructed above. This earlier wall may relate to a monument that was cleared to make way for its development (Hutt 1994: 85), although whether this earlier monument was damaged by earthquakes is not clear as the traditional construction date is slightly prior to the historic record of the 1681 CE earthquake. Such a scenario may be more plausible for the Maju Dega temple, with construction traditionally ascribed to 1690 CE (Hutt 1994: 88), and would link to the proliferation of large stepped plinth temples in the Kathmandu Valley in the late seventeenth century (Tiwari 2009). However, without historic records and until clearer scientific dating sequences are available, such an assertion is conjectural and it is not possible to link these episodes of levelling or reconstruction definitively as responses to seismic events. However, it remains a possibility alongside other opportunistic reasons for remodelling urban space.

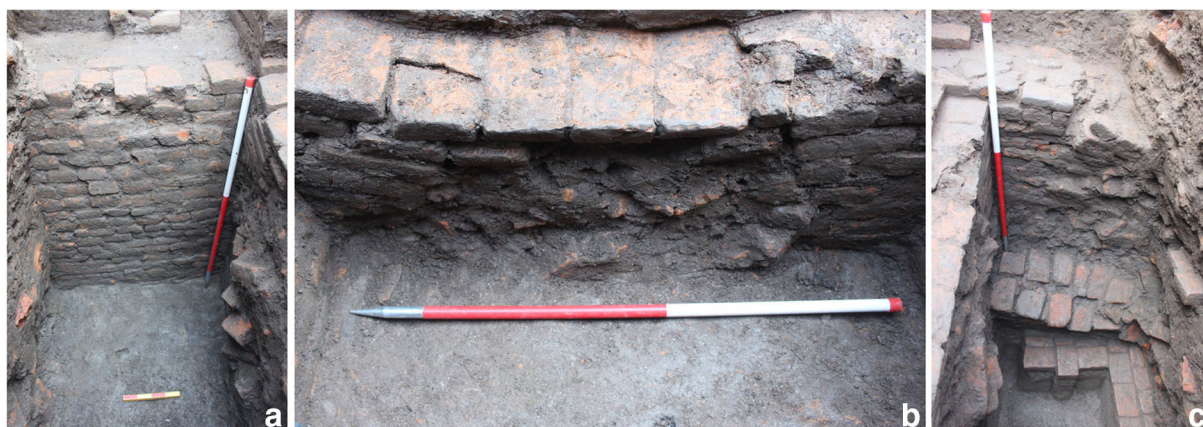
Fig. 8 Trench to the southwest of Jaisidewal Temple, with sequence of brick walls exhibiting shear crack and slight extrusion (a); tilting and collapse (b); crack and collapse of upper wall; and tilting of lower wall below (c)

To the southwest of the temple, a further trench was opened to record archaeological sequences prior to the drilling of geotechnical boreholes into natural soil profiles. Here, we identified a series of earlier brick wall alignments exhibiting EAEs, though unfortunately it was not possible to provide specific scientific dates for when this damage occurred. An east-west running wall, which was one brick thick, exhibited a shear crack and slight extrusion (Fig. 8a). A further brick wall running north-south, to the east of the alignment with the shear crack, tilted towards the west with several courses collapsing in antiquity to form a rubble spill (Fig. 8b). This wall was then abutted at its south by an east-west wall, which was fractured, with a large crack causing the wall to displace, break in two and lean outwards towards the northwest. Directly below this wall, and from an earlier phase, was an earlier east-west brick wall alignment, which also leaned and tilted towards the north (Fig. 8c). Though archaeological evidence for such damage may not always relate to earthquakes (Ambraseys 2006: 1009), a number of factors support this hypothesis. Not only located within

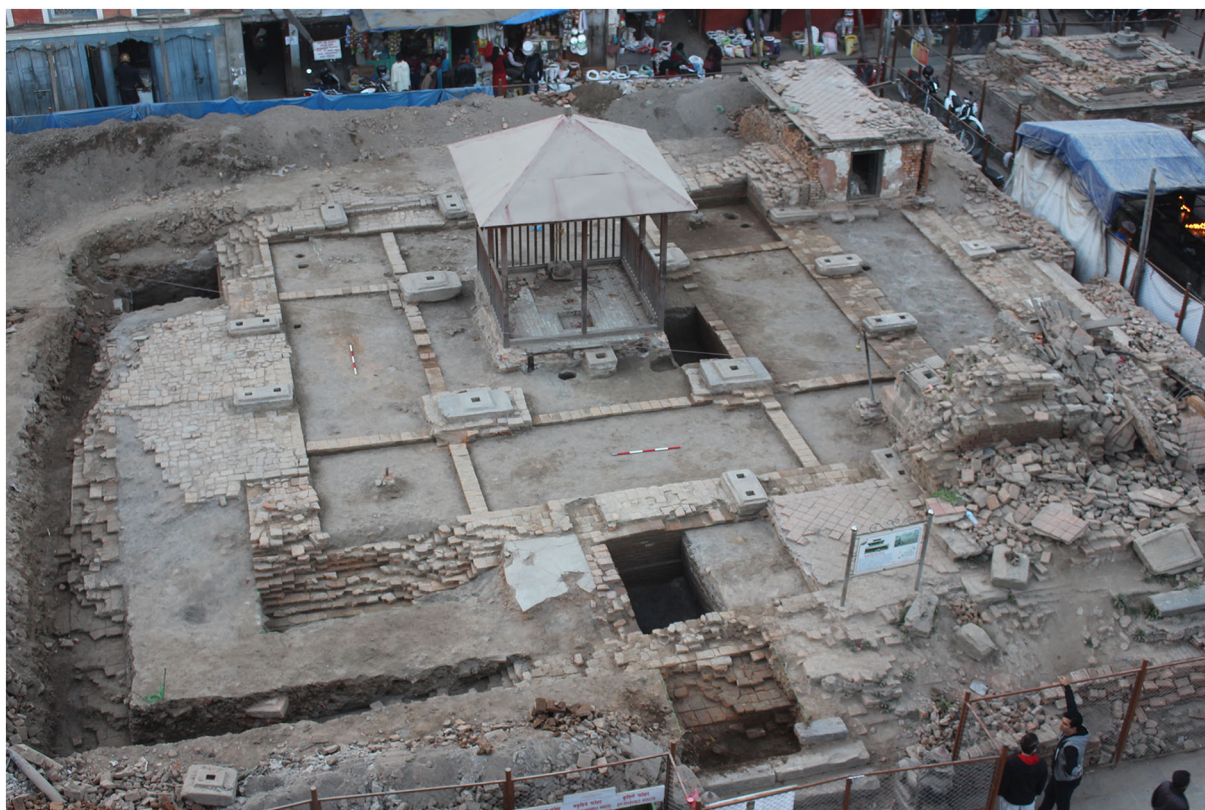
Fig. 9 Nine-celled mandala formed through brick-piers, foundation wall and cross-walls uncovered during archaeological assessments at the Kasthamandap

Collapsing during the hosting of a temporary blood donation clinic, efforts to recover the trapped, injured and dead included the use of heavy machinery. During our excavations, we found evidence of the damage caused by this post-earthquake emergency intervention in the form of dug-out foundations and scrape marks scoring the surface of the tiled floor (Coningham et al. 2016d). This floor had been laid around several saddle stones, which contained sockets to interconnect with the tenons of the wooden superstructure. In particular, the four major wooden pillars of the Kasthamandap were linked to four large saddle stones around the central Gorakhnath shrine. Excavations revealed that these saddle stones sat on brick piers set in mud mortar, each 2 m deep. These were surrounded by a large squared 12×12 -m foundation wall, also 2 m deep and constructed from brick and mud mortar, with smaller double saddle stones placed on its surface to link to the timber superstructure (Fig. 9). We identified that the large saddle

We also identified that the monument may have had been designed with inbuilt cosmological protection, as cross-walls, scientifically dated to 200 years after the monument's original construction, running between the brick piers and foundations, forming a nine-celled mandala design (a representation of the universe in microcosm). These cross-walls may have also formed some aspect of seismic bracing for the foundations. It has further been identified that the infills deposited within

the ‘cells’ formed by the cross-walls were purposefully prepared with soils and materials brought from outside. Preliminary geoarchaeological analysis suggesting that these deposits may have aided earthquake dampening for the monument’s foundations, and the thoughtful compositions of soils placed within the monument’s foundations may have taken on a symbolic significance, which has been recorded in textual sources (Coningham et al. 2019: 63). Further cosmological protection was identified with the recovery of gold foil discs with mandala designs within each of the sockets of the central saddle stones (Coningham et al. 2016d). Such deposits may have provided a ‘life-breath’ to a building and afforded its protection, as well as the prosperity and welfare to those performing the ceremony during the construction of a monument (Slaczka 2007: 84, 201).

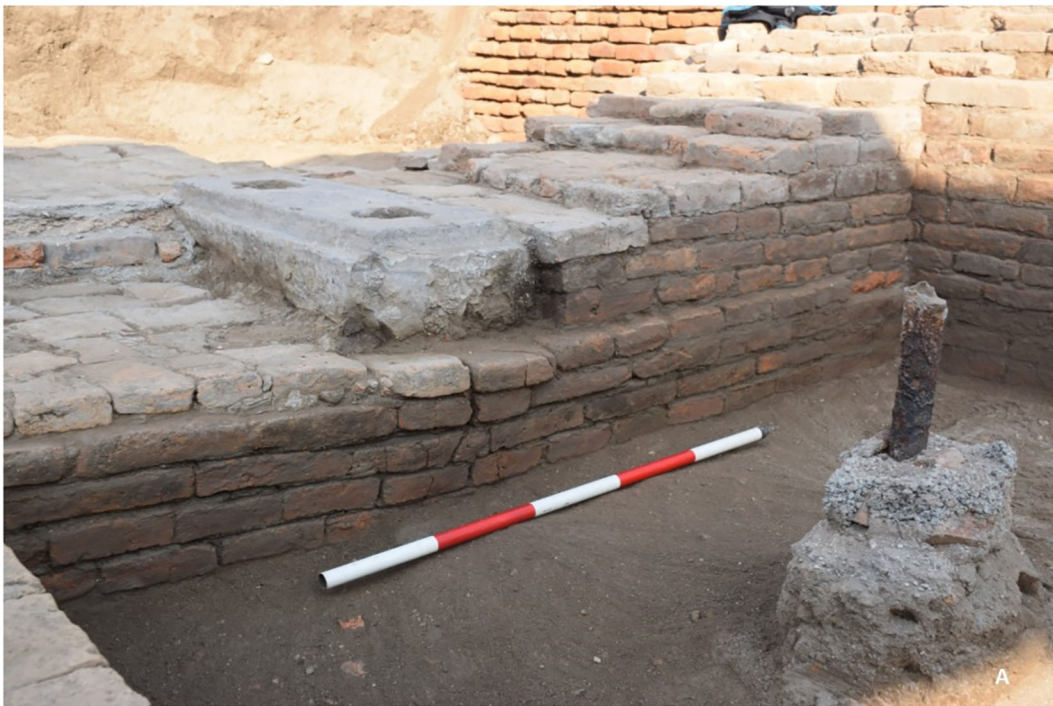
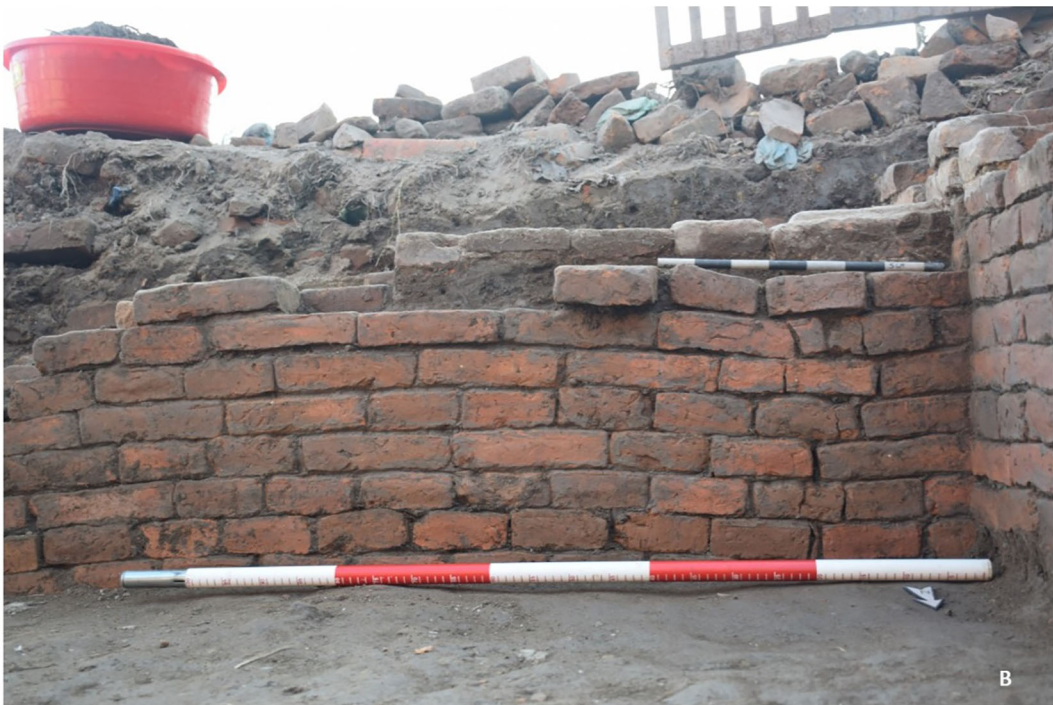
Fig. 10 Vertical cracks identified below a double saddle stone in the foundations of the Kasthamandap (a) and below a saddle stone in the foundations of the Gurujyu Sattal, Pashupati (b)

It would appear that the use of mud mortars within the foundations allowed for flexibility of the monument during seismic events. The only damage that could be linked to earthquakes was the identification of short vertical cracks located below a double saddle stone on the western length of the main foundation of the structure. Limited to the upper courses, it indicates stress of the load of the saddle stone and its interlinked superstructure, primarily induced by the pressure of vertical movement during a seismic event, causing the foundation below to be damaged (Coningham et al. 2018: 171; Fig. 10a). This also indicates that potential areas of stress and damage were minimised and localised, rather than causing catastrophic failures. It is likely that such a design with mud mortar brick masonry foundations linked to saddle stones and the superstructure above was designed to save the structure from further seismic stress, limiting damage to a few specific locations. Similar damage patterns and deformation of brickwork were also identified during excavations at the Gurujyu Sattal

at Pashupati (Fig. 10b). Again, the load of the timbers placed within the saddle stones, which were bonded by mud mortar to the brick foundations, caused small concentrated areas of vertical cracks below.
